General  
Technical  
Report  
FPL-GTR-159

# Condition Assessment of Timber Bridges

## 1. Evaluation of a Micro-Drilling Resistance Tool

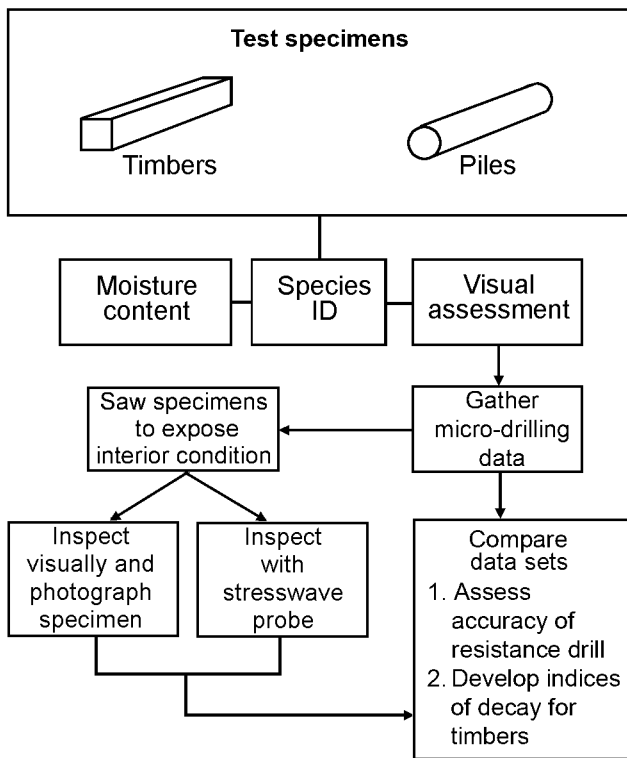
**Figure 1—Stages of this study**

This study was accomplished in several stages (Fig. 1). Several types of data were collected on the timber specimens in their original (unsawn) condition. First, the timber specimens were tested to determine moisture content and wood species. Second, the bridge timbers were visually inspected to locate deteriorated areas. Last, micro-drilling resistance measurements were collected from each of the timber bridge specimens.

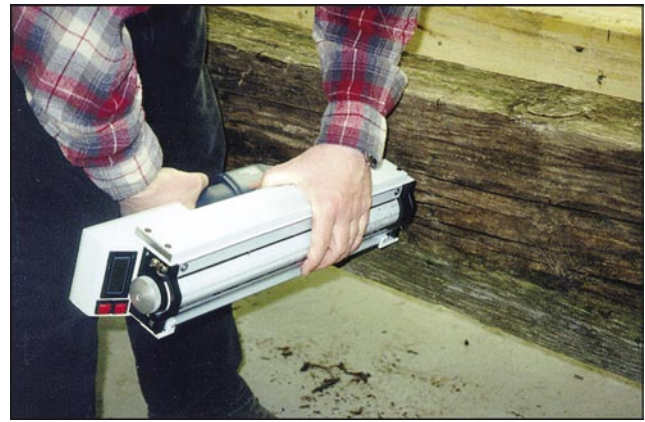
**Figure 2—IML RESI F300-S in use.**

The IML RESI F300-S micro-drilling device was used in this study to assess decay in the timber specimens (Fig. 2). The IML RESI F300-S performance is based on a micro-drilling resistance measuring method. A steel drilling bit 12 in. (305 mm) long with a diameter of 0.06 to 0.12 in. (1.5 mm to 3.0 mm) penetrates the wooden structure at a uniform speed while drilling resistance is measured. The measured resistance data (recorded on a relative 0–100% scale) is recorded on a wax paper strip at a scale of 1:1, printed, or captured electronically for downloading to a personal computer. The small-diameter drilling bit results in minimal damage to bridge components.

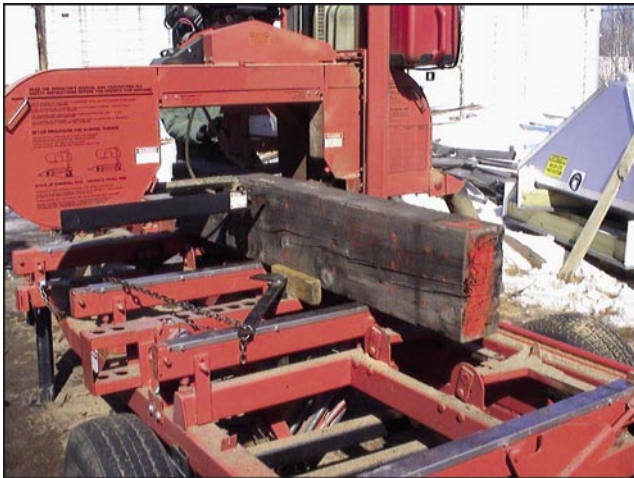
**Figure 4—Portable band saw cutting timbers lengthwise along measurement lines.**

Following the micro-drilling testing, each specimen was cut into slices using a portable band saw (Fig. 4). Each timber was cut along the measurement lines A, B, and C. Each section was then laid out so that interior faces could be visually assessed and documented with digital photographs. In addition, each sawn piece was evaluated using a stress-wave probe to determine the presence and extent of internal decay, checks, and splits.

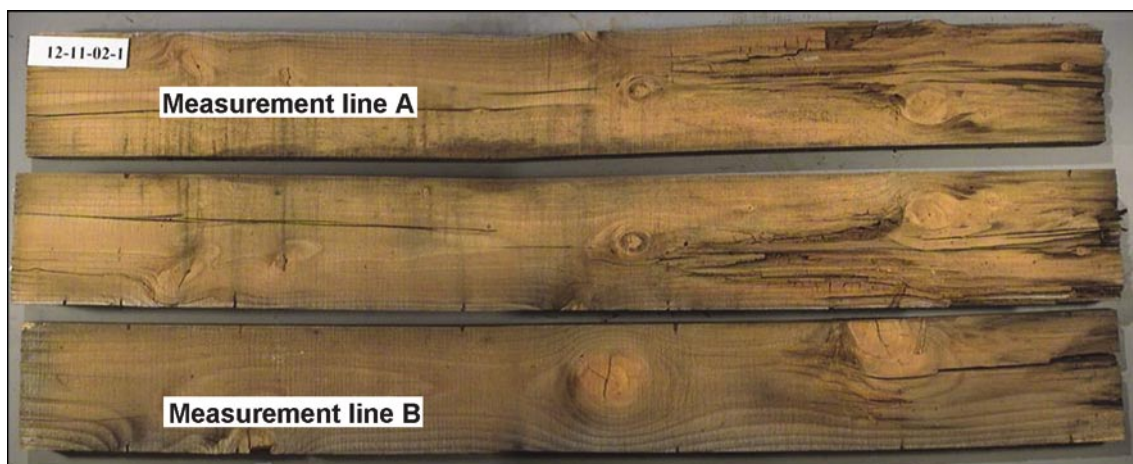
**Figure 5—Typical sawn timber specimen layout for photographic documentation.**

Figure 5 demonstrates how the samples were typically laid out for visual assessment and documentation. The top board corresponds with data collected along measurement line A. The bottom board corresponds with data collected along measurement line B.

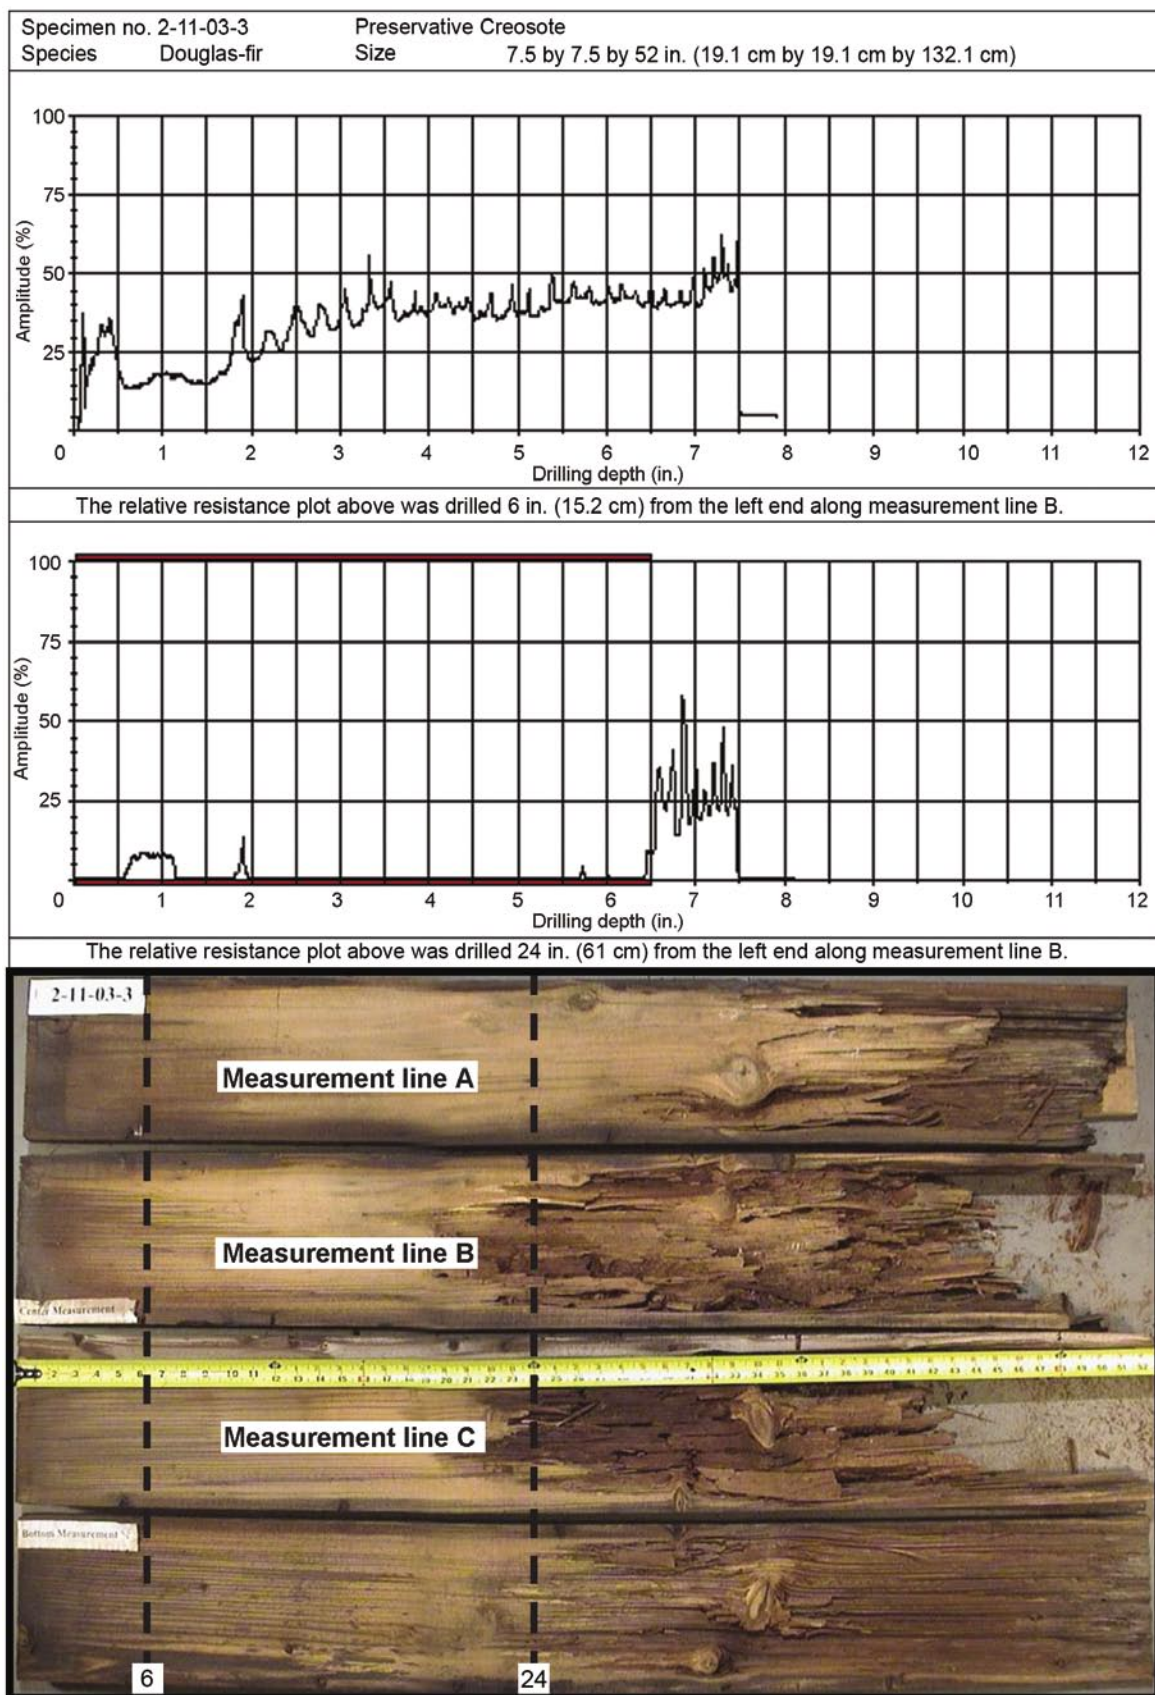
Figure 6—Comparison of resistance micro-drilling plots and interior photographs of bridge timber 2-11-03-3 reveals an example of severe deterioration. (Dashed lines denote drilling lines. Red bars at top and bottom of plots denote deterioration zones.)

Figure 6 illustrates typical results obtained from a test specimen that was severely deteriorated. Resistance plot data collected at the 4-in. (10.2-cm) drilling location along measurement line B shows severe deterioration for the first 6.5-in. (16.5-cm) drilling depth and has been marked with red bars at the top and bottom. Figure 7 illustrates typical results obtained from a test specimen that was moderately deteriorated. Resistance plot data collected at the 12-in. (30.5-cm) drilling location along measurement line B shows the effects of an internal check at nearly 6-in. (16.5-cm) drilling depth and has been marked with red bars at the top and bottom. Also, resistance plot data collected at the 24-in. (61-cm) drilling location along measurement line B shows moderate deterioration from 6.5-in. (16.5-cm) to 9.5-in. (24.1-cm) drilling depth and has been marked with red bars at the top and bottom. In contrast, Figure 8 illustrates typical results obtained from a test specimen that was sound wood, with no deterioration. An overall analysis of data from all 36 timber specimens led to the development indices of decay for the test specimens, as follows:

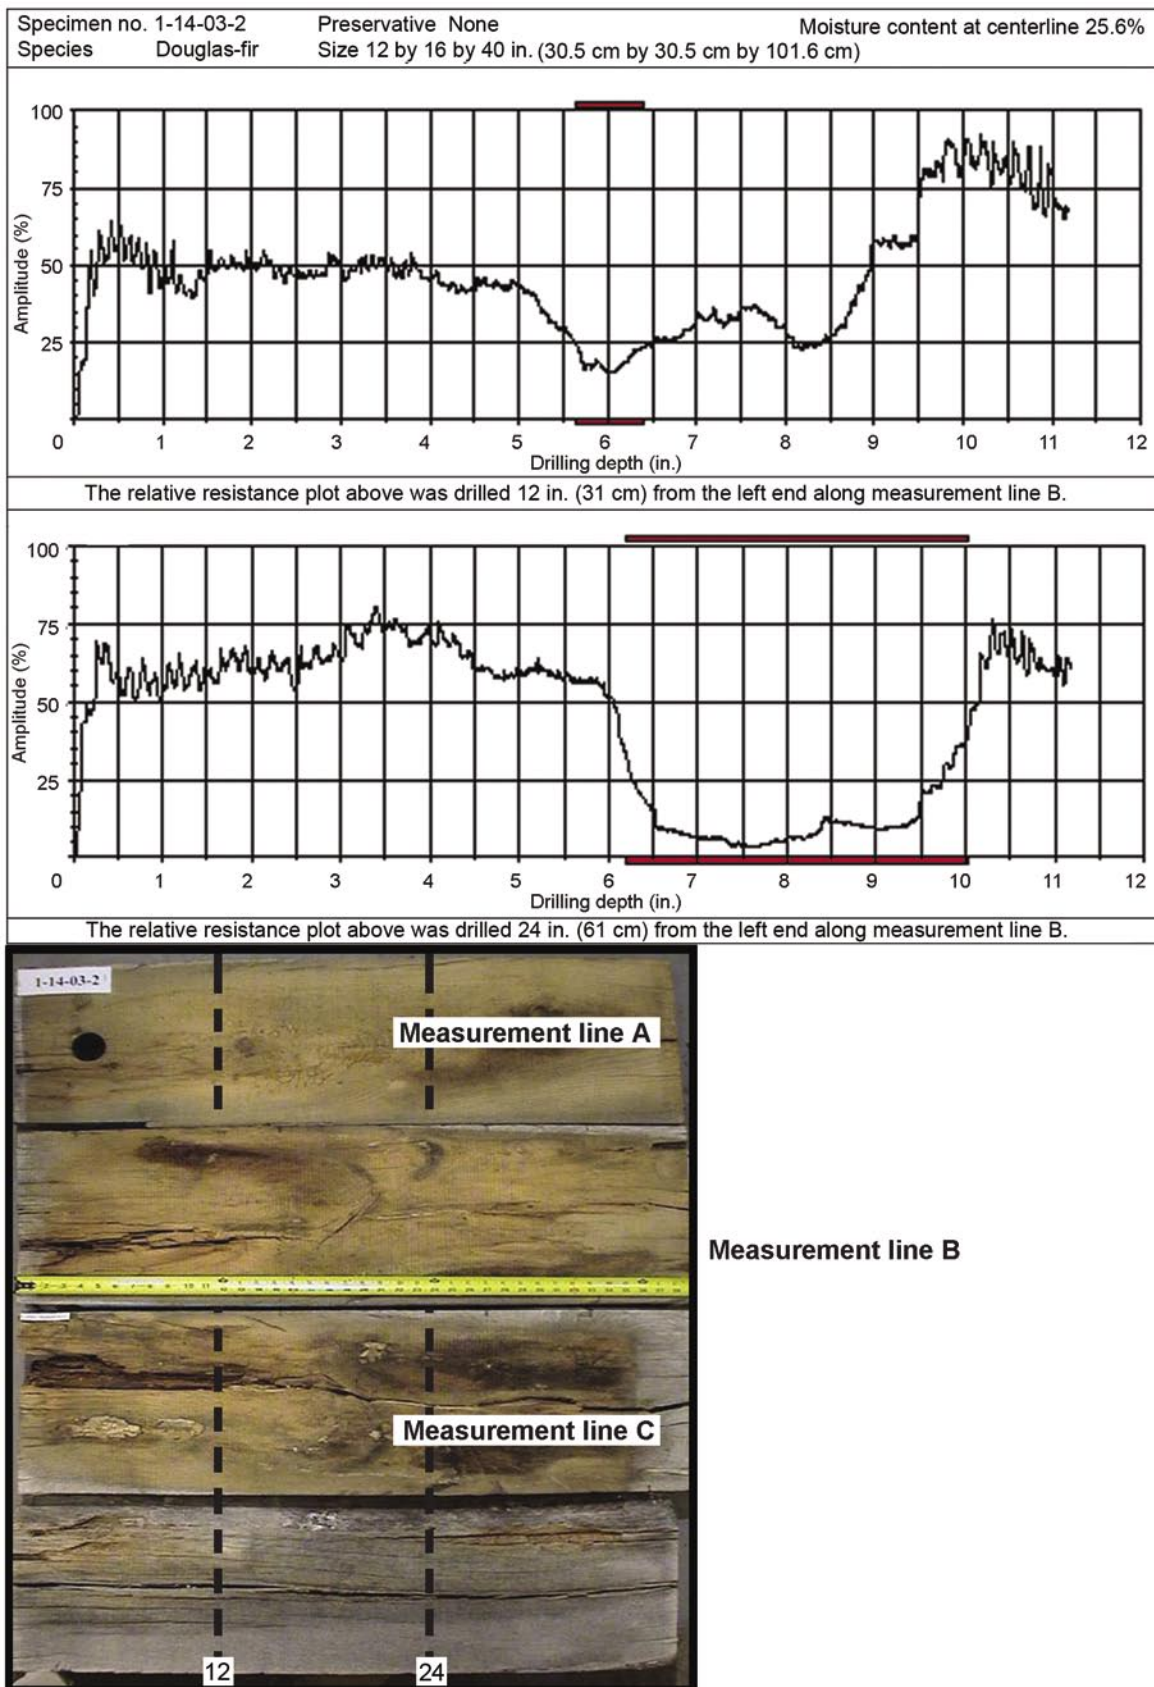
Figure 7—Comparison of resistance micro-drilling plots and interior photographs of bridge timber 1-14-03-2 reveals an example of deteriorated zones and sound wood zones. (Dashed lines denote drilling lines. Red bars at top and bottom of plots denote deterioration zones.)

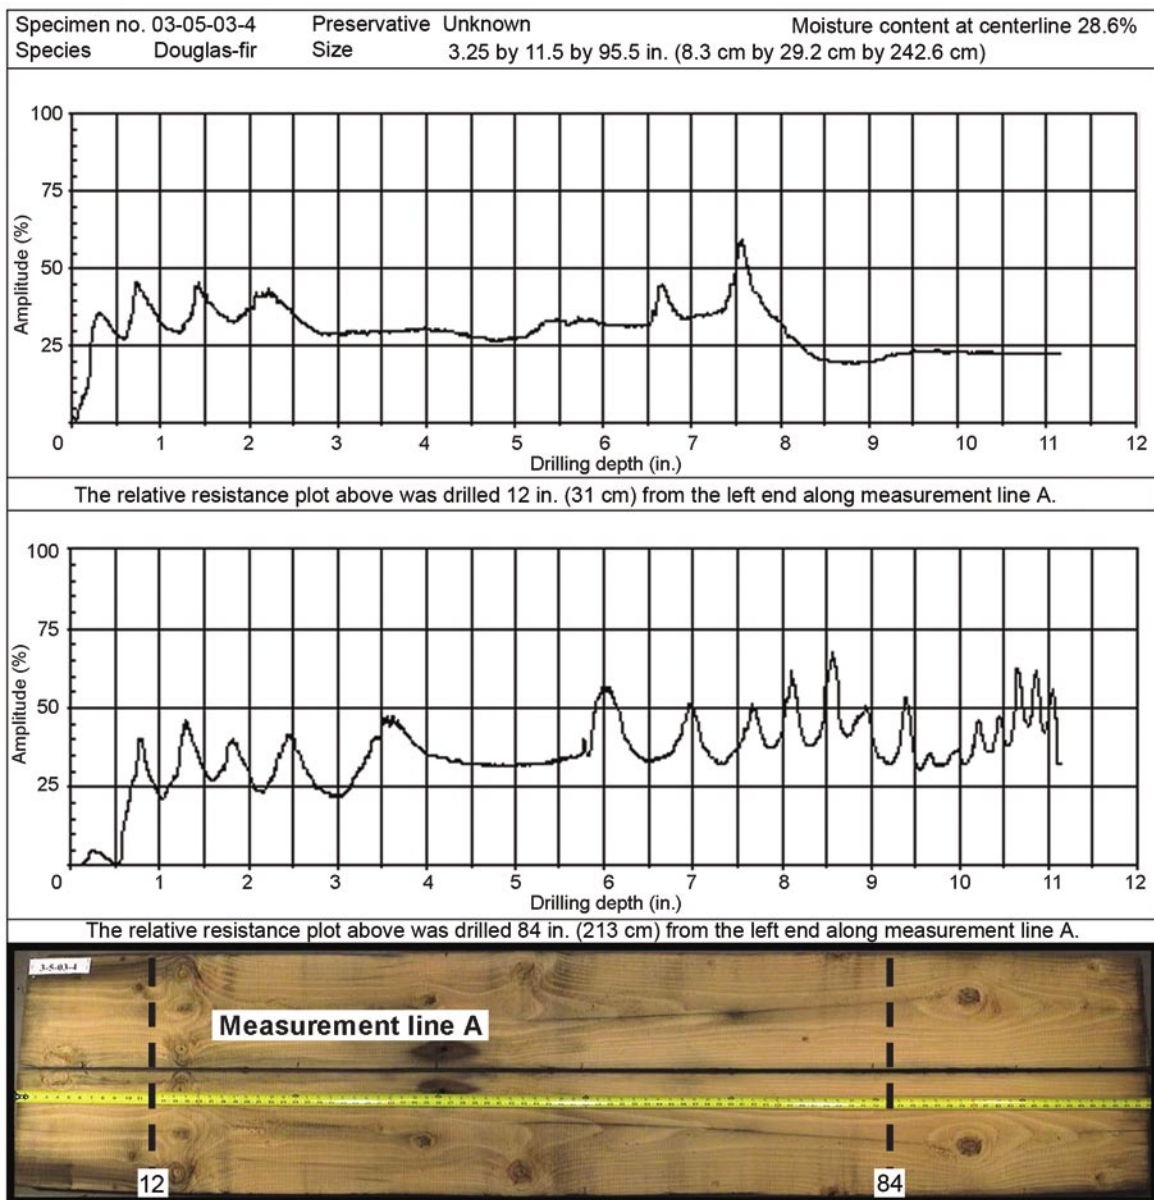
**Figure 8—Comparison of resistance micro-drilling plots and interior photographs of bridge timber 03-05-03-4 reveals an example of sound wood. (Dashed lines denote drilling lines.).**
