# **NAVAL POSTGRADUATE SCHOOL**

## **THESIS**

**DESIGN AND VALIDATION OF IMPROVED DYNAMIC  
CYLINDER PRESSURE MEASUREMENT FOR A DIESEL  
ENGINE**

September 2005

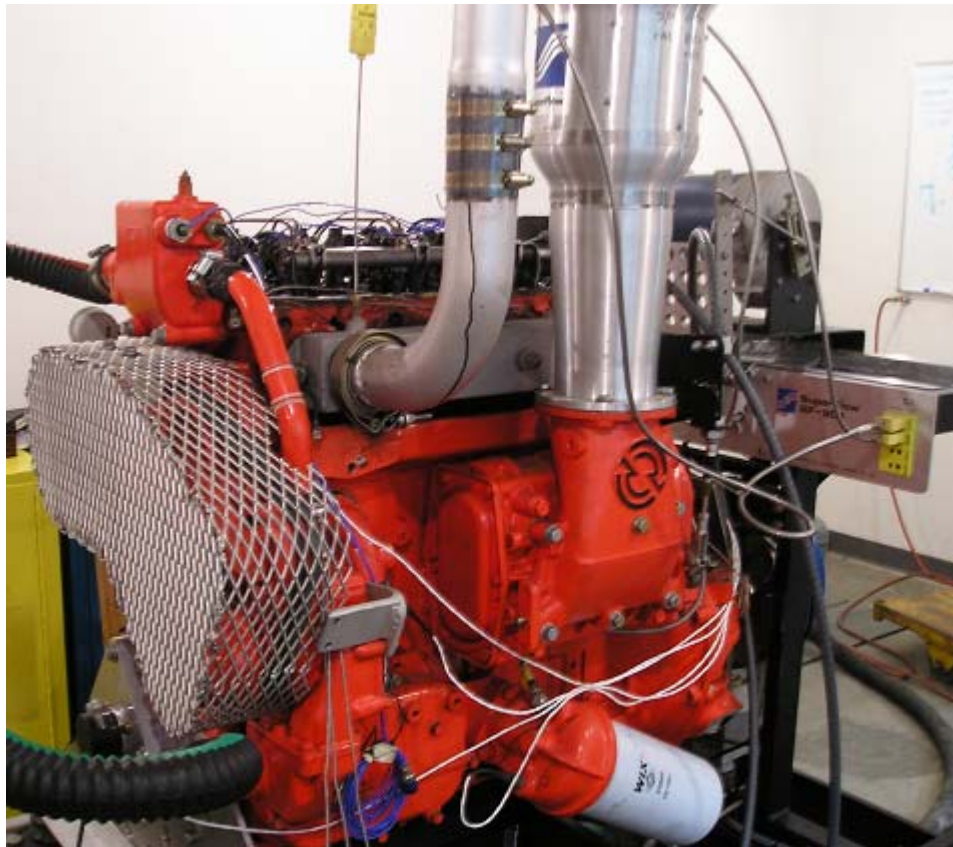
Figure 1. Engine Test Stand

The engine used for this research is a Detroit Diesel Series 53 engine model 5033-5001N, as shown in Figure 1. It is a two stroke engine set in an inline configuration. This engine was originally installed in an U. S. Army 1-1/4 ton 6x6 Cargo Truck, commonly known as the “Gamma Goat.” The engine characteristics are given in Table 1.

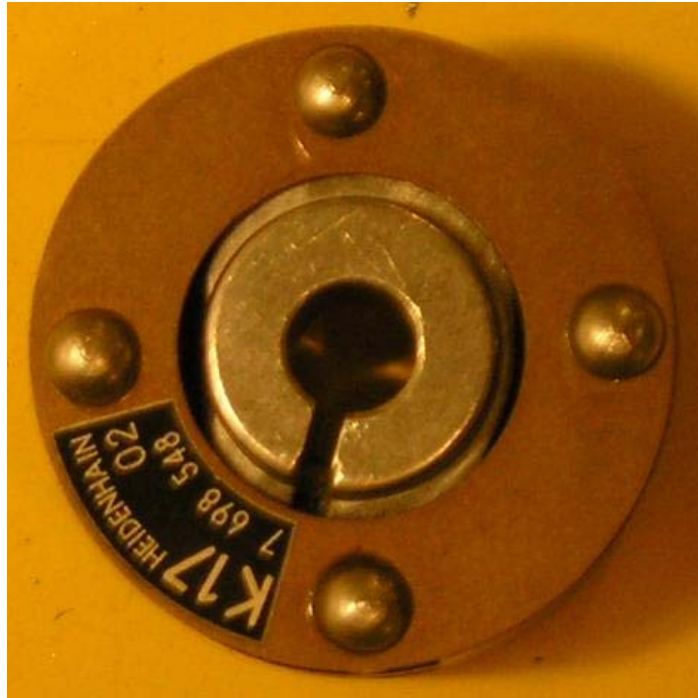
Figure 2. Coupling Device

The optical encoder mount has two parts. The first part is a device that is rigidly attached to the crankshaft. The second part is the equipment that mounts to the engine block. The encoder is connected to the mount by a coupling device that minimizes the noise transferred to the encoder through normal Diesel engine operation. The encoder mount has undergone many design iterations. The first encoder mount failed to provide adequate support for the encoder bearings [Ref. 1]. The second encoder mount was essentially an aluminum plate mounted on the end of three cantilevered beams. This design was inadequate because it was determined that the optical encoder mount was moving approximately  $\pm 0.02$  degrees with respect to the engine block which would result in large errors when coupled with the encoder [Ref. 2]. Hudson designed and installed the current encoder mounting system.

The optical encoder is bolted to the engine frame closest to the number one cylinder. The optical encoder housing is made of 2 plates of aluminum and uses three 3/8 inch bolts to secure the housing to the engine block. This design is similar to the previous iterations, but the previous designs had three aluminum plates in the engine block mount. Since the new design fit with only two plates, less vibration would be picked up by the optical encoder. Additionally, the optical encoder mount is fit with a coupling that damped out the radial and axial vibrations that had damaged previous encoders. This coupling device can be seen in Figure 2, and the entire optical encoder mount can be seen in Figure 3.

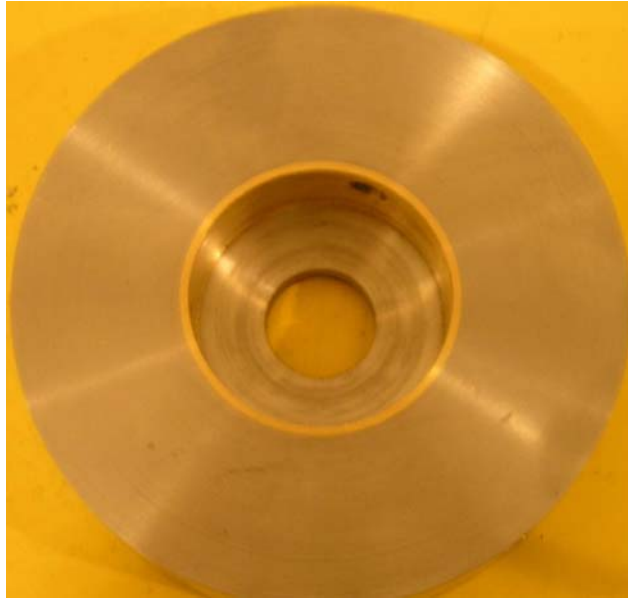
Figure 5. Picture of jig used to guide drill into crankshaft

Since the previous design failed because the set screws did not provide enough contact against the crankshaft, the new design would fix this problem by drilling into the crankshaft using a 0.25" drill piece. The crankshaft would have to be drilled as deep as the set screws would penetrate the crankshaft until the shoulder of the set screw would rest against the crankshaft instead of just the point making contact with the crankshaft. In order to ensure that the crankshaft would be drilled at the correct locations, it was necessary to design a jig that would attach to the crankshaft and provide the locations where the crankshaft was going to be drilled. Figure 5 shows the machined part, while the machine drawings can be seen in Appendix B.

The jig was designed to rest against the back of the crankshaft seal and held in place by a bolt. It was designed to be a clearance fit over the crankshaft, with three 0.25" holes, 120° apart. The dimension chosen for the distance of the holes was set so the drill would be able to fit in the space allotted. These holes would be the guide for the drill bit so the holes would be drilled in the correct spot in the crankshaft.

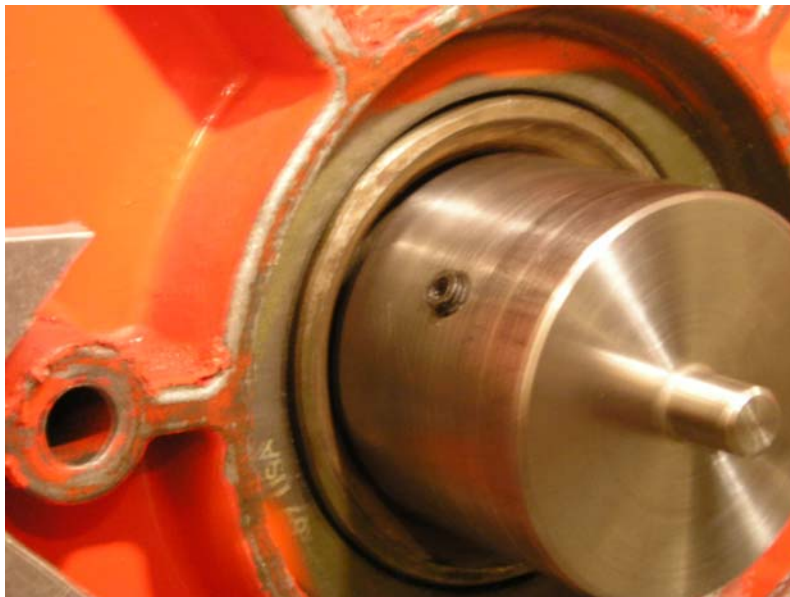
The encoder mount was designed similarly to Hudson's design. However, since the total thickness of encoder mounting system was constrained by the diameter of the engine block mount opening, the diameter of the encoder mount had to be smaller because a collar was going to slide over the set screws. Additionally, the extension where the flexible coupling attaches had to be at least 0.5" long. Since the jig had three 0.25" holes 120° apart, the encoder mount had to have the same parts. This would be a clearance fit, with the same dimensions as the jig. A picture of the after it has been installed on the crankshaft can be seen in Figure 6, and the machine drawings can be seen in Appendix B.

Figure 6. New encoder mount.  
Note set screw installed and clearance between  
crankshaft seal and encoder mount

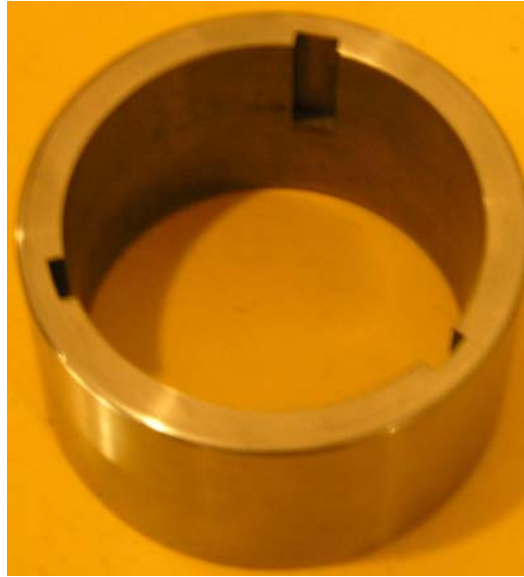
The collar was designed to slip over the encoder mount with three slots cut out at 120° apart. The slots stopped where the set screws were designed to come in, so the set screws would be able to slide into the slots and would hold the collar in place. It was necessary to ensure that the back of the collar did not rest on the crankshaft seal so the data acquisition would not be altered by outside sources. The collar can be seen in Figure 7, and the machine drawings are included in Appendix B.

Figure 7. Picture of Collar.  
Note the depth of the slots.

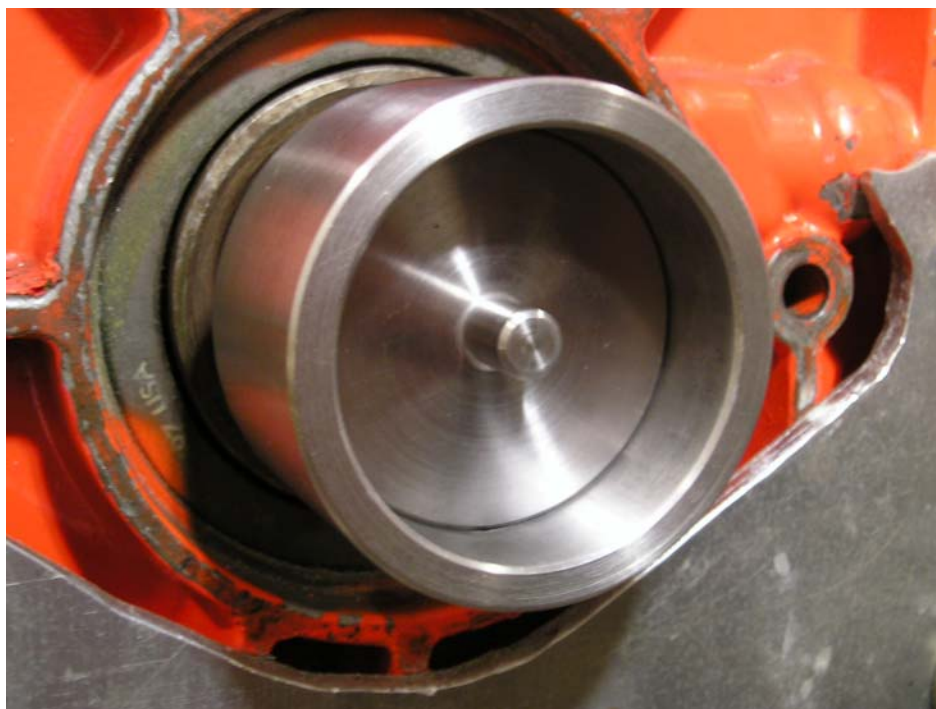
After the parts were manufactured, the parts had to be installed before the new system could be verified experimentally. After bolting the jig onto the crankshaft, drilling the holes, and removing the crankshaft, the three holes were found to be drilled to the proper depth. The installation of the encoder mount was next. Since there is very little clearance between the crankshaft and the mount, the encoder mount has to be arranged perpendicular to the crankshaft to facilitate installation. After the encoder mount was in place, loc-tight was considered for the set screws but was deemed not necessary since the set screws were going to be physically unable to back out after the collar was installed. After the set screws were in place, the slots in the collar did not fit over the set screws. It turned out that the set screws were not designed to be machined to the degree of accuracy calculated, so they had to be filed down a few thousandths of an inch before the collar slipped over the encoder mount. Figure 8 shows how the collar did not fit over the set screws, and Figure 9 shows the collar locked into place.

Figure 8. Installation of the collar over the encoder mount before the set screws were filed down
