Surface- and Ground-Water Monitoring and Mapping of Selected Features at the Blue Ridge Parkway Mt. Pisgah Campground, Haywood County, North Carolina, 2002

U.S. Geological Survey Open-File Report 2004–1073

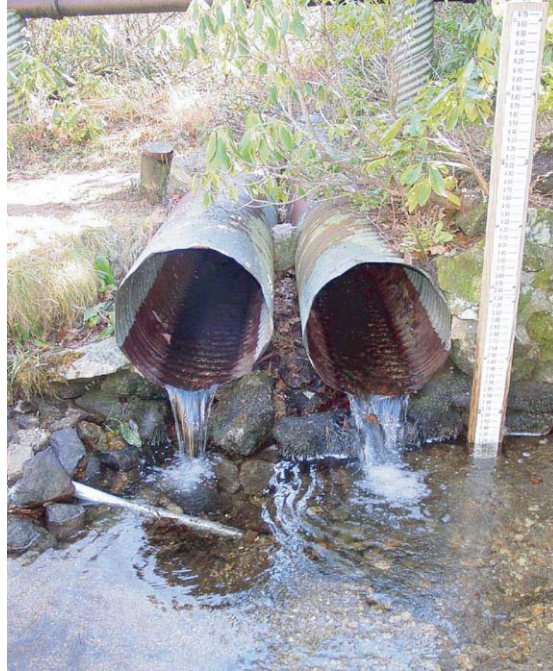
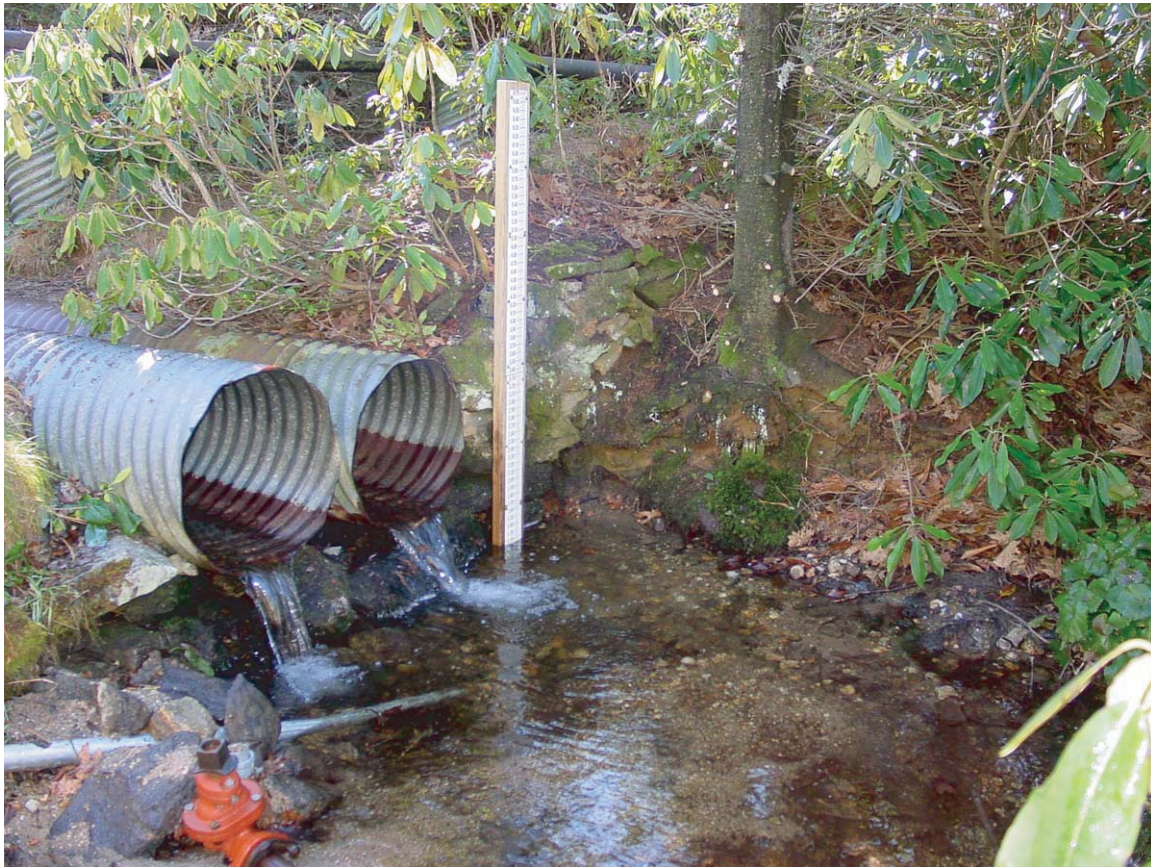
Figure 4. The downstream side of the double corrugated metal pipe (CMP) culvert where the U.S. Geological Survey gaging station was located at the Mt. Pisgah campground.

Water level (stage) and flow (discharge) in the stream draining the campground area were monitored from January 1 to December 31, 2002. An old access road that connects Loops B and C partially impounds surface-water drainage from the natural area (fig. 2). Immediately upstream from the old access road, several small streams converge into a single channel before flowing through two corrugated metal pipe (CMP) culverts that pass beneath the old roadbed (fig. 4). On the downstream side of the culvert, water empties into a small natural pool before flowing into a single, well-defined channel.

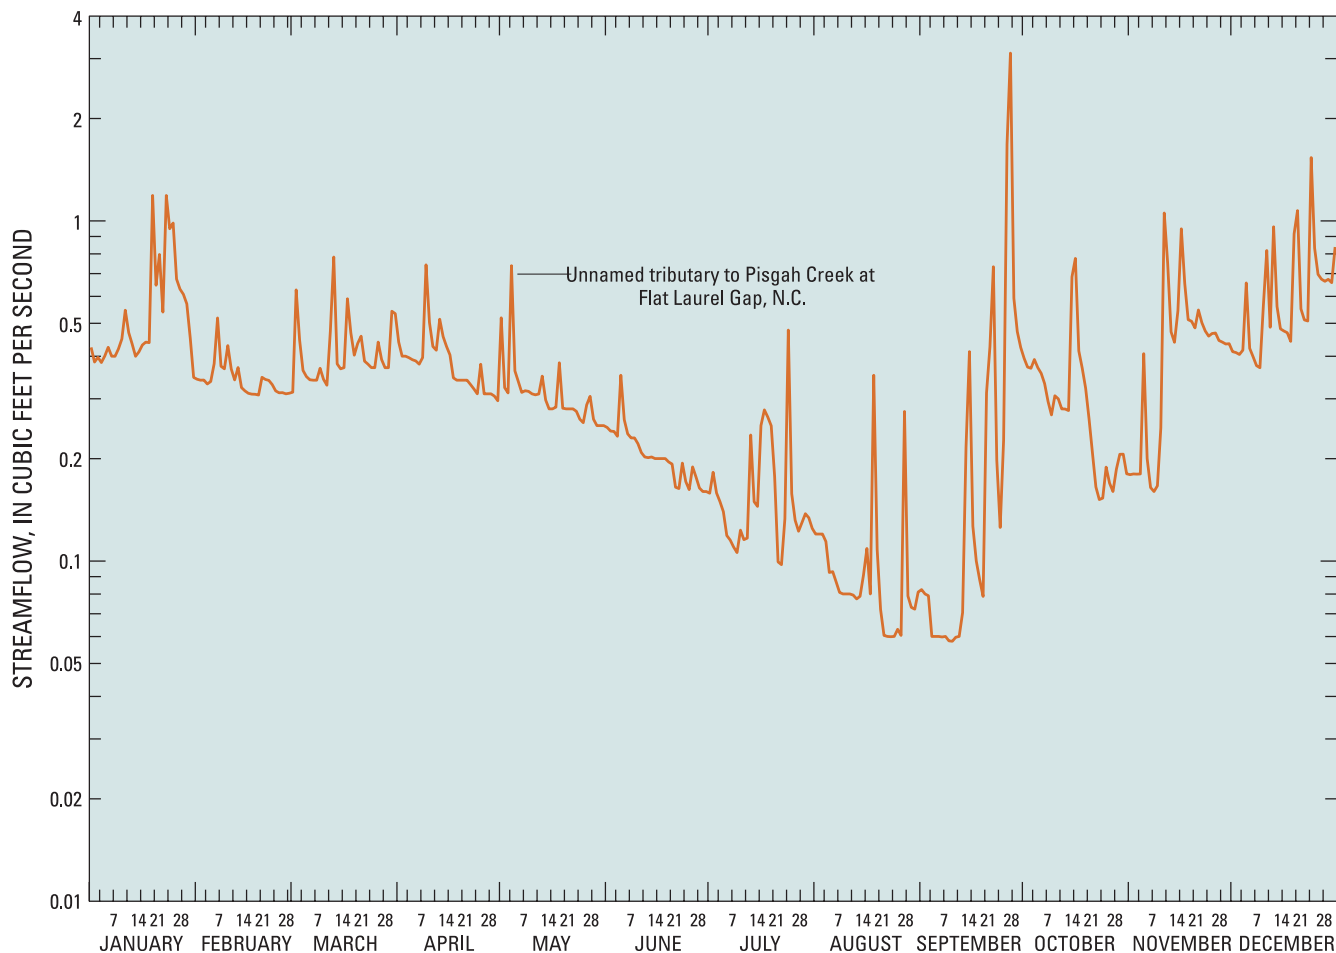
Figure 6. Daily mean streamflow values at unnamed tributary to Pisgah Creek at Flat Laurel Gap at the Mt. Pisgah campground.

Continuously recorded stage in the stream ranged from 1.09 to 1.89 ft above gage datum (4,838.06 to 4,838.86 ft above mean sea level) during the 2002 calendar year. Periodic measurements of streamflow (discharge) ranged in stage from 1.11 to 1.66 ft and in discharge from 0.07 to 4.71 cubic feet per second (ft^3/s). A stage/discharge relation was developed using these streamflow measurements, and corresponding discharge values were calculated for each stage value recorded by the gage. A hydrograph of mean daily discharges for calendar year 2002 is shown in figure 6 as calculated for each day of the period of study (table 1). An additional table containing daily maximum, minimum, and mean discharge values also is presented in the appendix (table A1).

Based on recorded stage data for calendar year 2002, streamflow from the natural area ranged from 0.05 to 9.7 ft^3/s . The annual daily mean flow for the year was approximately 0.35 ft^3/s (about 226,000 gallons per day). The instantaneous peak stage (1.89 ft) and discharge (9.7 ft^3/s) occurred on September 26, 2002, and the instantaneous minimum flow (0.05 ft^3/s) occurred on August 23 and September 7, 9, 10, and 11, 2002. The highest monthly mean flow occurred during December 2002, and the lowest monthly mean flow occurred during August 2002.
