# **Assessment of Habitat and Streamflow Requirements For Habitat Protection, Usquepaug–Queen River, Rhode Island, 1999–2000**

By DAVID S. ARMSTRONG and GENE W. PARKER

Open-File Report 02-438

In cooperation with the  
RHODE ISLAND DEPARTMENT OF  
ENVIRONMENTAL MANAGEMENT

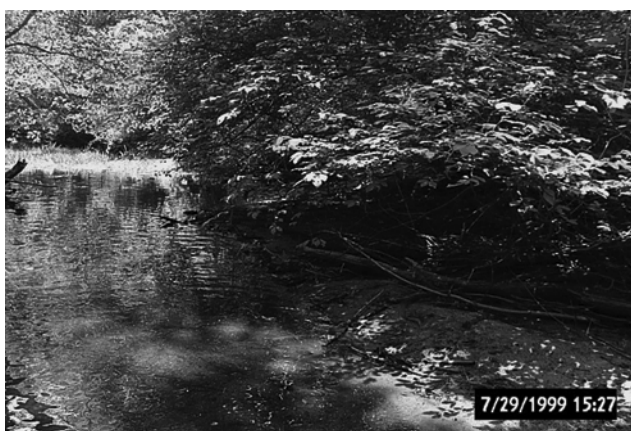
#### A. Vegetated sand bars, upstream view

#### B. Shallow stream margins, downstream view

**Figure 8.** Habitat features on the Queen River at Liberty Road (Site Q7), Exeter, Rhode Island: (A) vegetated sand bars, upstream view, and (B) shallow stream margins, downstream view.

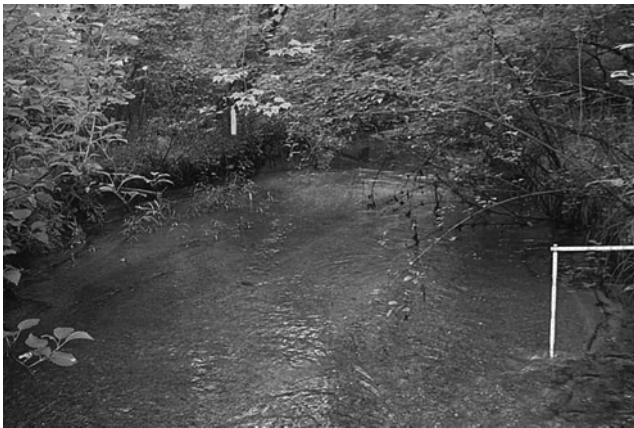
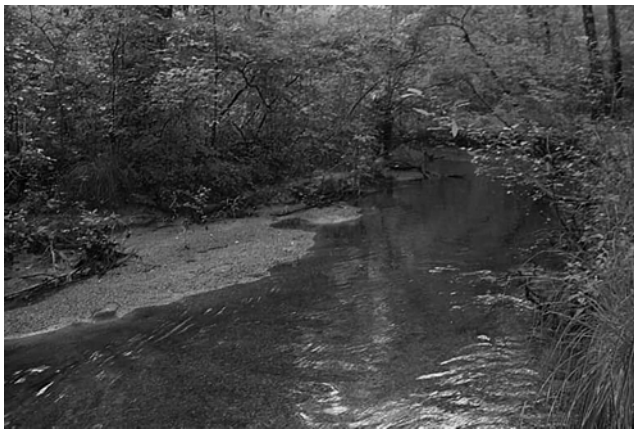
**A. Shallow water, upstream view**

**B. Loss of habitat at stream margins, upstream view**

**Figure 11.** Habitat features on the Queen River near School Land Road (Site Q4), Exeter, Rhode Island: (A) shallow water, upstream view, and (B) loss of habitat at stream margins, upstream view.

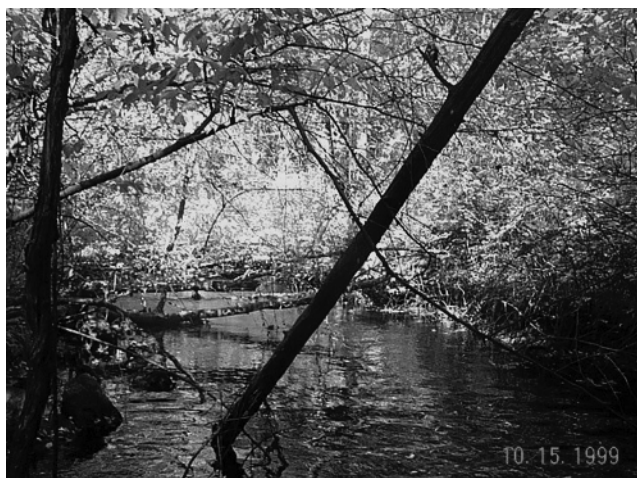
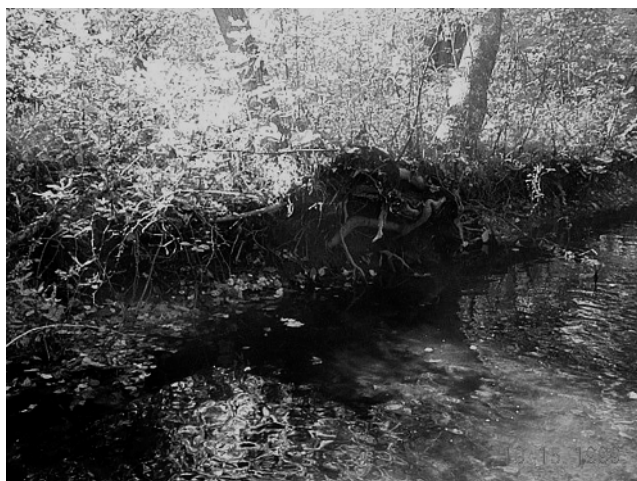
**A. Woody debris, upstream view**

**B. Loss of stream-margin habitat**

**Figure 13.** Habitat features on the Queen River near William Reynolds Road (Site Q2), Exeter, Rhode Island: (A) woody debris, upstream view, and (B) loss of stream-margin habitat.
