# WELL-INTEGRITY SURVEY (PHASE II) OF ABANDONED HOMESTEAD WATER WELLS IN THE HIGH PLAINS AQUIFER, FORMER PANTECH ORDNANCE PLANT AND TEXAS TECH RESEARCH FARM NEAR AMARILLO, TEXAS, 1995

U.S. GEOLOGICAL SURVEY  
Open-File Report 95-751

*Prepared in cooperation with the*  
U.S. ARMY CORPS OF ENGINEERS,  
TULSA DISTRICT

**By Glenn A. Rivers**

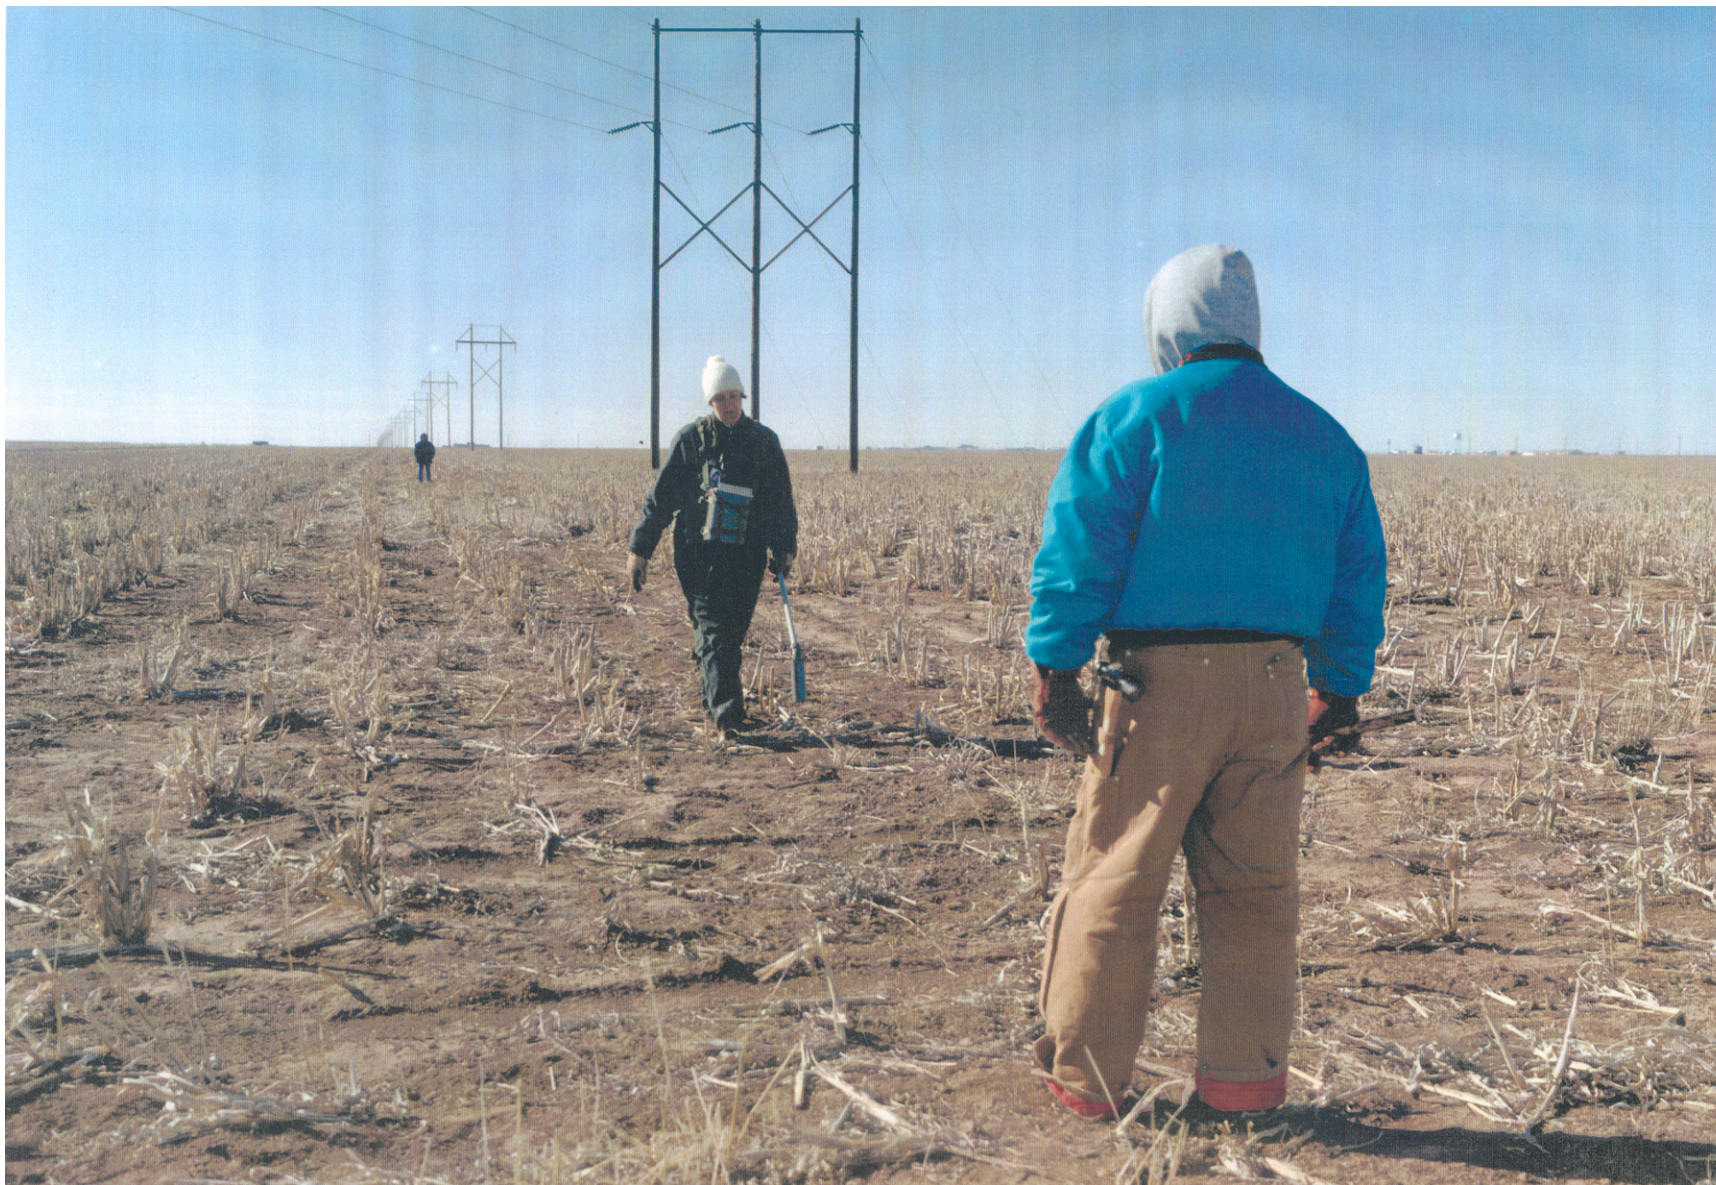
**Figure 4.** Magnetometer sweep at homestead site HL-4, former Pantex Ordnance Plant and Texas Tech Research Farm near Amarillo, Texas. Photograph by John S. Ebling.

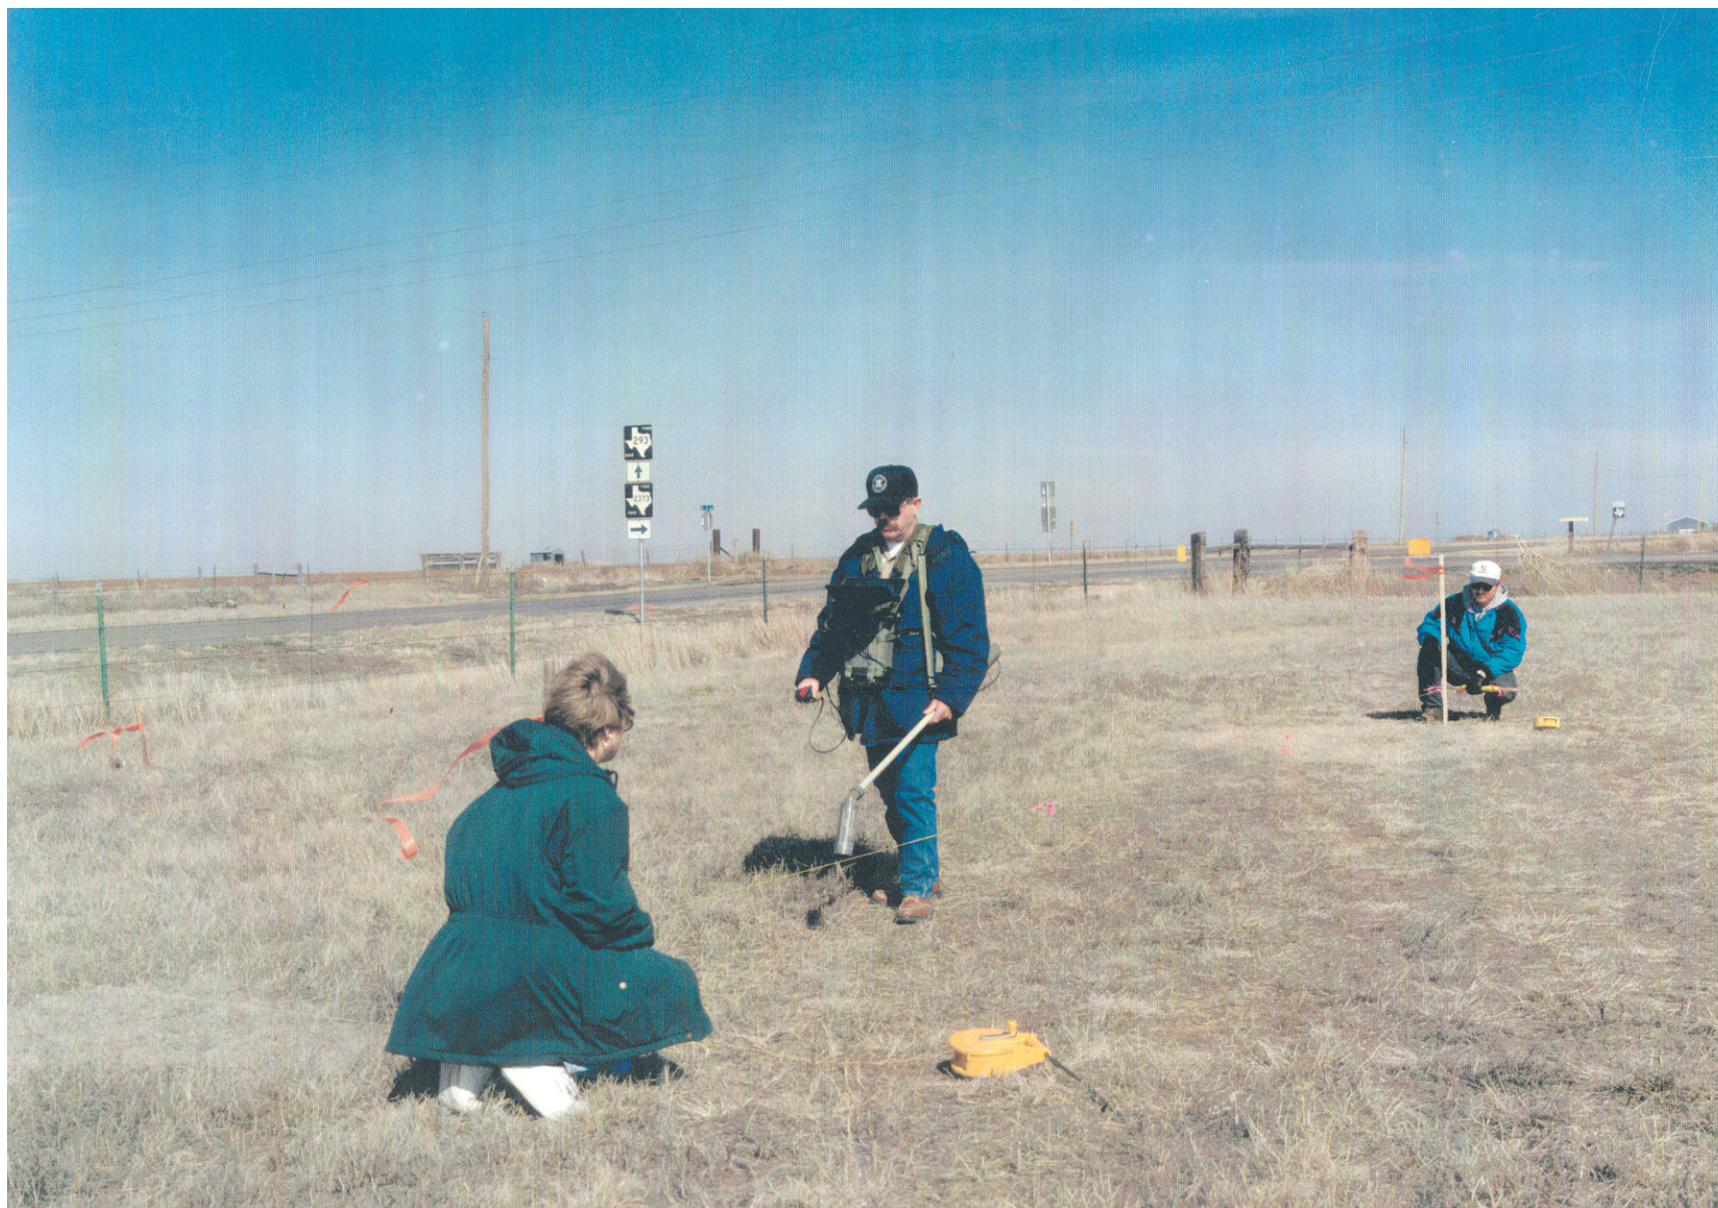
**Figure 7.** Magnetometer mapping survey at homestead site HL-4, former Pantex Ordnance Plant and Texas Tech Research Farm near Amarillo, Texas. Photograph by John S. Ebling.

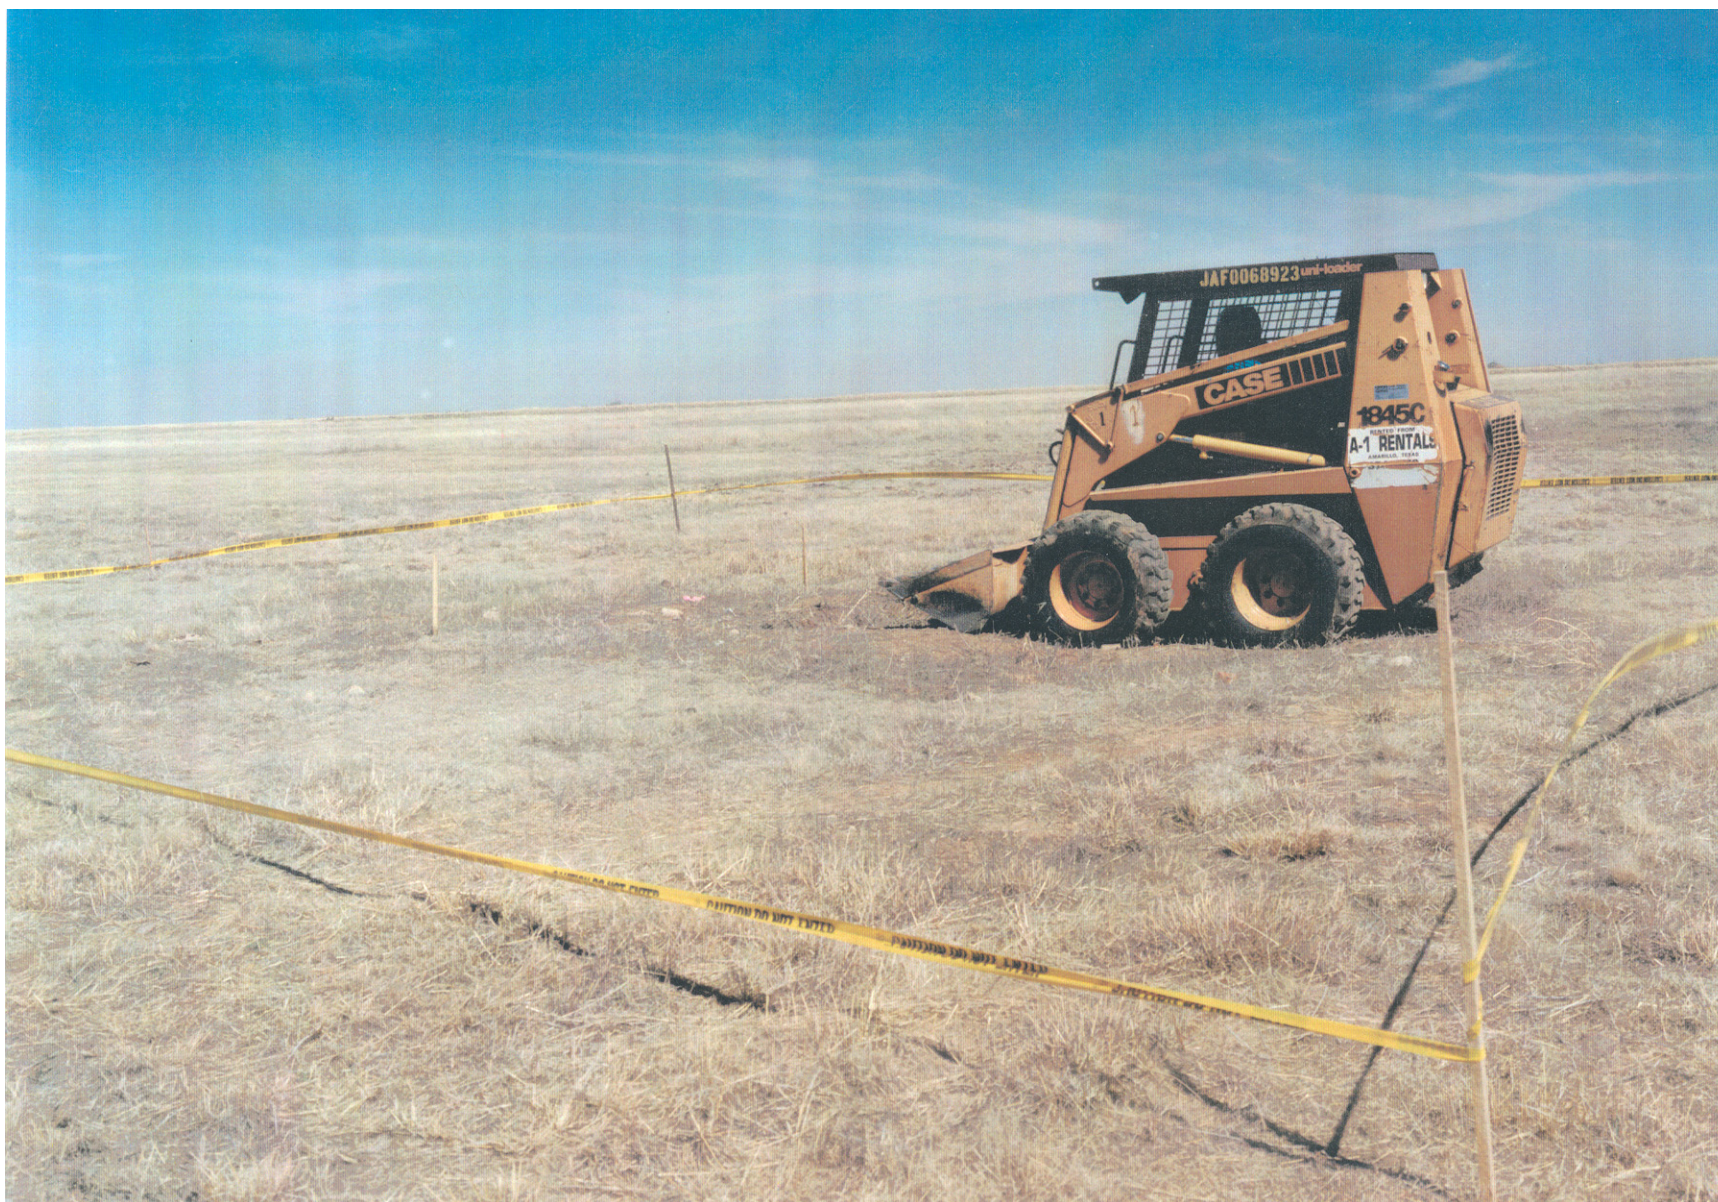
**Figure 9.** Case uni-loader used during well-integrity survey (phase II), former Pantex Ordnance Plant and Texas Tech Research Farm near Amarillo, Texas. Photograph by John S. Ebling.

The excavation process involved removing the soil with a Case uni-loader (fig. 9); identifying and removing, where possible, the source of the magnetic anomaly; verifying that the source had been removed by sweeping the excavated area with the magnetometer; and then returning soil to the excavated site. The maximum magnetic anomalies at the homestead sites and the objects that were excavated are listed in table 2. Appendices 2 and 3 show photographs of several abandoned homestead sites before and after excavation.

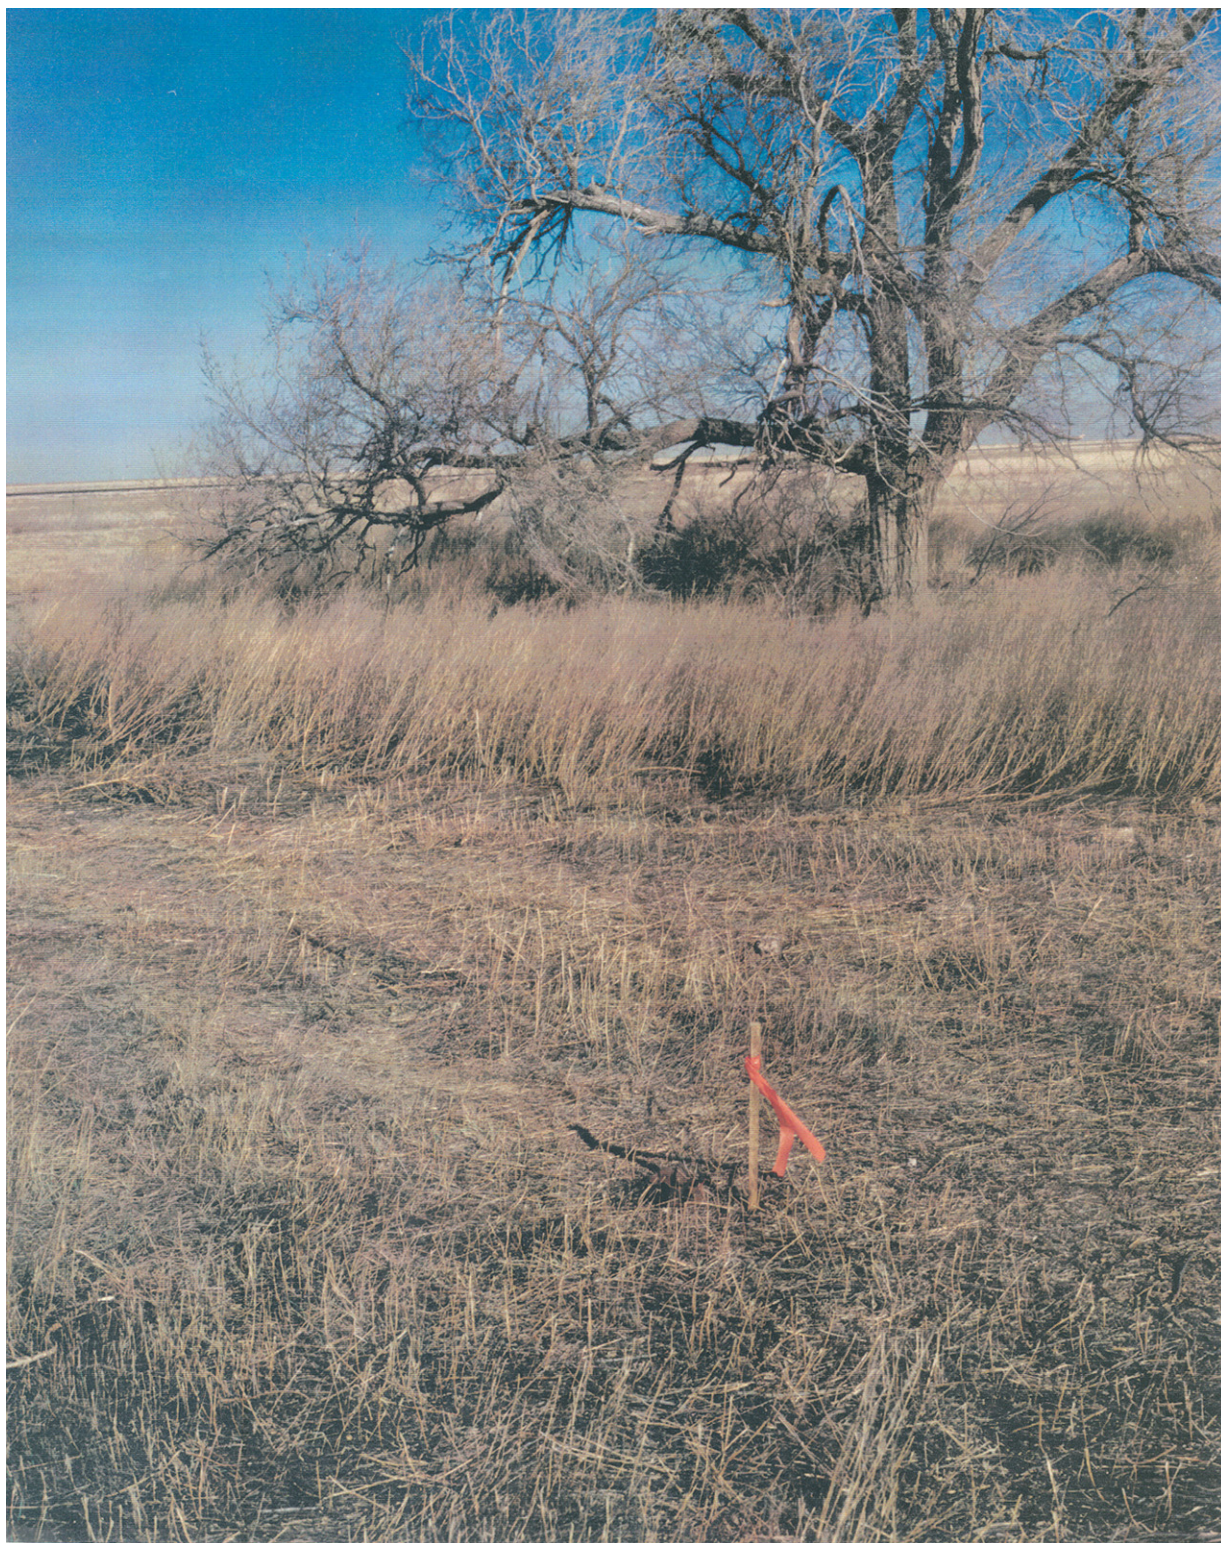
**Figure 10.** Well at homestead site HL-10, former Pantex Ordnance Plant and Texas Tech Research Farm near Amarillo, Texas. Photograph by John S. Ebling.

Tops of well casings were found at or above land surface at four abandoned homestead sites. The top of the casing at HL-4 is at land surface. The tops of casings at HL-10 (fig. 10), HL-11 (fig. 11), and HL-17 (fig. 12) are above land surface. Excavations at HL-3, HL-5 (fig. 13), and HL-9 exposed tops of well casings that had been pushed over and buried to about 18 in. below land surface.

The phase III work to investigate the condition of the casings of the eight wells located will include (1) cleaning debris from the wells and (2) obtaining downhole geophysical logs and color-video surveys. In addition, the following work elements could be included:

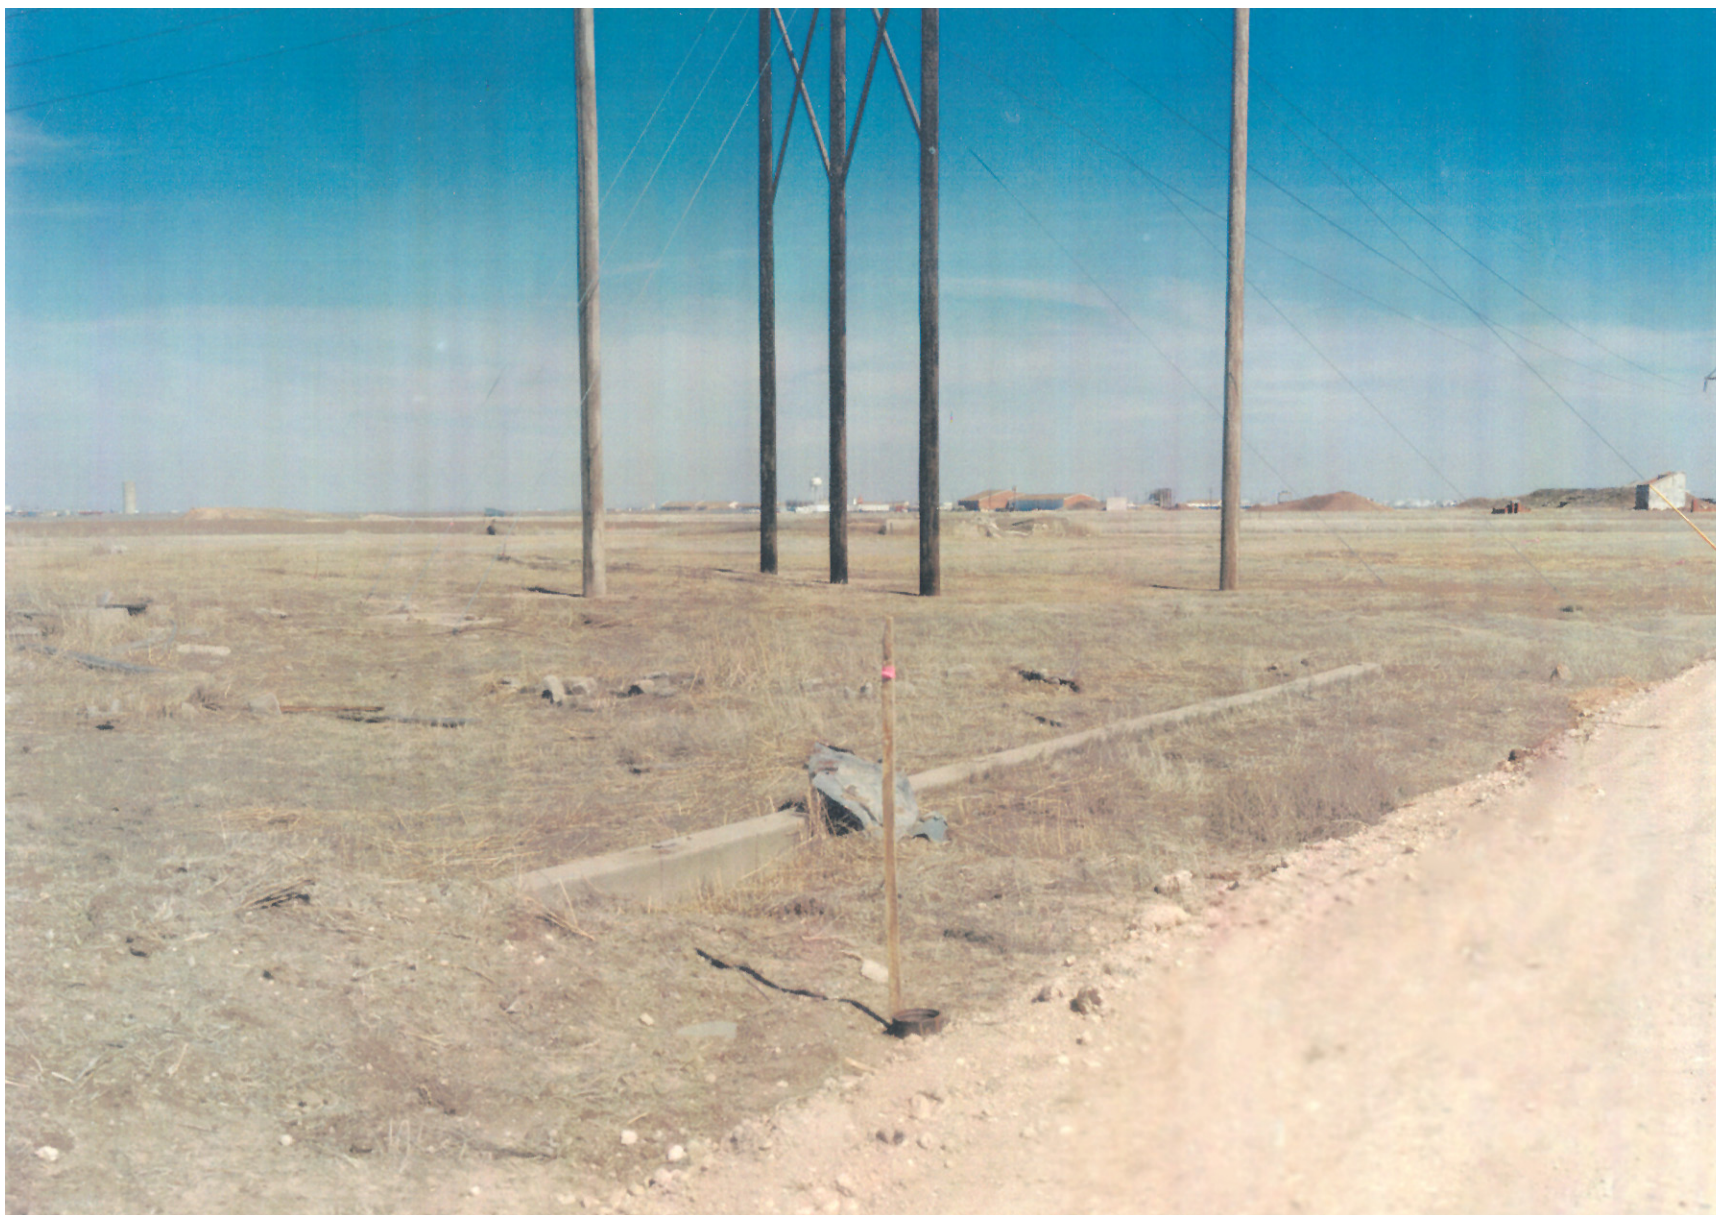
**Figure 11.** Well at homestead site HL-11, former Pantex Ordnance Plant and Texas Tech Research Farm near Amarillo, Texas. Photograph by John S. Ebling.

The casings at HL-11 and HL-17 were tentatively identified during the phase I field reconnaissance and verified during the cesium magnetometer sweeps and mapping surveys. Casings at HL-3, HL-4, HL-5, HL-9, and HL-10 were found during the cesium magnetometer sweeps and mapping surveys. Magnetic anomalies at the wells

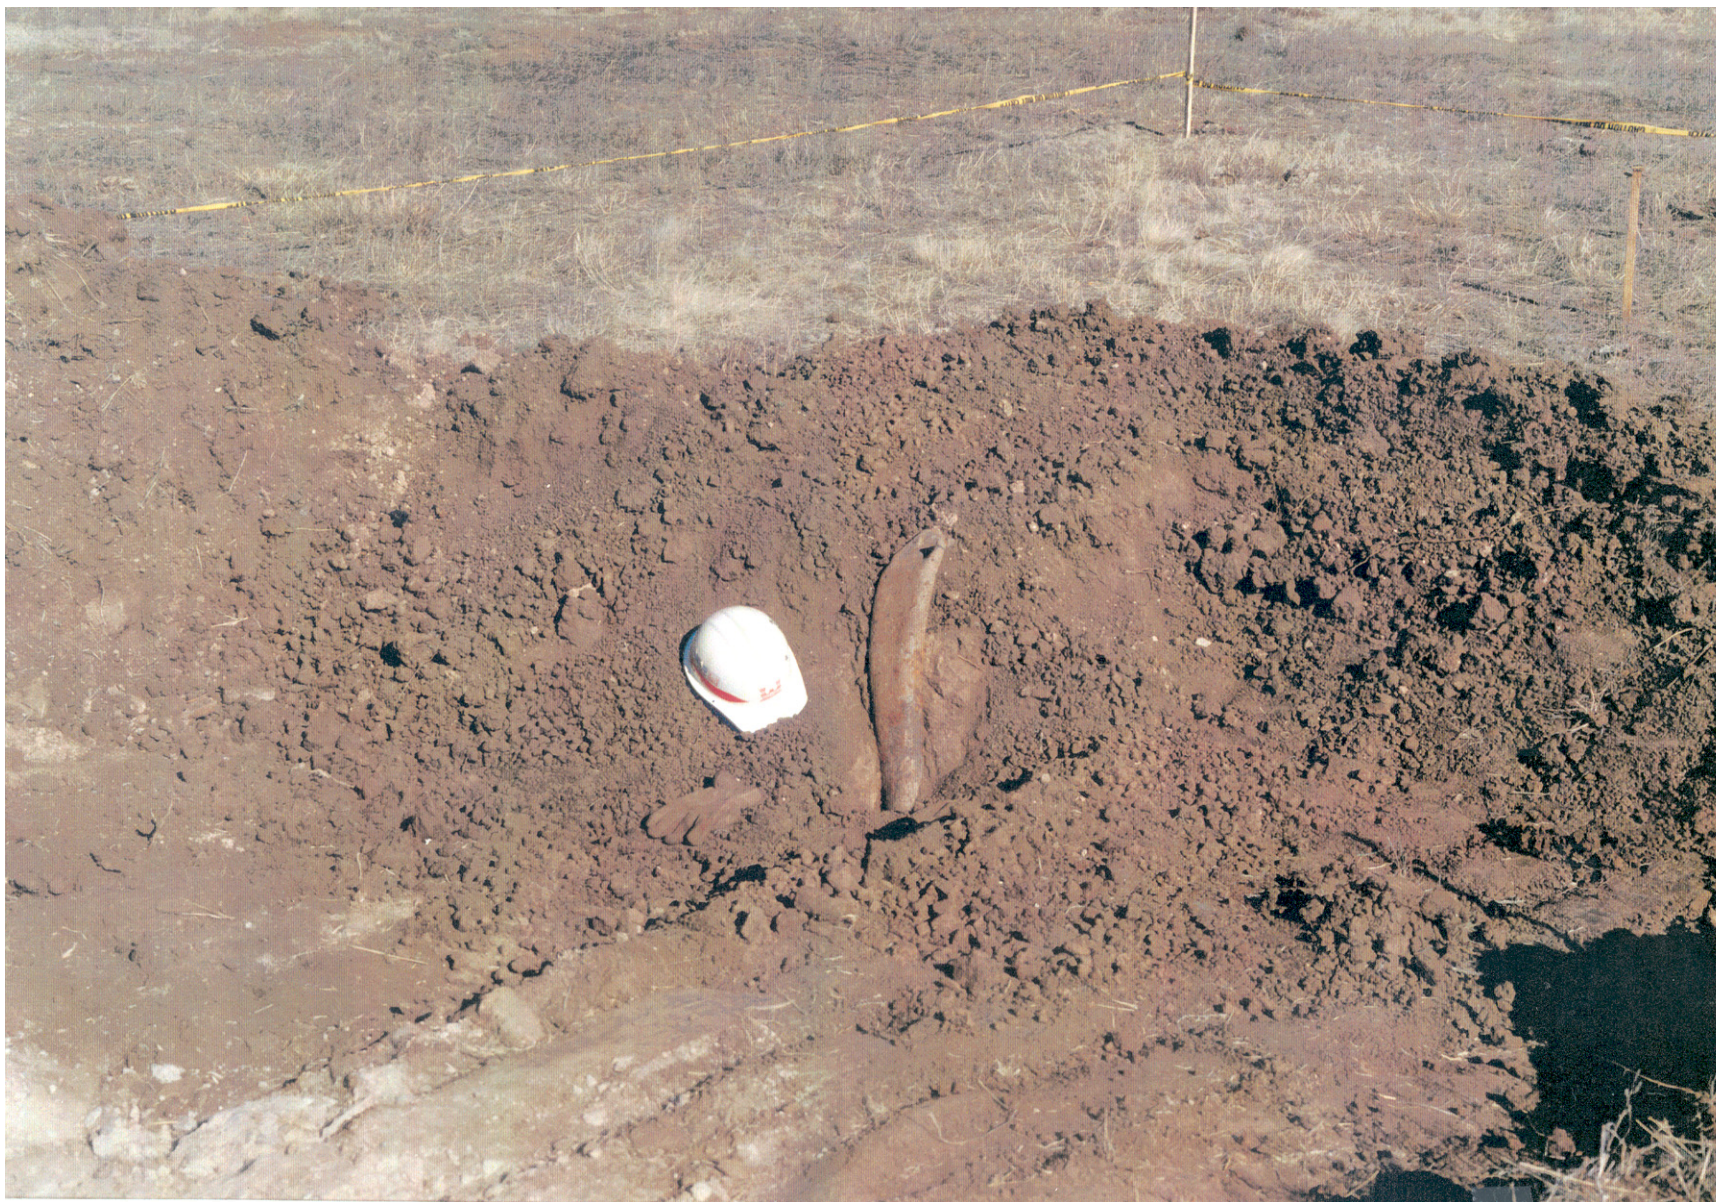
**Figure 13.** Excavated well casing at homestead site HL-5, former Pantex Ordnance Plant and Texas Tech Research Farm near Amarillo, Texas. Photograph by John S. Ebling.
