“THE GREAT CATARACT”

Effects of Late Holocene Debris Flows on Lava Falls Rapid, Grand Canyon National Park, Arizona

U.S. GEOLOGICAL SURVEY
Open-File Report 96—460

Prepared in cooperation with the
BUREAU OF RECLAMATION

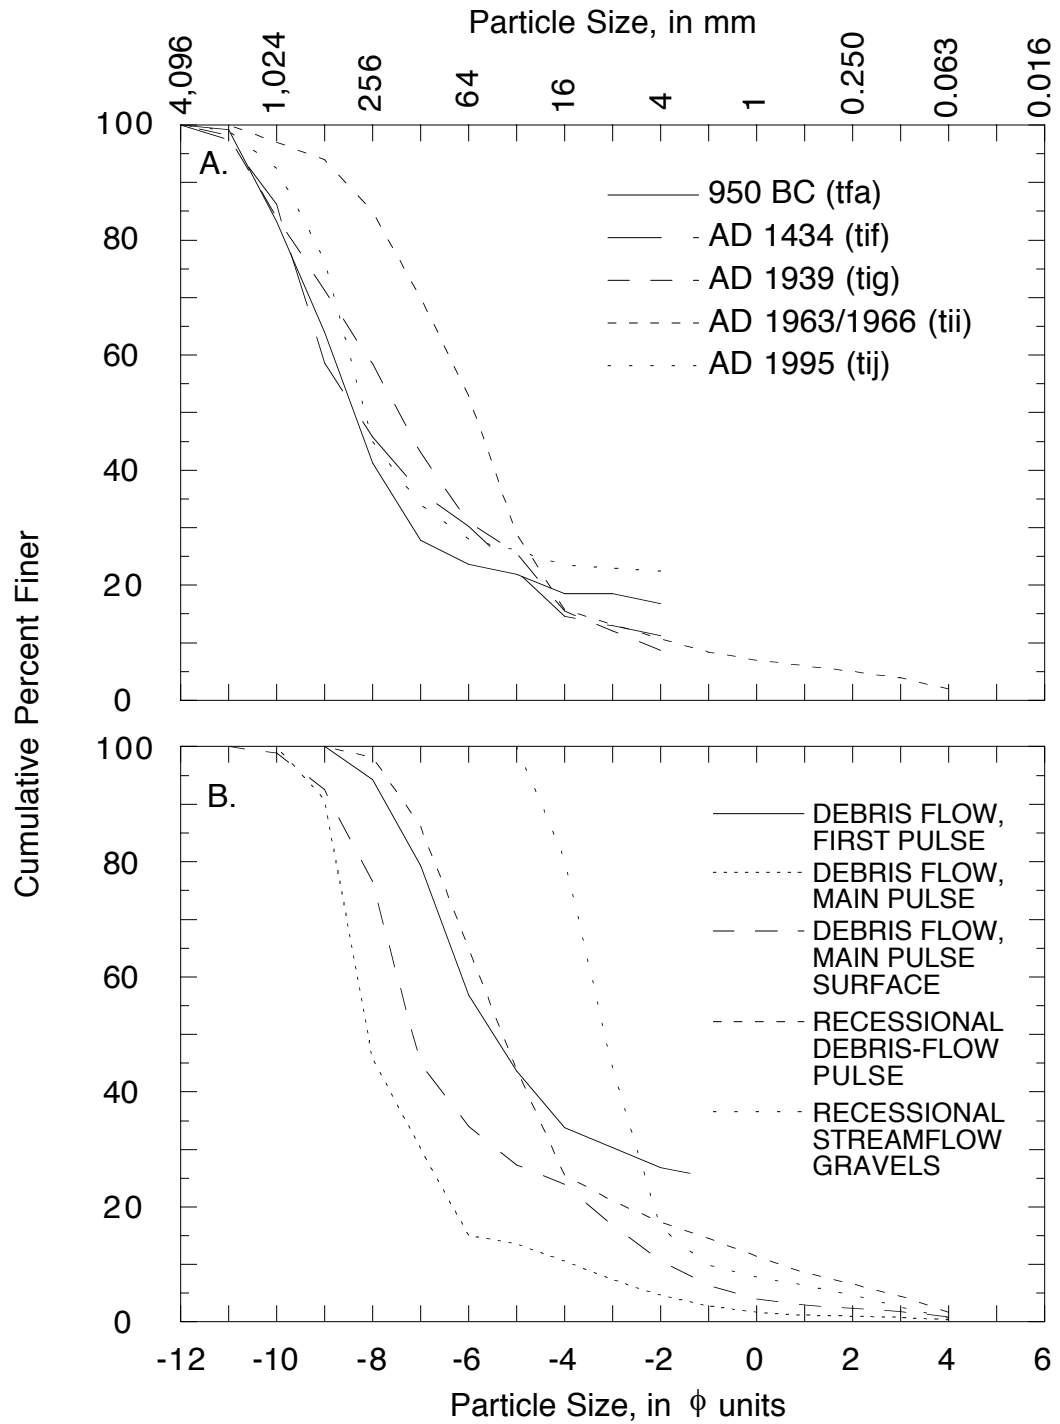
Figure 4. Particle-size distributions for debris flows in Prospect Canyon. A. Prehistoric and historic debris flows. B. Pulses of the 1995 debris flow

The surficial deposits on the Prospect Canyon debris fan are poorly sorted mixtures of particles that range in size from clay to boulders (fig. 4a). In general, about 10 percent of the deposits from Prospect Canyon debris flows are sand or finer; typically only 1-2 percent of the particles are silt and clay. Debris flows from Prospect Canyon contain less fine-grained material than most debris flows in Grand Canyon, which typically have 5-10 percent silt and clay and 20-30 percent sand (Melis and others, 1994). The coarseness of the debris-flow deposits is caused by the basaltic source material in Prospect Canyon. Much of the sand in Prospect Canyon debris flows is either suspended sediment eroded from Prospect Valley or ash from tuffs or the cinder cone on the west side of Prospect Canyon (fig. 3). The Hermit Shale, which contributes clay to most debris flows in Grand Canyon (Griffiths, 1995), is not exposed in Prospect Canyon and only contribute sediment in

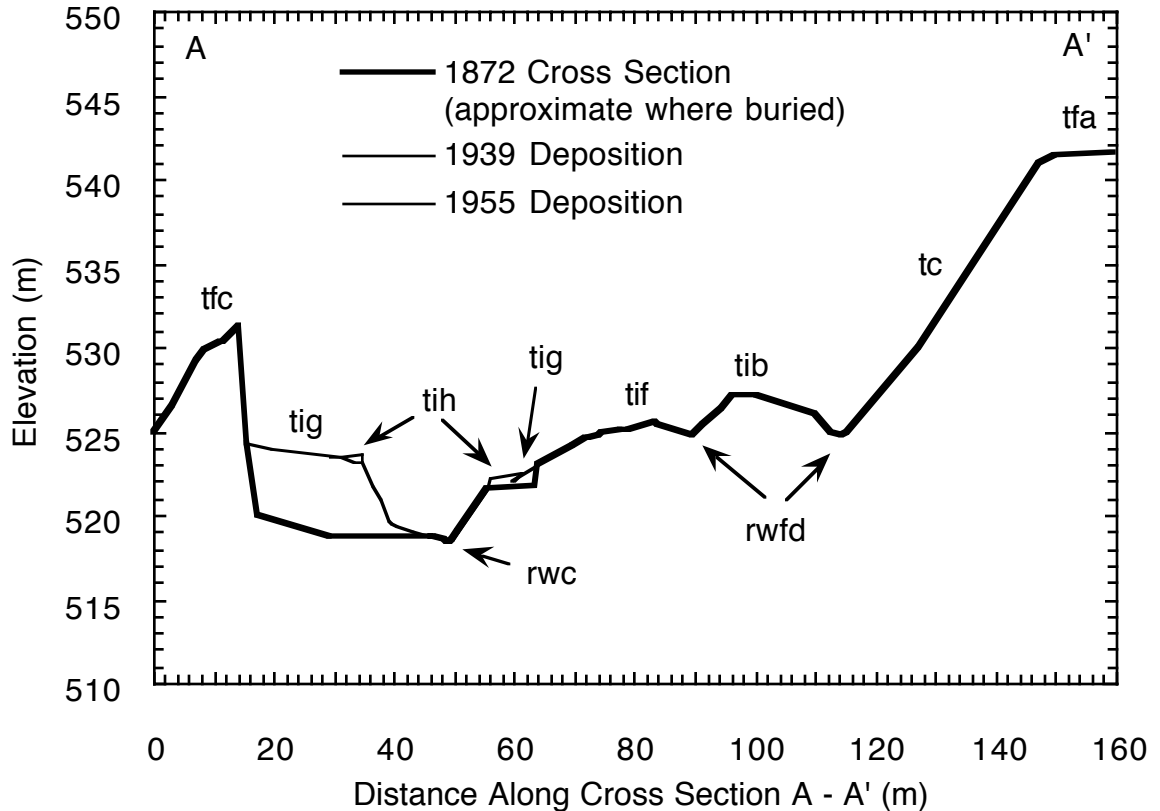
Figure 6. Cross section showing the relative elevations and positions of fan-forming and inset debris-flow surfaces along A - A' (see Plate I).

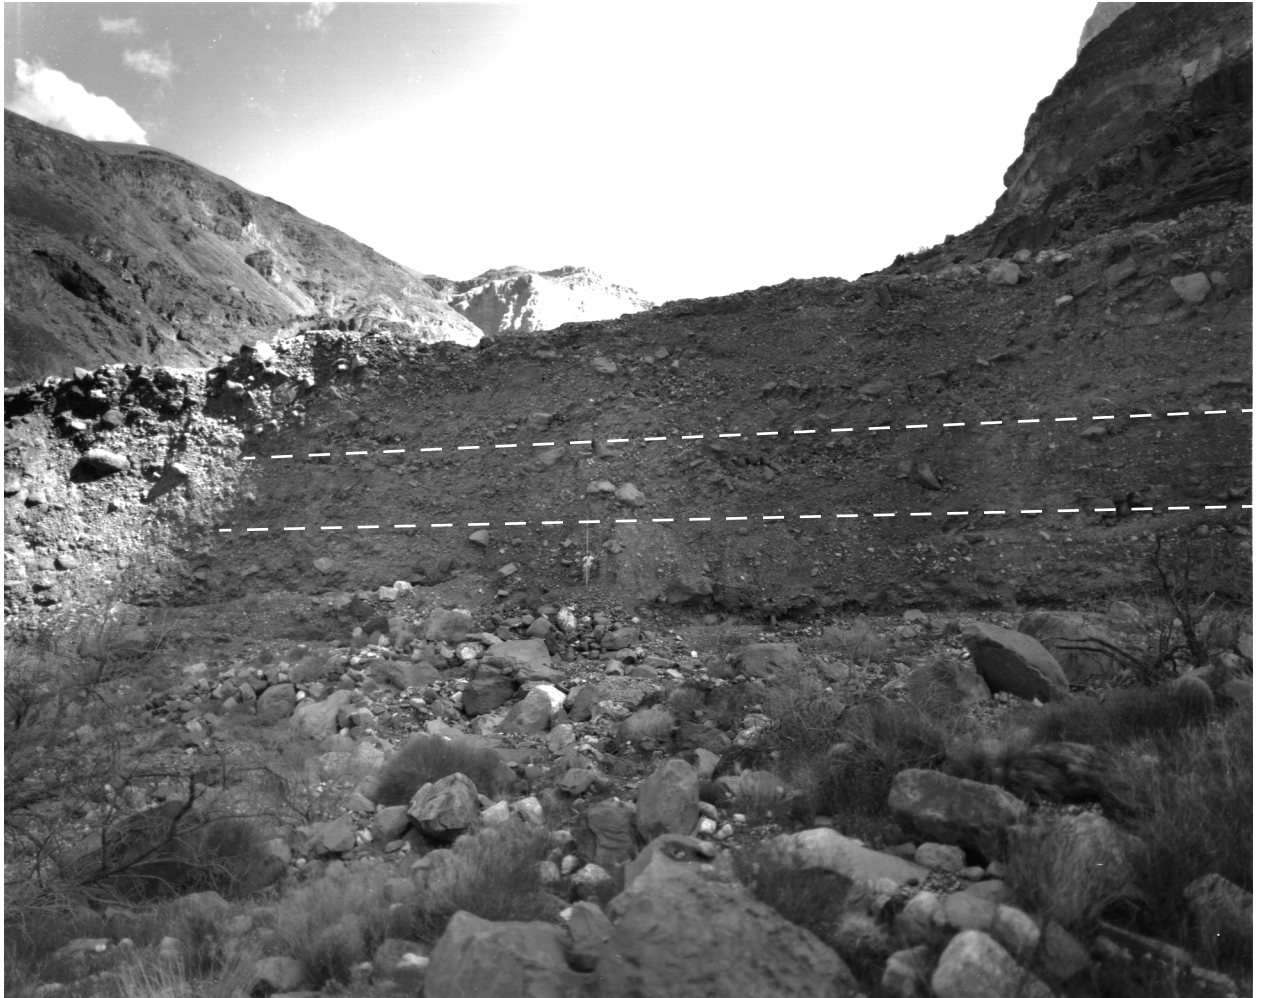
Figure 8. Stratigraphy of surface tfa on the Prospect Canyon debris fan. Dashed lines indicate the approximate contact points between stratigraphic layers.

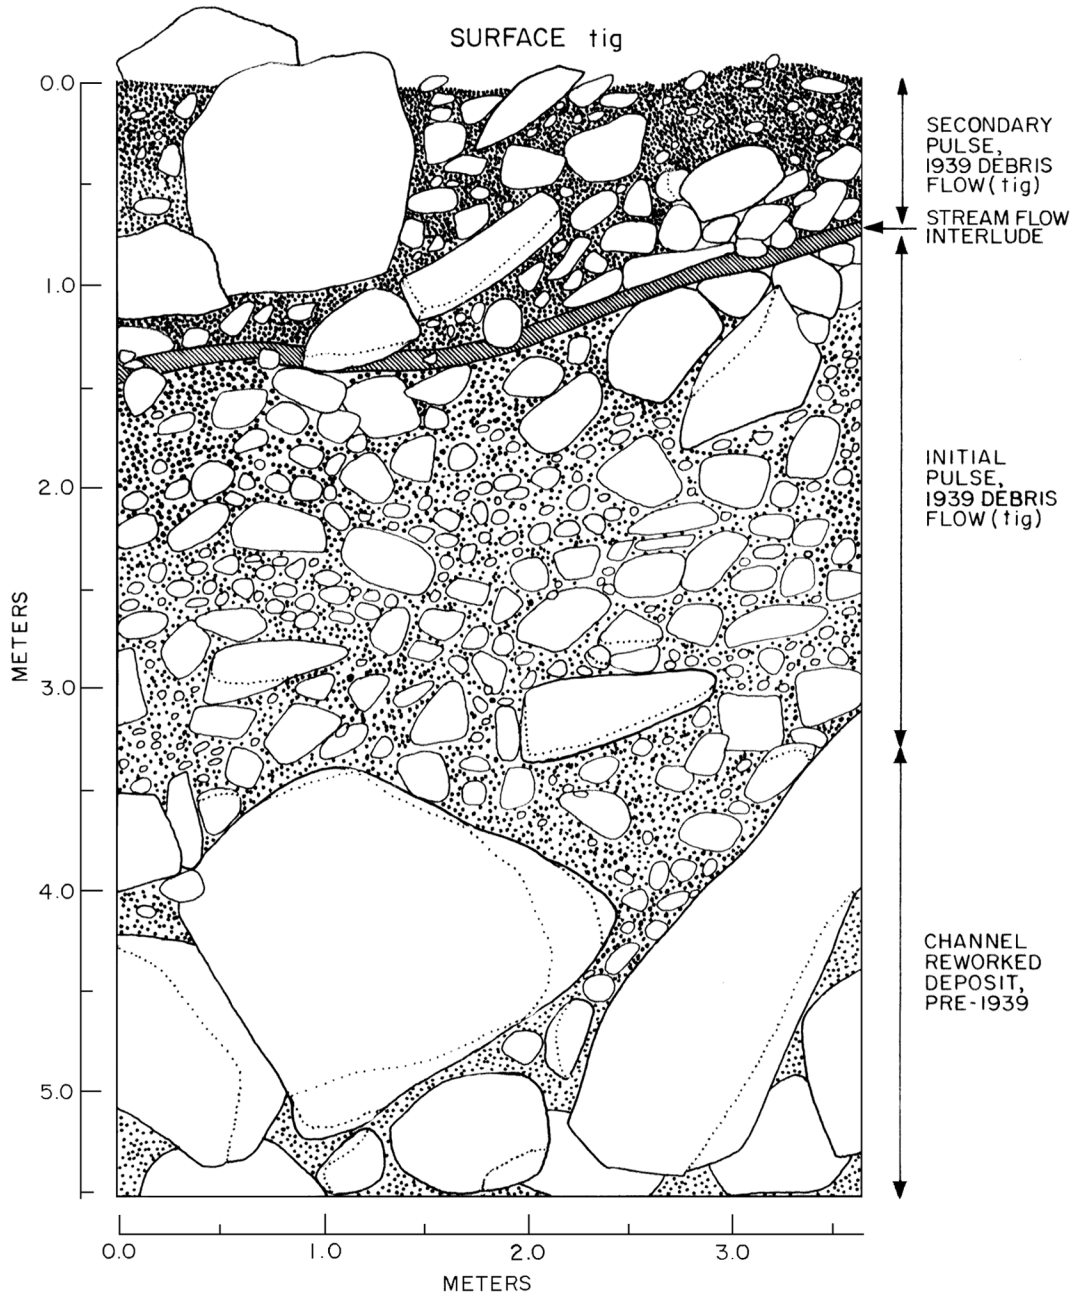
Figure 9. Stratigraphy of the 1939 debris-flow deposit (surface tig). A streamflow deposit of reddish silty sand (thin hatched band) is an intermediate phase of the event, separating the initial pulse (1.5-3.5 m) from a secondary pulse (0-1.2 m). The largest boulders at the bottom have b-axis diameters of 0.75-1.4 m.

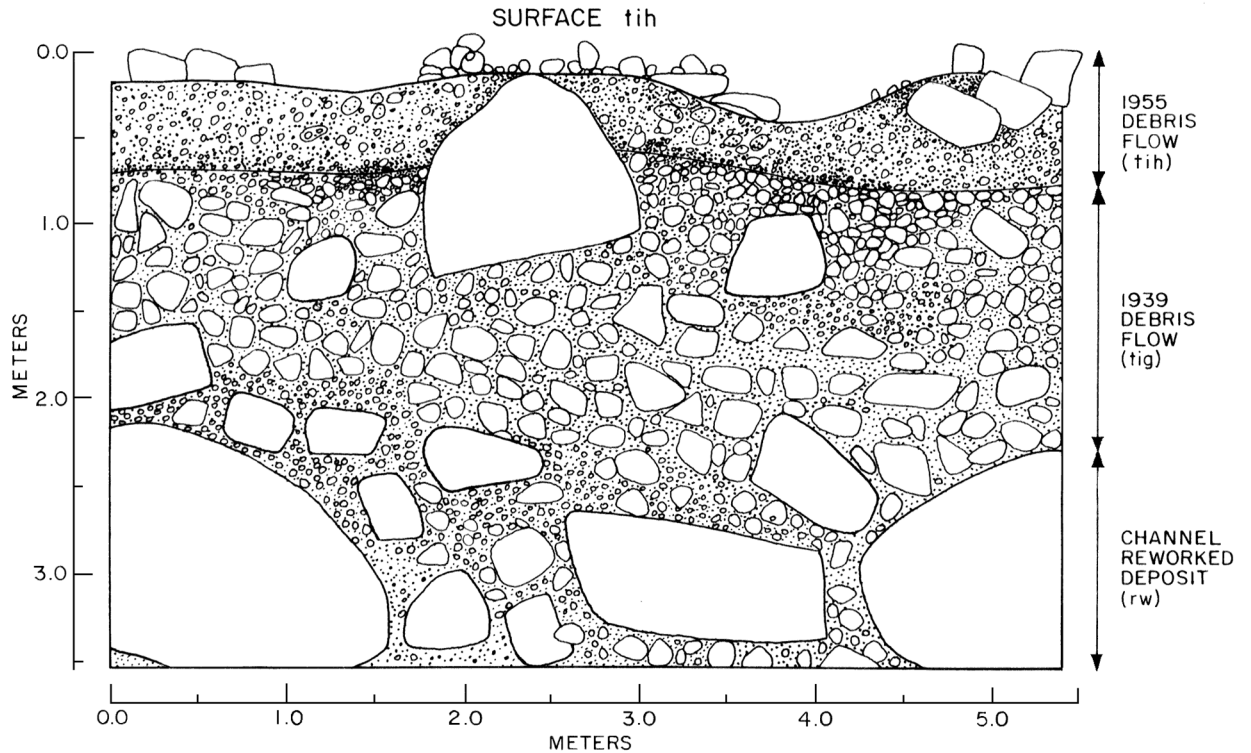
Figure 10. Stratigraphy of the 1955 debris-flow deposits (surface tih). The 1955 debris-flow deposit (0.6-1.0 m thick, tih) overlies the 1939 deposit (0.3-2.0 m thick). Stratigraphic breaks are faint, particularly between the 1939 deposit (tig) and the underlying reworked channel deposits.

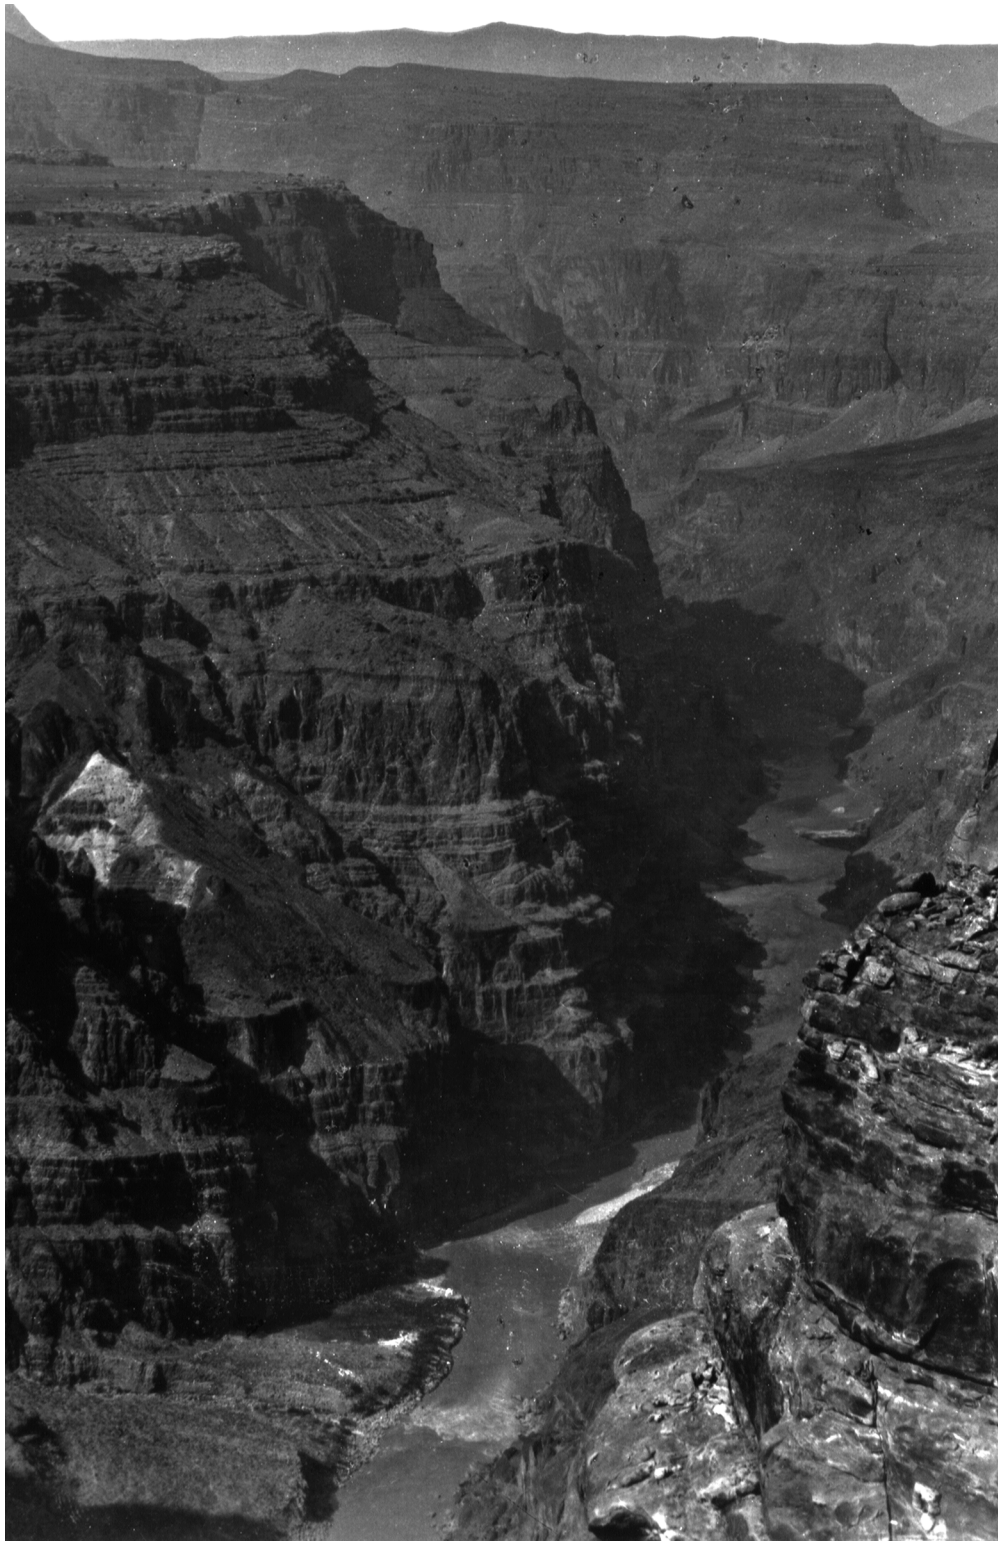
Figure 12. Downstream view of Prospect Canyon and Lava Falls Rapid from Toroweap Overlook (Stake 967). A. (April 16, 1872; J.K. Hillers, courtesy of the National Archives). Lava Falls Rapid as viewed by the Powell Expedition was completely different from the rapid now familiar to thousands of whitewater enthusiasts. Using photogrammetric rectification, we found that the rapid began 85 m farther downstream on the left side, and the head of the rapid formed a line perpendicular to flow. A prominent tongue of water entered the left side of the rapid, and its tail waves at the bottom flowed directly downstream. At the discharge shown (approximately $300 \text{ m}^3/\text{s}$), the area of the exposed debris fan is about 0.2 ha.

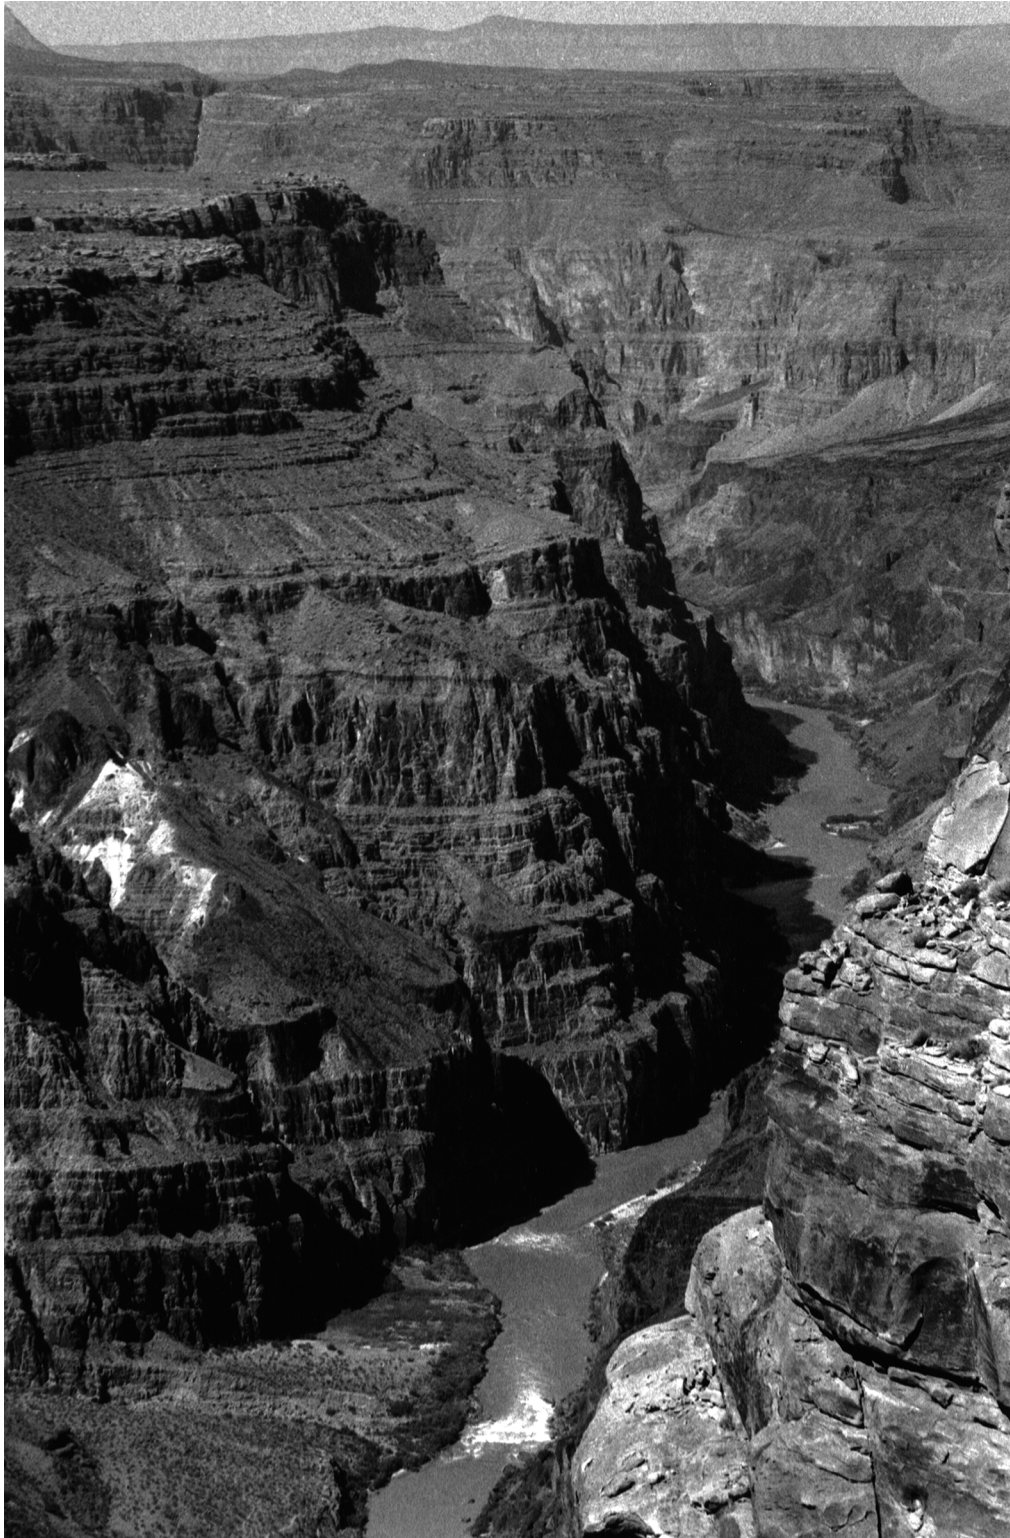
B. (June 10, 1979; R.M. Turner). After a series of debris flows from 1939 through 1966, Lava Falls Rapid changed substantially. At a discharge of about $340 \text{ m}^3/\text{s}$ in 1979, the head of the rapid slanted downstream to the right side, and the main tongue was on the right side. The tail waves were much farther downstream and curved towards the left. Two distinct levees in the mouth of Prospect Canyon were deposited between 1872 and 1966; the largest levee was deposited by the 1939 debris flow, and the smaller, inset levee is remnant channel fill from the 1963 and 1966 debris flows. The debris-flow deposits in the mouth of Prospect Canyon are overgrown with dense riparian vegetation.

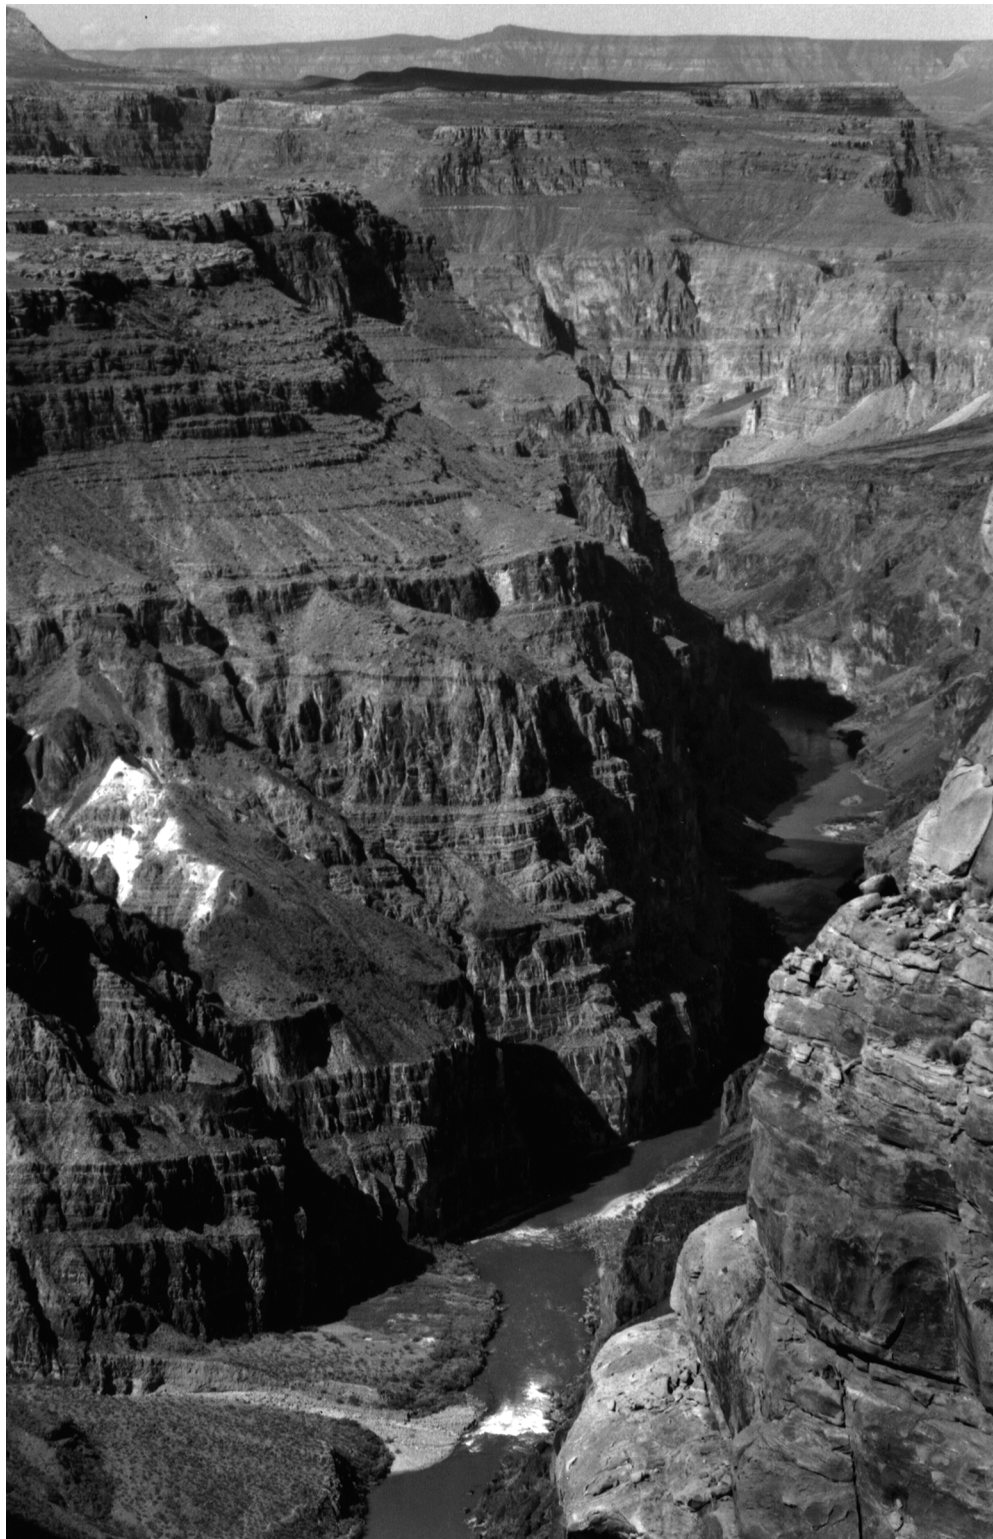
C. (May 16, 1995; R.M. Turner). The debris flow of March 6, 1995, initially constricted the Colorado River by 62 percent, but reworking quickly widened the river and reduced the constriction, as shown here, to about 50 percent. The constriction increased the drop through Lava Falls Rapid, accentuating its hydraulics, but some formerly prominent waves, such as the Big Wave, were not present. The 1963 and 1966 debris-flow deposits were completely eroded from the margins of Prospect Canyon. At this discharge of about $260 \text{ m}^3/\text{s}$, the exposed area of the new debris fan is 0.62 ha.

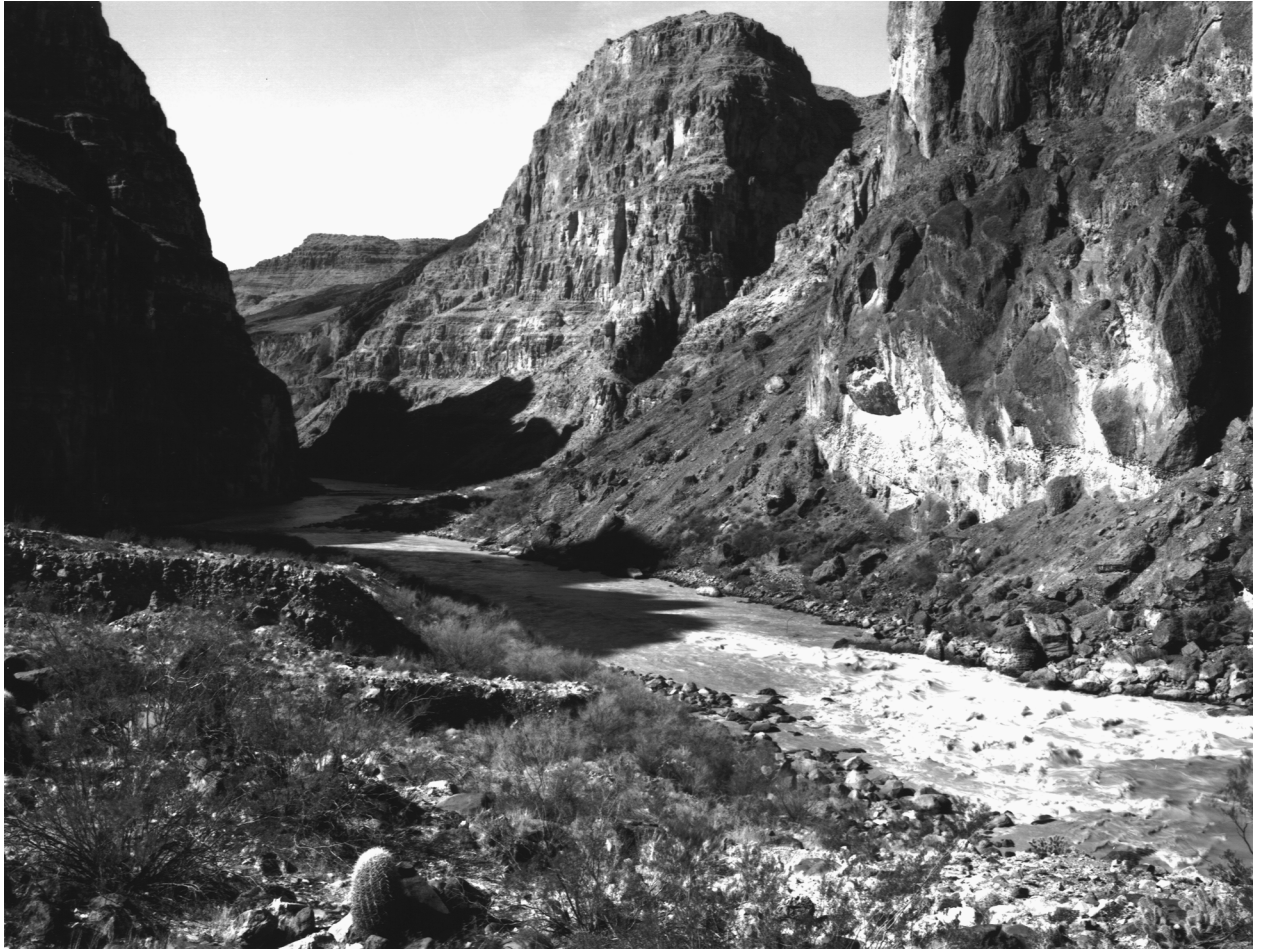
B. (February 11, 1990; R.M. Turner). Debris flows from Prospect Canyon changed the rapid substantially in the 20th century. The rapid now begins farther upstream. The 1939 debris flow deposited the prominent low surface at left center. Deposition during the 1939 event forced flow through the rapid to the right; the Deflector Rock moved downstream and was submerged at most water levels. The Black Rock deflects typical dam releases to the left. Debris flows in 1954, 1955, 1963, and 1966 deposited sediment along the left side of the rapid, changing a relatively quiescent area to whitewater choked with boulders.

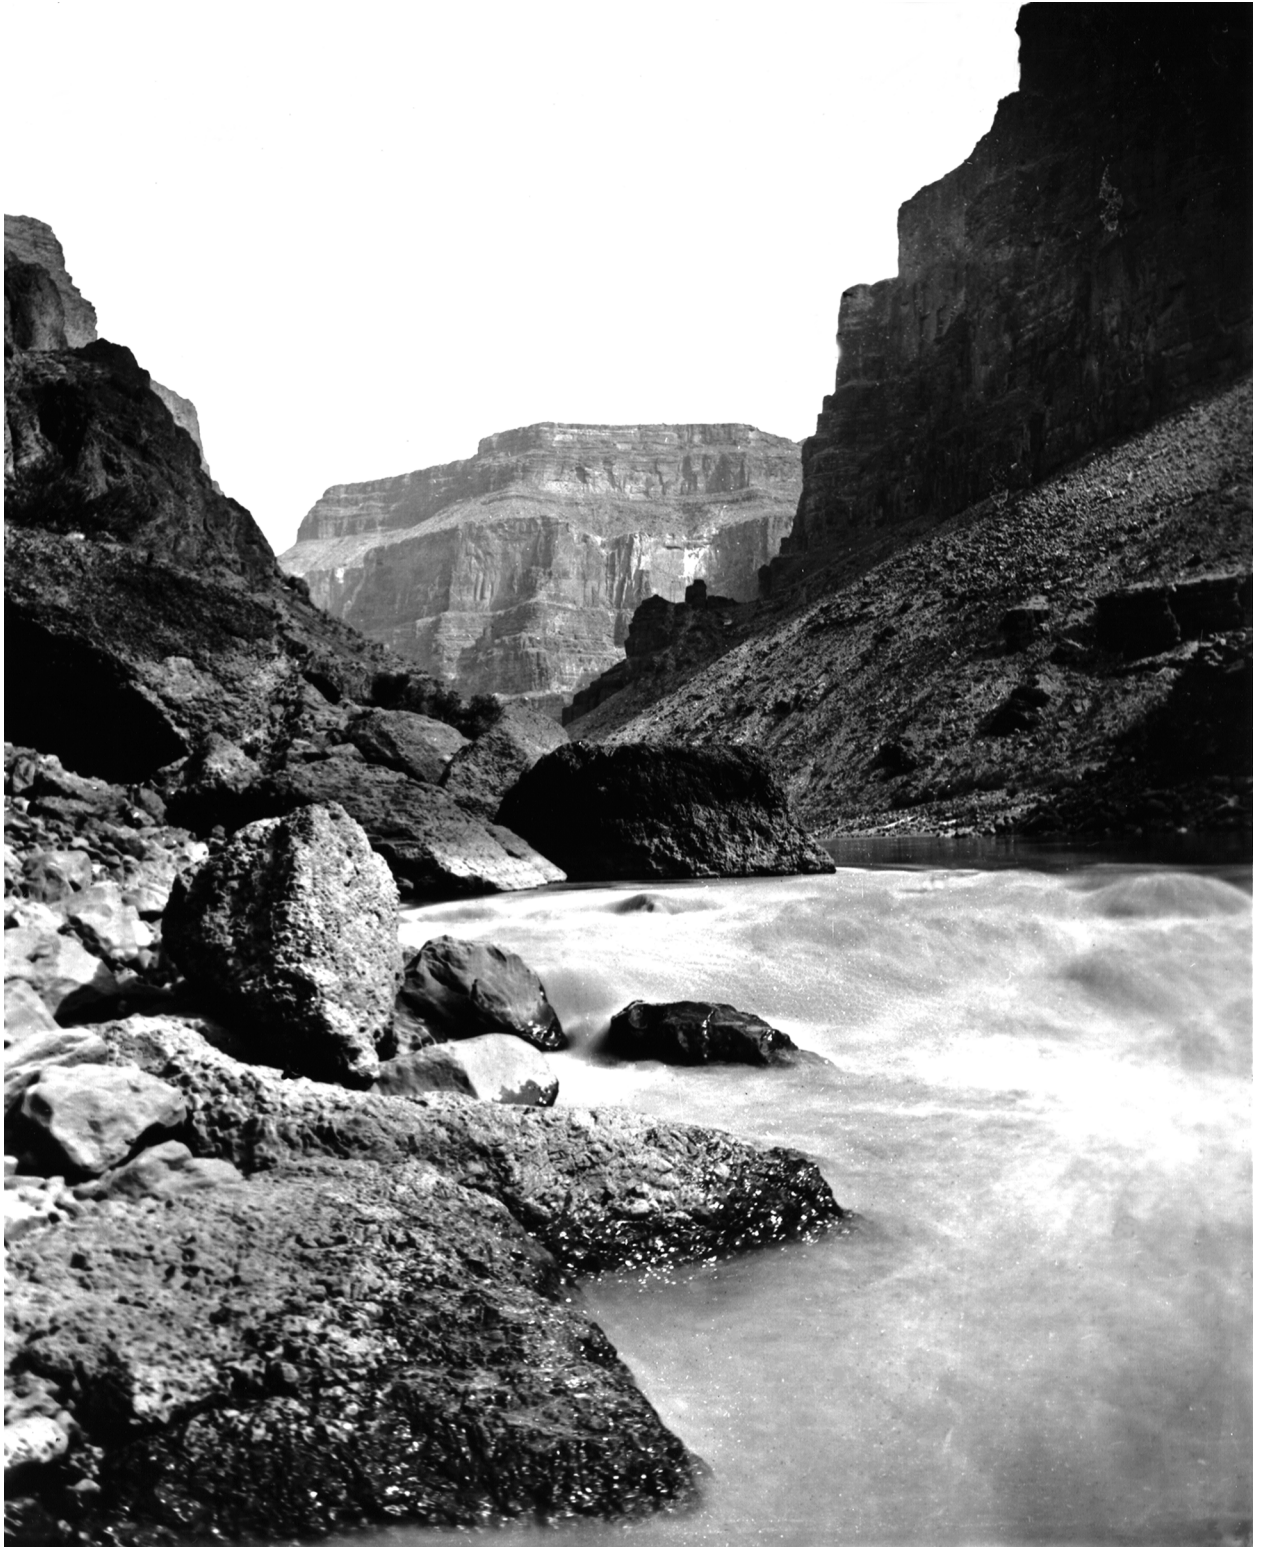
Figure 15. Upstream views of the head of Lava Falls Rapid from the right side (Stakes 2598 and 2662). A. (April 19, 1872; J. K. Hillers, courtesy of the National Archives). At a discharge of about $280 \text{ m}^3/\text{s}$, the Entrance Rock appears in the center; a very small eddy formed behind this rock in 1872. Many rocks and small pourovers are visible in the center of the photograph. This photograph is also shown in Graf (1979).

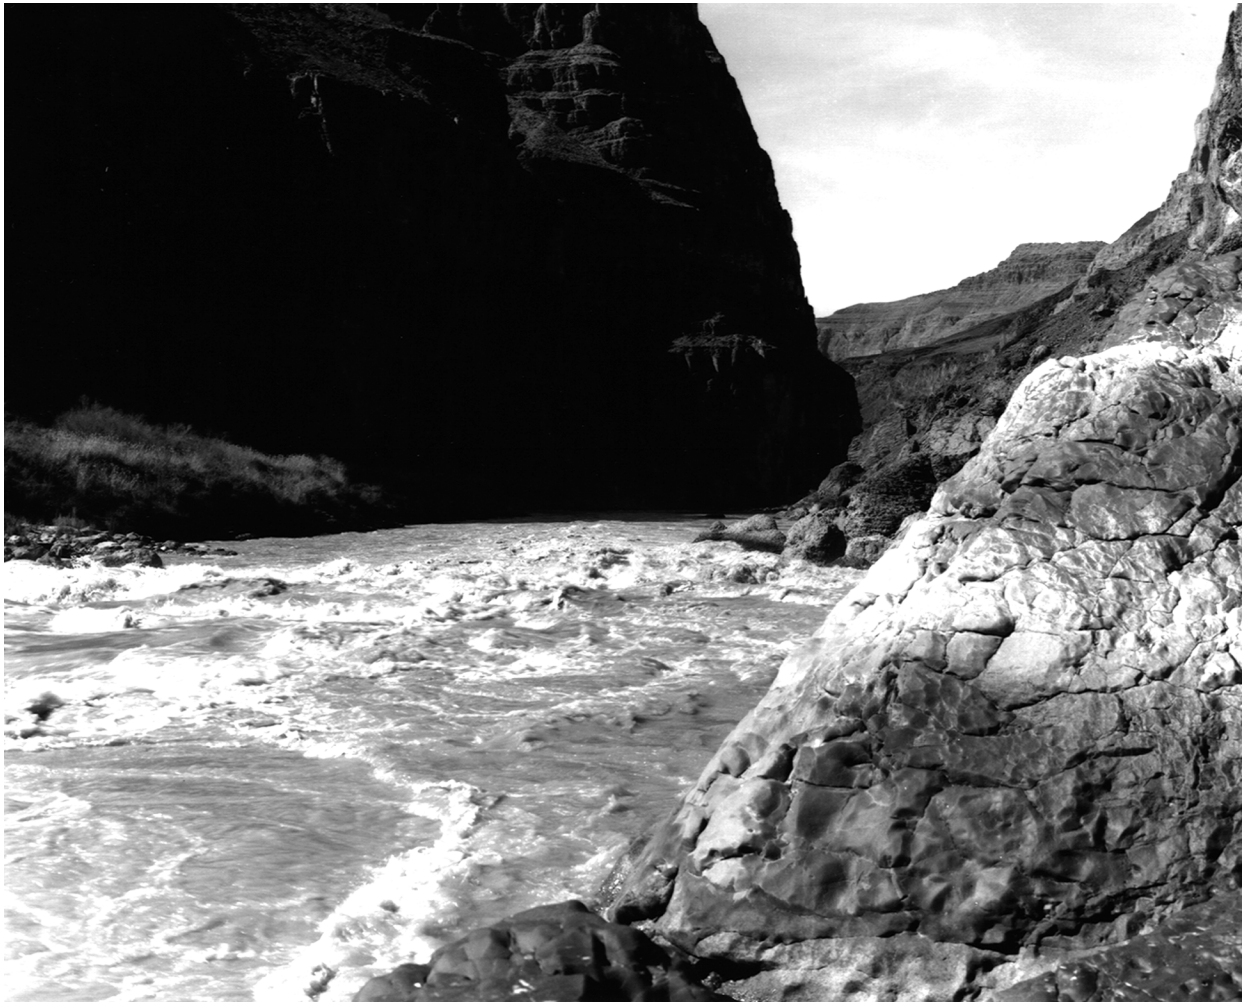
B. (March 9, 1993; L. Hymans). At a discharge of $310 \text{ m}^3/\text{s}$, no rocks are exposed in the center of the rapid. The Deflector Rock was rotated and moved downstream toward the center of the channel and usually is submerged. The Big Wave, to the left of the Black Rock, forms from flow over the submerged boulder. A large part of the basalt boulder in the right foreground has been eroded.

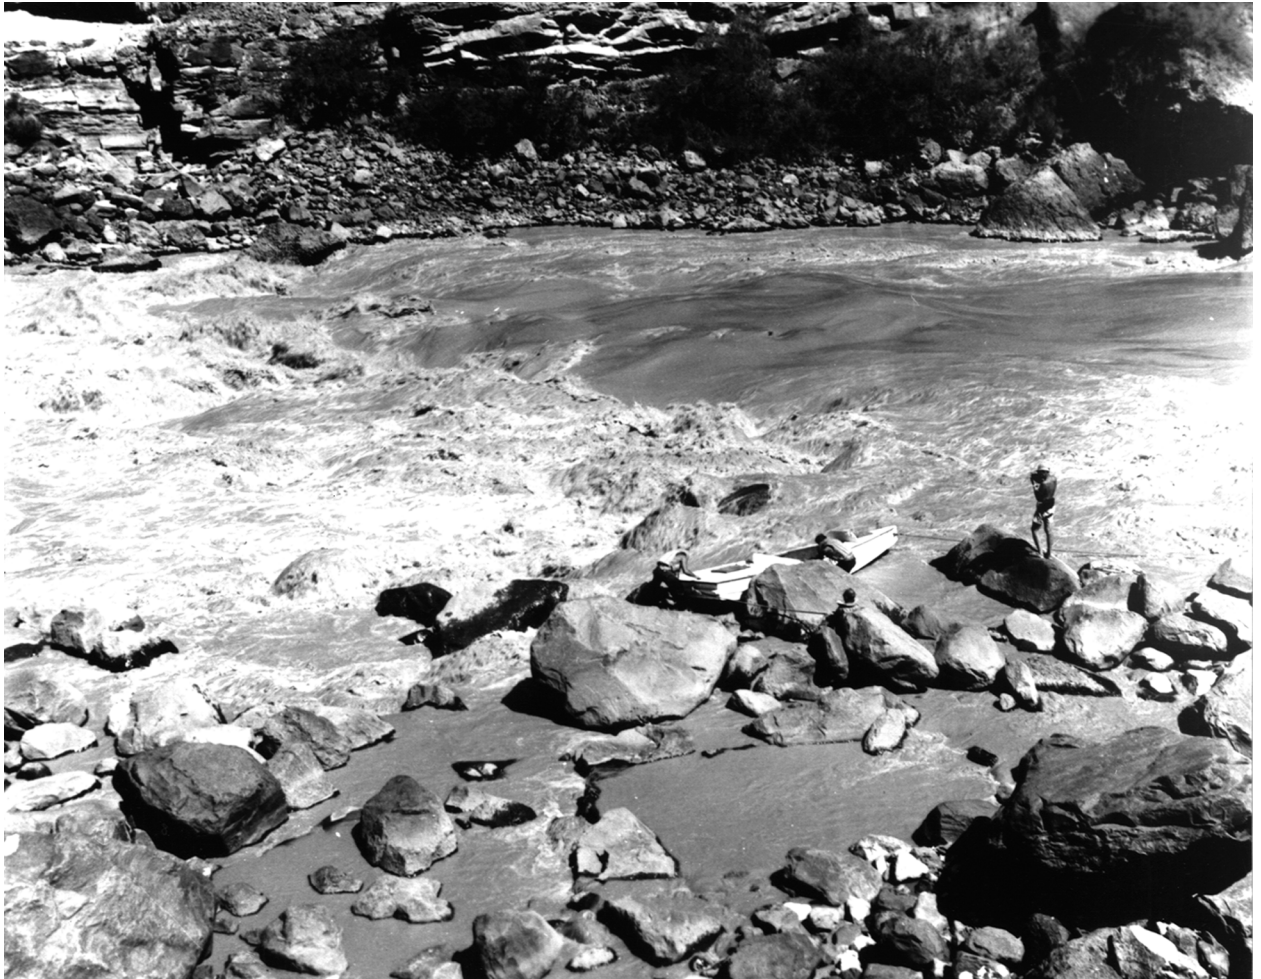
Figure 18. Views of Lava Falls Rapid from the left side (Stake 2660a). A. (July 26, 1942; N. Wilson, courtesy of the University of Utah Marriott Library). In this upstream view, the crew of the Nevills expedition is lining boats along the left side of the rapid. The 1939 debris flow completely changed the flow pattern in the rapid. The Pyramid Rocks were removed from the center of the rapid, and large holes punctuated the left side. The photographer stood on a debris fan that was 3-4 m higher than the fan in 1993; the deposits of the 1939 debris flow were subsequently reworked by Colorado River floods or Prospect Canyon debris flows.

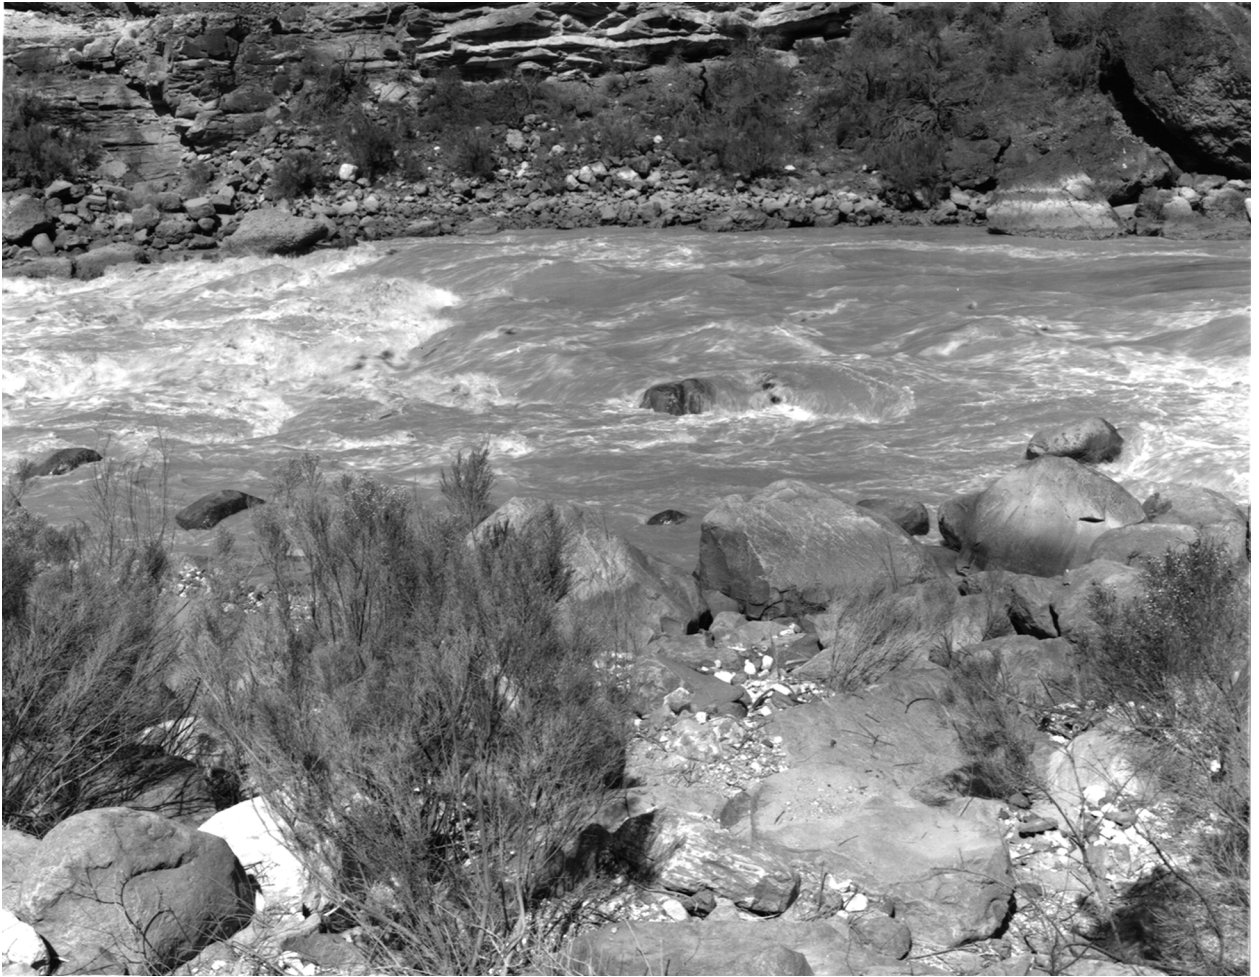
B. (March 10, 1993; S. Tharnstrom). At a discharge of 310-340 m³/s, the apparent stage is about 0.5 m lower than in 1942. Debris flows after 1942 deposited rocks in the center of the rapid that form the Ledge Hole, which does not appear in the 1942 view. Riparian vegetation has invaded the debris fan.

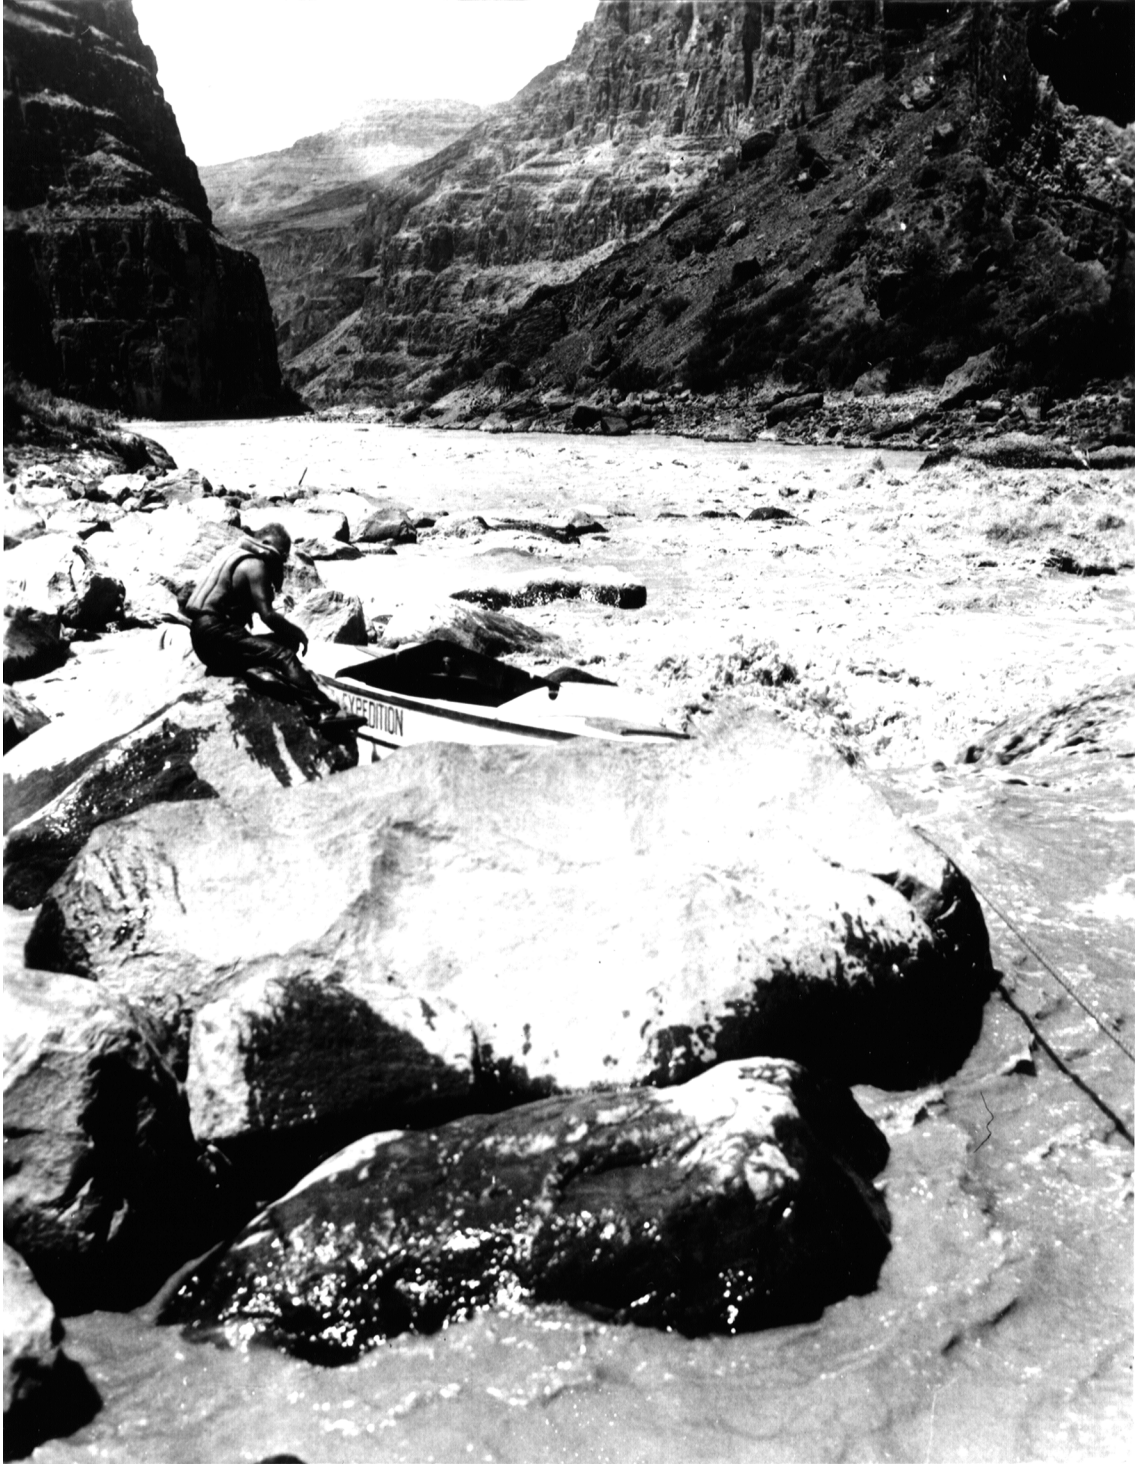
Figure 19. Downstream view of Lava Falls Rapid from the left side (Stake 2741). A. (July 27, 1941; W. Heald, courtesy of the University of Utah Marriott Library). A crew member of the 1941 Nevills expedition rests on a rock during a portage down the left shore. At a discharge of about $570 \text{ m}^3/\text{s}$, water is piling up against the Black Rock, shown in the upper right of the view. The pattern of the tail waves, which has changed in comparison to pre-1939 views, is the result of increased constriction of the Colorado River and displacement of the Deflector Rock during the 1939 debris flow. All foreground rocks in this photograph were deposited in 1939.

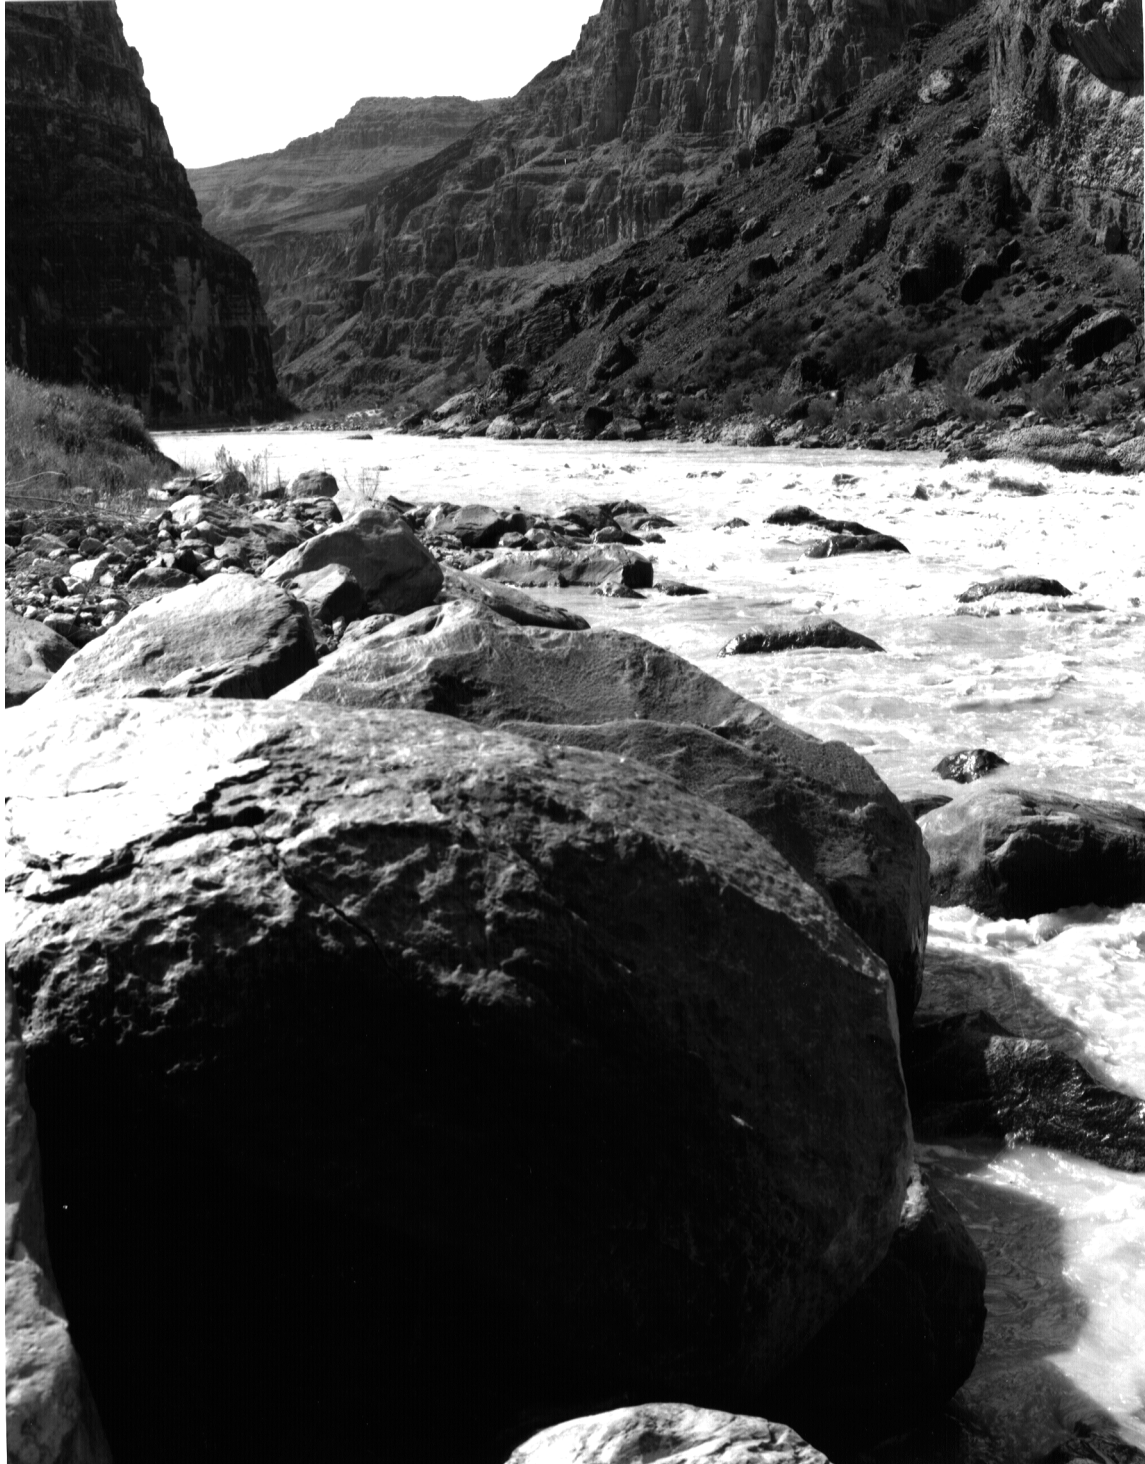
B. (March 10, 1993; S. Tharnstrom). Flow in the Colorado River is about 230-280 m³/s. Although many boulders have been transported in and out of the field of view by debris flows after 1941, several boulders in the midground remain. The boulder that the crew member is resting on in 1941, as well as the boulders immediately upstream, are in the same place. The foreground boulder, which has a b-axis diameter of 1.85 m, was probably deposited during the 1955 debris flow. The pattern of waves at the bottom of Lava Falls Rapid is similar in 1941 and 1993.
