“THE GREAT CATARACT”

Effects of Late Holocene Debris Flows on Lava Falls Rapid, Grand Canyon National Park, Arizona

U.S. GEOLOGICAL SURVEY
Open-File Report 96—460

Prepared in cooperation with the
BUREAU OF RECLAMATION

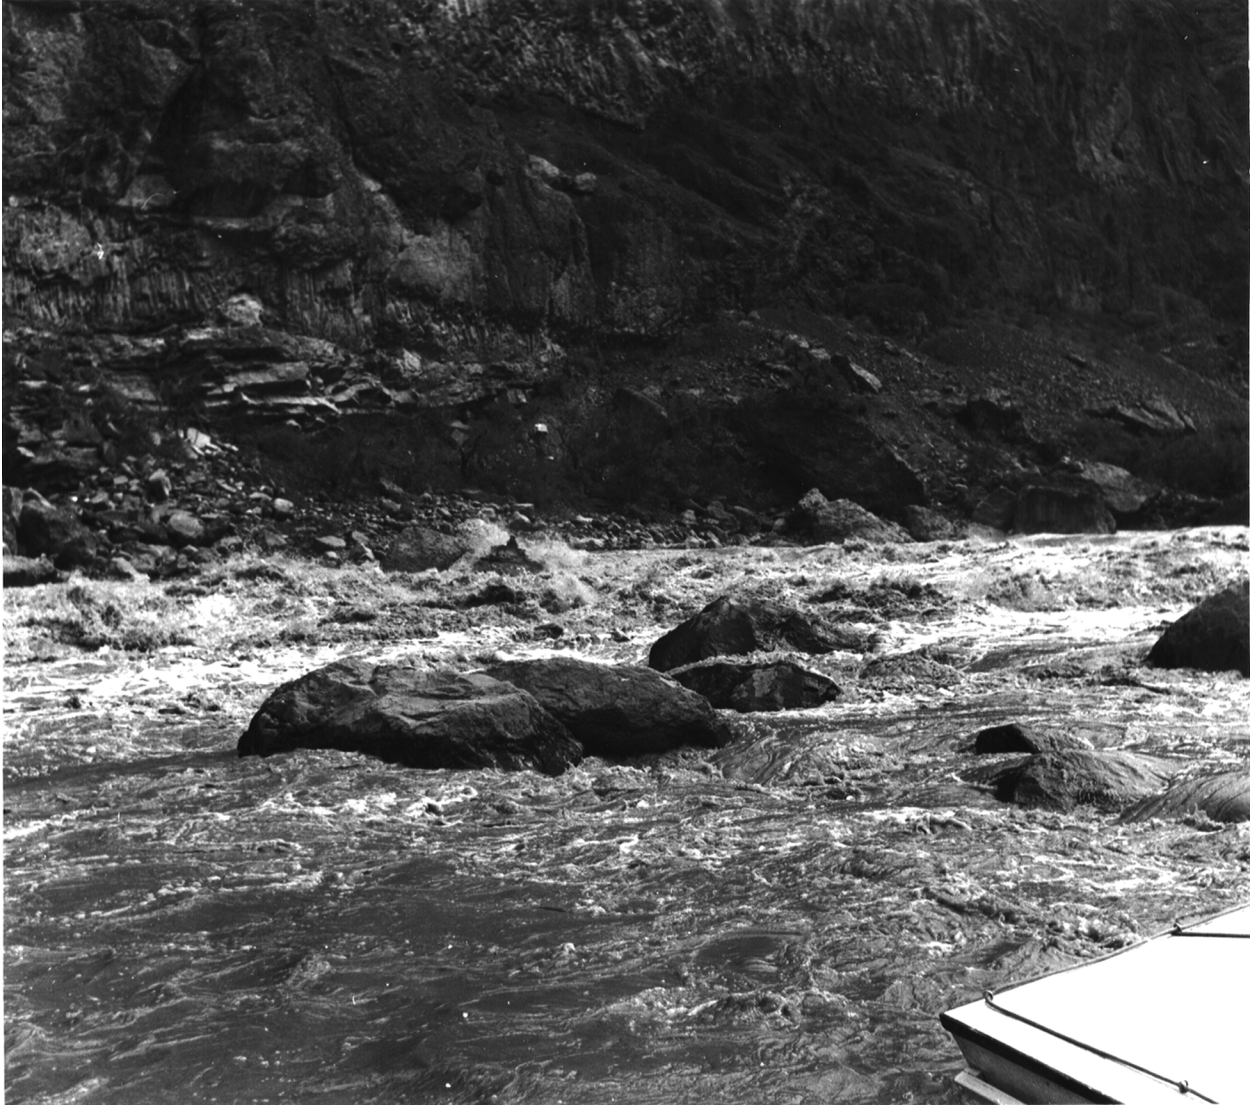
Figure 20. Upstream view of Lava Falls from the left side (Stake 2046).A. (July 7, 1950; P. T. Reilly). A motor boat passes through the V Wave, which appear in the left center of this upstream view. The large boulder at bottom center is approximately 1.5 m in diameter. The discharge is $470 \text{ m}^3/\text{s}$.

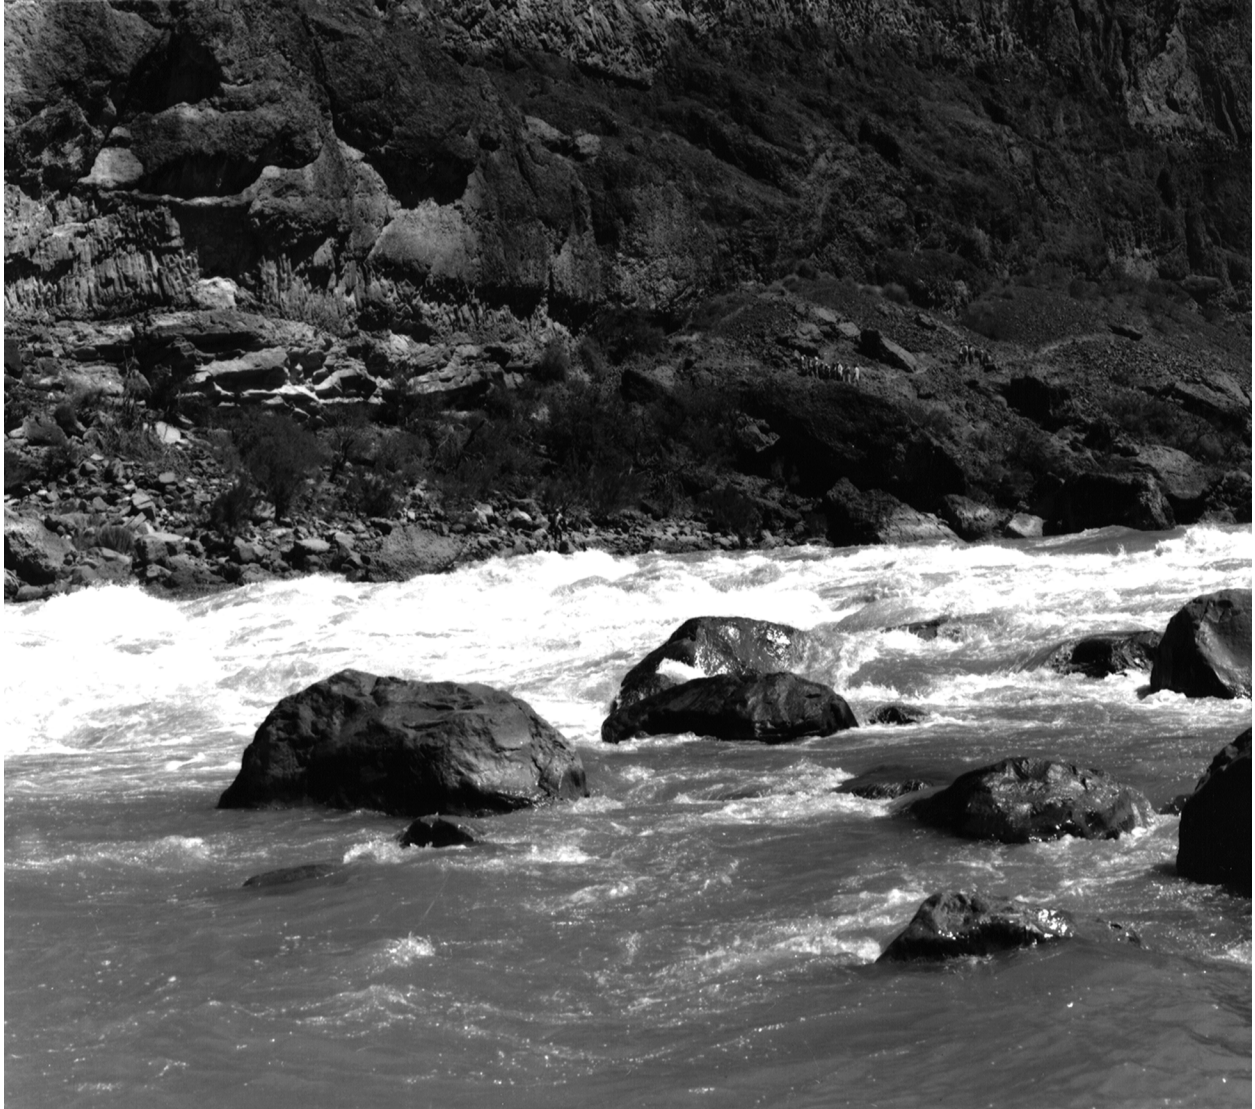
B. (August 16, 1991; R.H. Webb). The discharge is slightly lower than in the 1950 photograph. Several boulders in the foreground were not dislodged by debris flow and Colorado River floods after 1950. However, one foreground boulder has been transported out of the field of view. A boulder of approximately the same dimensions was also transported into the field of view (lower right). Both boulders probably were deposited by the 1955 debris flow.

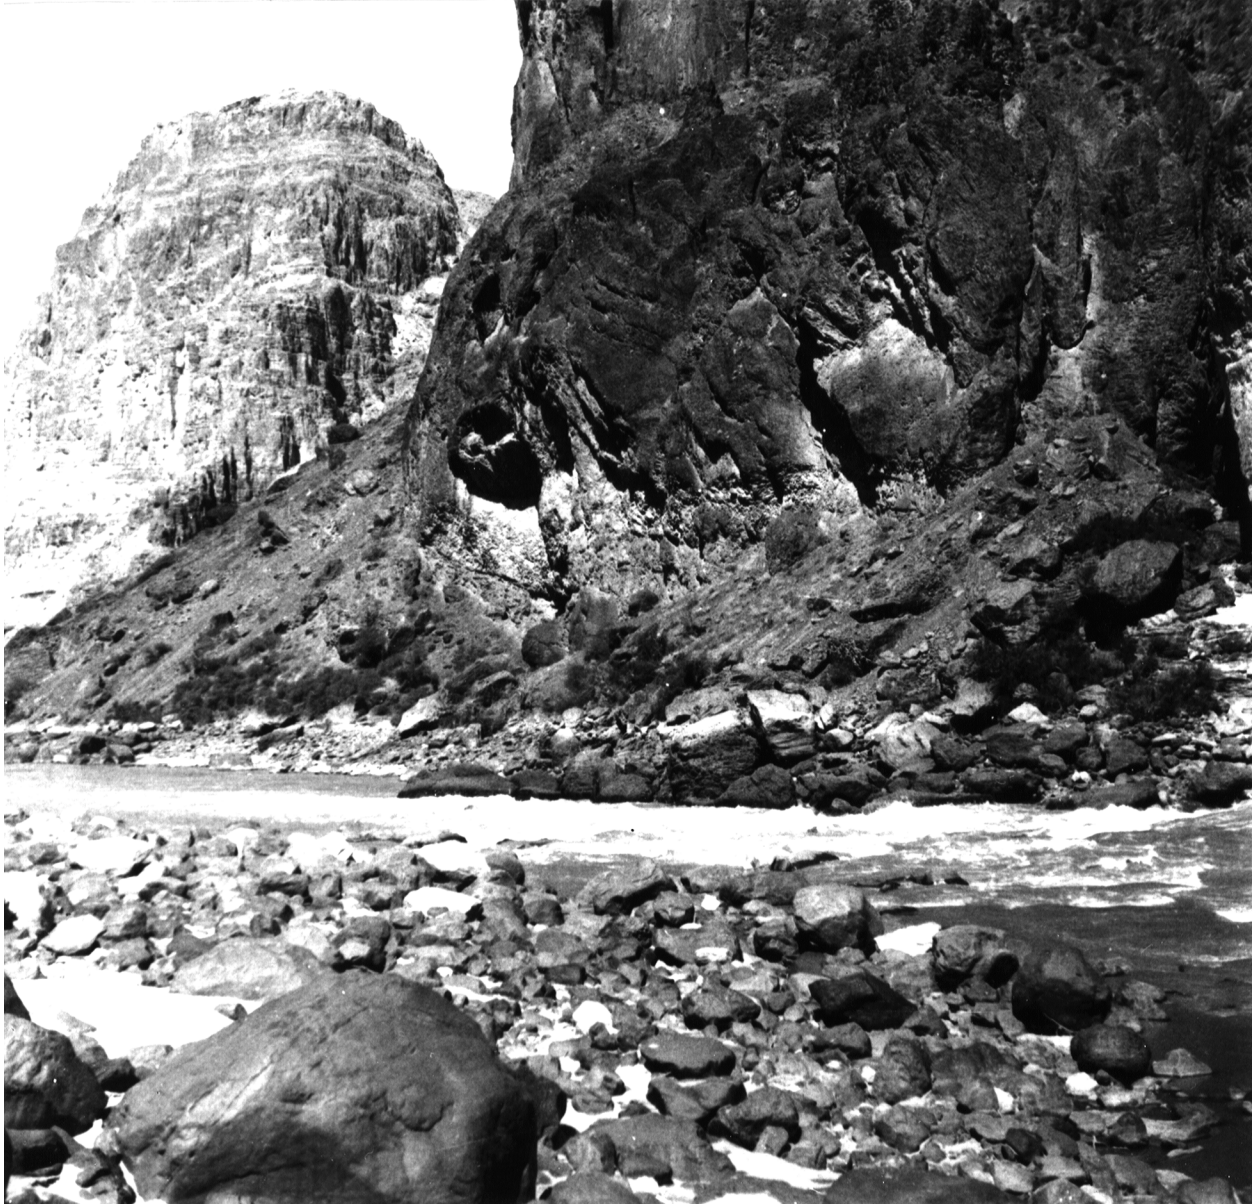
Figure 22. Downstream view of Prospect Canyon debris fan and lower Lava Falls Rapid (Stake 2002). A. (July 20, 1958; G. Staveley, courtesy of the Huntington Library). The discharge is $220 \text{ m}^3/\text{s}$, and the boulders on the debris fan are the net result of the 1939, 1954, and 1955 debris flows and reworking by the Colorado River. The 1957 flood in the Colorado River reworked the deposits of the 1954 and 1955 debris flows

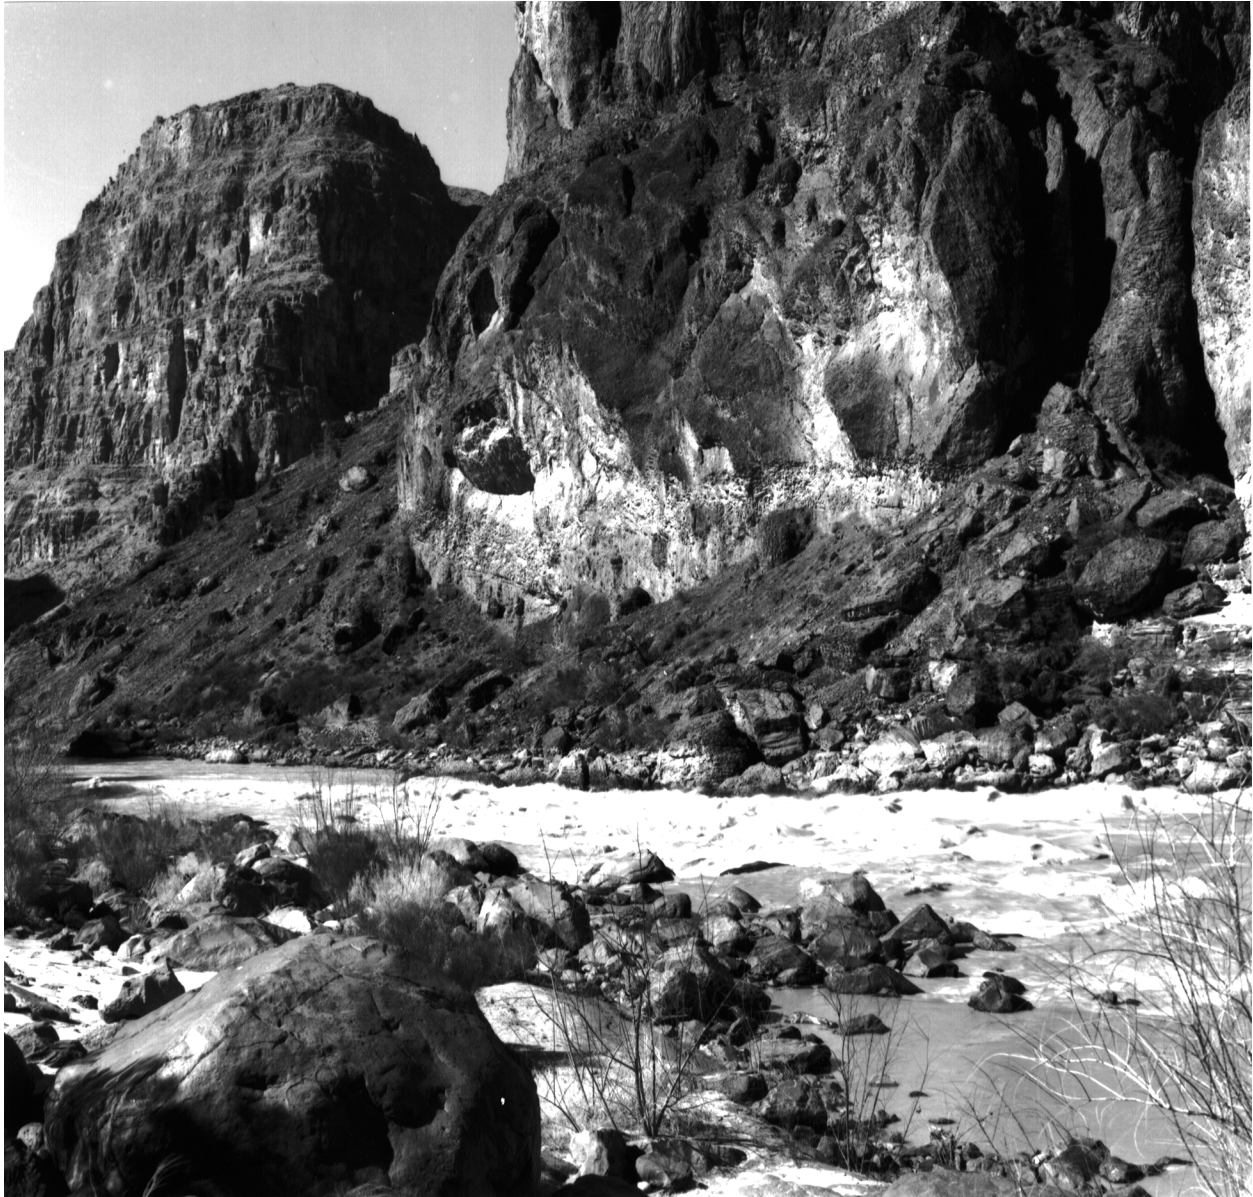
B. (February 20, 1991; D. Edwards). Although the stage was about 0.5 m higher than in the 1958 view, 6-10 boulders with diameters of 1 m or larger remain. Most of the foreground debris fan was buried by debris flows in 1963 and 1966. The debris fan decreased in size slightly between 1958 and 1991 although the size of boulders in the reworked zone appears unchanged.

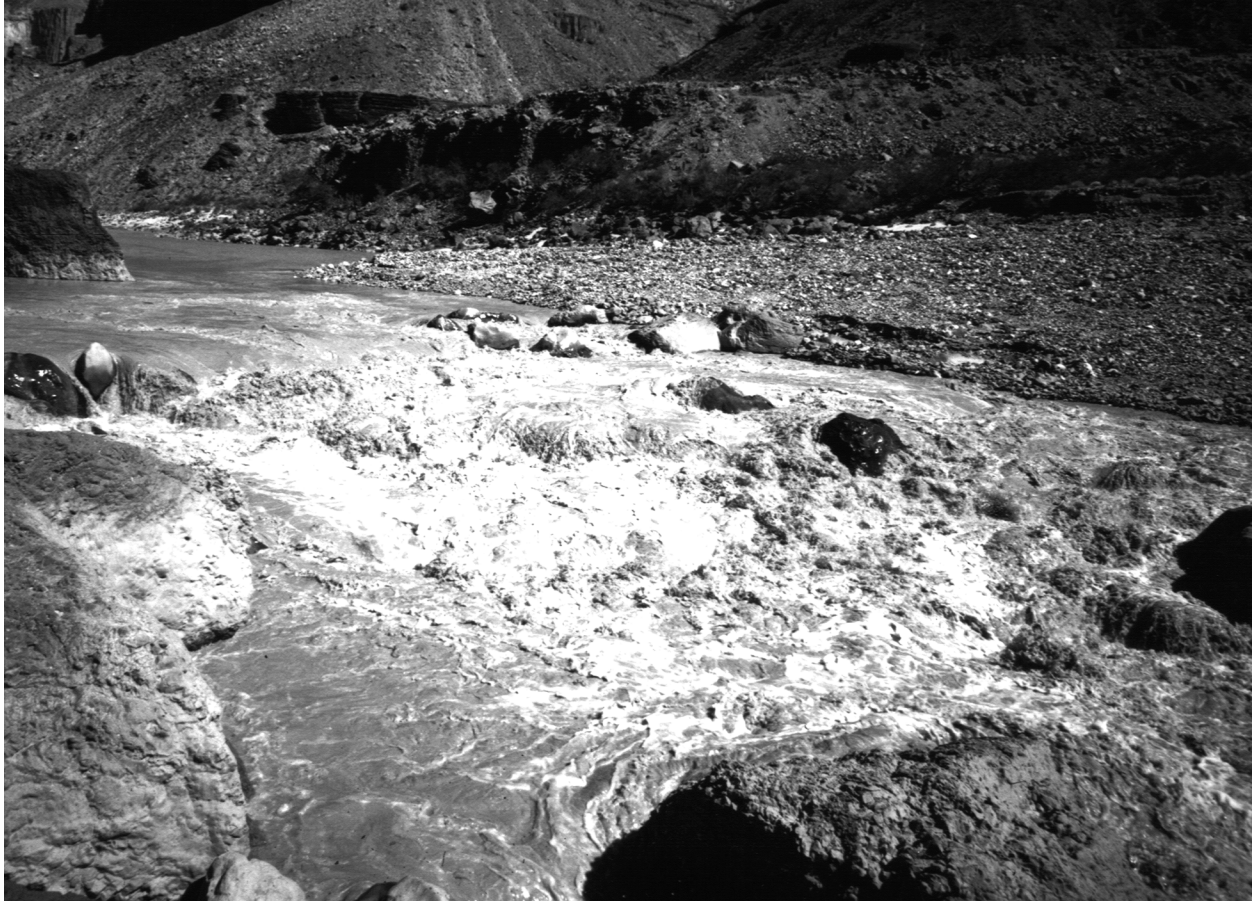
Figure 23. Upstream view of Lava Falls Rapid from the right side (Stakes 2005 and 3050). A. (September 25, 1963; photographer unknown, courtesy of the Huntington Library). This photograph was taken a short time after the September 1963 debris flow and shows its maximum constriction at a discharge of about $56 \text{ m}^3/\text{s}$. Boulders on the distal margin of the debris fan and in the center of the view created the Ledge Hole at higher discharges. The Meteor Rock, which creates the V Wave, appears on the right side of the view. The view shows the relatively fine-grained particle size that is characteristic of the 1963 deposits.

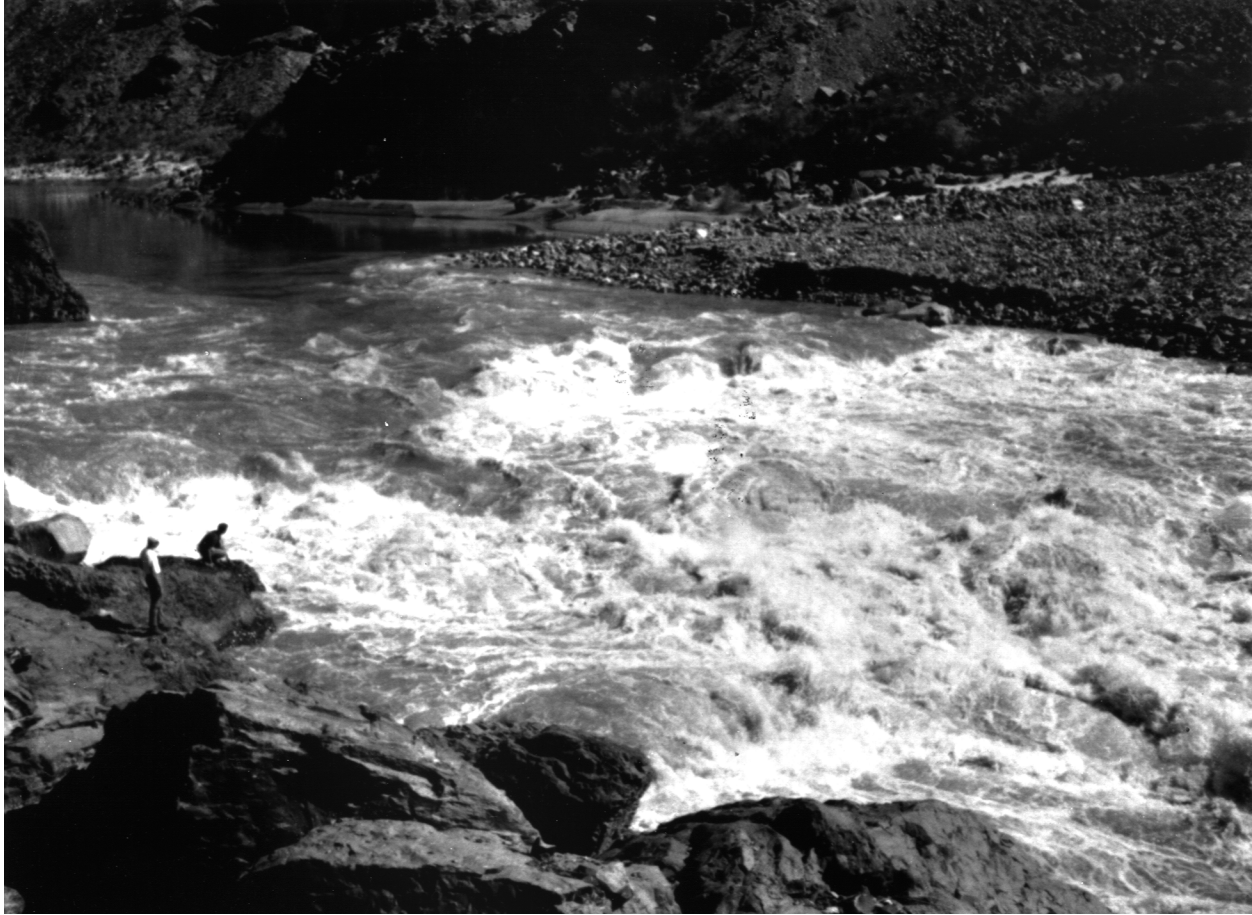
B. (February 21, 1965; J. Visbak, courtesy of the Huntington Library). This view, which is not a match of A, shows Lava Falls at a discharge of about $198 \text{ m}^3/\text{s}$. Dam releases up to $550 \text{ m}^3/\text{s}$ eroded the distal edge of the debris-flow deposit from 1963 through early 1965. Unlike the 1939 and 1955 debris flows, photographic evidence suggests that few boulders greater than 1 m in diameter were transported in the 1963 debris flow. As a result, most boulders in the 1963 debris flow fan were entrained during high dam releases in May-June, 1965.

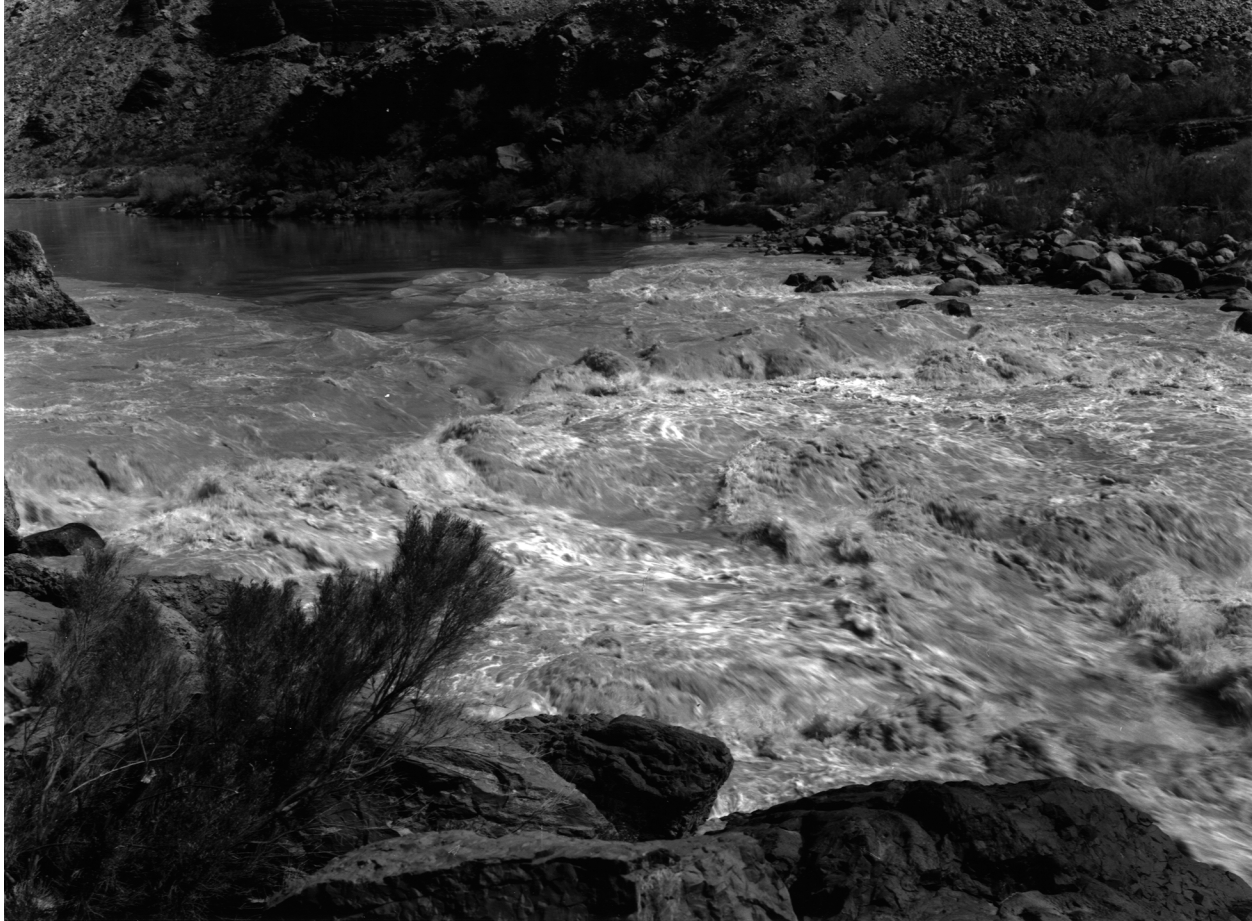
C. (March 10, 1993; L. Hymans). The discharge was about $350 \text{ m}^3/\text{s}$ in this match of the 1963 view. Reworking of the 1963 and 1966 debris-flow deposits was complete by that time, leaving little evidence of the former constriction. The boulders forming the Ledge Hole are submerged in this view but their hydraulic effect is clearly visible in the center of the view. The Meteor Rock was also covered, but the noteworthy hole that forms downstream of the Meteor Rock is visible.

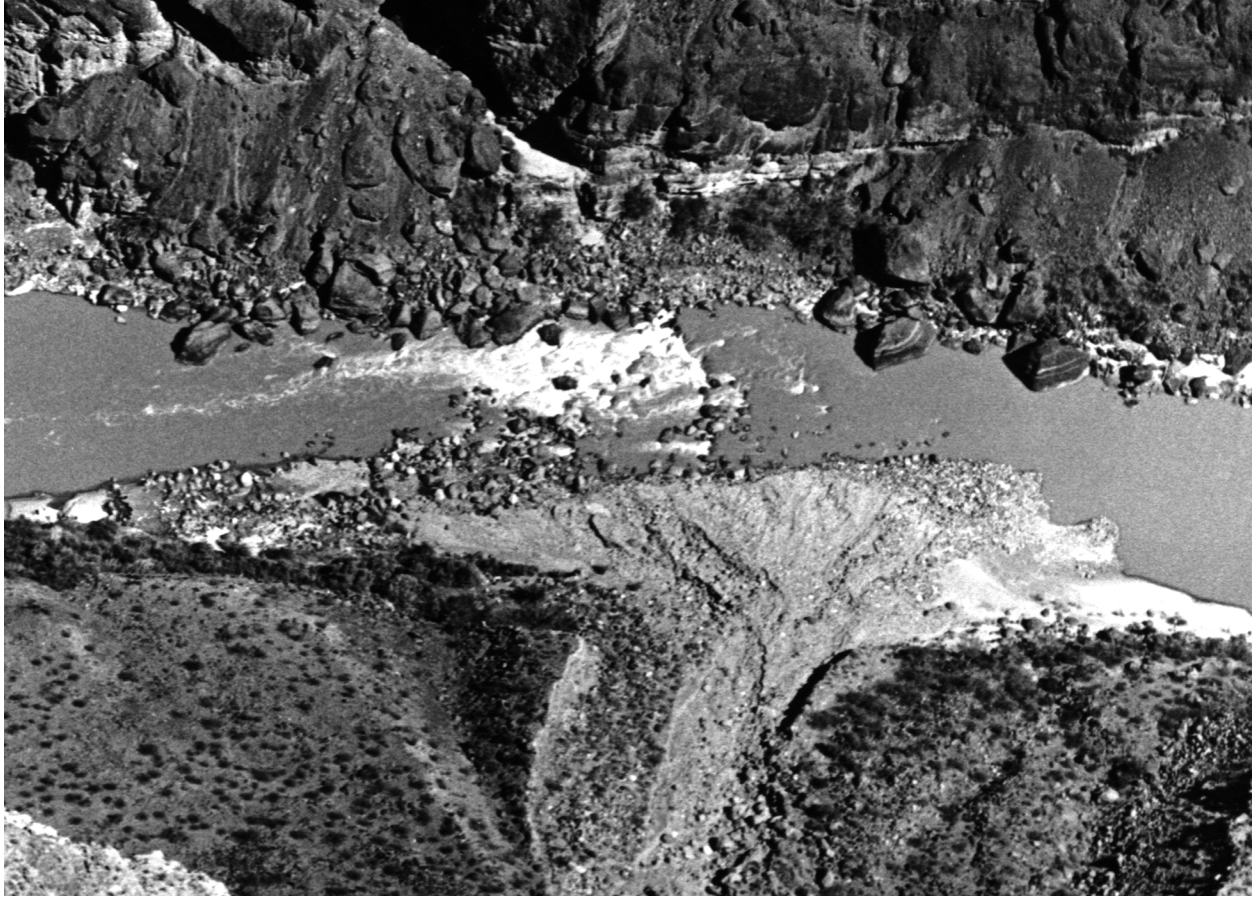
Figure 24. Oblique aerial view of Lava Falls Rapid and Prospect Canyon (May 20, 1964; P. T. Reilly). At a discharge of $37 \text{ m}^3/\text{s}$, the 1963 debris-flow deposit constricts the river by about 60 percent; the debris fan initially extended nearly to the middle of the Ledge Hole. This view shows the reworking by a peak discharge of $540 \text{ m}^3/\text{s}$. The Meteor Rock is visible in the center of the rapid, and the typically submerged Deflector Rock divided the tail waves.

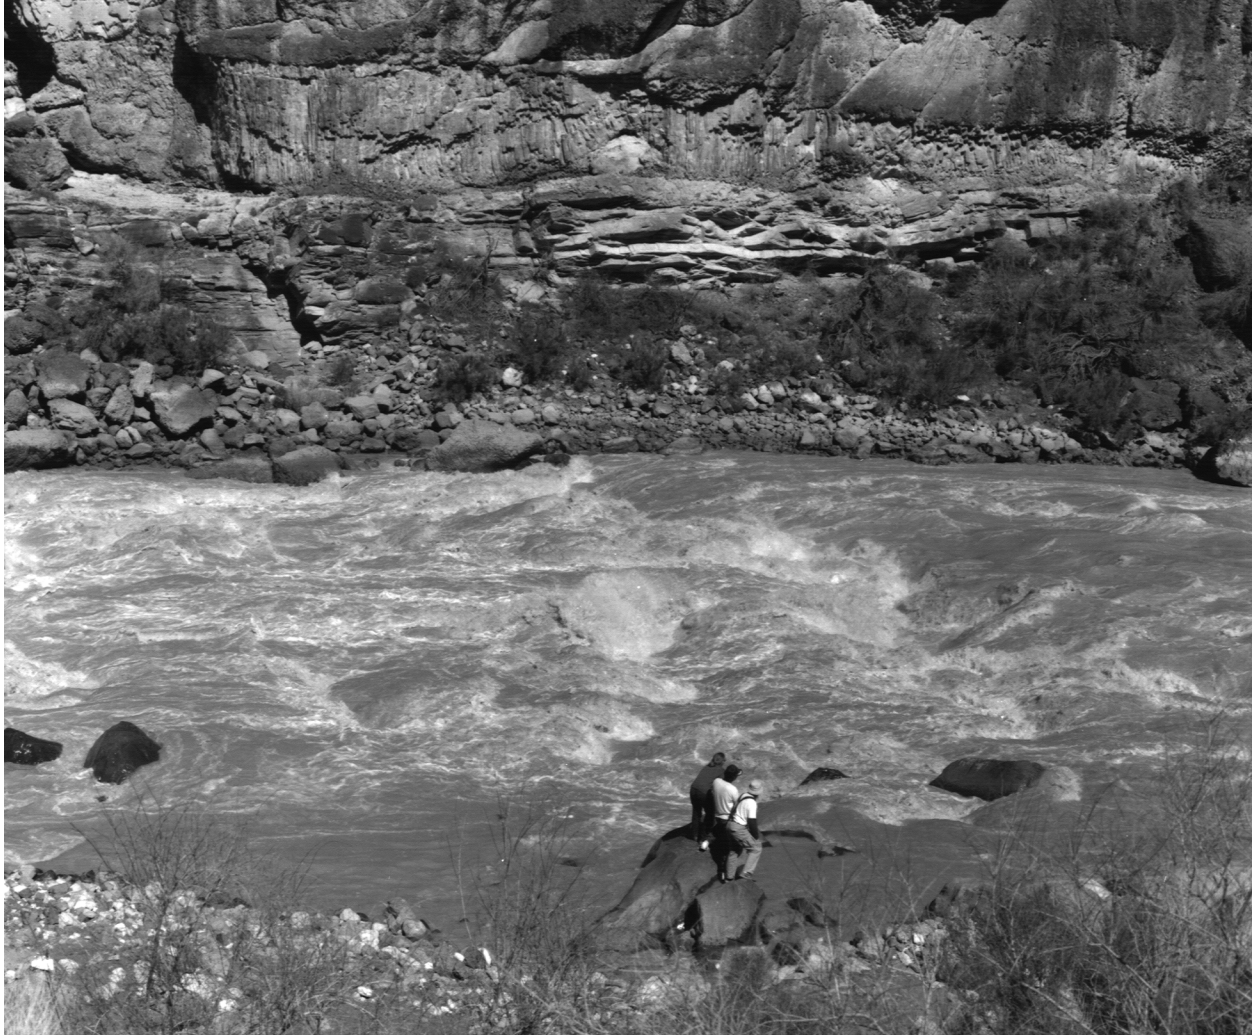
B. (March 8, 1993; R.H. Webb). The discharge was slightly lower than that in 1967. Most of the 1966 debris-flow deposit was removed in April 1973; the 1983 flood ($2,720 \text{ m}^3/\text{s}$) caused few changes in Lava Falls. The largest boulders, which controlled the major waves and holes in the rapid, were unchanged.

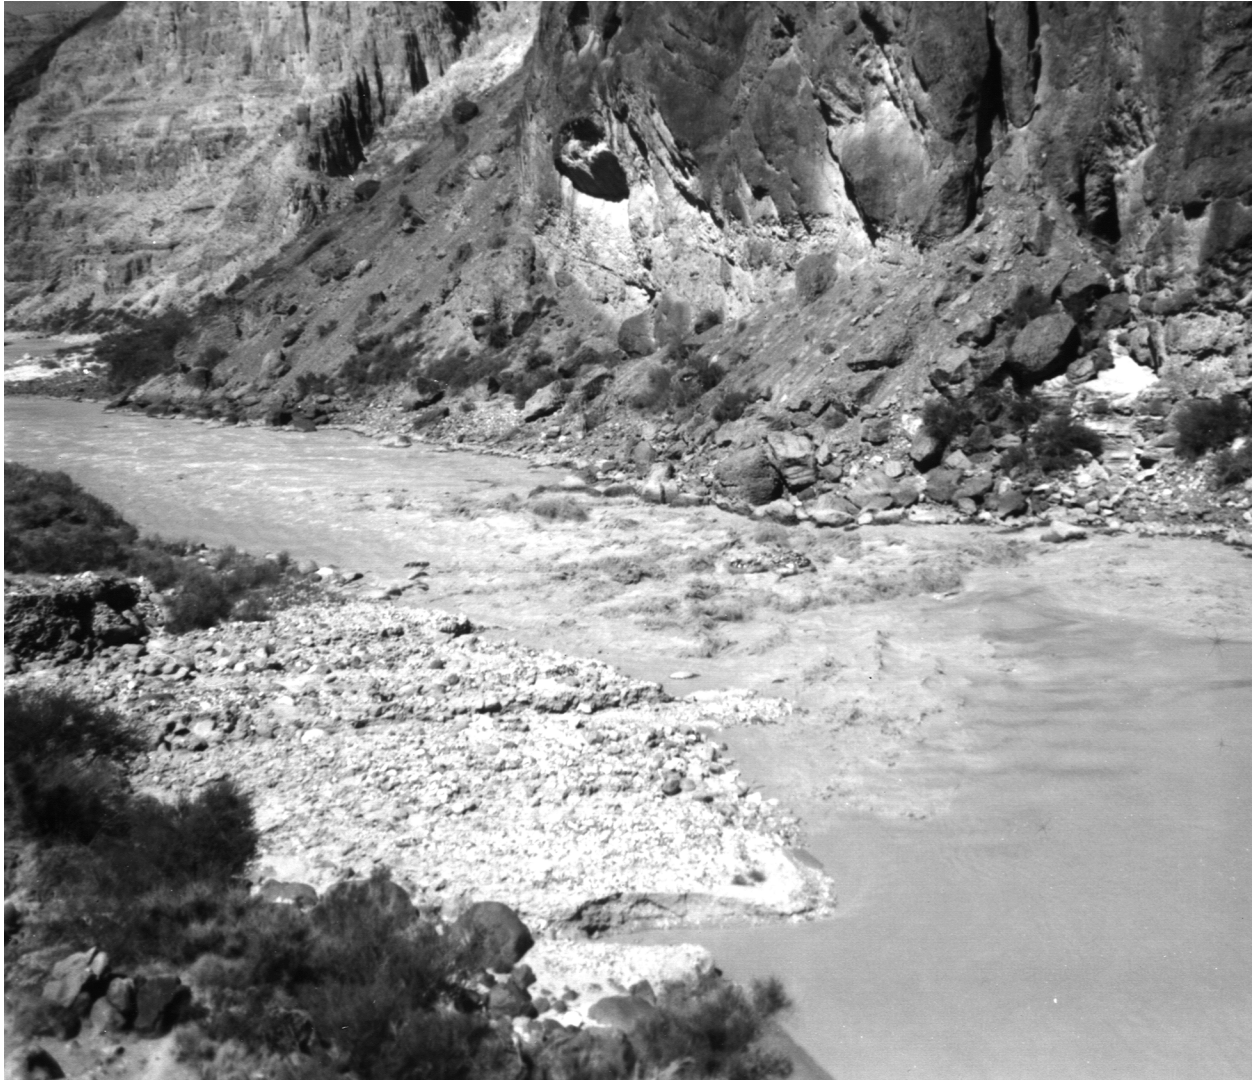
Figure 26. Downstream view of Lava Falls Rapid from the high surface on the left side (Stake 2964b). A. (August 1967; G. Luepke). At a discharge of about $340 \text{ m}^3/\text{s}$, the 1966 debris flow constricts the Colorado River by about 36 percent. According to the first river runner to view the rapid, the only effect of this debris flow was to eliminate the Left Run. A typical dam release and a small flood in the Little Colorado River on April 19, 1973, combined to form a peak discharge of $1,080 \text{ m}^3/\text{s}$, which removed the 1966 deposit.

Canyon (mile 65.5; Cooley and others, 1977; Webb and others, 1989) and elsewhere along the river, is the likely cause for the debris flow. An August 1967 photograph (fig. 26a) shows the extent of the aggraded debris fan. In addition to the poorly-sorted debris fan, small boulders were deposited on the left side of Lava Falls Rapid, reportedly closing off a previously used run (John Cross II, written commun., 1967). Most of the 1966 debris fan was removed by relatively small dam releases in 1972 and a small flood in the Little Colorado River in 1973.

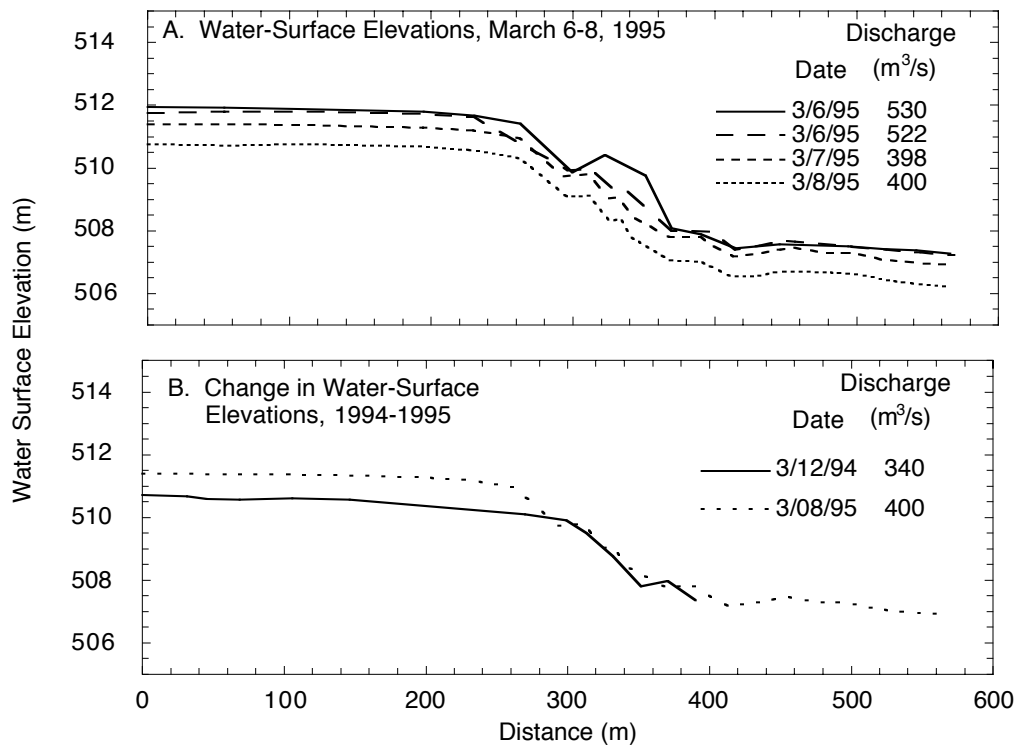
Figure 29. Longitudinal profile of the water-surface fall on the right side of Lava Falls Rapid. A. March 6-8, 1995. B. Comparison of water-surface profiles in March 1994 and March 1995.

Flow in the river was confined to a channel about 50 percent of its previous width, which caused distinct changes to the hydraulics of Lava Falls Rapid. The water-surface profile (fig. 29a) initially was greatly influenced by large waves on

The rapid changed slowly after noon on March 6. By mid-afternoon, a run developed just to the left of the Ledge Hole. By March 8, the configuration of the rapid and its water-surface profile stabilized (fig. 29). At a discharge of 400 m³/s, the constriction from the new debris fan caused the stage in the rapid to appear as if the discharge was 170 m³/s higher. The drop at the head of the rapid increased by 0.9 m from the 1994 water-surface profile for a roughly equivalent discharge (fig. 29b), although the stage remained similar through the rapid; in other words, the total drop through the main part of the rapid increased from 3.1 m in 1994 to 4.0 m in 1995.

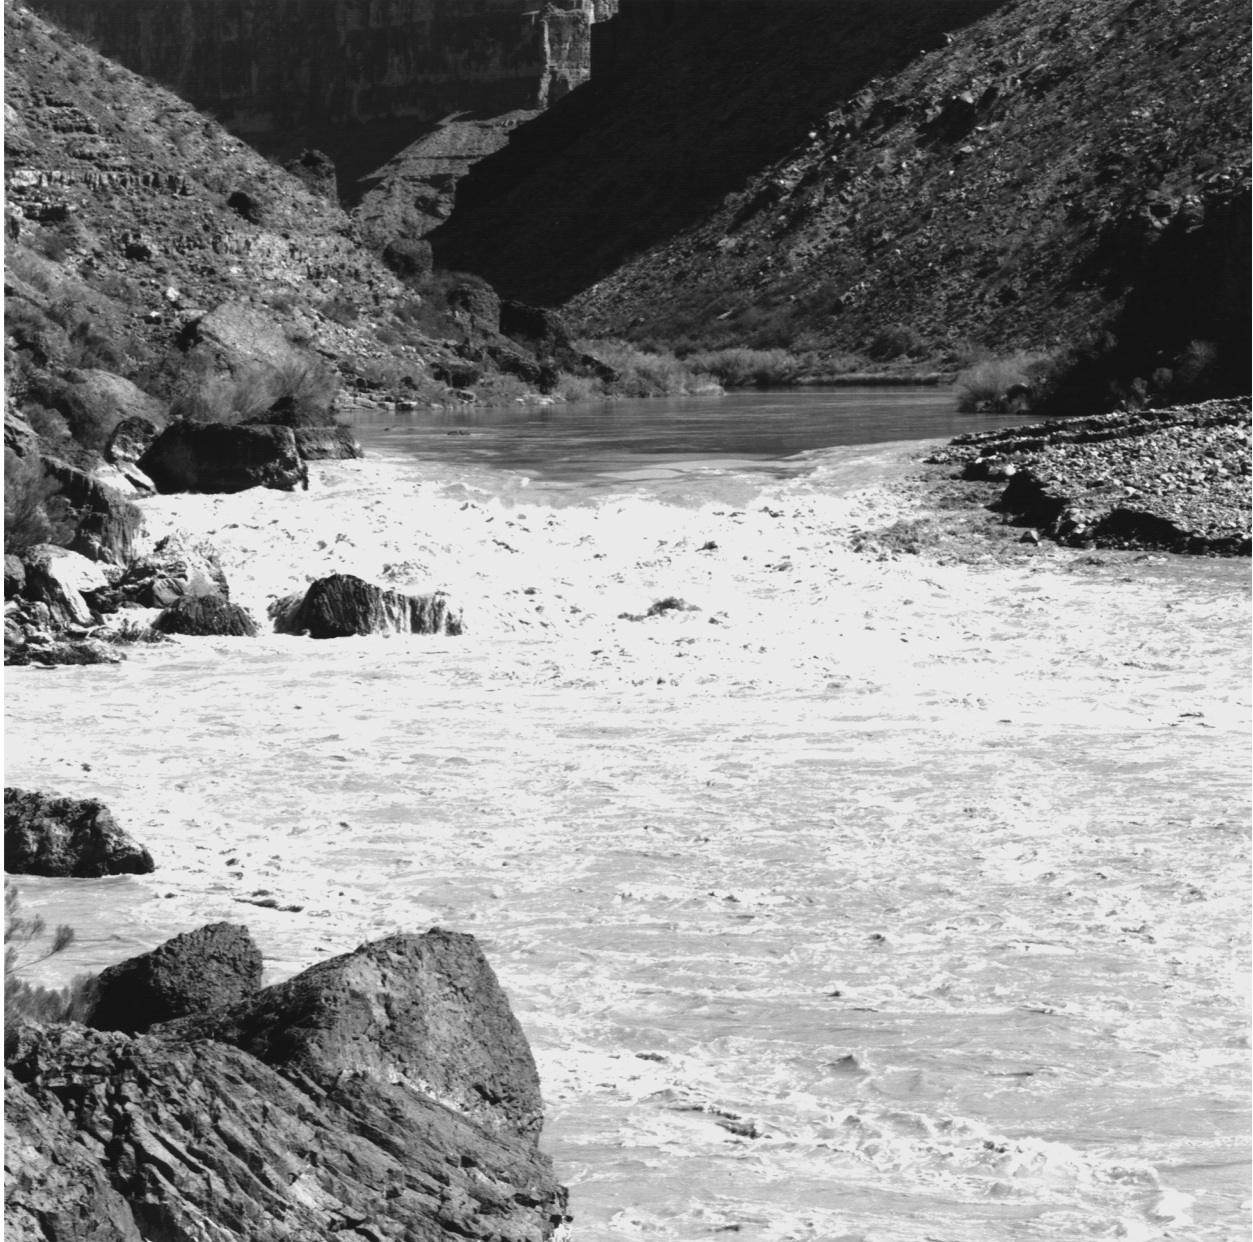
C. (March 6, 1995; S. Tharnstrom). The 1995 debris flow occurred about 11 hrs before this photograph was taken. A small flood of $500 \text{ m}^3/\text{s}$ in the Colorado River, combined with $14\text{-}28 \text{ m}^3/\text{s}$ of recessional flow in Prospect Canyon, reworked the distal edge of the debris fan. Water pours over the Black Rock, where it previously had not until discharges greater than $700 \text{ m}^3/\text{s}$. Fast water replaced the eddy in the foreground because reworked cobbles and gravel filled the pool downstream from the rapid.

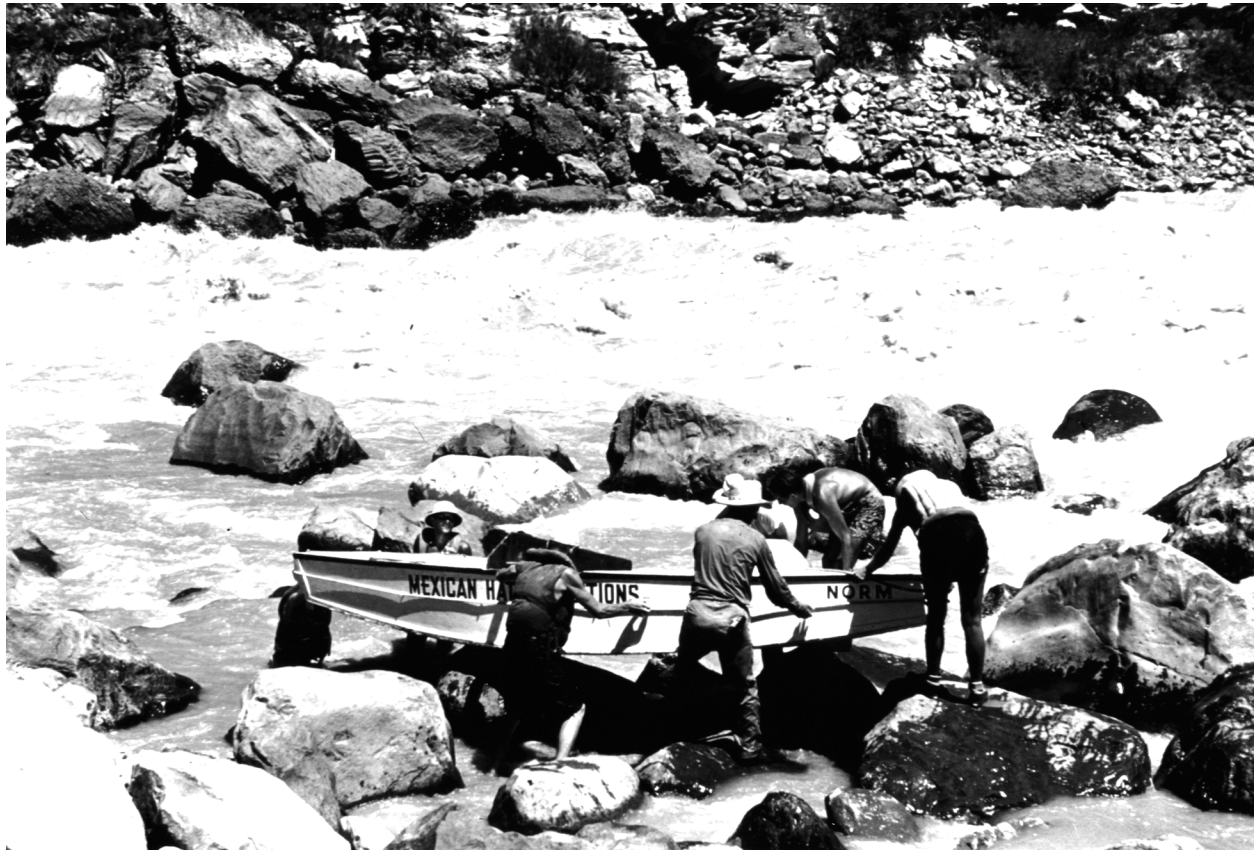
Figure 31. View across Lava Falls Rapid from river left (Stake 2969). A. (July 1952; T. Nichols). Before the advent of rubber rafts, most river trips portaged boats around Lava Falls Rapid. Here, Mexican Hat Expeditions trip paused during a portage with the boat completely out of the water on large boulders deposited in 1939.

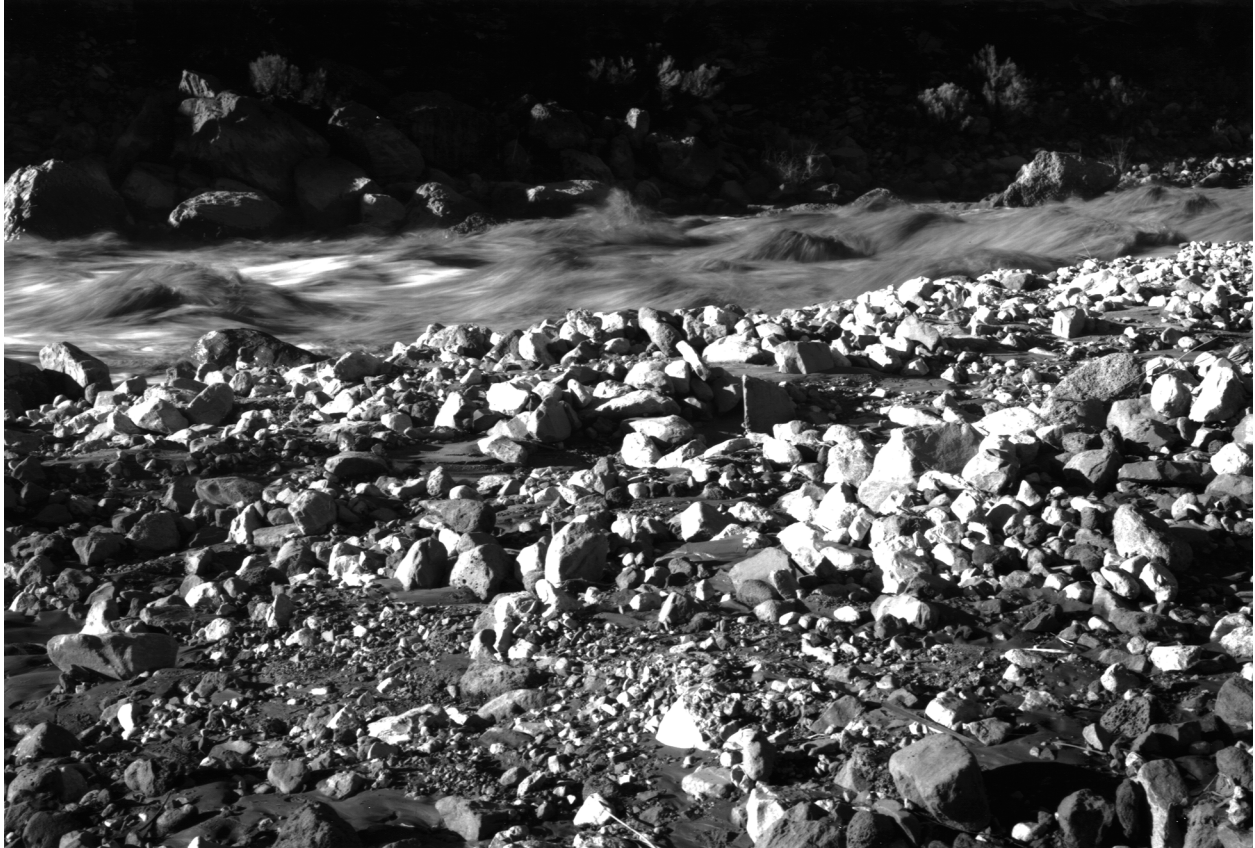
B. (March 7, 1995; D. Oldershaw). This match, which may be off by a meter or more, shows deposition by the 1995 debris flow. This view is probably similar to the view from the aggraded debris fans in 1955 and 1963; the 1954 and 1966 debris flows were considerably smaller. One of the boulders visible in the 1952 view is present at left center.

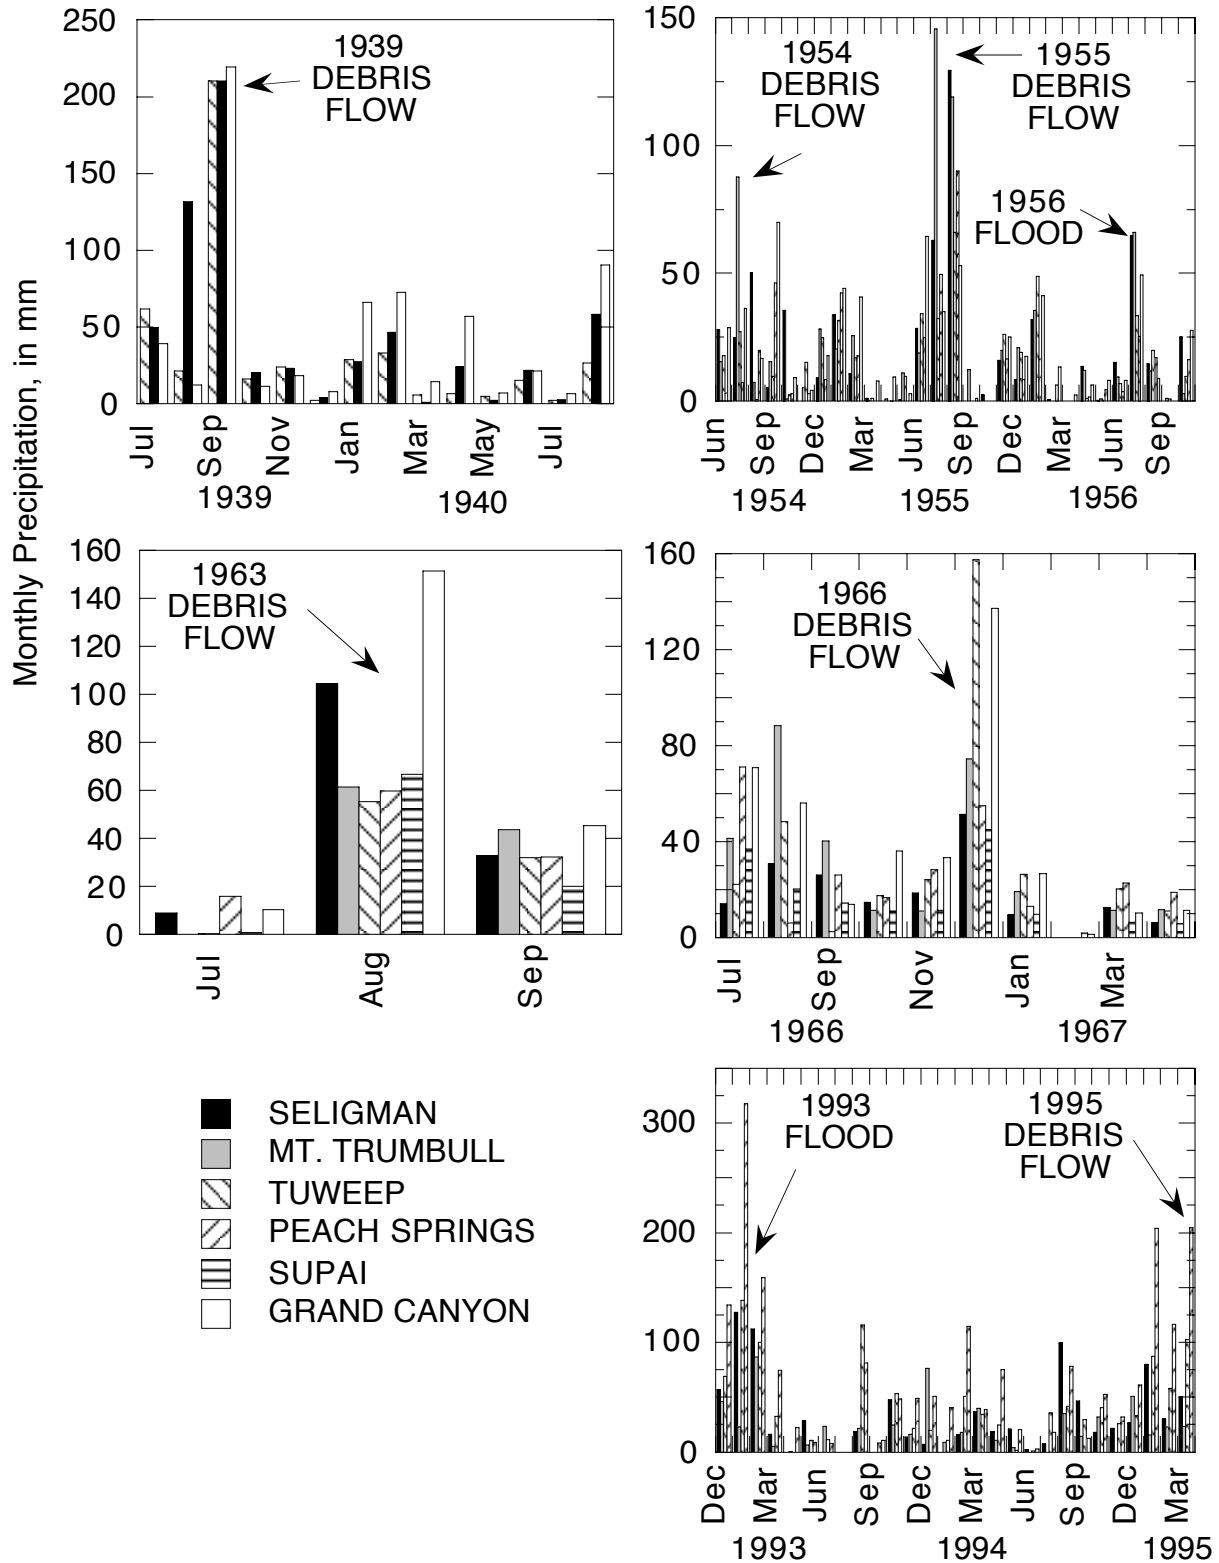
Figure 33. Monthly precipitation near the Prospect Valley drainage basin associated with Prospect Canyon debris flows and floods. A. July 1939 to August 1940. B. June 1954 to October 1956. C. July to September 1963. D. July 1966 to March 1967. E. December 1992 to March 1995.

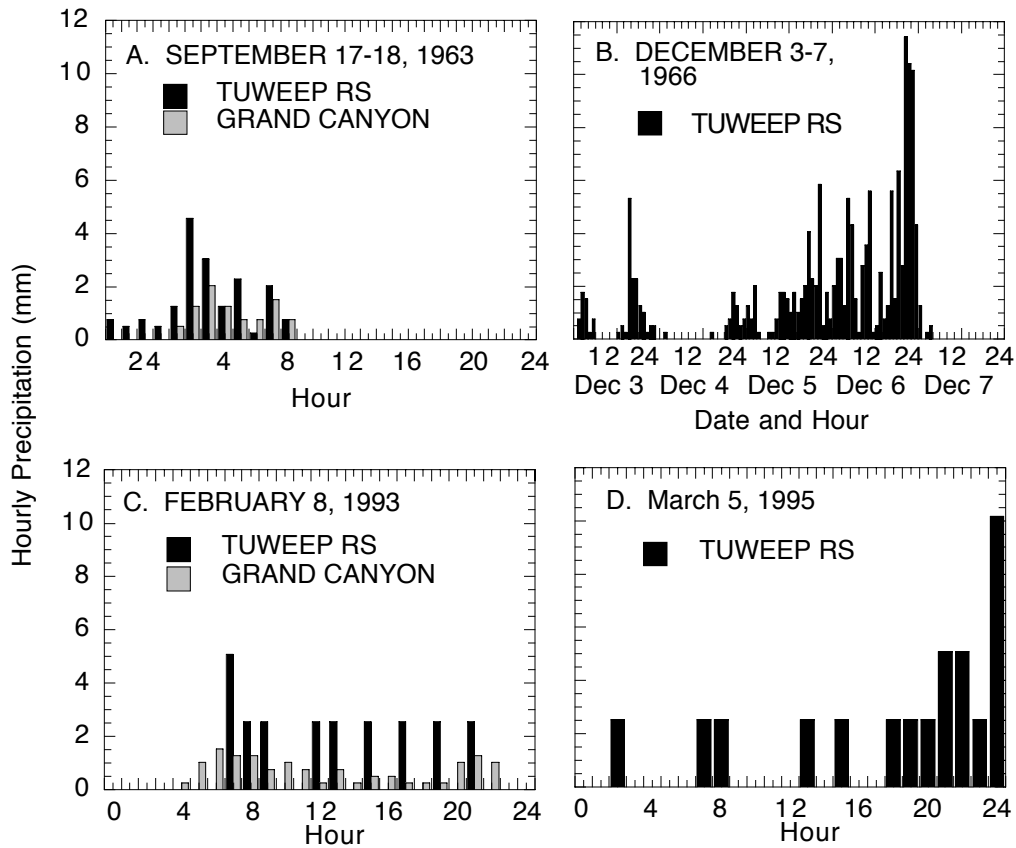
Figure 34. Hourly precipitation at Tuweep Ranger Station and Grand Canyon during three historic debris flows and one flood in Prospect Canyon. A. September 1963. B. December 1966. C. March 1995. D. February 1993.
