# Failure Mechanisms of Fiber Optic Sensors Placed in Composite Materials

Eric Udd, Mike Winz, and Stephen Kreger  
Blue Road Research  
376 NE 219<sup>th</sup> Avenue  
Gresham, OR 97030

Dirk Heider  
University of Delaware, Center for Composite Materials  
Newark, Delaware 19716  
302 831-8898, Fax: 302 831-8525

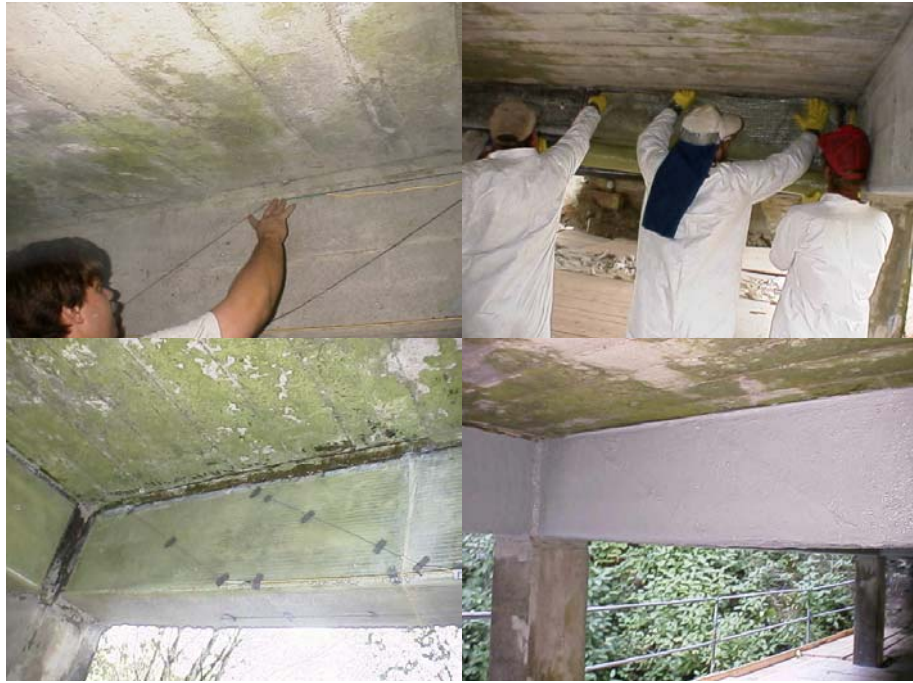
Figure 10. Installation of fiber grating strain sensors, pre-strained in a tube and placed into concrete and the composite over wrap of a bridge beam.

For large composite installations it may be possible to integrate cabled fiber directly into the composite material. This was done to support an installation of 28 fiber grating strain sensors onto the Horsetail Falls Bridge [13] in the Colombia River Gorge of Oregon. Figure 10 shows the sensors being installed in 1998. Although two of the sensors were lost during construction, the other 26 fiber grating sensors continue to operate without failure. In general, once fiber grating strain sensors are installed into a composite part, failure if it occurs is almost invariably outside of the part at the point of ingress/egress or somewhere in the fiber cabling/connectors outside the composite part. The exception to this is when the composite part itself is subject to catastrophic failure, although there have been many experimental cases when the part fails completely and the fiber sensor survives as it is the strongest component of the composite. An example of this is shown in Figure 11 where 2.5 cm thick composite parts were fabricated with integrated sensors and subject to testing until failure. In some cases even when the part was completely broken the fiber grating strain sensor survived with the optical fiber in the center of the part being the only item connecting the two halves of the part

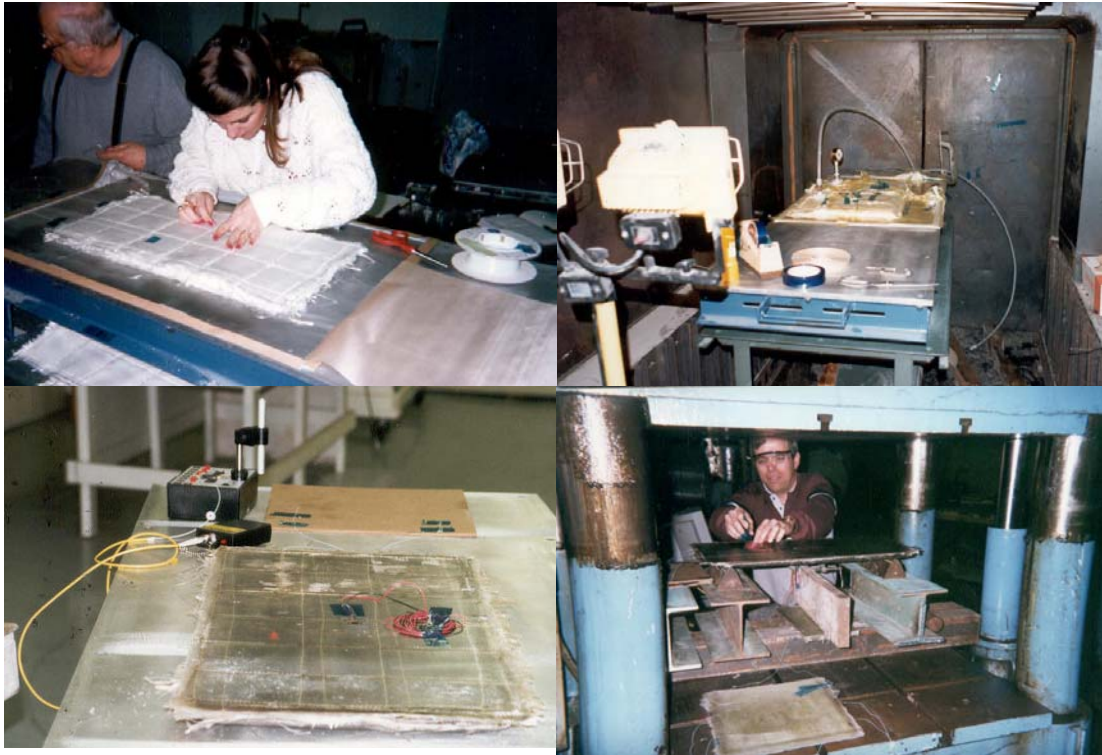
Figure 11. Integration and test of fiber grating sensors into a 2.5 cm thick composite part subject to break testing under 15,000 kg loads

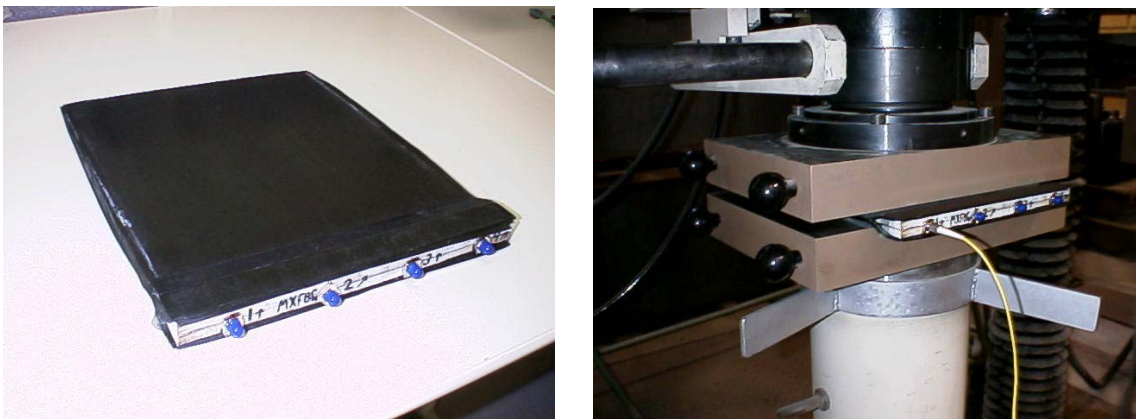
Figure 12. Composite panel used to measure shear and transverse strain in a composite bridge bearing with integrated connectors

To avoid problems with strain relief it is possible to build connectors directly into the composite part. One of the first efforts to do so involved a bridge bearing part [14] that was designed to measure transverse and shear strain between a bridge deck and piling.

This system, which is shown in Figure 12, was subject to 300,000 lb loading tests and a similar panel with an integrated connector was subject to repeated strikes by a 20 kg chisel point from heights of up to 3 meters. Fiber grating sensors suffered no measurable damage during these tests; the connectors performed well throughout and only suffered damage when one was directly struck by a rebound of the chisel point. The end of a fiber optic feed through associated with the connector protruding beyond the part was crushed but was readily repaired by using a replacement part.
