NRL/MR/6180--05-8928

## General Atomics Smart Microsensors — FY05 Shipboard Fire Test Results

# GENERAL ATOMICS SMART MICROSENSORS – FY05 SHIPBOARD FIRE TEST RESULTS

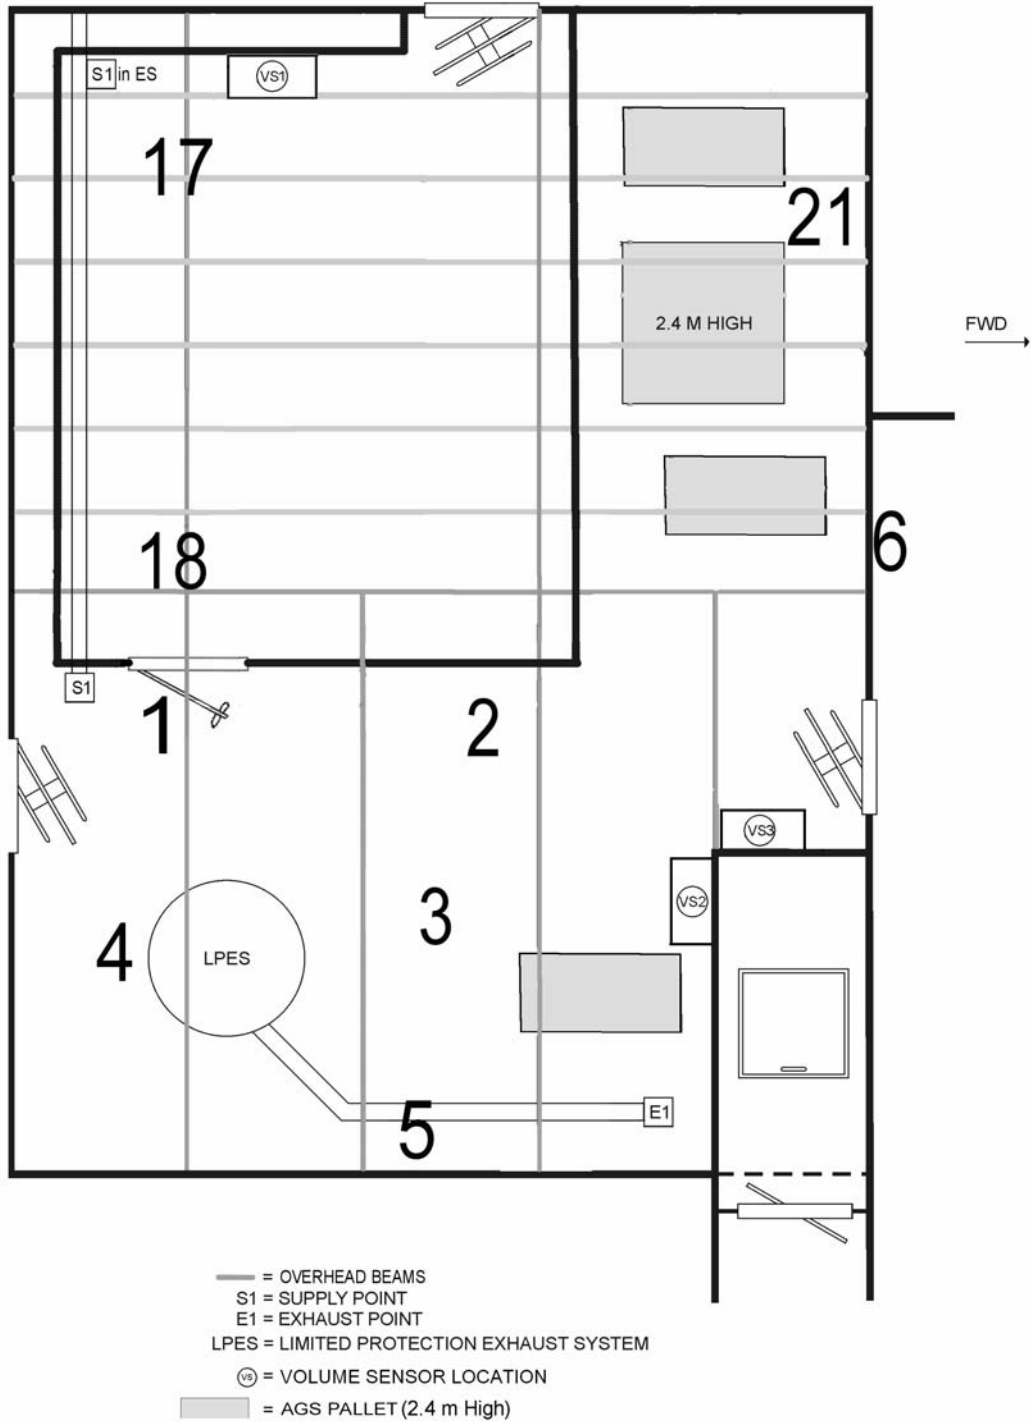
Fig. 3 — Layout of deck obstructions and source locations within 3<sup>rd</sup> deck magazine

In addition to the overhead beams, light fixtures, and a partial overhead grid in the 3rd deck magazine, obstructions, in the form of mock AGS pallets, were located on the deck within the compartment. The mock pallets were approximately 2.4 m (8.0 ft) in height 1.22 m (4.0 ft) wide and varied from 0.61 to 1.22 m (2 ft to 4 ft) in length. Figure 3 shows the layout of the mock AGS pallets and source locations within the 3<sup>rd</sup> deck magazine.

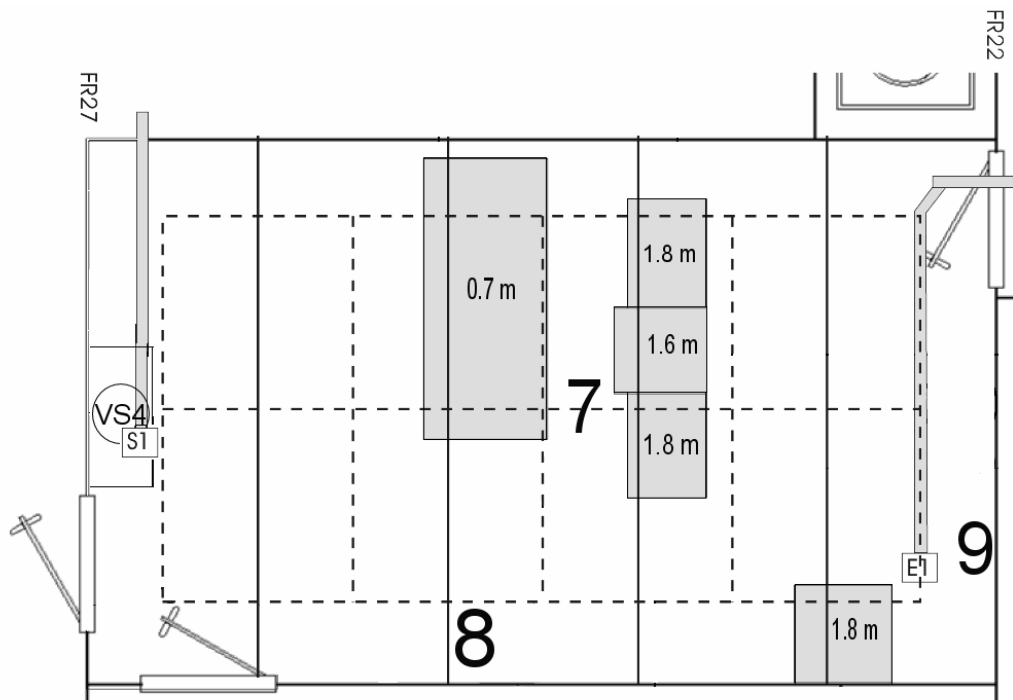
Fig. 4 — Layout of deck obstructions and source locations within 2<sup>nd</sup> deck magazine

In addition to the light fixtures, overhead (OH) beams, and the OH grid, cabinets were placed on the deck within the compartment. The cabinets varied in height (Fig 4) and were dispersed throughout the compartment. Figure 4 shows the source locations and layout of the cabinets within the 2<sup>nd</sup> deck magazine, the layout is similar to the layout used in CVN 21 Fire Threat to Ordnance [11].

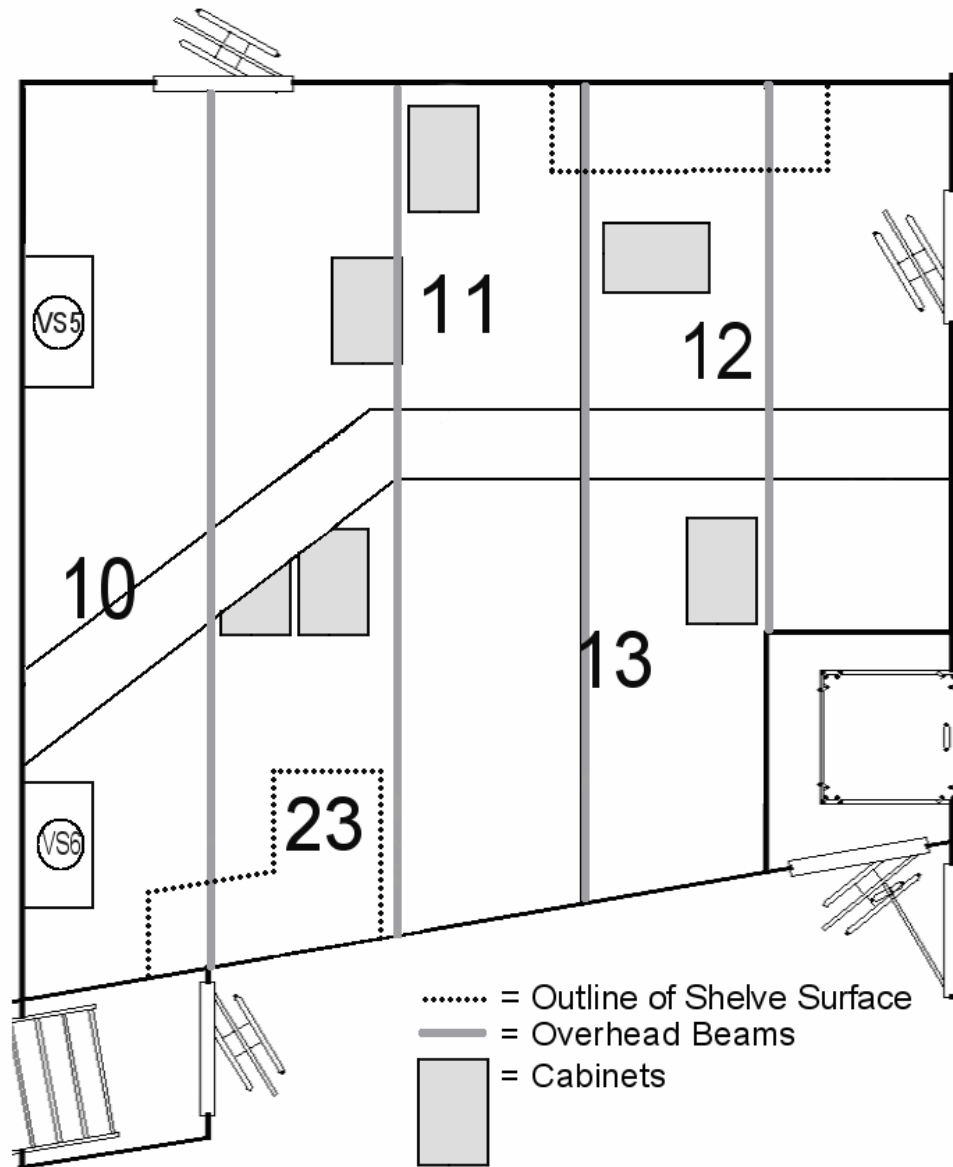
Fig. 5 — Layout of deck obstructions and source locations within 2<sup>nd</sup> deck operations office

Obstructions, in the form of cabinets, were placed in the operations office. The cabinets were dispersed throughout the compartment. Figure 5 shows the ventilation duct, source locations, and the layout of the cabinets within the 2<sup>nd</sup> deck operations office. Figure 6 shows the ventilation duct, source locations, and the layout of the cabinets adjusted to accommodate source location 22 within the 2<sup>nd</sup> deck operations office (tests VS5\_35 – VS5\_39).

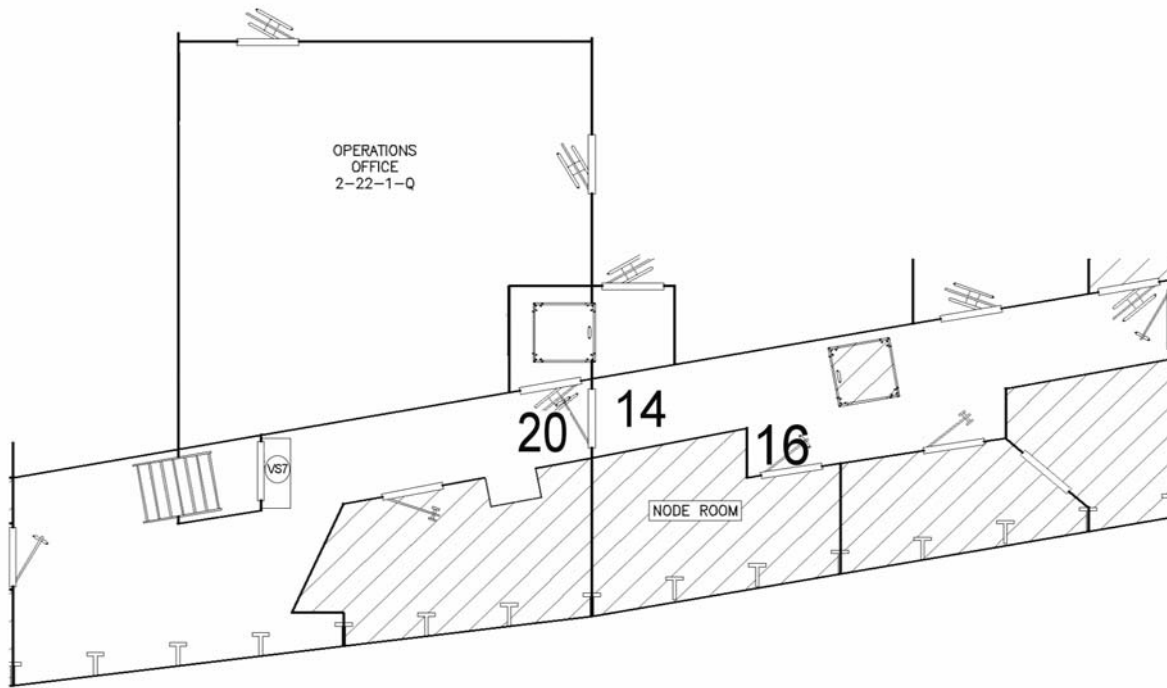
Fig. 7 — Layout of the 2<sup>nd</sup> deck starboard passageway source locations

The starboard Passageway on the 2<sup>nd</sup> deck of the ex-USS *Shadwell* was used as a test space. The overall dimensions of this space were 16.8 m (55.5 ft) forward to aft, 1.1 m (3.7 ft) port to starboard, and a height of 3.0 m (10.0 ft). A door separated the aft and fwd sections of the passageway. The door was left open during testing to elongate the passage way. Figure 7 shows the starboard passageway in relation to the operations office along with the source locations.

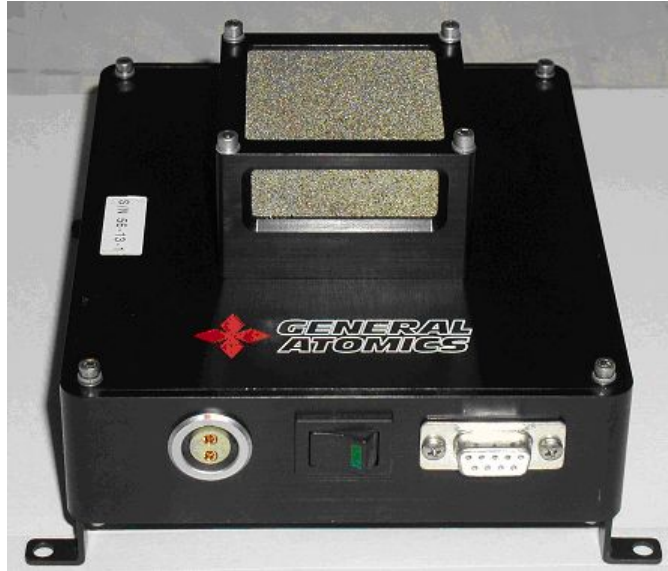
Fig. 8 – GA Smart Microsensor Prototype.

The GA microsensor prototype, shown in Fig. 8, is composed of a physical sensing system, graphical user interface software, and a 24 VDC power supply. The physical sensing system involves a microsensor array of economical, durable, high-temperature ceramic-metallic (cermet) sensor elements, shown in Fig. 9. An electrochemical (voltammetric) measurement technique was used to generate the complex response waveform from the microsensors. Voltammetry involves applying a varying potential (typically a triangular waveform) across an electrochemical cell and measuring the resultant current. The electrical characteristics of an electrochemical cell (i.e. current vs. voltage response) are influenced by the presence of analyte gases.

The graphical user interface (GUI) software provided with the GA Smart Microsensor provides control of the device, real-time graphical representation of the data, and the ability to log the data to an ASCII text file. Various settings for the GA Smart Microsensor can be modified through the GUI. The default settings were used for all settings, with the exception of the sensor operating temperature and the step voltage (scan rate). A set point operating temperature of 260 °C and a scan rate of 400 mV/s were used for this test series, based on preliminary laboratory testing.
