# **MITIGATION OF SCC AND CORROSION FATIGUE FAILURES IN 300M LANDING GEAR STEEL USING MECHANICAL SUPPRESSION**

Paul S. Prev  y and N. Jayaraman  
Lambda Research  
5521, Fair Lane, Cincinnati, OH 45227 – 3401

## **ABSTRACT**

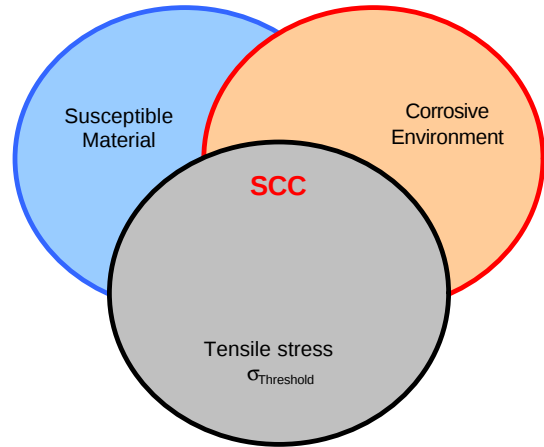
FIGURE 1 - SCC susceptibility diagram illustrating the need for the combination of a susceptible material, corrosive environment and threshold tensile stress to cause SCC.

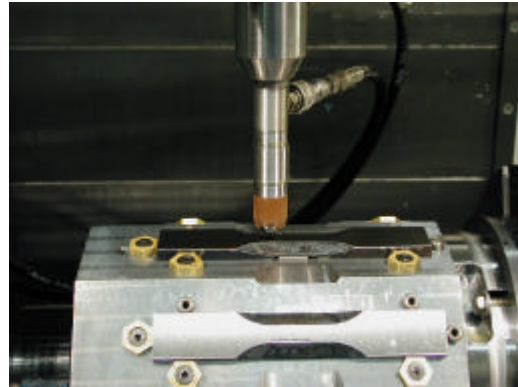
FIGURE 2 - A set of 8 thick section specimens being LPB processed in a 4-axis CNC milling machine.

LPB process parameters were developed by Surface Enhancement Technologies, LLC. (SET) for thick sections of 300M steel using proprietary methods. The CNC control code was modified to allow positioning of the LPB tool in a series of passes along the gage section while controlling the burnishing pressure to develop the desired magnitude of compressive stress with relatively low cold working. Figure 2 shows a thick section fatigue specimen in the process of being LPB processed in the four-axis manipulator on the CNC milling machine.

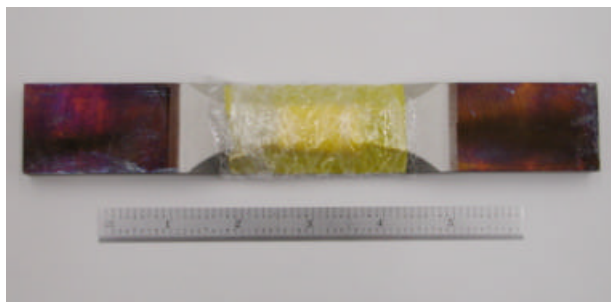
FIGURE 3 - A thick section specimen with salt solution soaked tissue wrapped around the gage section.

Corrosion fatigue testing was performed in a medium of neutral 3.5% NaCl salt solution made using de-ionized water. Filter papers were soaked with the solution, wrapped around the gage section of the fatigue test specimen, and sealed with a plastic film to avoid evaporation. Figure 3 shows a specimen with the acid salt soaked filter paper sealed around the gauge section. To simulate FOD, a semi-elliptical surface notch of depth of  $a_0=0.020$  in. (0.5 mm) and surface length of  $2c_0=0.060$  in. (1.5 mm) was introduced in selected groups of specimens by electrical discharge machining (EDM), as shown in Figure 4. Figure 5 shows the specimen mounted in the four-point bend fixture assembled for fatigue testing in a Sonntag SF-1U HCF machine. The following list describes the test conditions used in this study:

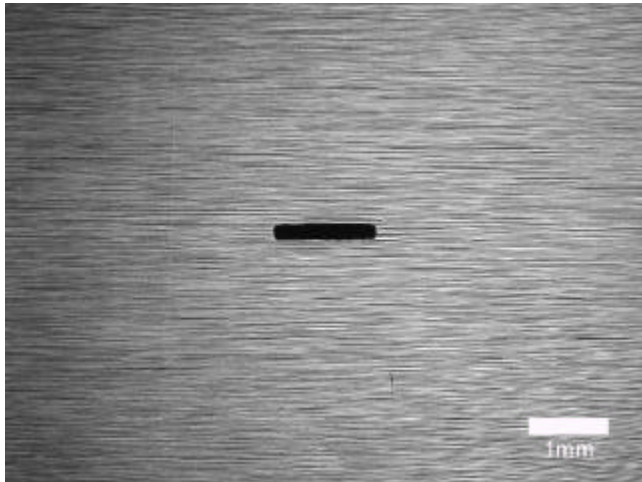
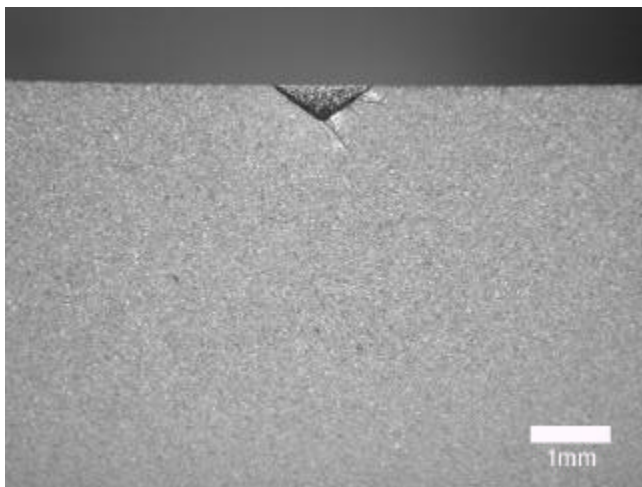
FIGURE 4a.

FIGURE 4 - EDM notch to simulate FOD. (a) Top view, and (b) Cross-section of a 0.020 in. deep notch.

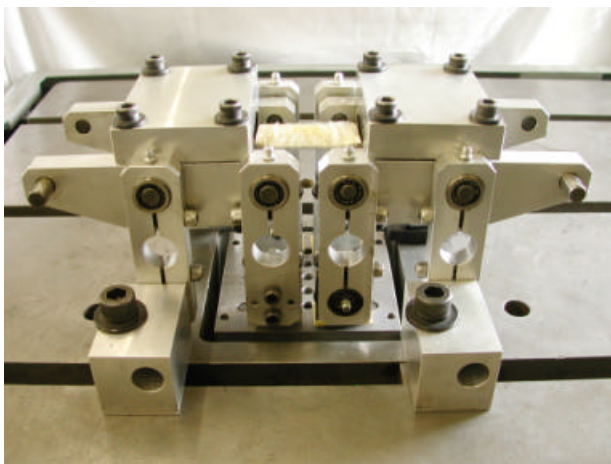
FIGURE 5 - Fatigue test set up.

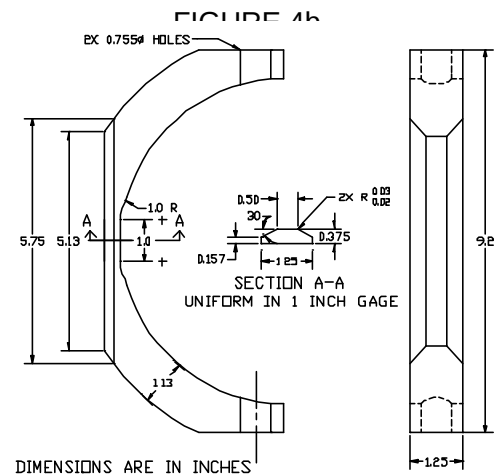
FIGURE 6 - C-ring specimen for SCC tests.

SCC tests were performed on C-ring specimens (Figure 6) machined out of an actual landing gear made of 300M steel. The gage region of the C-ring specimen had a cross section similar to the fatigue specimens shown in Figure 2. This design made it possible to investigate the effect of surface treatments like LPB for the SCC tests. Typically, when the specimen is loaded with a bolt through the  $\frac{3}{4}$  in. (19 mm) hole, the outer surface of the trapezoid is in tension, and the tensile stress is uniform over the 1 in. long parallel gage section of this specimen. From the knowledge of the applied forces on the (instrumented) bolt, the bending moment and the corresponding tensile stress on the outer surface can be calculated. Three sets of specimens (both in untreated condition and LPB treated) were SCC tested at 150, 165 and 180 ksi. The SCC test consisted of alternate immersion of the loaded specimen in a neutral 3.5% NaCl solution made with de-ionized water (10 min. in solution and 50 min. in air at room temperature). The load was monitored as a function of time, and the time to failure was noted.

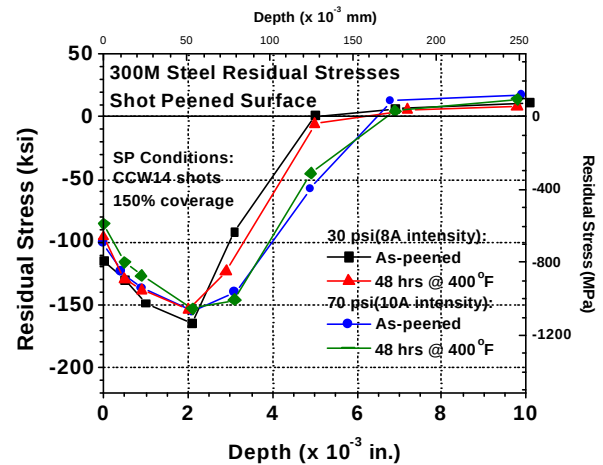
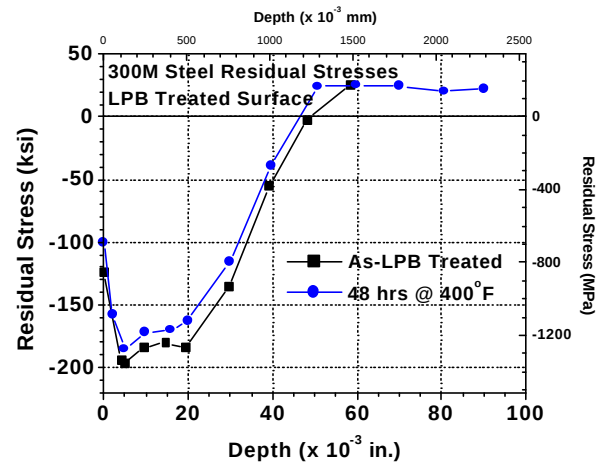
FIGURE 7 - Residual stress distribution for SP and LPB processed specimens. Thermal exposure at 400°F showed no significant effect on residual stresses.

The residual stress distributions measured as functions of depth are presented graphically in Figure 7. Compressive stresses are shown as negative values, tensile as positive, in units of ksi ( $10^3$  psi) and MPa ( $10^6$  N/m<sup>2</sup>). SP treatment at 8A intensity shows surface compression in the range of -100 to -115 ksi (-690 to -790 MPa), which becomes more compressive to about -150 ksi (-1035 MPa) at a depth of about 0.002 in. (0.05 mm), and rapidly relaxes to nearly zero at a depth of about 0.005 in. (0.125 mm). The 10A intensity of peening introduced a little deeper compression to a depth of 0.007 in. (0.18 mm). The residual stresses from both the SP treatments did not relax significantly after thermal exposure to 400°F for 48 hours. LPB treatment produces surface compression of -100 ksi (-690 MPa), which becomes more compressive to about -180 ksi (-1240 MPa) at depths of 0.005 to 0.020 in. (0.125 to 0.5 mm) and gradually decreases to zero at a depth of about 0.050 in. (1.25 mm). Again, thermal exposure to 400°F for 48 hours did not result in significant relaxation of residual stresses.

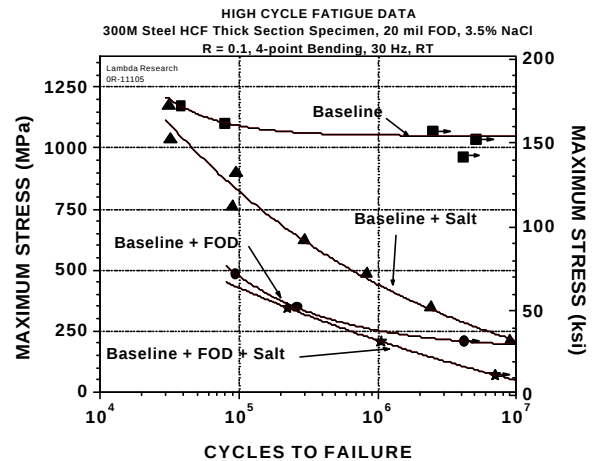
FIGURE 8 - Baseline fatigue results

Figures 8-11 show the HCF and corrosion fatigue performance of 300M steel in the form of S-N curves. In Figure 8, the baseline material performance with and without the EDM notch

and exposure to the corrosive environment is presented. The unnotched baseline condition shows a fatigue strength (endurance limit at about  $10^7$  cycles)  $S_{max}$  of about 150 ksi (1035 MPa). In the presence of a neutral (3.5% NaCl) salt solution environment, the corrosion fatigue strength for baseline drops dramatically to about 30 ksi (205 MPa). In fact, the baseline material, which exhibited a strong endurance limit behavior, showed a total loss of endurance strength in the presence of salt solution. Introduction of a semi-elliptical EDM notch of nominal size  $a_0=0.020$  in. (0.5 mm) and  $c_0=0.030$  in. (0.75 mm) drastically decreases the fatigue strength to about 30 ksi (~140 MPa) for air and to less than 10 ksi (70 MPa) for corrosion environment. Power law lines were fitted to the data in Figure 8, and represent the average behavior of the material in its baseline condition.

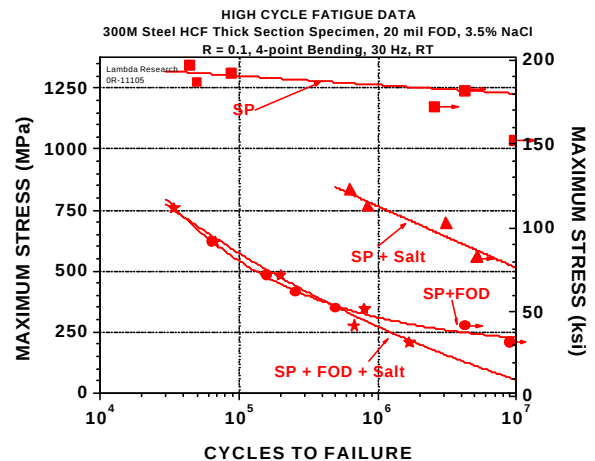
FIGURE 9 - Fatigue results for SP

Figure 9 shows the HCF and corrosion fatigue performance of both unnotched and notched SP treated specimens. Benefits of surface compression from the SP treatment are clearly seen by way of improved HCF performance of the unnotched specimens. Corrosion fatigue strength in the presence of neutral salt environment drops to about 75 ksi (515 MPa). It is interesting to note that this drop of fatigue strength by a factor of 2 is not as severe as the factor of 5 drop seen in the baseline material. The small benefits of shallow compression from shot peening are evident in these results. However, the introduction of a 0.020 in. (0.5 mm) deep notch reduces the performance similar to the notched baseline condition both in air and in the presence of the neutral salt environment. This is not surprising since the corresponding residual stress profile (shown in Figure 7) indicates a depth of compression much shallower than the depth of the EDM notch.

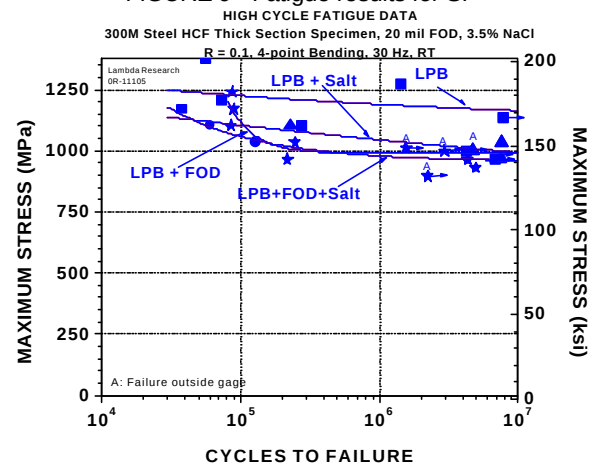
FIGURE 10 - Fatigue results for LPB

Figure 10 shows the HCF and corrosion fatigue behavior of LPB treated specimens. The unnotched specimen shows superior HCF performance with a fatigue strength of 175 ksi (1200 MPa). Figure 10 also shows that fatigue data from all of the other test conditions with LPB treatment. Notched HCF and both notched and unnotched corrosion fatigue test results may be grouped into one set of data at a slightly lower fatigue strength of 145 ksi (1000 MPa). Three conclusions may be reached from this data. First, the LPB process has effectively mitigated corrosion fatigue. Second, the HCF and corrosion fatigue performance of this group is statistically similar to the unnotched baseline material. Third, the endurance limit behavior that was absent in both baseline and SP treatment when tested in the neutral salt solution environment is restored with the LPB treatment.

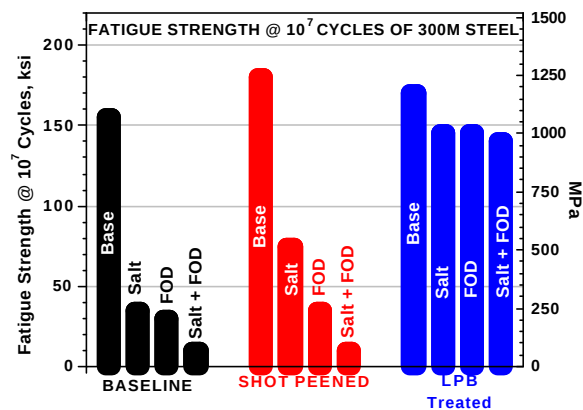
FIGURE 11 - Summary of fatigue results

Figure 11 shows a summary of HCF and corrosion fatigue test results. Here, it is evident that for both baseline and SP materials, a 0.020 in. (0.25 mm) deep EDM notch greatly decreases the HCF and corrosion fatigue strength to a value between 30 and 10 ksi (200 and 70 MPa). In contrast, the LPB treated specimens withstood the same EDM notch with a fatigue strength of 145 ksi (1000 MPa). Again, the HCF and corrosion fatigue performance for the LPB treated specimens are consistent with the residual stress distributions seen in Figure 7.

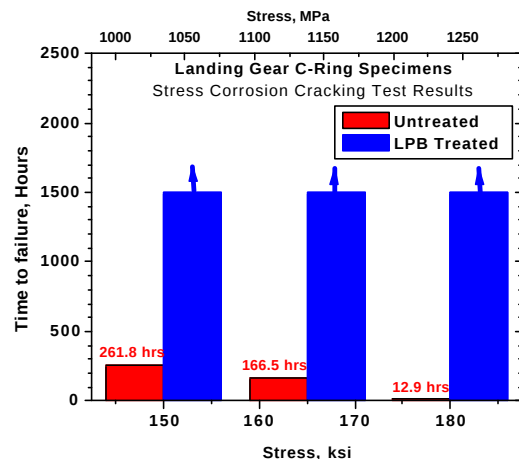
FIGURE 12 - SCC test results.

In Figure 12 the SCC test results show that the untreated baseline material had SCC time to failure of 261.8 hrs at 150 ksi (1034 MPa), 166.5 hrs at 165 ksi (1138 MPa) and 12.9 hrs at 180 ksi (1241 MPa), respectively. The LPB treated specimens did not fail even after 1500 hrs of exposure at all three stress levels. In fact, when the specimens were loaded to higher stress levels in the hope of getting them to crack by SCC, instead of cracking, the specimens were severely bent at higher loads. These results indicate the deep surface compressive stresses from LPB fully mitigated SCC.

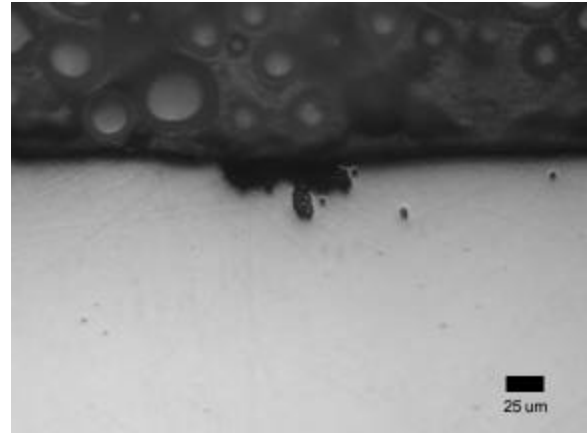
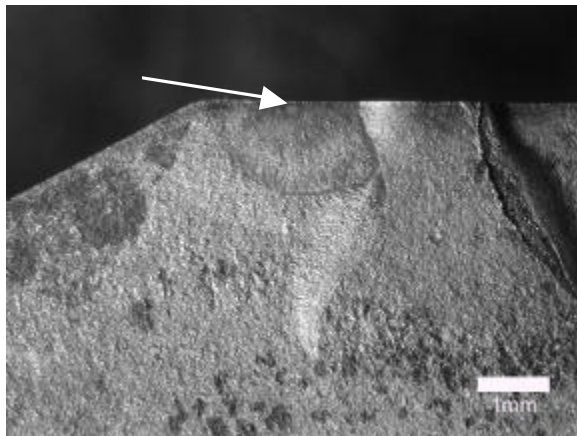
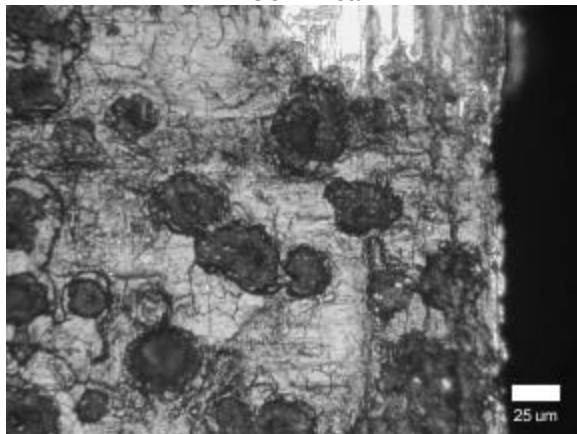
FIGURE 13 - (a) Fracture surface showing crack initiation (arrow) from a corrosion pit, (b) gage surface of the specimen showing a typical set of corrosion pits, and (c) cross-sectional view of a typical corrosion pit in a corrosion fatigue tested baseline specimen; S/N 97,  $S_{max}=50$  ksi,  $N_f=2.4(10^6)$  cycles (~24 hours)

Fractographic analyses presented here are limited to unnotched, corrosion fatigue tested specimens with baseline, SP and LPB conditions. Fractographic analyses of the notched and other HCF test conditions yielded results that are expected and consistent with the fatigue test results shown in Figures 8-11, therefore were not considered to be worthy of inclusion. Figures 13, 14 and 15 show the mechanisms of crack initiation and crack growth under corrosion fatigue conditions, of unnotched specimens. Figure 13a shows the fracture surface of a baseline specimen with a single crack initiation site near the corner of the trapezoidal cross-section. Figures 13b and c show the role of corrosion pits on the crack

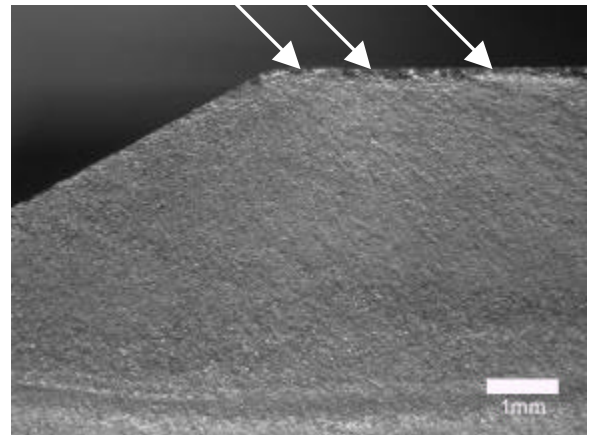
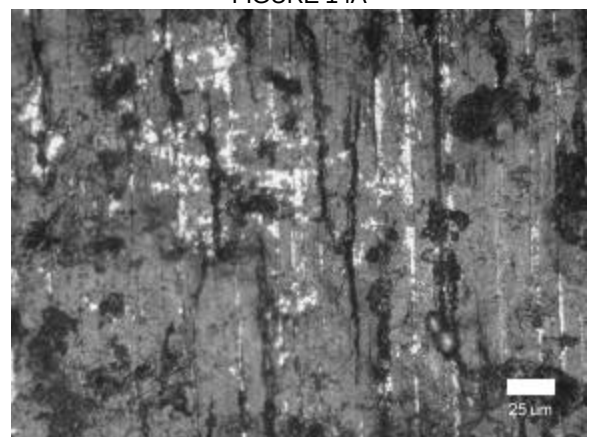
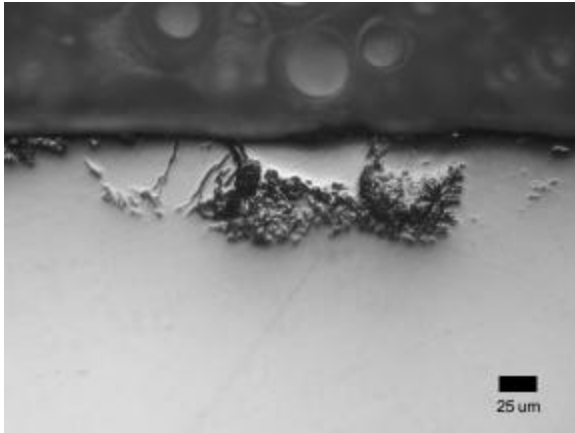
FIGURE 14 - (a) Fracture surface showing multiple crack initiation (arrows) sites, (b) gage surface showing a set of typical corrosion pits, and (c) cross-sectional view of a typical corrosion pit in a corrosion fatigue tested SP specimen; S/N 94,  $S_{max}=100$  ksi,  $N_f=3.1(10^6)$  cycles (~30 hours)

initiation process. Similarly Figures 14a, b and c, and Figures 15a, b, c and d show the optical fractographs, the gage of surface with corrosion pits, and the cross-sectional view of a corrosion pit in an unnotched SP and LPB specimen. In all cases, severe pitting of the gage surface is evident, and the cross-sectional views indicate a gradual increase in the depth of corrosion pitting damage with increased time of testing. In both baseline and SP specimens, the corrosion pits resulted in early crack initiation at low stresses, leading to final failure. In contrast, for LPB specimens, despite the higher stress levels and deeper corrosion pitting damage, the corrosion fatigue performance is minimally affected. This is seen in Figures 15a and b, where subsurface crack initiation is evident despite the presence of deep corrosion pits similar to the one seen in the cross-sectional view in Figure 15d.

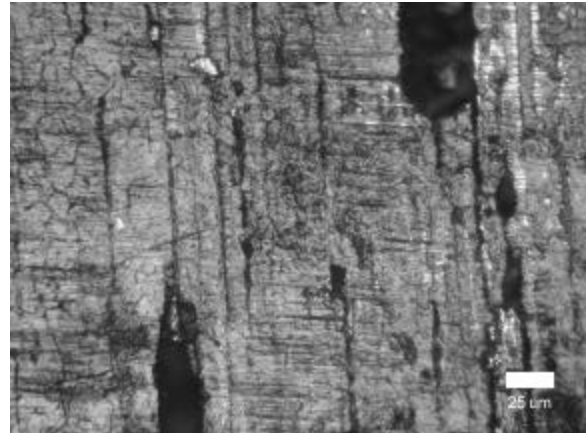
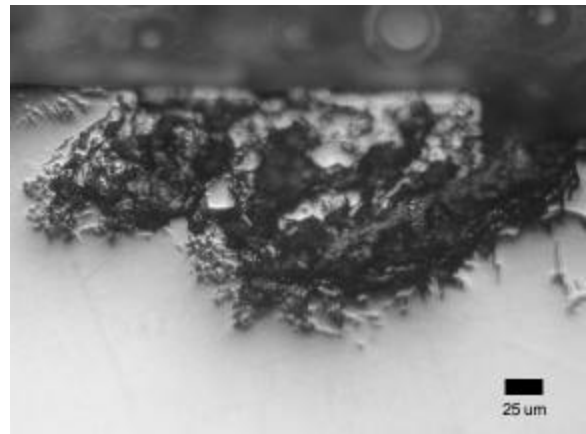
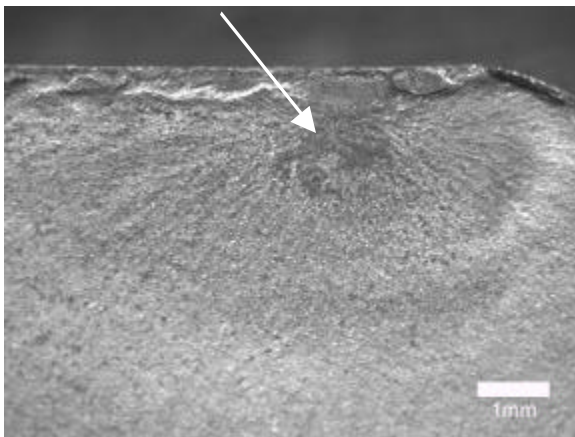
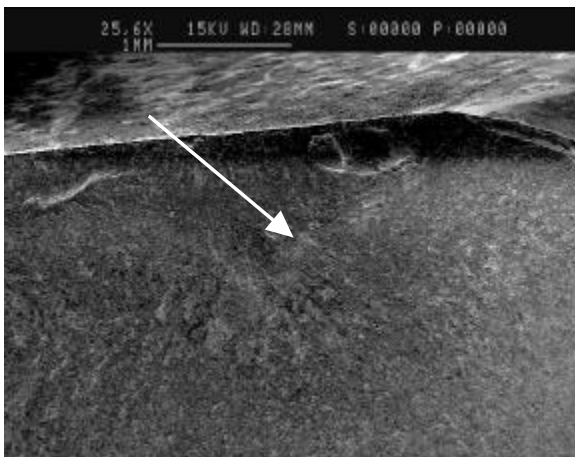
FIGURE 15 - (a) Optical fractograph showing sub surface crack initiation (arrow) site, (b) SEM fractograph showing the same region, (c) gage surface corrosion pits, and (c) cross-sectional view of a typical corrosion pit in a corrosion fatigue tested LPB specimen; S/N 11,  $S_{max}=150$  ksi,  $N_f=7.1(10^6)$  cycles (~70 hours)
