# Mitigation of Active Corrosion Fatigue and Corrosion Pit Initiated Fatigue in AA7075-T6 with Low Plasticity Burnishing

Paul S. Prev  y and N. Jayaraman  
Lambda Research

John T. Cammett  
NAVAIR

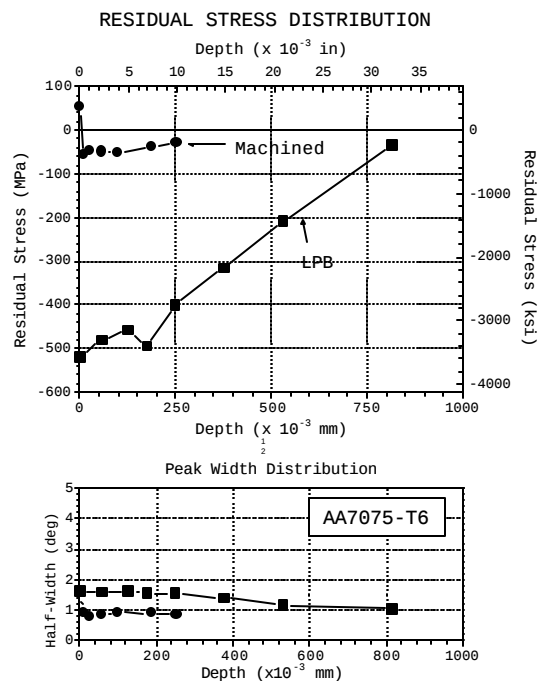
**Figure 2** - Residual stress and half width distribution in machined and LPB processed AA7075-T6.

The residual stress distributions developed by machining and LPB processing of 7075-T6 are shown in Figure 2. Machining of 7075-T6 produced low tension on the surface and compression of less than -68 MPa (-10 ksi) below the surface. In contrast, LPB produced maximum compression on the order of -480 MPa (-70 ksi) between the surface and a depth of nominally 0.2 mm (0.008 in.). Maximum cold work occurs from the surface through the region of maximum compression, and then diminishes with depth. X-ray diffraction measurement could not be made reliably below a depth of 0.5 mm (0.02 in.) in the 7075-T6 because of the coarse grain size encountered at depths beneath the deformed surface layer.

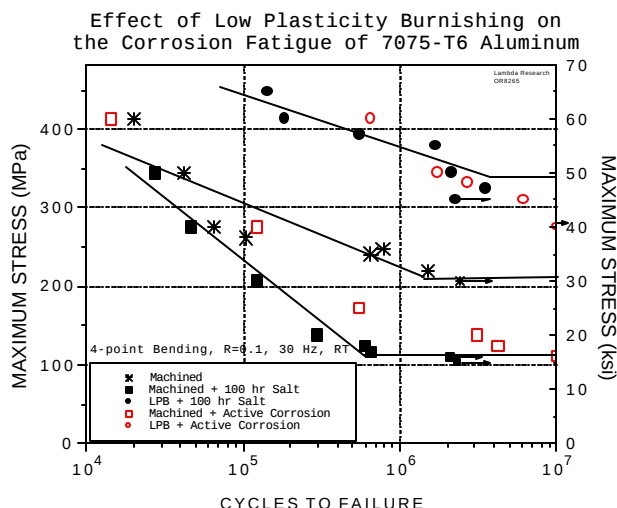
**Figure 3** - High cycle fatigue results for salt fog pitted and active corrosion fatigue of machined 7075-T6 with and without LPB processing prior to exposure to corrosion.

The S/N curves generated for 7075-T6 in both the baseline (as-machined) and LPB conditions, after 100 hr salt fog exposure or active corrosion fatigue, are presented in Figure 3. Fatigue tests were continued for a minimum of  $2.5 \times 10^6$  cycles with a maximum run-out at  $1.2 \times 10^7$  cycles. The fatigue data are presented as semi-logarithmic S/N curves in terms of the maximum stress.

The S/N curves for samples with pitting from prior salt fog exposure appeared to exhibit an endurance limit, implying infinite life below some threshold stress level. As commonly observed in studies of corrosion fatigue, the S/N curves for samples exposed to active corrosion during fatigue testing do not appear to have an endurance limit.<sup>14</sup> In the discussion that follows, the results are considered and compared in terms of the fatigue life at nominally  $2 \times 10^6$  cycles.

The machined (end milled) surface condition produced an apparent endurance limit on the order of 200 MPa (30 ksi). Salt fog exposure for 100 hrs reduced the endurance limit to nominally 100 MPa

(15 ksi), half that of the original machined surface before exposure to salt fog generated pitting corrosion. Loss of nominally half the extended life fatigue strength following salt fog corrosion pitting appears to be typical of the degradation reported in the literature<sup>3</sup>. The fractional loss of fatigue life at stress levels above the endurance limit increased rapidly as the maximum stress level reduced, reaching an order of magnitude at the 200MPa (30ksi) endurance limit

Active corrosion fatigue in 3.5% NaCl solution, with no prior corrosion damage, degraded the fatigue strength relative to the as-machined condition by an amount only slightly less than prior pitting corrosion up to a life of  $10^7$  cycles. Note the failure occurring in active corrosion fatigue at the  $10^7$  cycle endurance limit for a maximum stress of 110 MPa (16 ksi). The data appear to suggest further reduction in fatigue strength with increasing life and the absence of an endurance limit for active corrosion fatigue of the machined 7075-T6 surface.

LPB prior to salt fog pitting resulted in a 70% increase in the endurance limit, from nominally 200 MPa (30 ksi) to over 330 MPa (48 ksi). LPB prior to corrosion pitting increased the fatigue life at stress levels above the base line endurance limit by two orders of magnitude, a 100X life increase over the un-corroded original machined surface.

A comparable benefit in fatigue performance was observed for LPB prior to active corrosion fatigue in 3.5% NaCl solution. As noted above, a true endurance limit may not exist for the active corrosion fatigue mechanism; however, the fatigue strength at  $10^7$  cycles was at least 282MPa (41ksi), 32% higher than the un-corroded original machined surface. Fatigue lives were 100 times that of the baseline for stress levels above the baseline endurance limit of 220 MPa (32 ksi).
