# GEOMORPHIC AND VEGETATIVE RECOVERY PROCESSES ALONG MODIFIED STREAM CHANNELS OF WEST TENNESSEE

Prepared by the  
U.S. GEOLOGICAL SURVEY

in cooperation with the  
TENNESSEE DEPARTMENT OF TRANSPORTATION

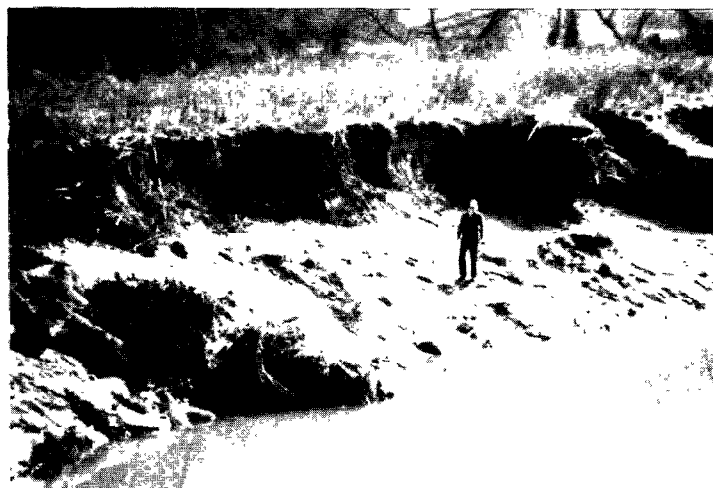
Figure 34.—Typical planar failure, South Fork Obion River (station number 07024550, river mile 11.4, 1984).

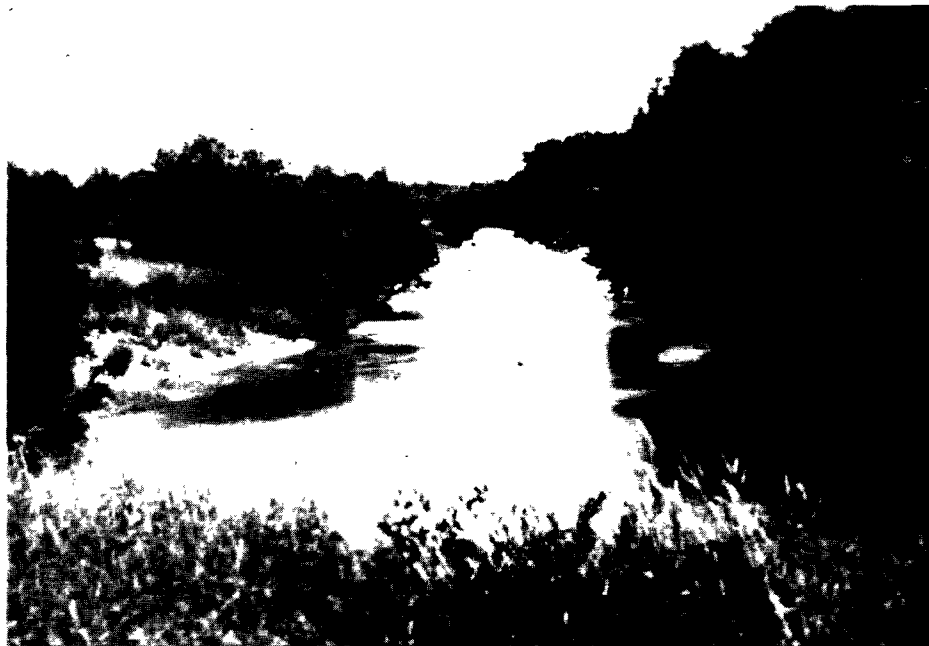
Figure 50.--Point-bar development along a reach during late aggradation stage (stage V), Porters Creek at Hebron, Tenn. (station number 07029445).

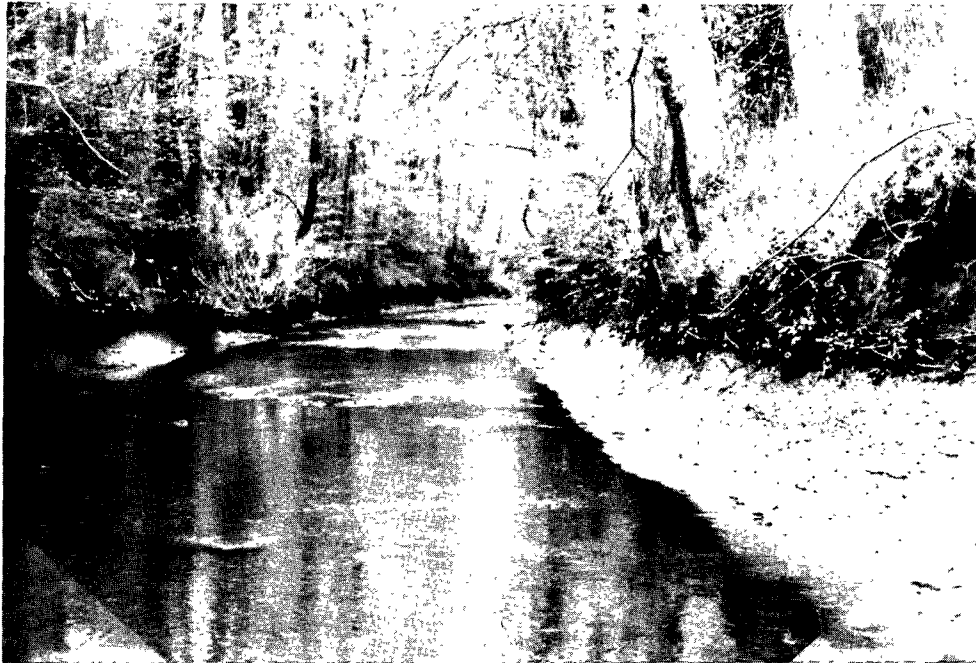
Figure 56.--Upstream view of Davidson Creek near U.S. Highway 51; site is a typical reach during degradation stage (stage III).
