INVESTIGATION OF COPPER CONTAMINATION AND CORROSION SCALE  
MINERALOGY IN AGING DRINKING WATER DISTRIBUTION SYSTEMS

AFIT/GES/ENV/06M-05

THESIS

March 2006

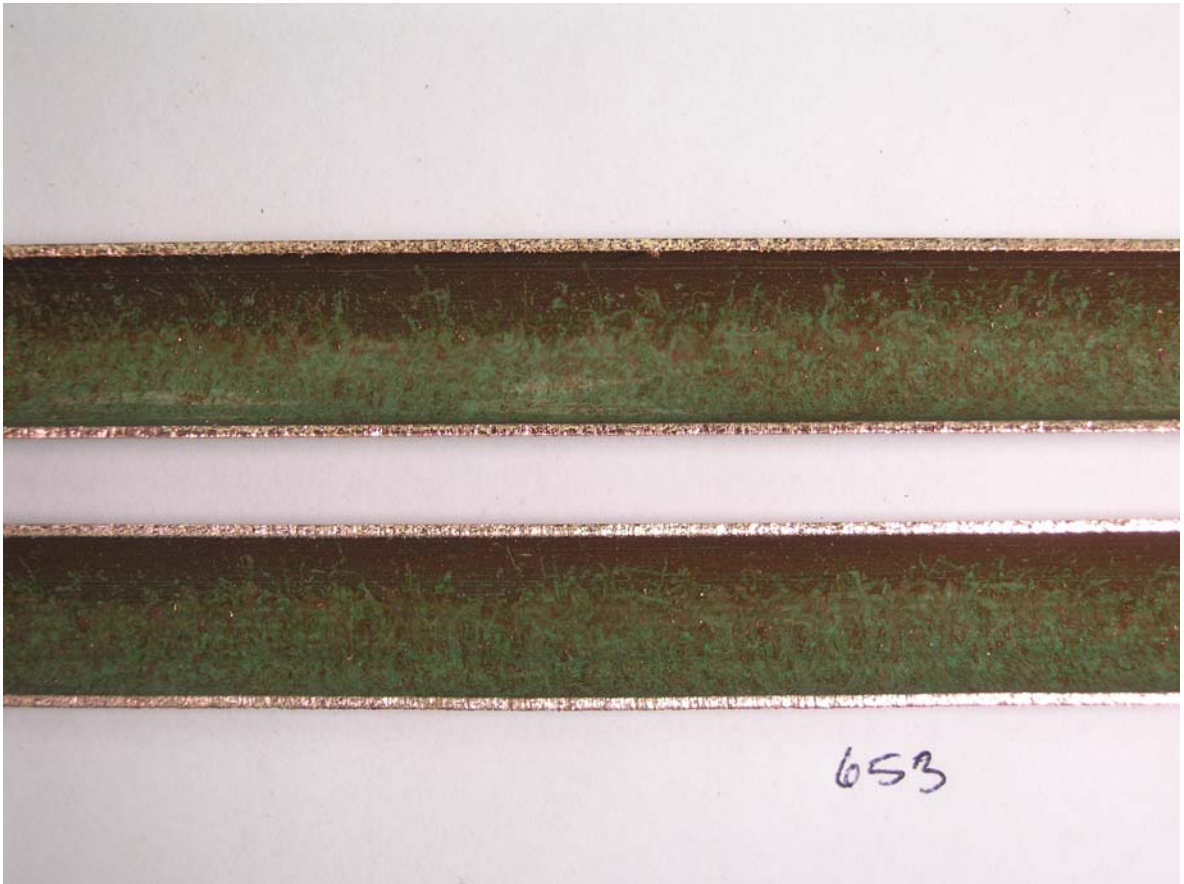
**Figure G.8.** Digital picture of the copper pipe.

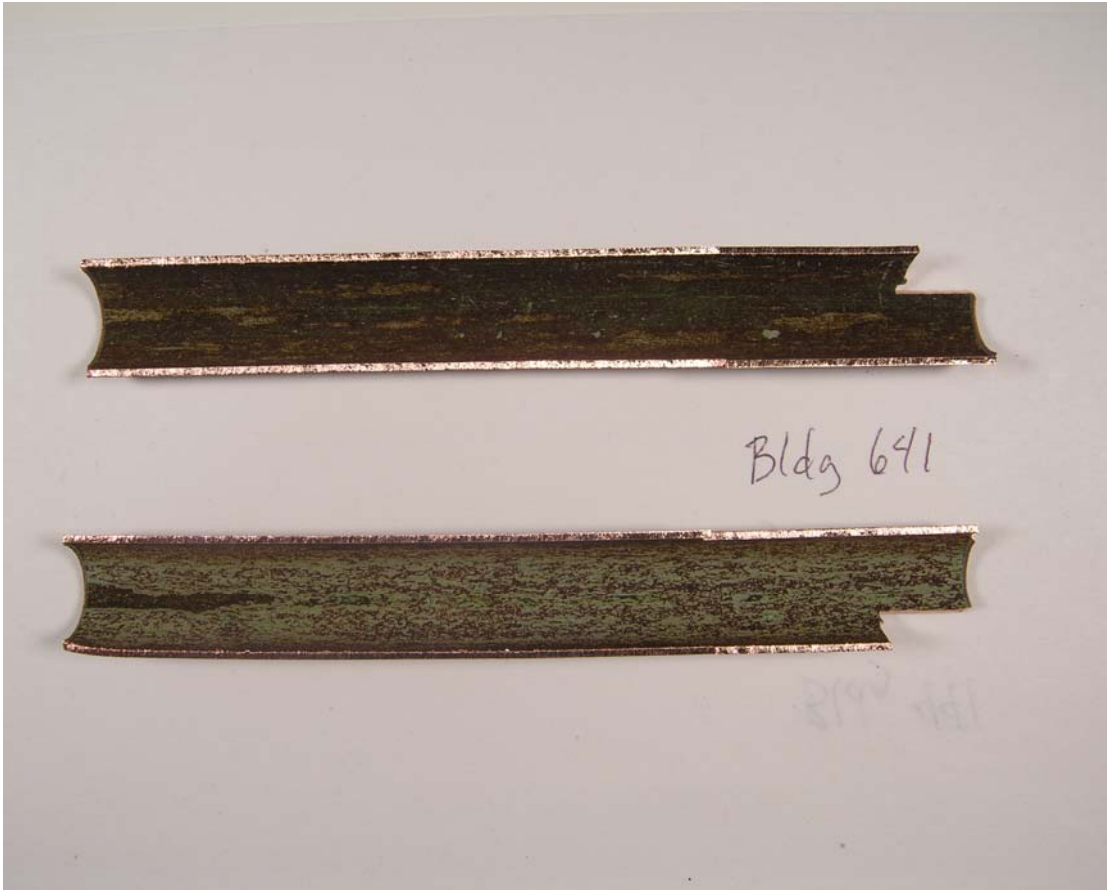
**Figure G.16.** Digital picture of the copper pipe.

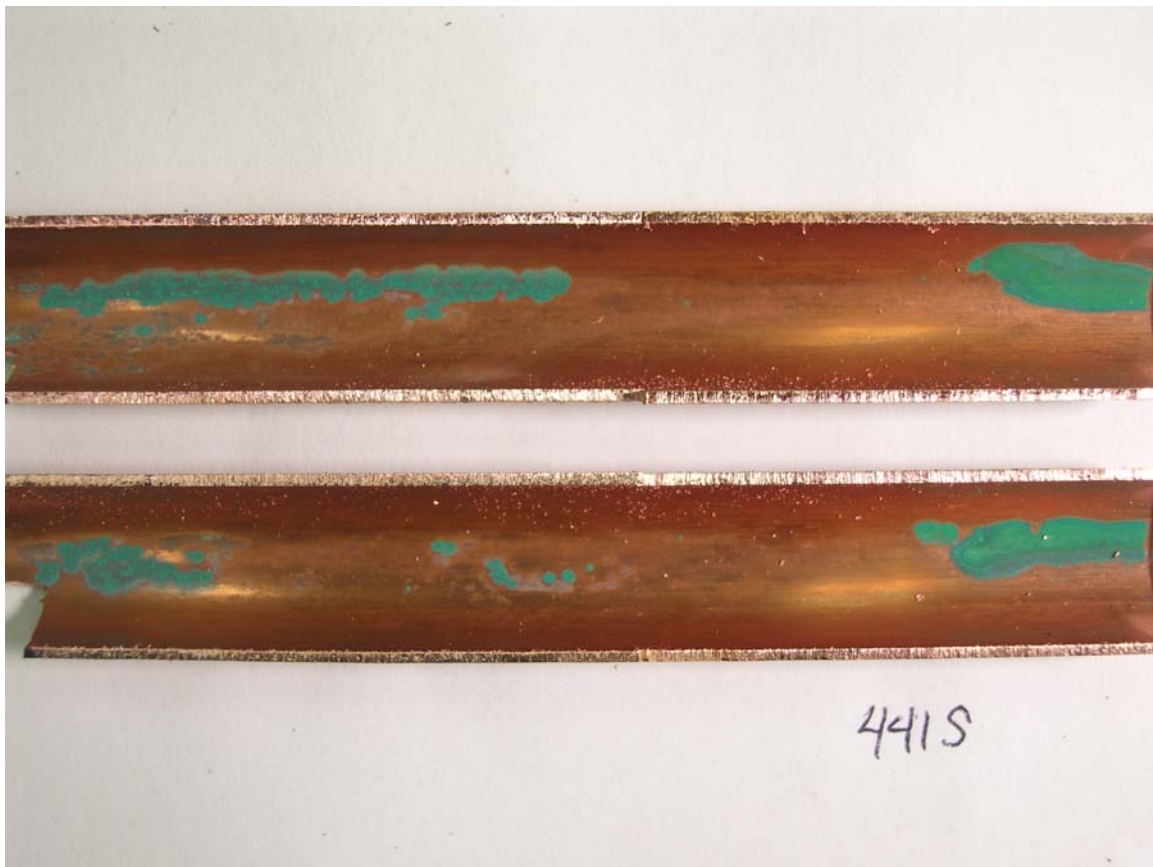
**Figure G.74** Digital picture of the copper pipe.
