## Double Lap Shear Testing of Coating Modified Ice Adhesion to Liquid Oxygen Feed Line Bracket, Space Shuttle External Tank

May 2006

Final report

Prepared for   National Aeronautics and Space Administration

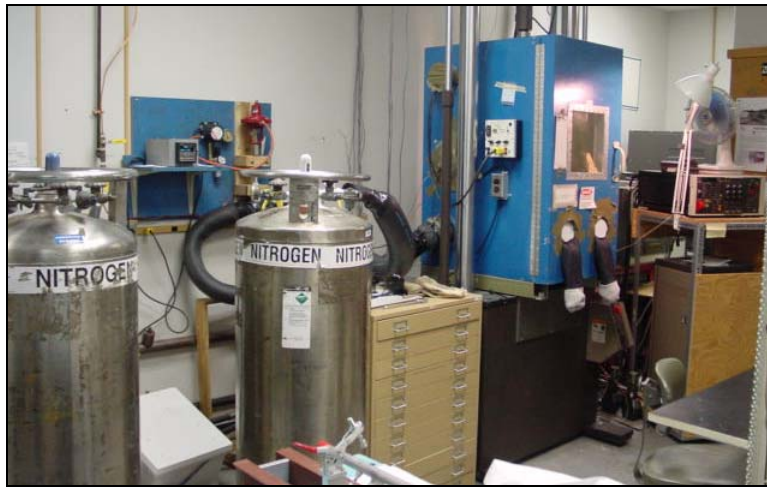
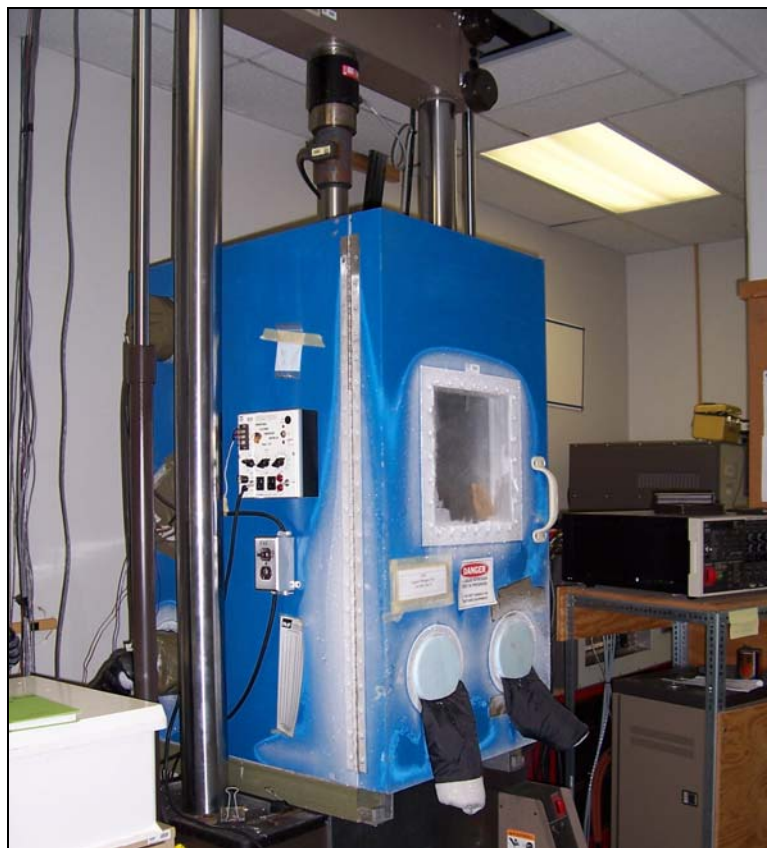
a. Wide view.

b. Close view.

Shear testing was performed on an MTS machine, which is a closed-loop electro-hydraulic servo-controlled system, in a temperature controlled test chamber (Fig. 5). A displacement transducer incorporated in the loading actuator was used to control the system and measure the deformation. The controller can be programmed for a constant deformation rate or series of constant rates. Because of the large load differences anticipated between the uncoated controls and the high performance coatings, two load cells in line with the loading actuator were used. This configuration provides greater measurement resolution and accuracy.

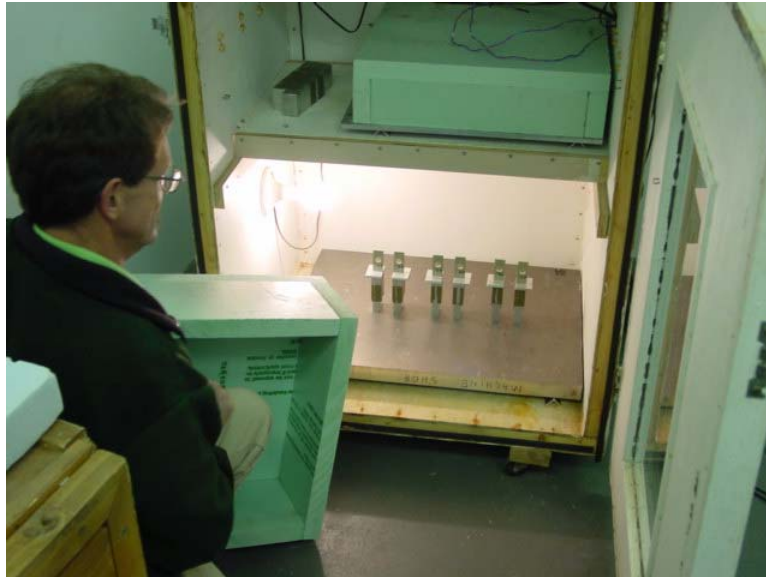
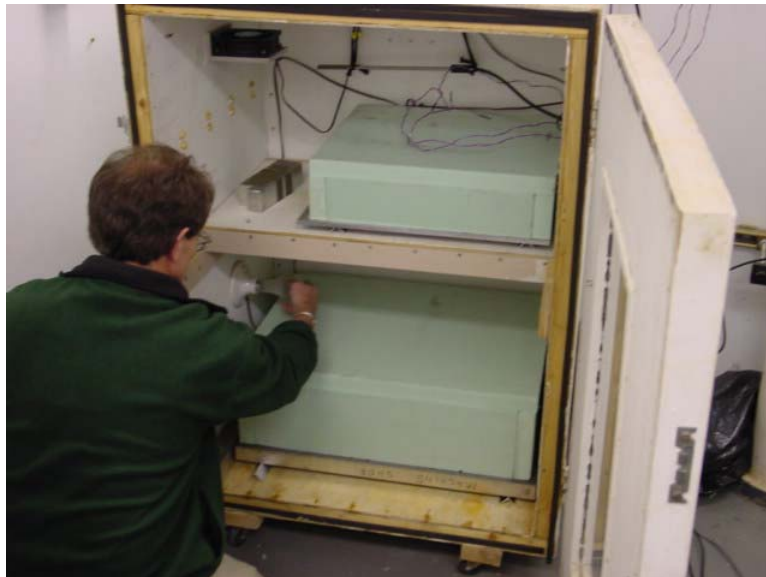
a. Placing the samples.

b. Insulated cover to isolate the samples inside the cold box for maximum temperature stability.

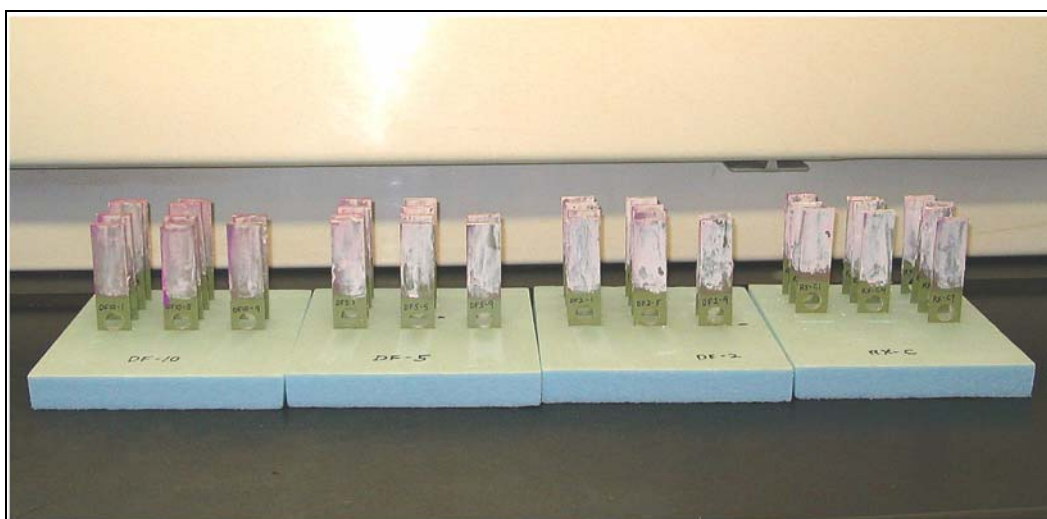
Figure 11. Phase 2 coated coupons prior to testing: Left group has 10% DF1040, second group has 5% DF1040, third group has 2.5% DF1040, and far right group has 0% DF1040.

All the mixes were applied using latex laboratory gloves. Care was taken to make only a single, rapid pass over the surfaces and edges of the coupons because subsequent passes resulted in damage to the rapidly drying initial coating. The 0% mix with no DF 1040 had a very dry consistency, making it the most difficult to apply. With increasing DF 1040, the application became easier. About 10% of the time, lumps in the mixtures were inadvertently applied to the panels. These were carefully removed with the fingertip and more coating mixture was lightly dabbed onto that area. Sample 9 of the 2.5% mix and Sample 6 of the 5% mix had large coated areas that contained clumps of dry Teflon powder. All the sample groups are depicted in Figure 11 following the coating application. The subsequent phase 2 test dates with corresponding mixes and coupons tested are presented in Table 3. The 2.5% coupons were kept in reserve and were not tested.

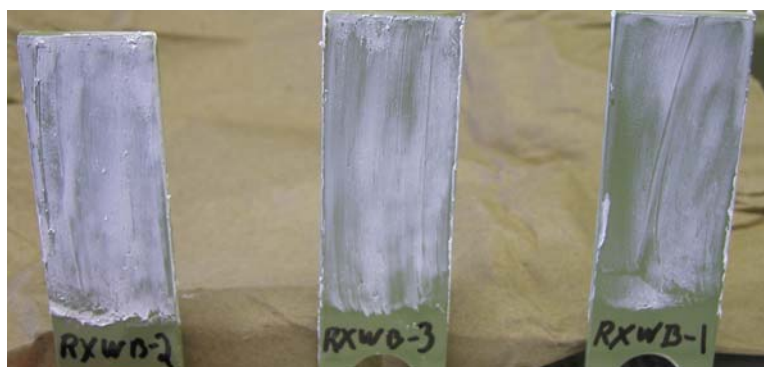
a. Prior to water stream exposure.

Figure 12. Phase 3 RW coupons prior to and following exposure to a water stream.

ings were applied using latex laboratory gloves, as before, and the Koropon surfaces were not abraded. Of this group of mixes, the RD coating was the easiest to apply. The RW samples, using the RP material, were allowed to dry and cure before being exposed to a forceful water stream (Fig. 12), which did not change the visual appearance of the coated coupons. Half of the coupons in the RP, RM, and RD groups were left untouched after application and curing, and are denoted as “a” sample subgroups RM(a), RP(a), and RD(a). The remaining coupons were wiped off with laboratory wipes after curing (Fig. 13) and are called “b” subgroups: RM(b), RP(b), and RD(b). The cure time of the RD coating was only about 30 minutes prior to wiping, much shorter than the 1.5-hour cure of the RM, RP, and RW coatings. The phase 3 coating preparation and handling, application, resistance to weathering by water, and durability testing program is presented in Table 4.

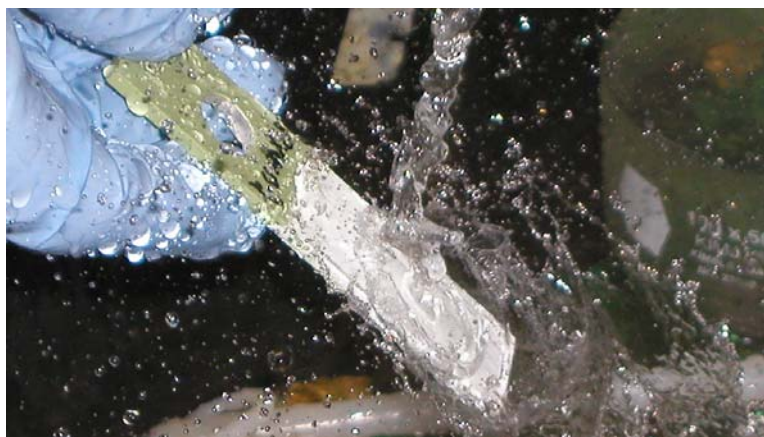
b. During water stream exposure.

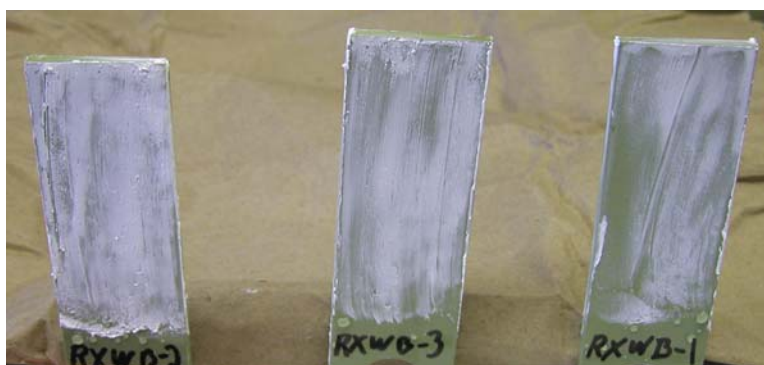
c. After exposure to water stream.

Figure 12 (cont'd). Phase 3 RW coupons prior to and following exposure to a water stream.

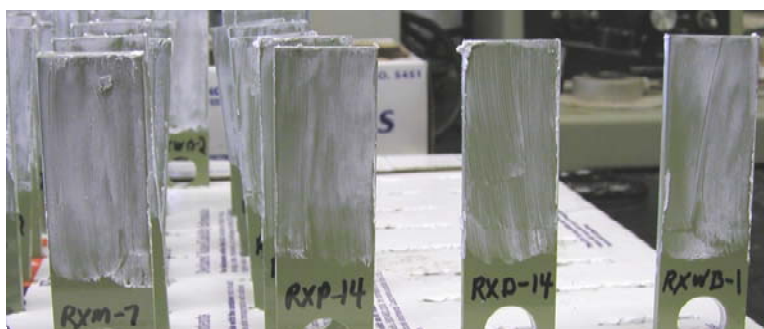
a. RM, RP, RD, and RW coupons after coating application.

Figure 13. Phase 3 coupons after coating both with and without wiping.

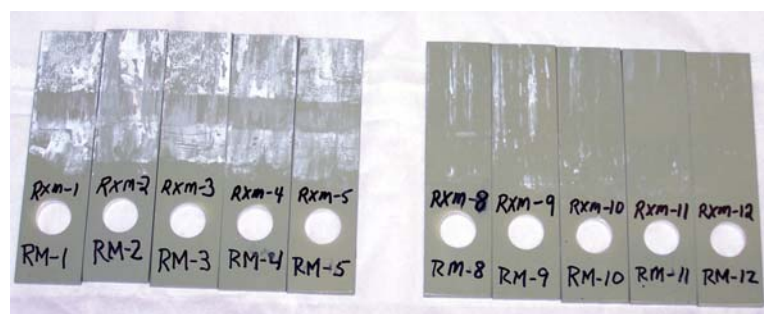
a. Non-wiped and wiped subgroups after one test cycle

Figure 45. Effect of repeated test cycles on visual appearance of phase 3 RM coating.

Each of the phase 3 coating mixes and treatments were visually similar through the three cycles of double lap shear testing. Figure 45 documents visual changes in the appearance of the RM coating after each test cycle. Figure 45a depicts both wiped and non-wiped subgroups after one test cycle. Whitish coating material can be seen on the coupon surfaces of both groups. Figure 45b depicts the same coupons having less visible coating remaining after two test cycles, and Figure 45c shows these coupons after three test cycles. The progressive loss of coating material from the coupons is evident through the test cycles, even for the wiped coupons. As in phase 2, this loss of coating material was accompanied by improved performance of the remaining coating.

The Kruskal-Wallis test indicates a significant statistical difference between the peak load performances among each of the RM, RP, and RD non-wiped “a” and wiped “b” groups in phase 3. Peak loads for each of the non-wiped subgroups were not significantly different from the phase 1 RXM results, and the non-wiped RW peak loads were not significantly increased. Average work is compared for all coated sample groups and cycles in Figure 46, by strain rate. Corresponding average work for the phase 3 controls was 14.4 lb-in. at the low strain rate and 113 lb-in. at high strain. There were notable improvements in average work at both strain rates for all groups between cycles 1 and 3. The non-wiped RP(a) group yielded superior work performance at both strain rates in cycle 3 relative to all other groups and cycles. The removal of excess coating in early test cycles could explain optimal work in later cycles for the non-wiped groups, and photo documentation (Fig. 45) indicates the same potential mechanism could be acting for the wiped groups.

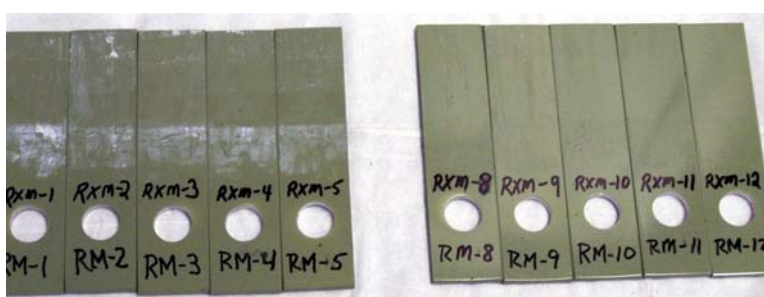
c. After three test cycles.

Figure 45 (cont'd). Effect of repeated test cycles on visual appearance of phase 3 RM coating.
