# **Retention of Pre-construction Primer in Tank Coating Systems**

**NSRP Project 3-96-3**

**November 2002**

**PREPARED BY:  
ASSOCIATED COATINGS CONSULTANTS, INC.  
And  
NATIONAL STEEL AND SHIPBUILDING  
IN COOPERATION WITH  
FRIEDE GOLDMAN HALTER  
GULFPORT, MS**

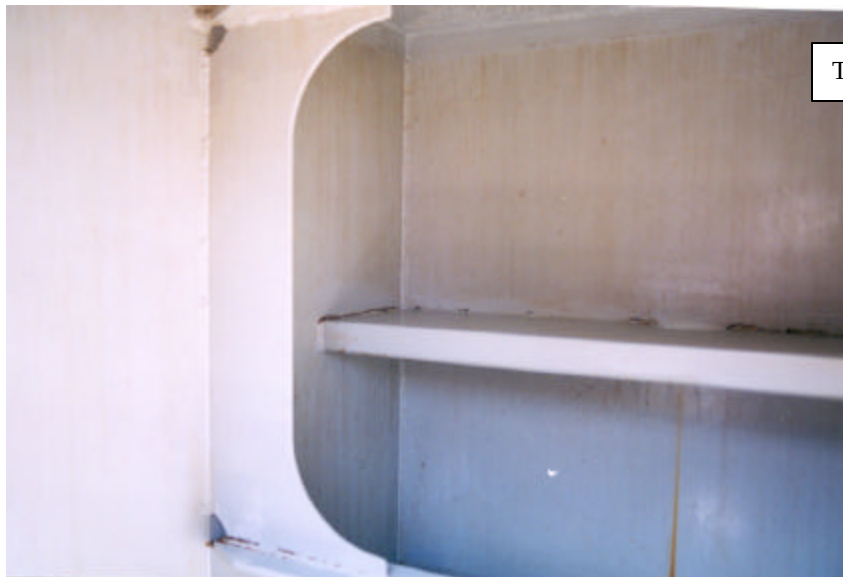
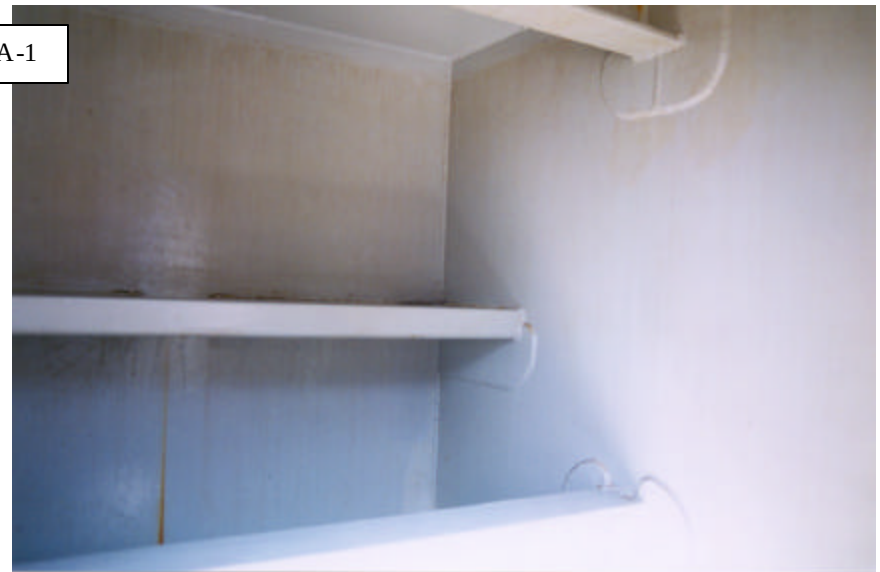
Tank A-1

Tank A was pre-primed with a 52% zinc load, solvent-based material. All secondary surface preparation of welds and damaged areas was accomplished with power tools. Cell A-1 was topcoated with a 93 % volume solids epoxy from the same supplier as the primer. There were no significant failures in this cell. There were only a total of seven pinholes with rust in the entire tank.

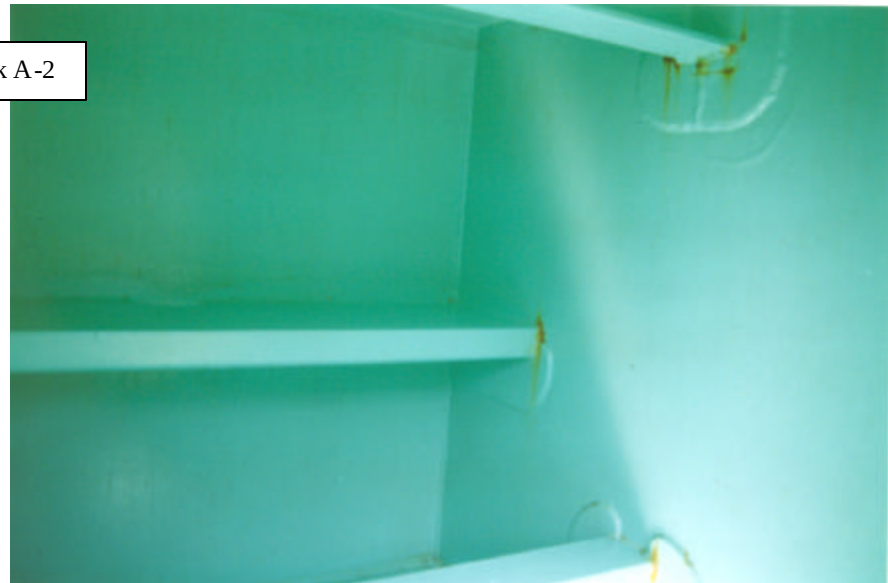
Tank A-2

Cell A-2 was topcoated with a 98% solids material. This material was qualified to Mil-P-23238 as a edge retentive epoxy. The material had also passed MARINTEK qualification. The only failure was associated with minor cracking at a weld on the right flat.

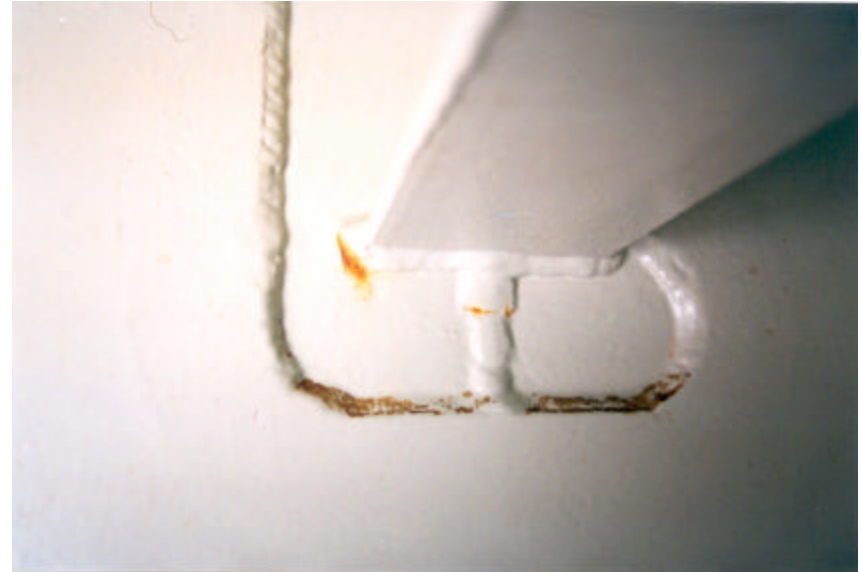
Tank A-3

Cell A-3 was topcoated with a 67% solids material. Only three pinholes showed any rust. There was minor cracking at one weld.

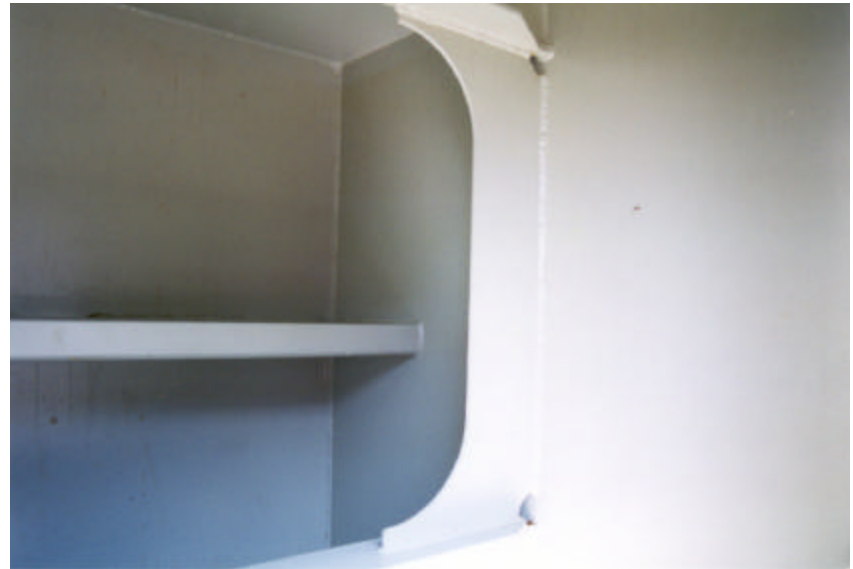
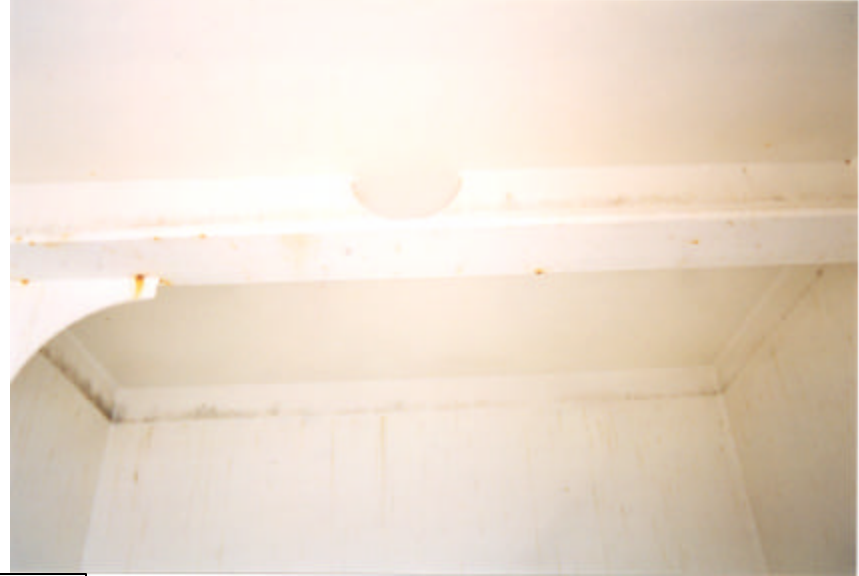
Tank B-1

Cell B-1 was topcoated with a high solids (98% volume solids) topcoat from the same supplier. Because of manufacturing problems, this material was subsequently removed from the market. Most of the failures were associated with failure at the welds. Some cracking at welds was observed.

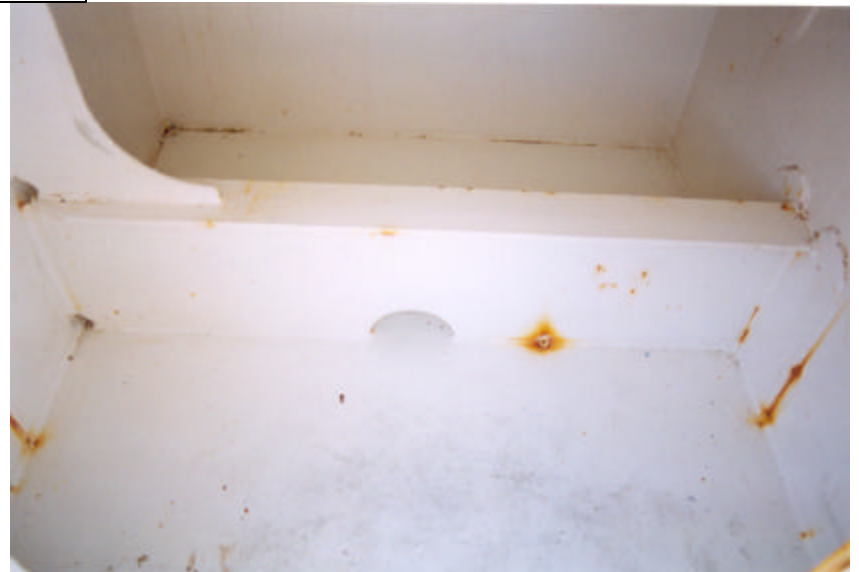
Tank B-2

Cell B-2 was topcoated with a full thickness, waterborne, high ration inorganic zinc topcoat. There was some failure associated with some of the power tool cleaned welds; however, the primary failure mode was erosion and depletion of the zinc. The zinc acted as an anode, which sacrificed to the protected steel. Had a zinc anode been used in conjunction with this system, the system longevity would have increased. This was the case in a previous NSRP Tank Lining test program (3-93-1) where a solvent based inorganic zinc with zinc anode cathodic protection demonstrated no failure after six years of testing.

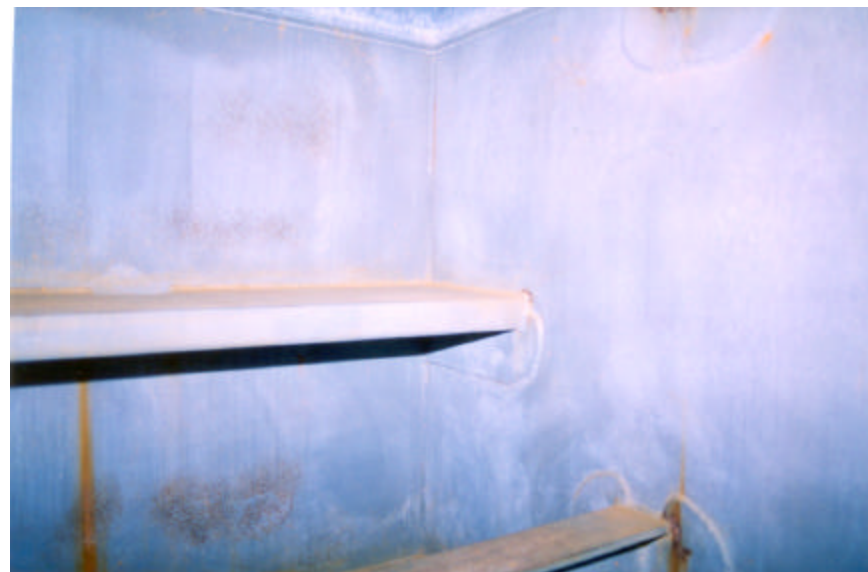
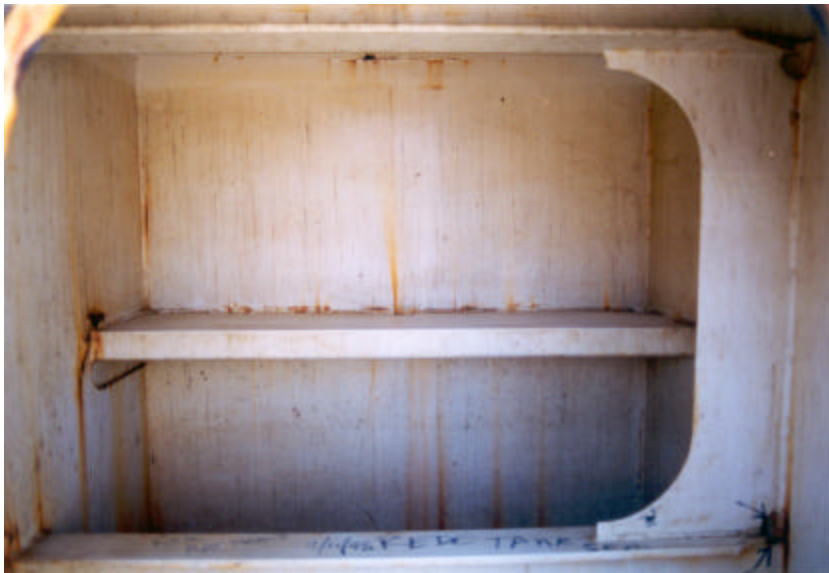
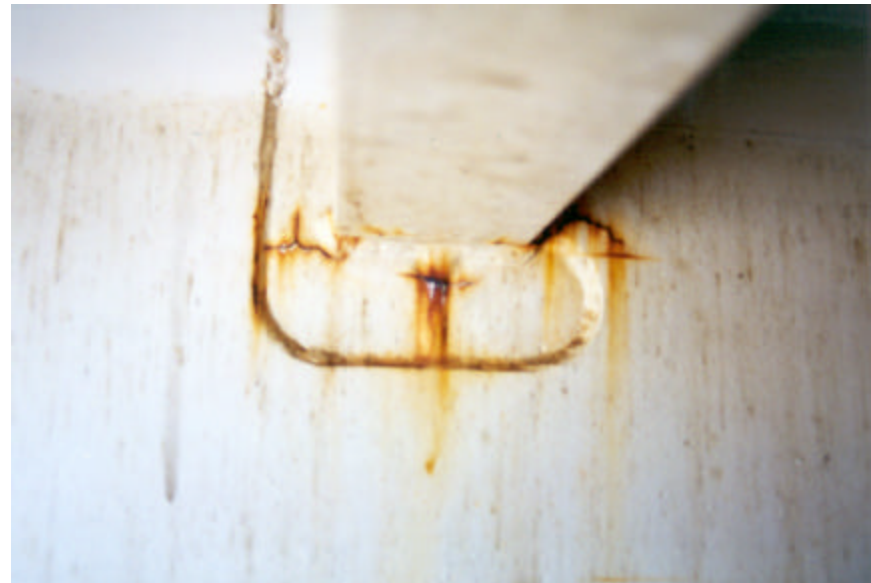
Tank B-3

Cell B-3 was topcoated with an 80% solids material. Because of schedule constraints, this tank was not completed properly. Many pinholes and holidays were identified but not repaired prior to placing the tank under test. As a result, defects began to appear early in the program. The lesson learned here is that attention to detail in assuring the job is complete is at least as important as the lining selection. Unfortunately, this is the only tank coated with this product so that no comparisons could be made over an alternate PCP.
