# LOW PLASTICITY BURNISHING (LPB) TREATMENT TO MITIGATE FOD AND CORROSION FATIGUE DAMAGE IN 17-4 PH STAINLESS STEEL

Paul S. Prevéy ([pprevey@lambda-research.com](mailto:pprevey@lambda-research.com))  
N. Jayaraman ([njayaraman@lambda-research.com](mailto:njayaraman@lambda-research.com))  
Lambda Research, 5521 Fair Lane, Cincinnati, OH 45227 – 3401

Ravi Ravindranath ([ravindranara@navair.navy.mil](mailto:ravindranara@navair.navy.mil))  
NAVAIR, Patuxent River, MD 20670-1908

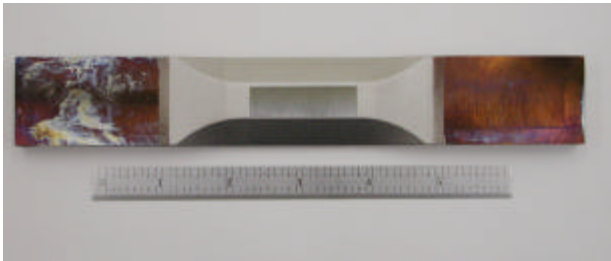
Figure 1a: Photograph of a typical thick section specimen.

Thick section fatigue specimens were finish machined out of the heat-treated bars by LSG. A typical fatigue specimen is shown in Figure 1a, which has a trapezoidal cross section in the gauge section. This special design enables the testing of specimens with a deep surface layer of compressive residual stress. The trapezoidal cross section HCF sample was designed to force fatigue failures to initiate in the compressive gage section surface under 4-point bend loading.

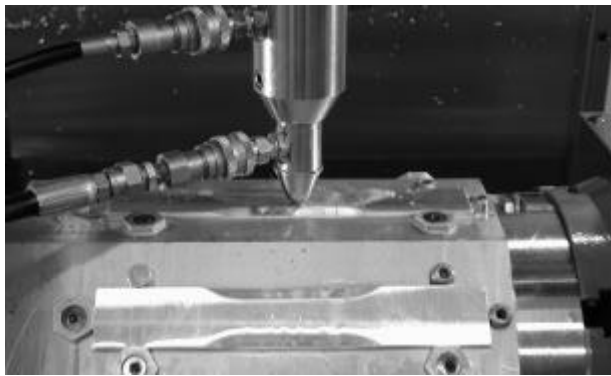
Figure 1b: A set of 8 thick section specimens being LPB processed in a 4-axis CNC milling machine.

LPB process parameters were developed by Surface Enhancement Technologies, LLC, (SET) for thick sections of 17-4 PH Stainless Steel using proprietary methods to impart the greatest depth and magnitude of residual stress with minimal cold work. The CNC control code was modified to allow positioning of the LPB tool in a series of passes along the gage section while controlling the burnishing pressure to develop the desired magnitude of compressive stress with relatively low cold working. Figure 1b shows a thick section fatigue specimen in the process of being low plasticity burnished in the four-axis

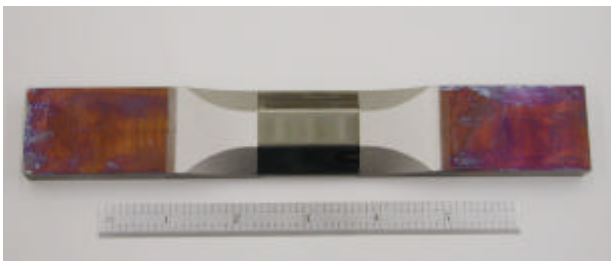
Figure 1c: The LPB treated surface patch in the gage section of a thick section specimen.

manipulator on the CNC milling machine. Figure 1c shows a thick section fatigue specimen with a LPB processed top surface.

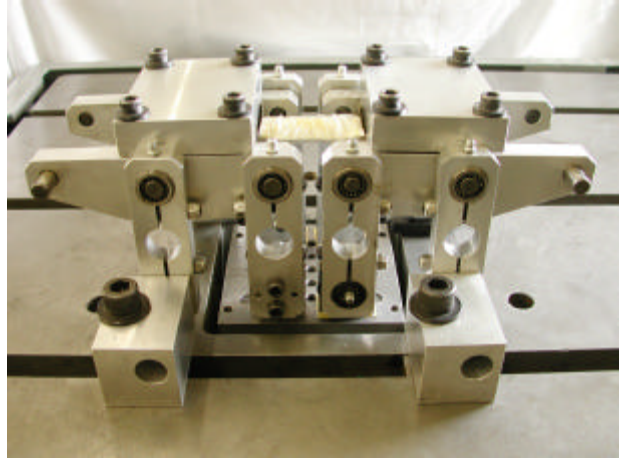
Figure 1d: A specimen mounted in the 4-point bend fatigue test set-up.

All high cycle fatigue tests were performed under constant amplitude loading on a Sonntag SF-1U fatigue machine. A photo of the fatigue test setup is shown in Figure 1d. Fatigue testing was conducted at ambient temperature ( $\sim 72^{\circ}\text{F}$ ) in four-point bending mode. The cyclic frequency and load ratio,  $R$ , were 30 Hz and 0.1 respectively. Tests were conducted to the event of specimen fracture or until a "run-out" life of  $2.5 \times 10^6$  was attained whichever occurred first. Run-out specimens were subsequently re-tested to fracture at a minimum stress of at least 20 ksi greater than the stress level at which run-out had occurred. For analysis purposes, such re-tests were regarded as virgin tests and results were included thus in S-N results. Cycling was terminated upon separation of the sample or when displacement resulting from severe cracking exceeded equipment limits. Specimens from tests terminated for the latter reason were subsequently broken by hand to

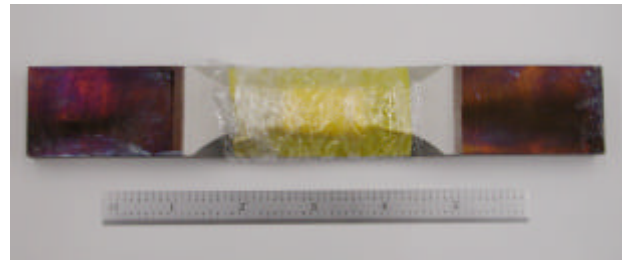
Figure 1e: A thick section specimen with salt solution soaked tissue wrapped around the gage section.

Initially, baseline HCF tests were conducted on LSG and LPB treated specimens in air with and without the EDM notch. Other corrosion fatigue tests were carried out in a medium of aqueous salt solution on specimens with LSG, SP and LPB surface treatment, both with and without an EDM notch. Corrosion fatigue testing was performed using a 3.5% NaCl salt solution with pH of about 7. Filter papers were soaked with the solution, wrapped around the gage section of the fatigue test specimen, and sealed with a plastic film to avoid evaporation. The pH of the solution was adjusted by adding either NaOH or HCL. Figure 1e shows a specimen with the acid salt soaked filter paper sealed around the gauge section. Figure 1e shows the specimen mounted in the four-point bend fixture assembled for fatigue testing in a Sonntag SF-1U HCF testing machine.

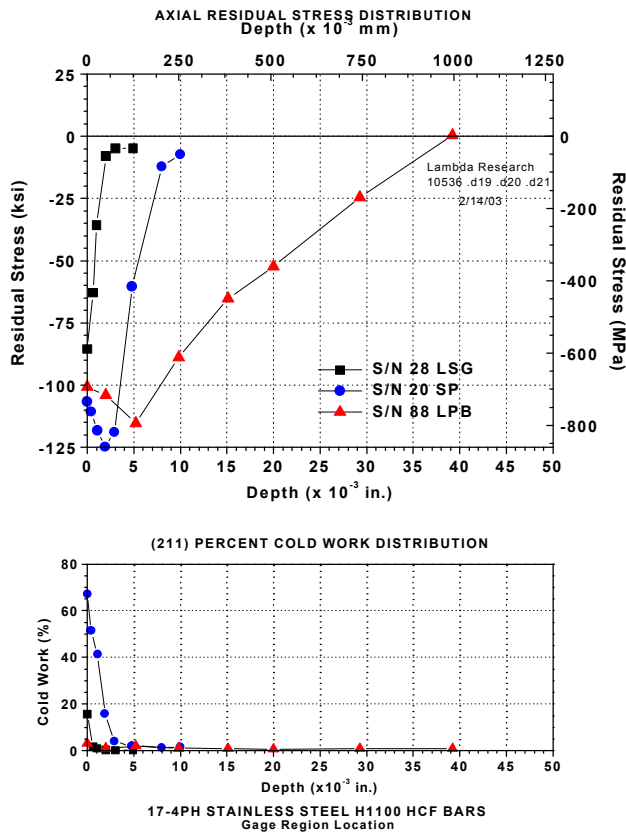
Figure 2. Residual stress distribution for LSG, SP and LPB processed (and fatigue tested, all in air) specimens. S/N28 (LSG):  $S_{max} = 140$  ksi ( $\sim 965$  MPa);  $N_f = 3,303,607$  cycles, S/N20 (SP):  $S_{max} = 185$  ksi ( $\sim 1275$  MPa);  $N_f = 148,980$  cycles, S/N88 (LPB):  $S_{max} = 210$  ksi ( $\sim 1,450$  MPa);  $N_f = 200,445$  cycles

The residual stress distributions measured as functions of depth are presented graphically in Figure 2. Compressive stresses are shown as negative values, tensile as positive, in units of ksi ( $10^3$  psi) and MPa ( $10^6$  N/m<sup>2</sup>).

Figure 2 shows the residual stress (RS) and %cold work (CW) profiles for specimens subjected to LSG, SP and LPB treatment after fatigue testing. The LSG specimen shows surface compression of about -85 ksi ( $\sim -585$  MPa), which decreases rapidly to nearly zero at a depth of 0.002 in. ( $\sim 0.05$  mm). This specimen is cold worked 15% at the surface. In comparison, SP treatment shows surface compression of about -105 ksi ( $\sim -725$  MPa), which becomes more compressive to about -125 ksi ( $\sim -860$  MPa) at a depth of about 0.002 in. ( $\sim 0.05$  mm), and rapidly relaxes to nearly zero residual stress at a depth of about 0.010 in. ( $\sim 0.25$  mm). More importantly, the SP treatment produces a very high degree of cold work, nearly 70% cold work on the surface, which decreases to nearly zero within a depth of 0.005 in. ( $\sim 0.125$  mm). In contrast to both these, LPB

treatment produces surface compression of -100 ksi ( $\sim -690$  MPa), which becomes more compressive to about -115 ksi ( $\sim -790$  MPa) at 0.005 in. ( $\sim 0.125$  mm) and gradually decreases to zero at a depth of about 0.040 in. ( $\sim 1$  mm). LPB produces surface cold work of  $< 5\%$ , which decreases to nearly zero within 0.001 in. ( $\sim 0.025$  mm).

The low cold work associated with the LPB process is credited with the high stability of the compressive residual stresses of LPB treated parts to thermal exposure and mechanical overload conditions. In contrast, the SP treated specimens tend to go through recovery and recrystallization processes that are dominant in highly cold worked parts, and thereby lose the beneficial compressive residual stresses.

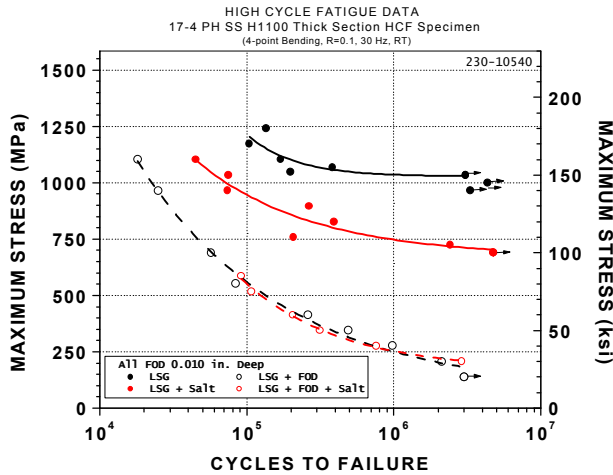
Figure 3. Baseline HCF and corrosion fatigue results plotted in the form of S-N curves for LSG treatment. The fitted lines are used in Figures 4 and 5 for the purpose of comparison of fatigue performance of SP and LPB treated specimens.

Figures 3-6 show the HCF and corrosion fatigue performance of 17-4 PH Stainless Steel (H1100) in the form of S-N curves. In Figure 3, the baseline material (LSG) performance with and without the EDM notch is presented. The unnotched LSG condition shows a fatigue strength, (endurance limit at about  $10^7$  cycles)  $S_{max}$  of about 150 ksi ( $\sim 1035$  MPa). In comparison, corrosion fatigue for LSG results in a fatigue strength of about 100 ksi ( $\sim 690$  MPa).

Introduction of a semi-elliptical EDM notch of nominal size  $a_o = 0.010$  in. (0.25 mm) and  $c_o = 0.030$  in. (0.75 mm) drastically decreases the fatigue strength to about 20 ksi ( $\sim 140$  MPa) for both air and corrosion environments. With the EDM notch, the fatigue lives at higher stresses show a corresponding decrease of over an order of magnitude in comparison to the unnotched specimens. In Figure 3, power law lines were fitted to the data and these lines are included in the presentation of data. The lines in this figure represent the average behavior of the material in its baseline LSG condition, and are used in Figures 4 and 5 for purposes of comparison with other surface treatment processes.

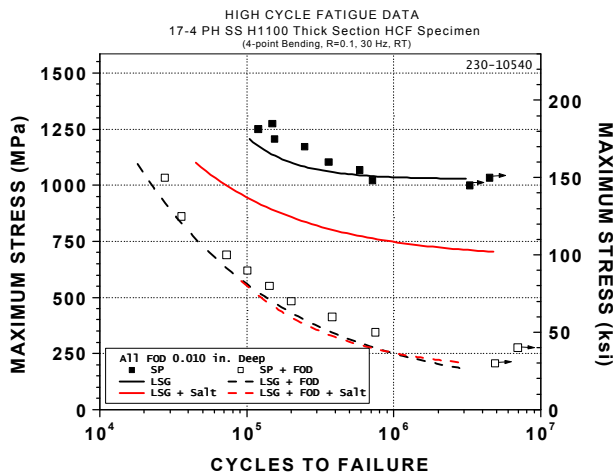
Figure 4. HCF results for SP treatment. Baseline data for LSG treatment (fitted lines from Figure 3) are shown for comparison. Corrosion fatigue tests were not performed on SP treated specimens since no significant benefit in HCF behavior was observed due to shot peening, as seen in this figure.

Figure 4 shows the HCF performance of both unnotched and notched SP treated specimens. This figure includes fitted lines from Figure 3, representing the baseline performance. Benefits of surface compression from the shot peening treatment are clearly seen by way of considerably improved HCF performance of the unnotched specimens. The unnotched HCF

performance of the SP treated specimens is comparable to that of the HCF performance of the unnotched LSG (baseline) material.

However, the introduction of a 0.010 in. (0.25 mm) deep notch knocks the performance down

to be similar to the notched LSG (baseline) condition. This is not surprising since the corresponding residual stress profile (shown in Figure 2) indicates a depth of compression much shallower than the depth the EDM notch.

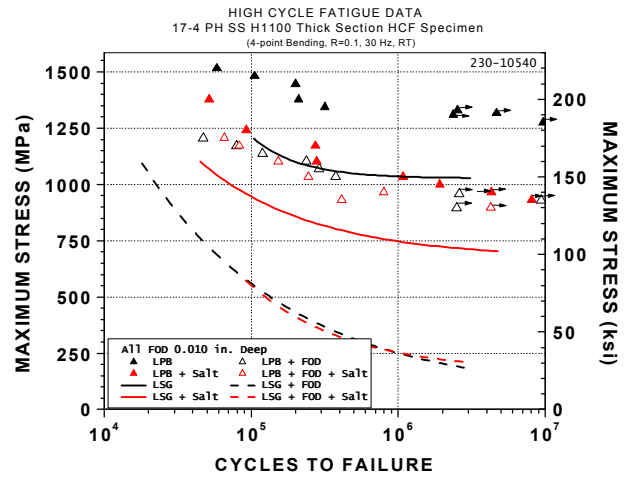
Figure 5. Corrosion fatigue and HCF results for LPB treatment. Baseline data for LSG treatment (fitted lines from Figure 3) are shown for comparison.

Figure 5 shows the HCF and corrosion fatigue behavior of LPB treated specimens. Again, the trend lines for the baseline LSG material from Figure 3 are included in this Figure. The unnotched LPB treatment shows superior HCF performance with a fatigue strength of 190 ksi (~1310 MPa). Figure 5 also shows that fatigue data from all of the other test conditions with LPB treatment, notched HCF, and both notched and unnotched corrosion fatigue may be grouped into one set of data. A couple of inferences may be reached from this data. Firstly, the fact that the notched HCF data, and the notched and unnotched corrosion fatigue data are practically indistinguishable in LPB treated system shows that for all practical purposes LPB process has negated the effects of corrosion in the corrosion fatigue process. Secondly, it is interesting to note that the HCF and corrosion fatigue performance of this group are statistically no worse than the unnotched baseline (LSG) material.

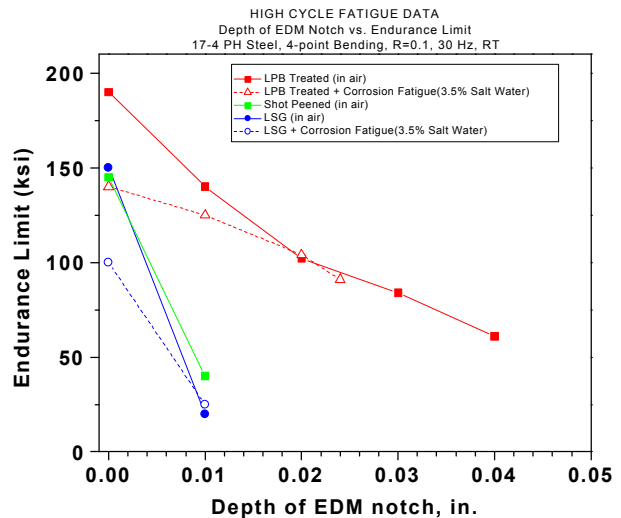
Figure 6: HCF and Corrosion fatigue performance as a function of EDM notch depth in 17-4 PH SS - H1100. Note that while for LSG and shot peened specimens a notch of 0.010 in depth resulted in dramatic loss of fatigue strength. LPB even with a 0.040 in. of notch depth has good fatigue strength. Also, note that for LPB, the HCF and corrosion fatigue behavior of notched specimens are practically indistinguishable.

Figure 6 shows a summary of HCF and corrosion fatigue tests for a number of specimens with deeper EDM notches up to a depth of 0.040 in. (~1 mm). Here, it is evident that for both shot peened and LSG materials, even a 0.010 in. (0.25 mm) deep EDM notch greatly decreases the HCF and corrosion fatigue strength to a value between 25 and 40 ksi (~170 and 275 MPa). In contrast, the LPB treated specimens withstand even a 0.040 in. (~1 mm) deep EDM notch with a fatigue strength of at least 55 ksi (~ 380 MPa). Again, this HCF and corrosion fatigue performance for the LPB treated specimens are easily explained based on the residual stress distributions seen in Figure 2.

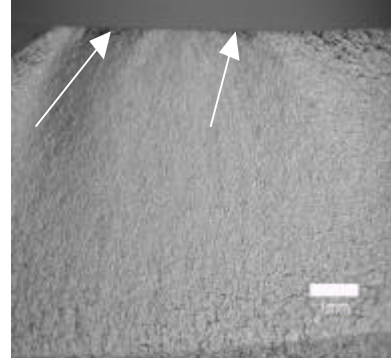
Figure 7a: LSG, Smax = 170 ksi (1,170 MPa), Nf = 103,997 cycles – arrows indicate multiple crack initiation sites.

Figure 7: Optical fractographs of unnotched LSG, SP and LPB specimens tested in air.

Figure 7 shows optical fractographs of unnotched specimens fatigue tested in air. Figure 7a shows the fracture surface of a LSG specimen with multiple crack initiation sites, while Figures 7b

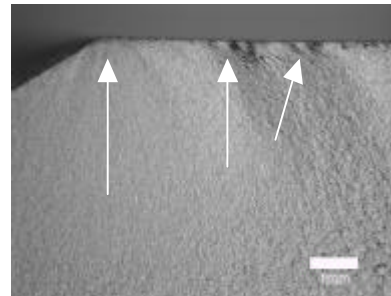
Figure 7b: SP, Smax = 181 ksi (1,250 MPa), Nf = 119,245 cycles – arrows indicate multiple crack initiation sites.

and 7c show the surface of a shot peened and LPB treated specimens, respectively, with crack initiation sites. The general features of the fracture surface are typical of crack initiation followed by fatigue crack growth to failure. Figure 8 show SEM fractographs of a corrosion fatigue

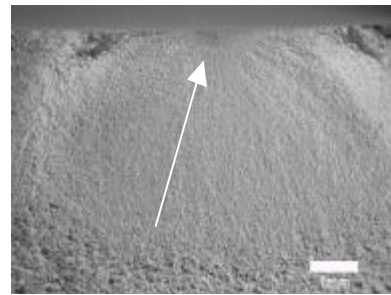
Figure 7c: LPB, Smax = 195 ksi (1,345 MPa), Nf = 316,663 cycles – arrow indicates one dominant crack initiation

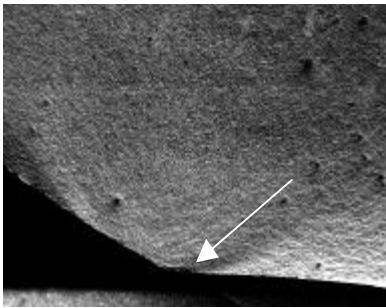
Figure 8a: LSG + Salt unnotched,  $S_{max} = 120$  ksi (825 MPa),  $N_f = 391,342$  cycles – arrow indicates initiation site

Figure 8: SEM fractographs of corrosion fatigue tested LSG specimens

tested unnotched LSG specimen. Again, a single dominant initiation site leads to crack growth. The higher magnification SEM image in Figure 8b indicates the intergranular fracture mode typical of fatigue crack growth conditions under corrosion fatigue conditions. Figure 9 shows optical fractographs of corrosion fatigue tested specimens with EDM notches. Figures 9a through 9d show fractographs of a corrosion fatigue tested LPB specimen. Here, Figures 9a and b show a single crack initiation site, and Figures 9c and d show the gage side view near the crack origin and below the fracture surface. Evidence of crack initiation at a corrosion pit is evident in these SEM photographs. Figure 10 shows optical fractographs of EDM notched LPB treated specimens under corrosion fatigue conditions. Again the crack initiation and growth regions are quite evident in these fractographs.

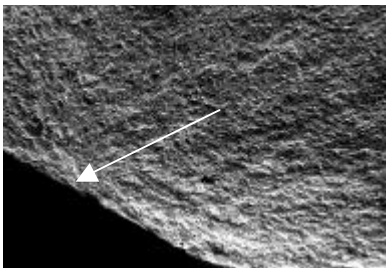
Figure 8b: Same as 8a, but higher magnification

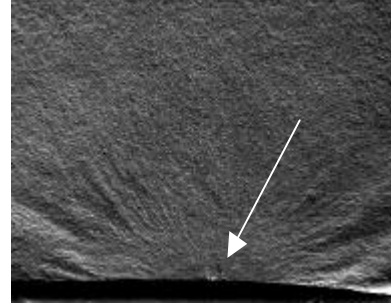
Figure 9a: LPB + salt unnotched,  $S_{max} = 150$  ksi (1,035 MPa),  $N_f = 316,613$  cycles – arrow indicates initiation

Figure 9: SEM fractographs of a corrosion fatigue tested LPB specimen.

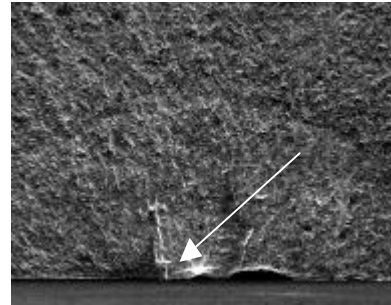
Figure 9b: Same as 9a, but higher magnification

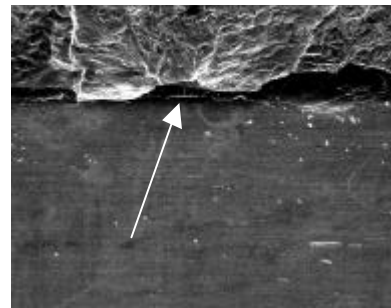
Figure 9c: Same region as 9a, gage surface near crack initiation site (arrow).

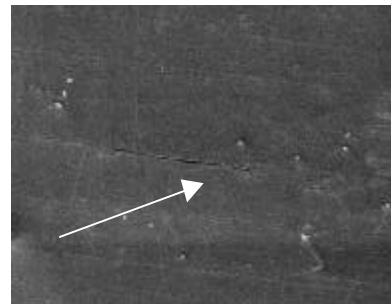
Figure 9d: Same as 9a, cracking on the gage surface just below the crack initiation site.

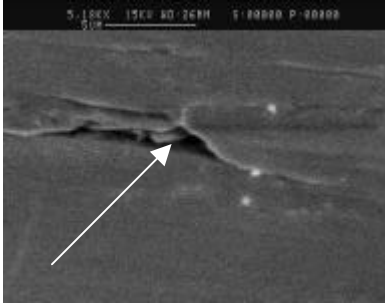
Figure 9e: Cracking on the gage surface just below crack initiation site at the initial stage of formation of a corrosion pit (arrow).

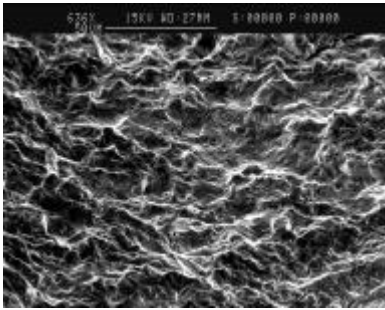
Figure 9f: Intergranular crack growth, in a region away from the initiation site.

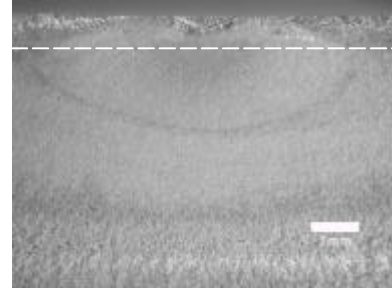
Figure 10a: Optical fractograph of corrosion fatigue tested notched (0.010 in.) specimen LPB + salt 0.010 in. EDM notch.  $S_{max} = 140$  ksi (965 MPa);  $N_f = 794,917$  cycles – note the notch depth is smaller than the approximate LPB processed zone (dotted white line).

The HCF and corrosion fatigue results presented in Figure 3-6 and the fractographic observations in Figures 7-10 are fully consistent with the residual stress results shown in Figure 2. For both LSG and shot peened specimens, the depth of compression is less than 0.010 in. (~ 0.25 mm) and correspondingly, the HCF and corrosion fatigue performance for both these conditions deteriorated to very low values. The depth of compression achieved in LPB treated specimens is > 0.040 in. (~ 1 mm), that correspondingly nearly equals the limit of tolerance of EDM notch for corrosion fatigue.

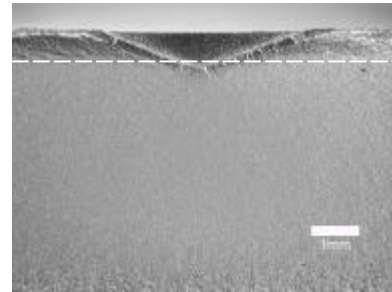
Figure 10b: Optical fractograph of HCF tested notched (0.040 in.) specimen. LPB 0.040 in. EDM notch  $S_{max} = 83$  ksi (570 MPa);  $N_f = 424,044$  cycles – note the notch depth is the same as the approximate LPB processed zone (dotted white line)
