**EFFECT OF ENVIRONMENT ON CREEP BEHAVIOR OF AN OXIDE/OXIDE  
CFCC WITH  $\pm 45^\circ$  FIBER ORIENTATION**

THESIS

AFIT/GAE/ENY/06-J15

***AIR FORCE INSTITUTE OF TECHNOLOGY***

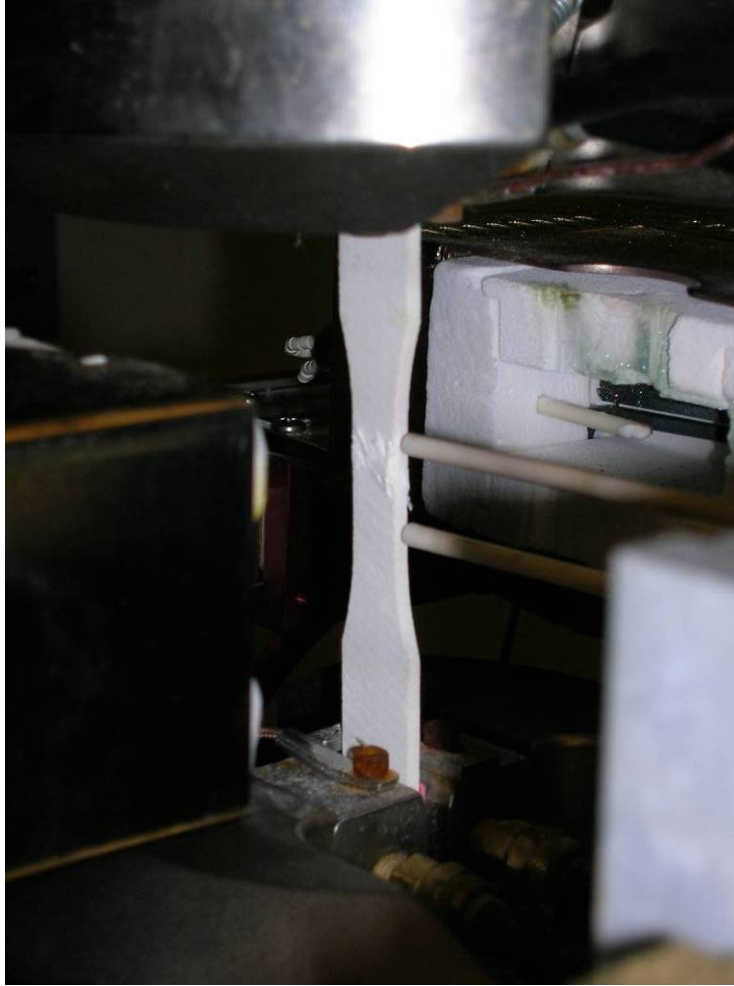
**Figure 17. Extensometer on a fractured specimen.**

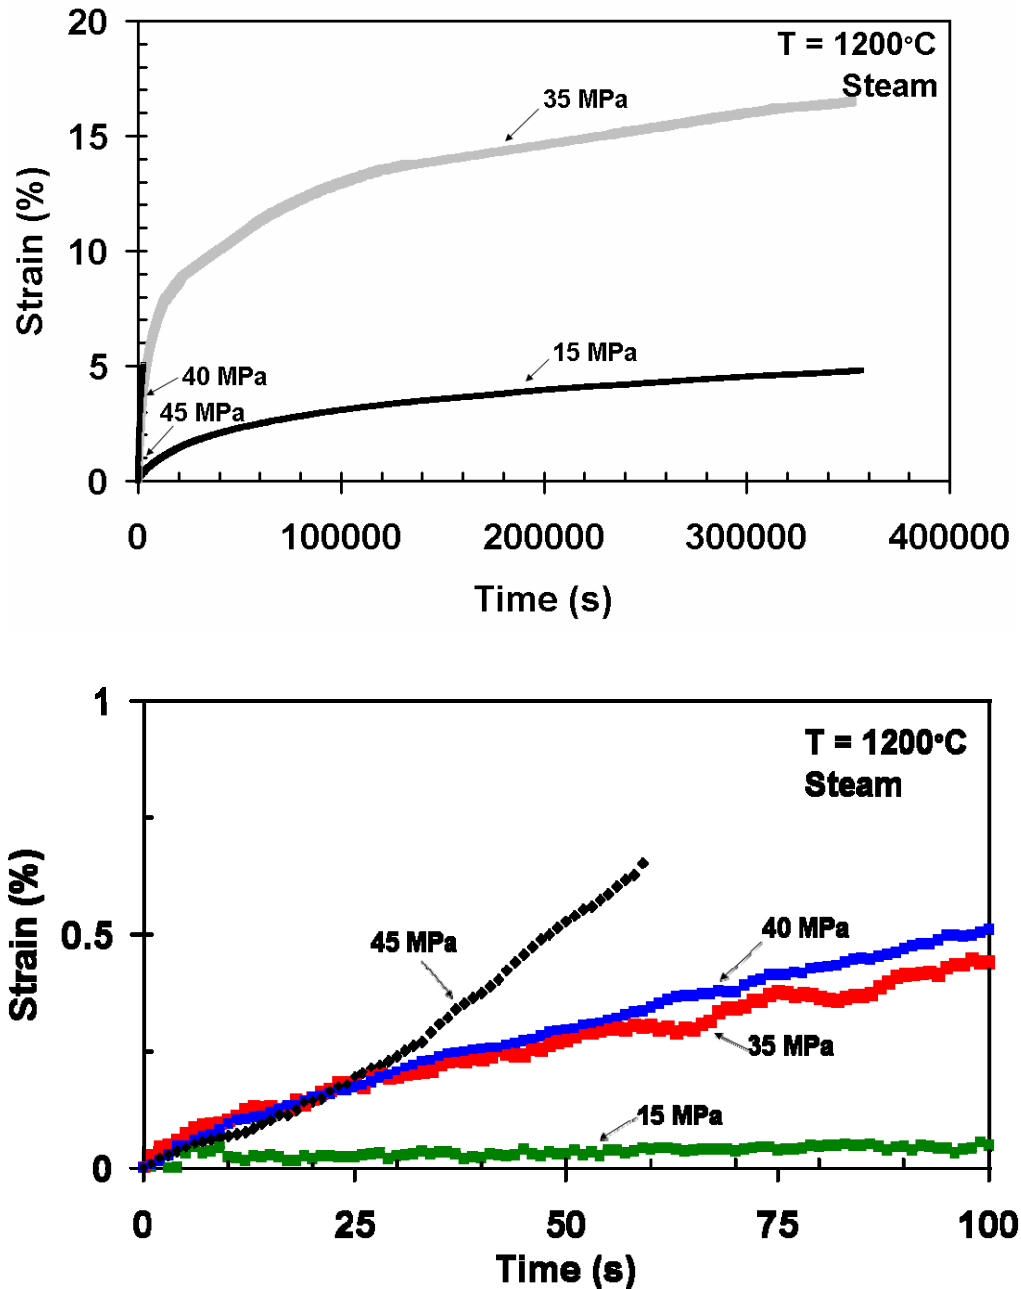
Figure 34. Creep-strain vs. time in 100% steam at 1200°C.

The creep curves obtained at 1200°C in steam are presented in Figure 34.

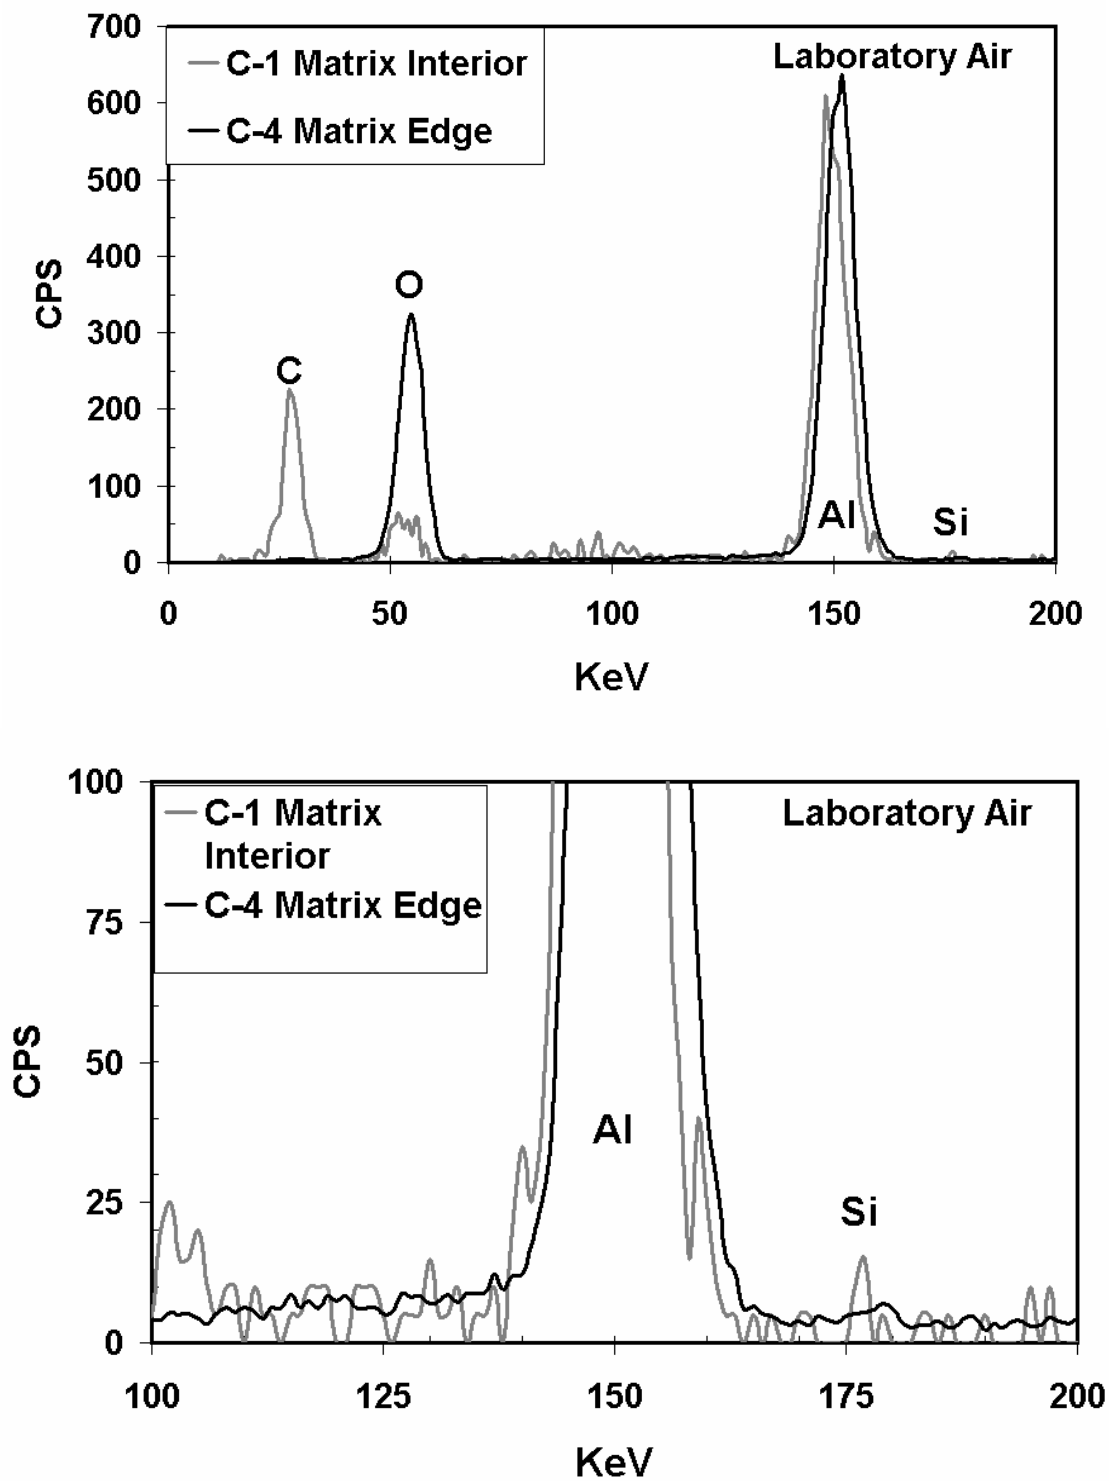
Figure 72. EDS spectra of the matrix interior compared to the spectra of the matrix edge in the specimens tested in laboratory air.

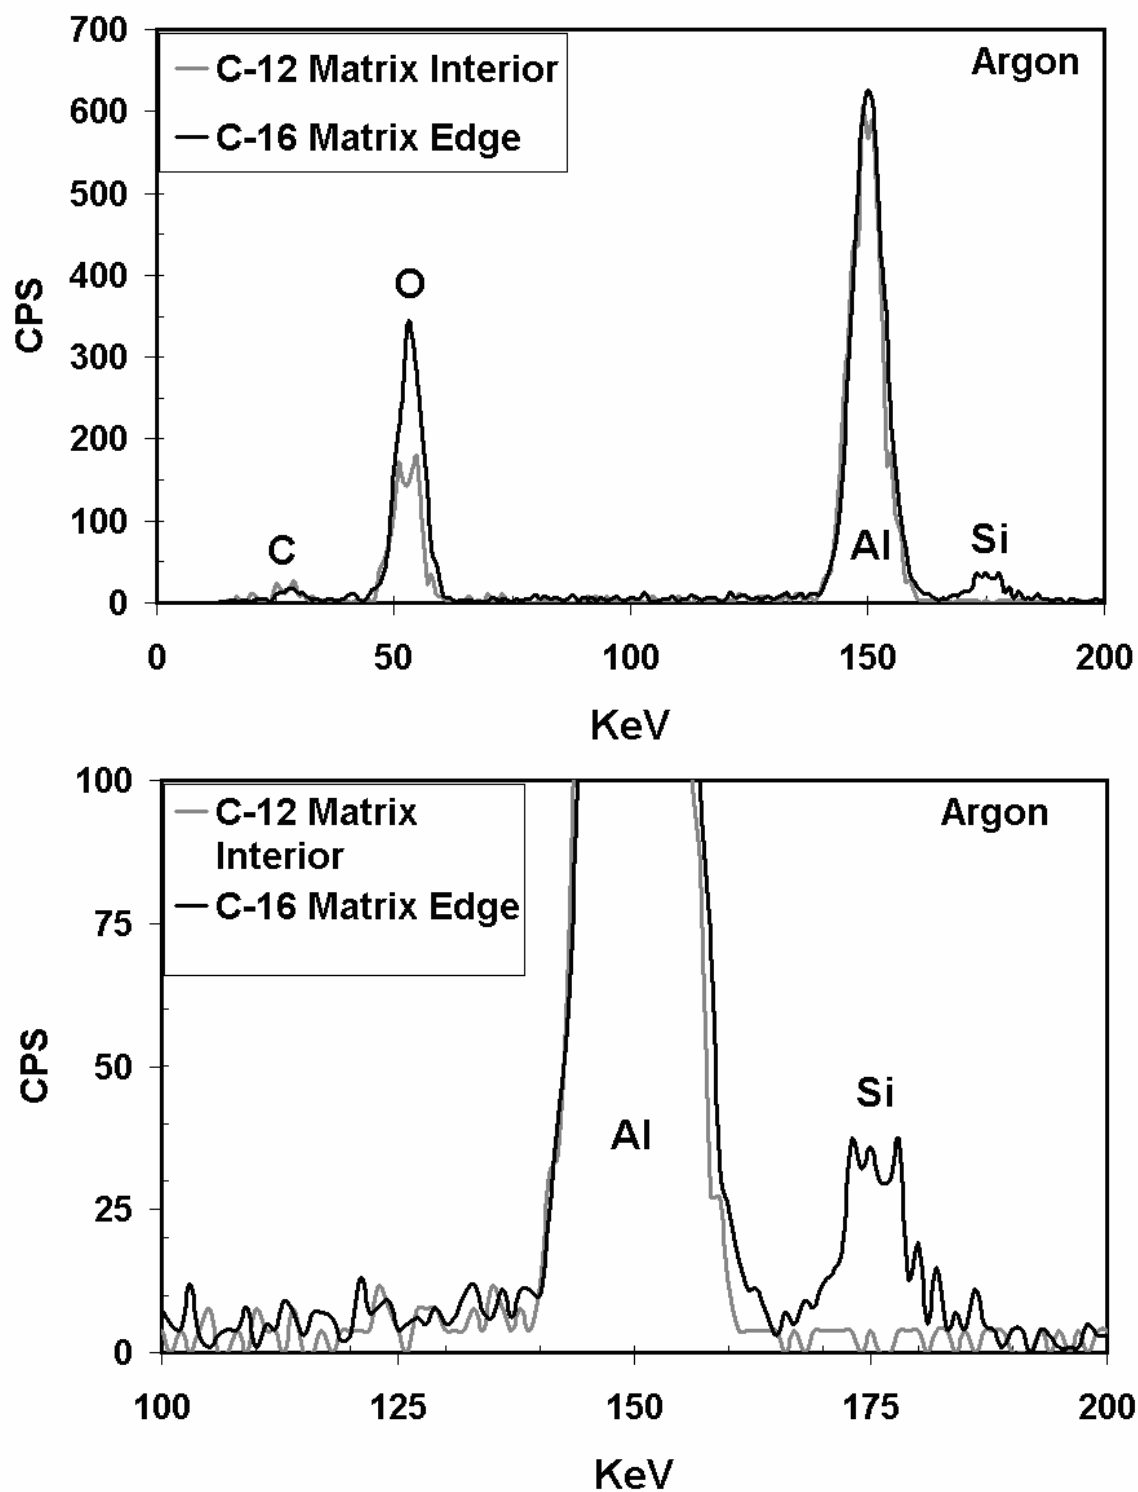
Figure 74. EDS spectra of the matrix interior compared to the spectra of the matrix edge in the specimens tested in 100% argon.
