Effect of Armoring a Cohesive Nearshore with a Thin Cobble Lag, Shoreham, Michigan

by Mohammad Dibajnia, James Selegean, and Andrew Morang

PURPOSE: This Coastal and Hydraulics Engineering Technical Note (CHETN) summarizes monitoring results of the 1995 lake bed paving project conducted at Shoreham, MI, on Lake Michigan by the U.S. Army Engineer Research and Development Center (ERDC), in collaboration with The U.S. Army Engineer District, Detroit. The CHETN also discusses the effectiveness of lake bed paving in reducing cohesive lake bed downcutting and mitigation of bluff erosion. The lake bed paving concept was examined as an innovative alternative to traditional revetment construction to protect the shoreline.

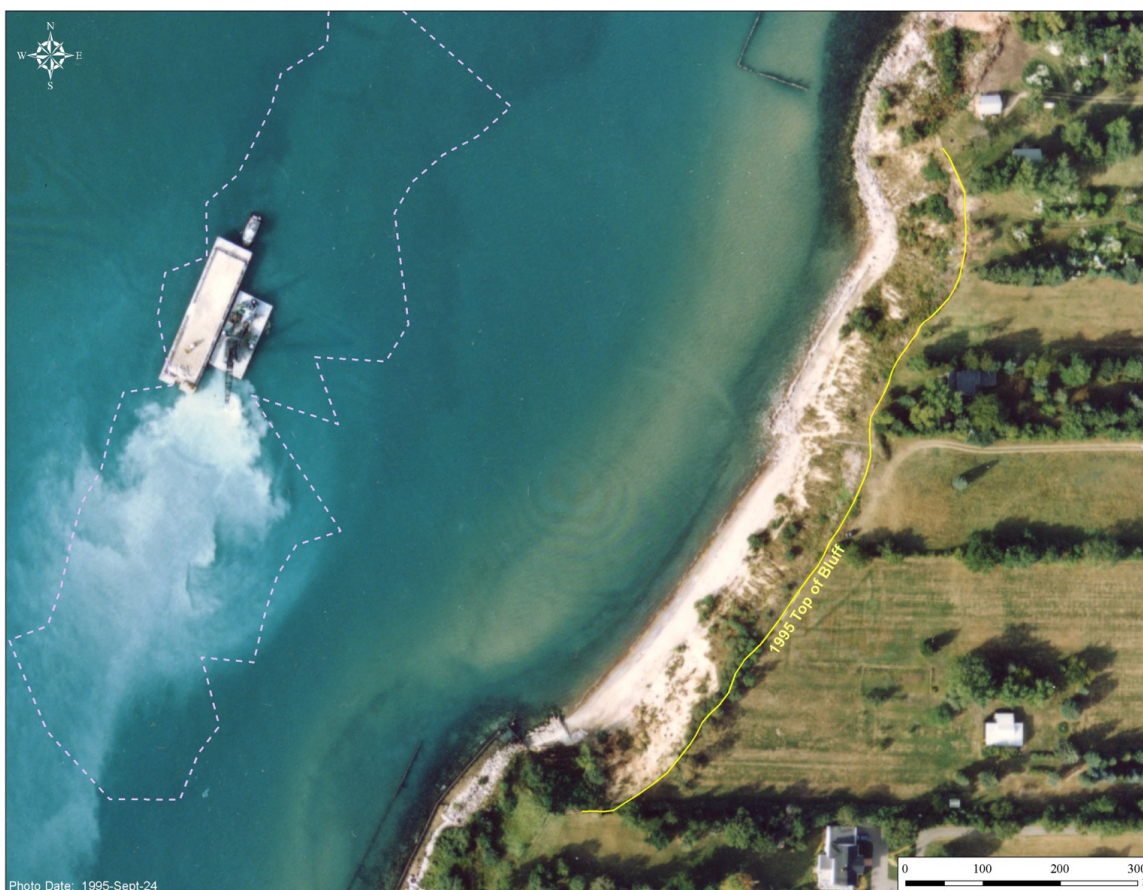
In September–October 1995, the Detroit District placed approximately 45.7 cm (18 in.) of stone on the lake bed near Shoreham, MI (Figure 2). The purpose of this study was to demonstrate that downcutting of the lake bed could be arrested with a relatively thin layer of cobble armor. A reduction in downcutting of the nearshore should ultimately lead to a reduction in bluff recession (Parson, Morang, and Nairn 1996). The stone placement encompassed an area roughly 335 m (1,100 ft) long, commencing at the 3.7-m (12-ft) contour (IGLD 1985 datum) and extending 152 m (500 ft) lakeward. Forty-three survey lines were taken at the site following the placement of the stone in 1995. These original survey lines were reoccupied in 2005.

Figure 2. Stone placement captured in the September 1995 aerial photograph.

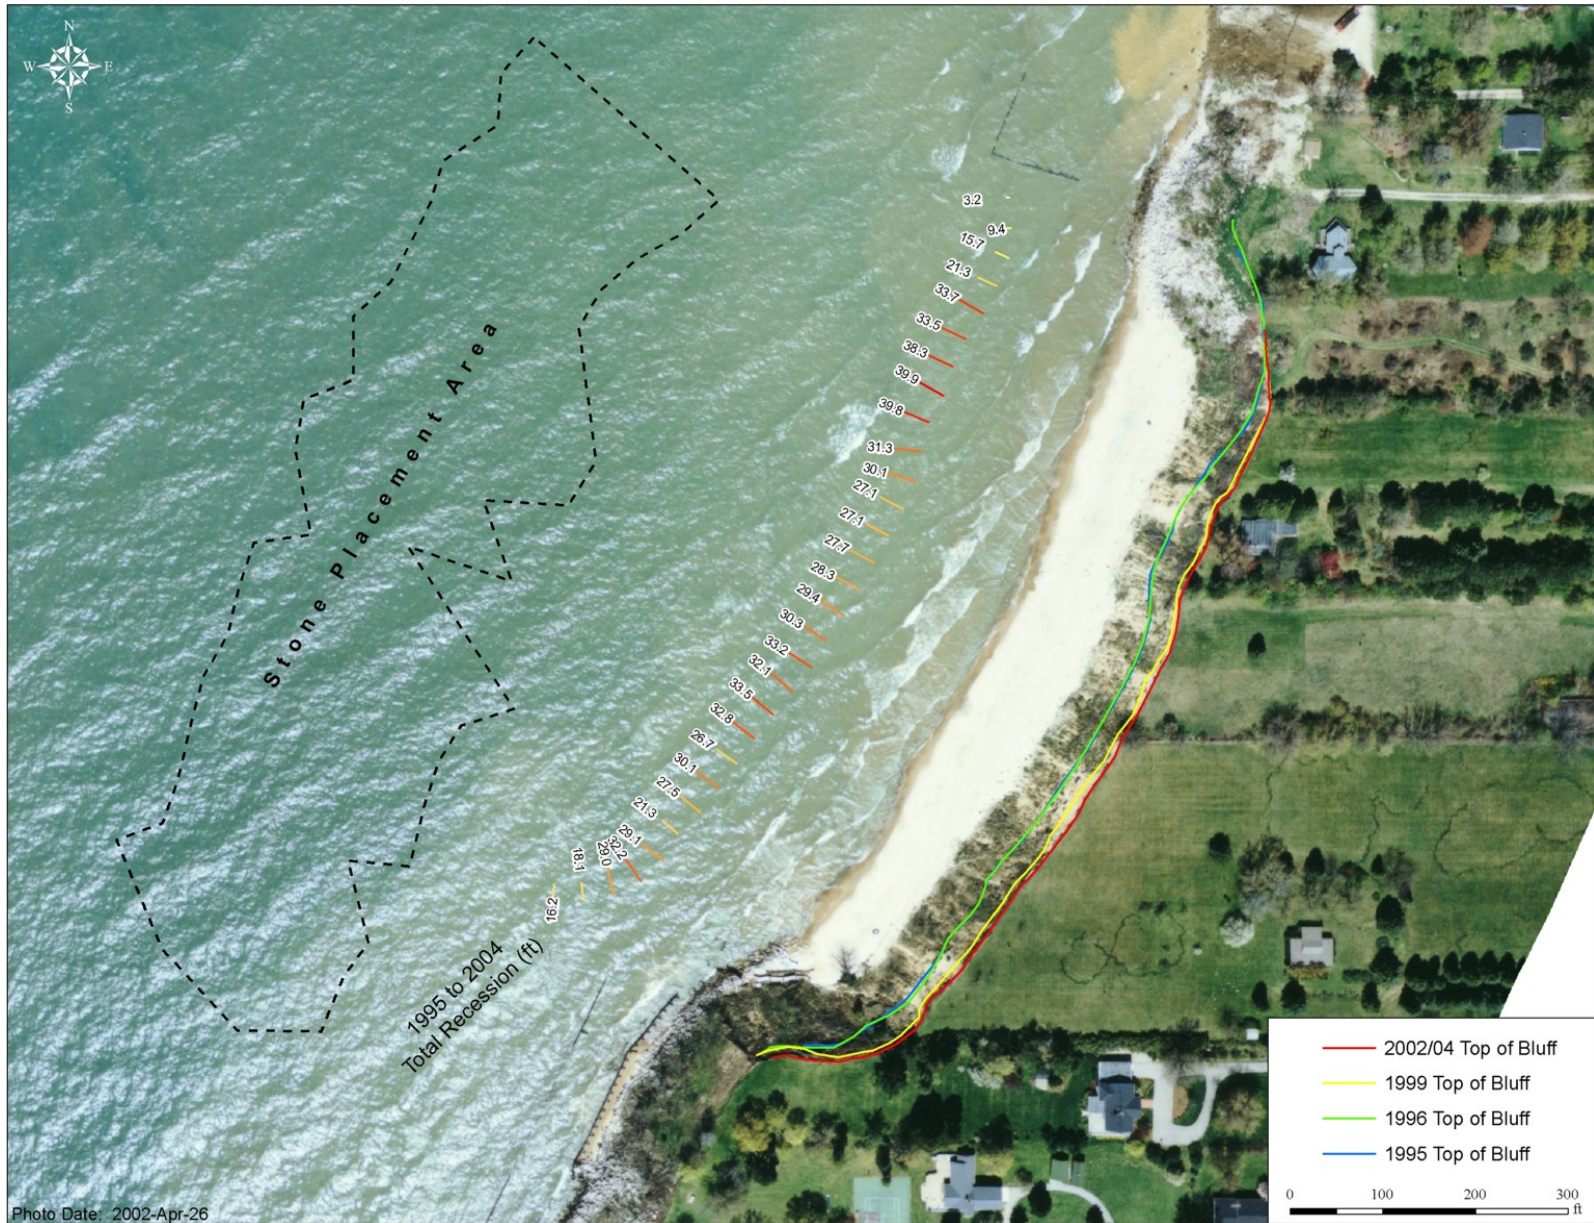
Figure 5 shows bluff recession details since completion of stone placement project to present. Total recession between 1995 and 2004 for every 10 m (32.8 ft) along the Shoreham bluff are also given in this figure. Average total recession is 8.4 m (27.6 ft), which translates to a recession rate of about 0.9 m/year (3 ft/year) close to its long-term average. In this figure, the 2002 and 2004 lines are identical, i.e., there was no bluff erosion between these years likely because of recent low lake levels. During low lake levels there is little or no direct wave attack on the bluff face, which explains the growth of vegetation on the bluff face. During periods of high lake levels the bluff face is much steeper with little or no vegetation.

Figure 5. Bluff recession at Shoreham, MI, between 1995 and 2004.

- c.* Subsequent to the placement of the cobble lag at Shoreham, MI, the bluff has continued to erode at a rate close to its long-term average recession rate between 1995 and 2004 (i.e., 0.9 m/year (3 ft/year)); however, it is possible that some long-term benefit may be realized through the development of a shelf in the nearshore.

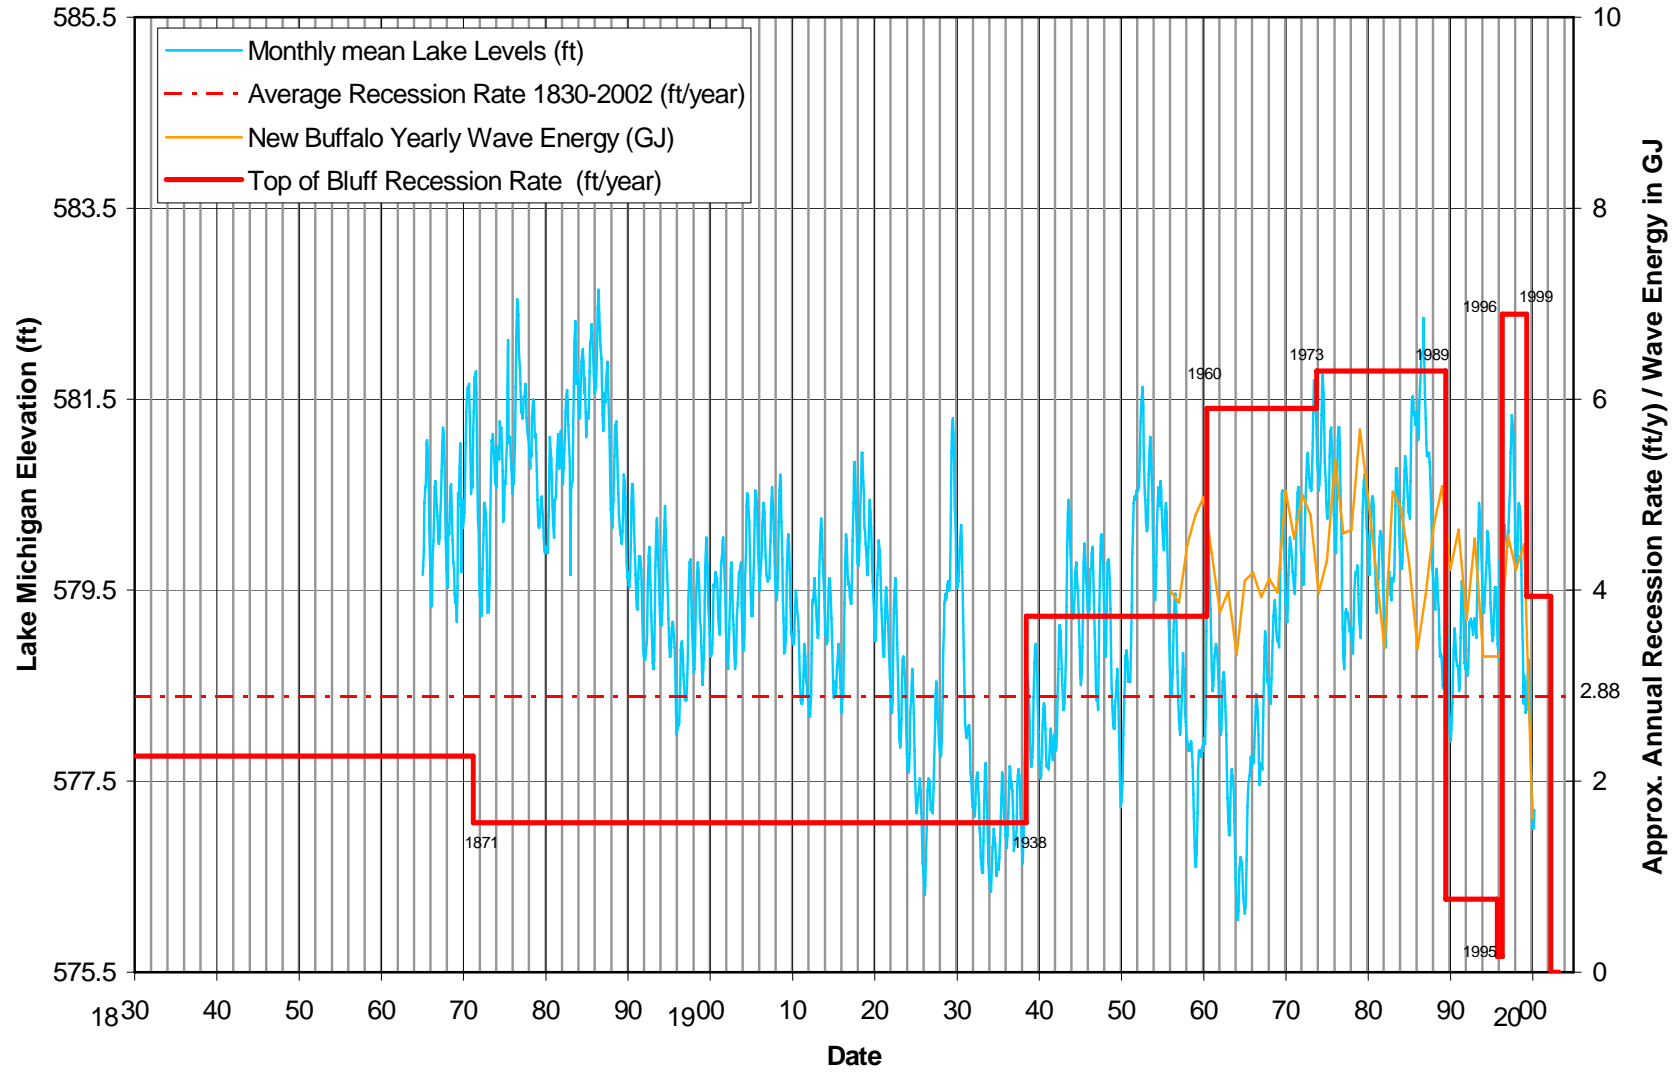
Using this information, the historic retreat rates for periods between each available and reliable snapshot were calculated at Shoreham. Figure 6 provides: (a) time along the x-axis from 1830 to present; (b) the estimated bluff crest retreat rate (referenced to the left hand scale), which appears as a step function as it relates to the change in the bluff position between snapshots taken at the beginning and end of each segment; (c) the average bluff retreat rate for the period from 1830 to 2004; and (d) the lake level variations from 1830 to present. In general, higher retreat rates have occurred during periods of high lake levels.

Figure 6. Bluff recession rate at Shoreham, MI, and Lake Michigan levels.

- d.* Historically, bluff erosion at Shoreham (like other parts on Lake Michigan) has been severe during high lake level periods. Recent bluff erosion after completion of the project has also occurred during high lake levels between 1996 and 1999.

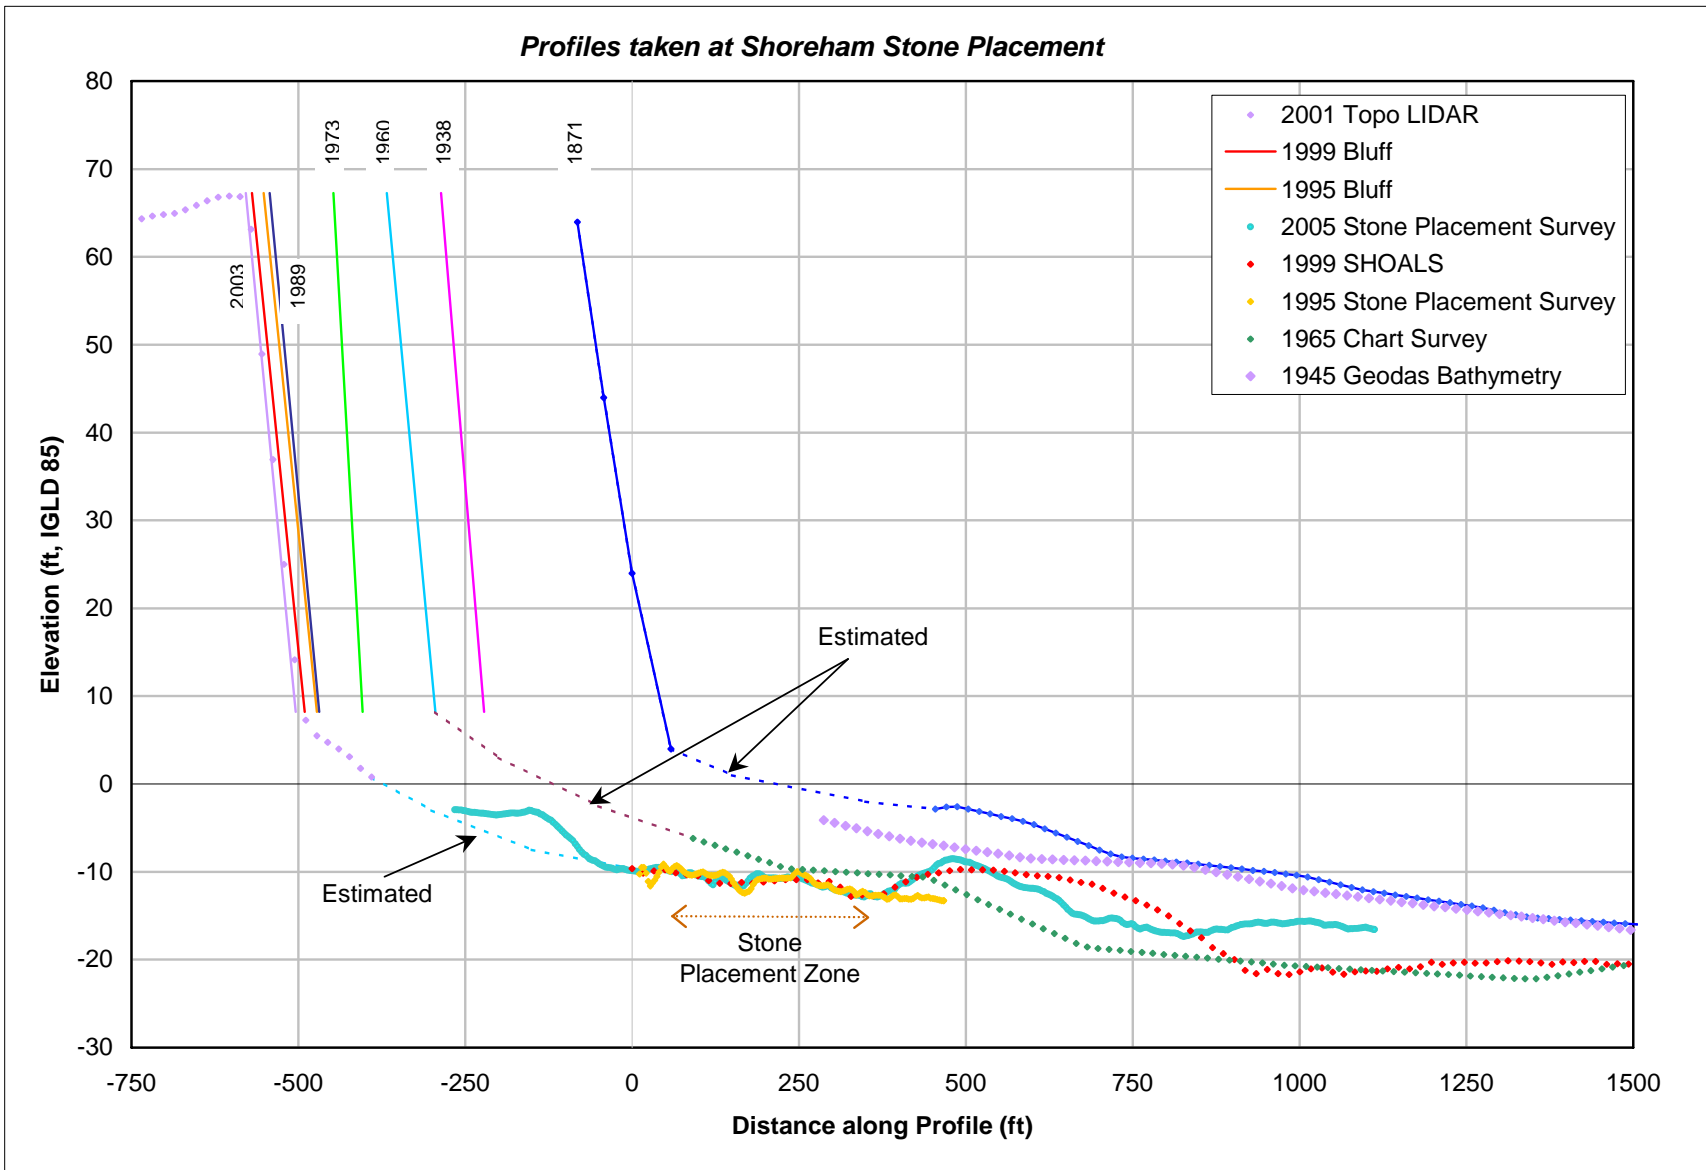
Figure 8 shows the data along the profile line indicated in Figure 7, together with other survey data and bluff lines. None of the data sets provide data in shallow water. Therefore, part of the nearshore bathymetry in this figure had to be estimated. It may be seen that lake bed lowering had continued between the 1871 and 1965 surveys. The lowering, however, stopped sometime after 1965, and the 2005 survey shows some sand accumulation on the lakeward side of the stone layer. This is likely because of the U.S. Army Corps of Engineers' beach nourishment activities downdrift of St. Joseph Harbor since 1970. A bar is also observed shoreward of the stone area in the 2005 survey.

Figure 8. Historic and recent nearshore profiles at Shoreham, MI.

From Figure 8, it may be seen that the stone surface is at about 3 m (10 ft) below LWD. Hindcast data for other nearby projects indicates that the wave climate in the area is calm for about 30 percent of the time (40 percent when ice is included), and wave height is less than 2 m (6.6 ft) for about 55 percent of the time. Thus, for a total of 85 to 95 percent of the time the wave height is less than 2 m (6.6 ft). Consequently, most waves propagate over the placed stone surface without energy dissipation. As downcutting is believed to be proportional to the rate of wave energy dissipation, it is therefore unlikely that the stone layer has had any effect on reduction of downcutting between the stone placement area and the shore. Moreover, downcutting rate increases as the depth decreases towards the shoreline, and it is the downcutting rate in shallow water close to the bluff toe which controls the bluff erosion (Philpott 1984; Davidson-Arnott 1986; Kamphuis 1987). It is therefore concluded that the present paving was placed too far offshore. Unfortunately, the deep placement was necessary because of the barge and equipment used at the time. Lake bed paving would be more effective if placed in shallower waters close to the shoreline.
