TECHNICAL REPORT 1943  
July 2006

**Impulse Flashover Tests at  
Edgar Beauchamp High Voltage  
Test Facility, Dixon, California**  
In Support of Cutler Insulator Failure Investigation

P. M. Hansen  
**SSC San Diego**

G. Dann  
**Naval Facilities Engineering Service Center**

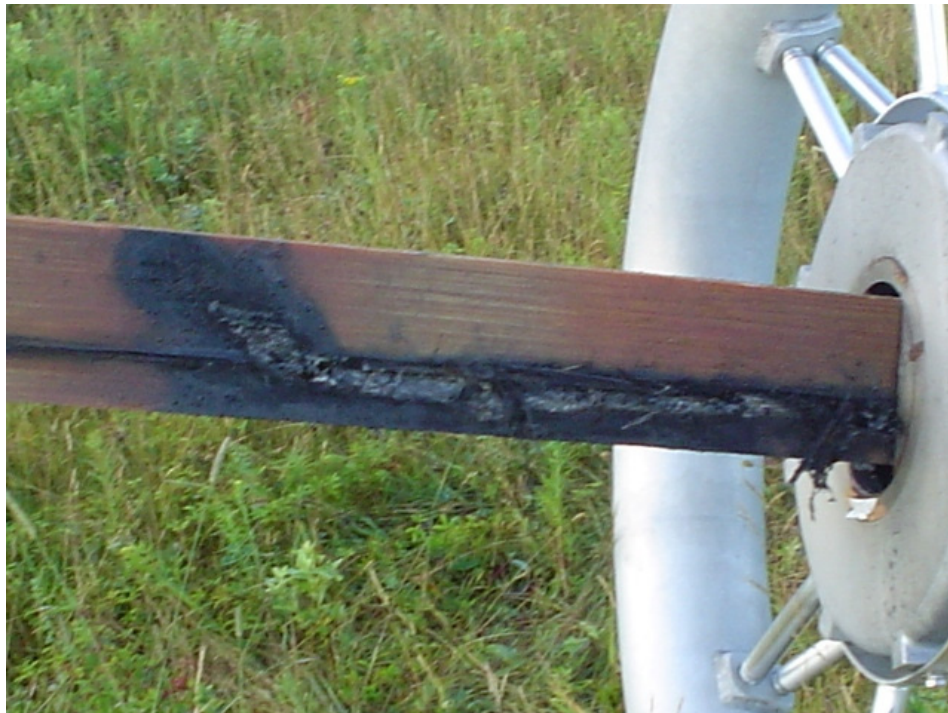
Figure 1. Cutler safety core insulator failure #4.

The fourth failure occurred in conjunction with a rare, very large, lightning strike (100-kAmp peak current [3]), which shattered the porcelain tube and heavily tracked the fiberglass belt but left the belt intact structurally (Figure 1).

The pressure relief diaphragm was intact following the fourth failure. That fact and other analysis reported by Zueck [4] indicated the porcelain was shattered from the outside, by either thermal stress or the shock wave from the high-current lightning bolt.

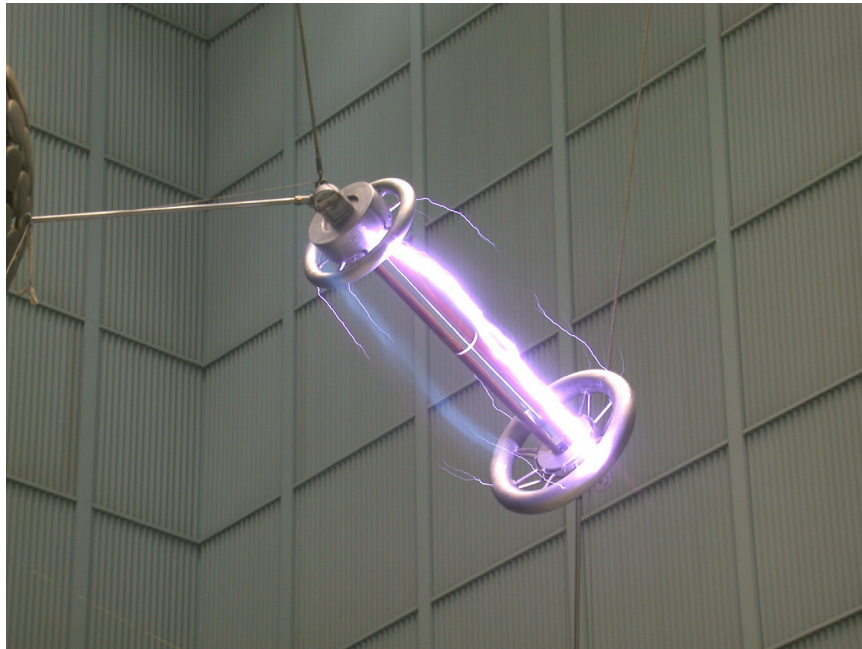
Figure 2. Cutler safety core test at Hydro Quebec.

The Hydro Quebec tests were performed on both the safety core insulator by itself and with the two large corona rings that had been left in place at Cutler from the original long string of fail-safe insulators. For these tests, the porcelain tube of the safety core insulator was replaced with a plastic see-through tube. The test report [5] contains pictures of every flashover for these tests. Figure 2 shows one of these pictures for the safety core insulator by itself.

In Figure 2, note that the streamers in the air from ring-to-ring have not quite made connection, while the flashover path down the surface of the insulator has been completed. Also, note that the surface flashover path appears to terminate at the porcelain metal interface of the smaller corona ring (upper end). Lightning simulators of the type used at Hydro Quebec simulate the full threat voltage waveform that might be generated by a lightning strike, but they do not provide the full threat current. Consequently, the flashovers along the surface did not cause any damage inside or outside the insulator.

This figure includes the 6-MV/ $\mu$ s curve where flashover just started to occur on the leading edge of the pulse. The next curve, 7 MV/ $\mu$ s, is where flashover began occurring on the surface. The picture in Figure 16 shows the flashover path observed for this level of  $dV/dt$ . At greater values of  $dV/dt$  the flashover path was entirely along the surface (Figure 2).

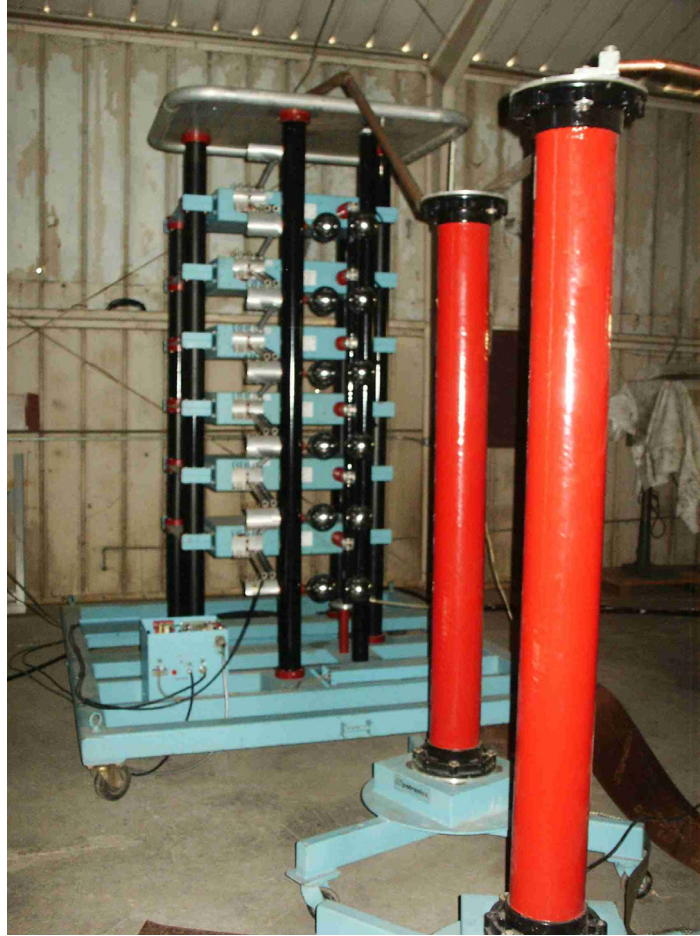
Figure 3. Hipotronics Impulse Generator.

The EBHVTF has an impulse lightning tester that is rated at 600 kV peak. The Hipotronics IG-600 Impulse Generator (IG) was purchased by the Navy Facilities Engineering Service Center around 1989. It was unboxed, cleaned, reassembled, and readied for use in the “barn” at Dixon. Figure 3 shows the impulse generator in the background. The red vertical tubes in the foreground contain a capacitor load and resistive voltage divider.

The IG is a six-section Marx generator. Each stage has a capacitor that can be charged to 100 kV DC, but under normal operations is limited to a maximum charging voltage to 80 kV DC. The IG has a selection of resistors that can be installed in various combinations to produce impulse waves of desired front (rise) and tail (decay) rates. We started with front resistors of about 15 ohms (25 || 50) and tail resistors of about 150 ohms (200 || 450), which provided a standard pulse of 1.2 x 50  $\mu$ s. Later, we changed the front resistors to about 7 ohms (25 || 10), which produced a rise time of about 0.8  $\mu$ s. Finally, we installed shorting bars for the front resistors, which produced a rise time of about 0.6  $\mu$ s. This is the fastest pulse this generator can produce.

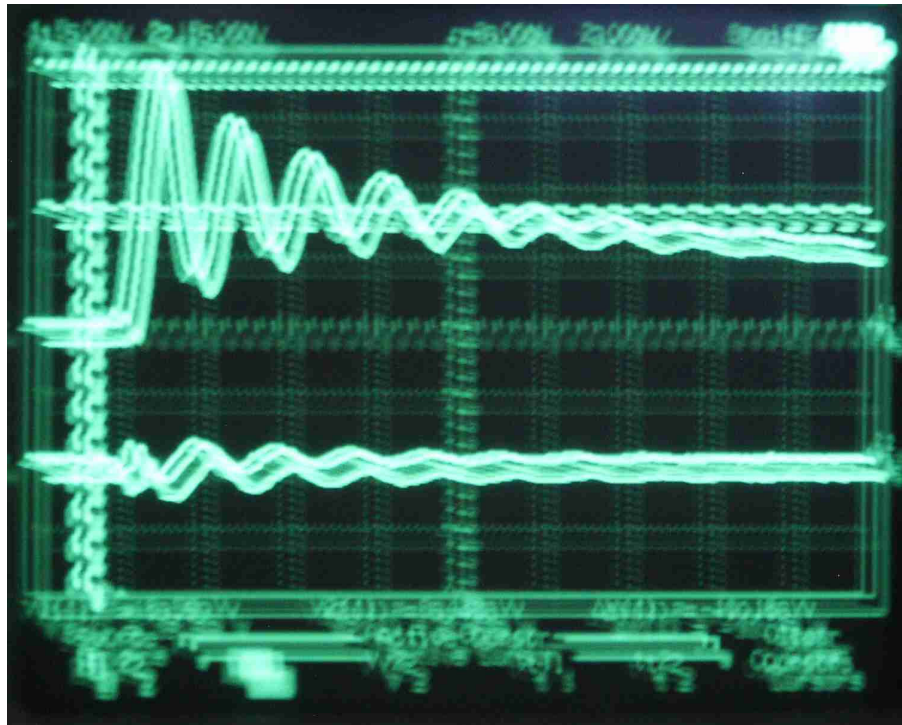
Figure 4. V and I with shorting bars for the front resistor, V below flashover. Flashover has not occurred.

With shorting bars in place of front resistors, the voltage wave displayed decaying oscillation. The rise time was about 0.6  $\mu$ s. Note that in Figure 4 that flashover has not occurred and the current shown is leakage current.

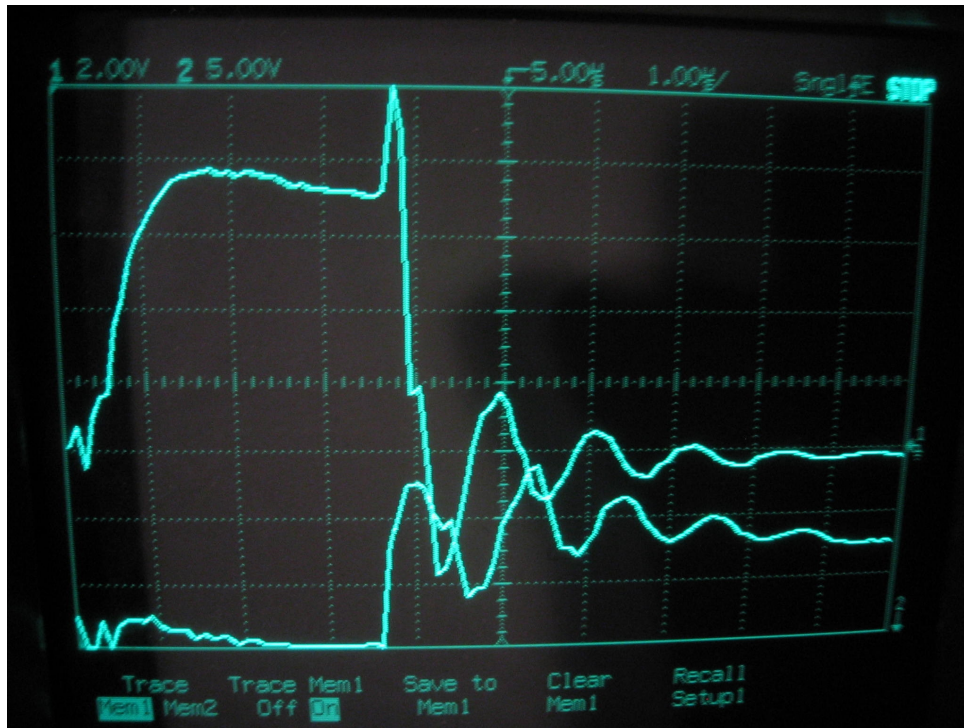
Figure 5. V and I with shorting bars for the front resistor, V just above flashover. Flashover occurs well after voltage peak.

As the charging voltage is increased, the first flashovers occur well after the voltage peak. Figure 5 shows an example of the voltage and current waveforms for that condition. The large peak in the current waveform at the same time that the voltage waveform is cut off is the evidence of flashover. The current rings down as an exponentially damped sine wave.

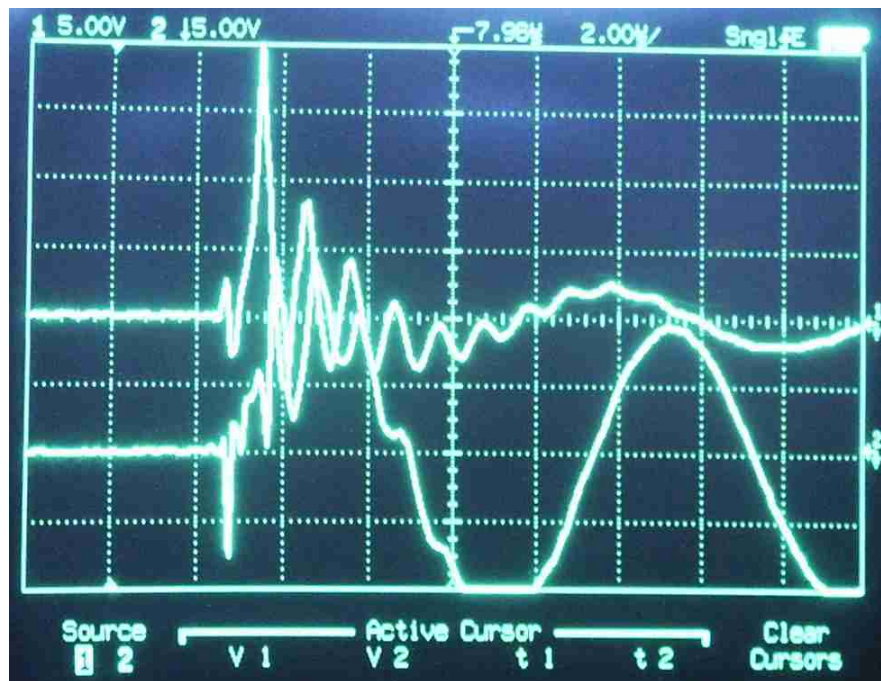
Figure 6. V and I with shorting bars for the front resistor, voltage well above flashover. Flashover occurs on leading edge of pulse.

As the charging voltage is raised further,  $dV/dt$  increases and flashover occurs earlier in the pulse so that the current peak and voltage drop move to the left. At sufficiently high  $dV/dt$ , flashover occurs on the leading edge of the voltage waveform before it reaches the maximum peak. An example of this is shown in Figure 6.

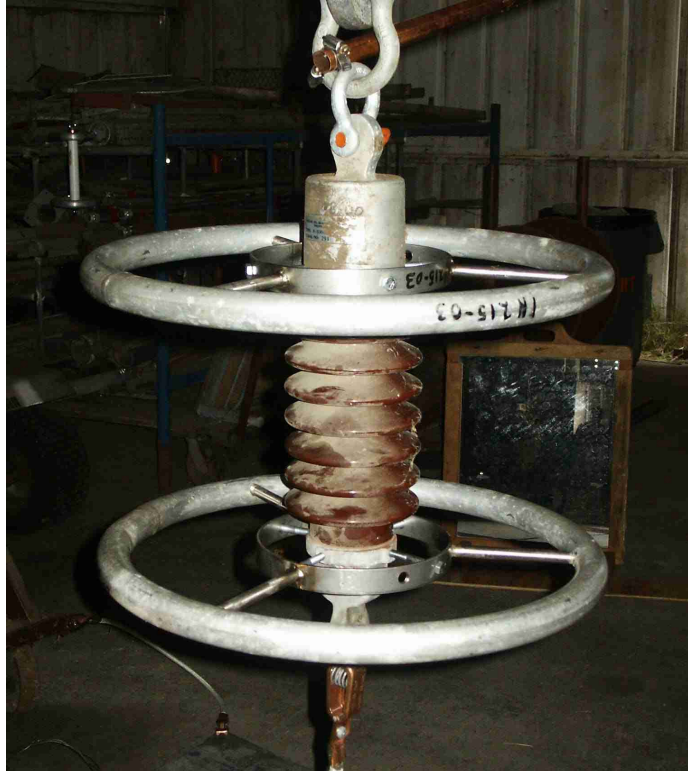
Figure 7. Austin A-S3003S safety core insulator with two large rings.

This configuration (Figure 7) was hit with a series of pulses starting with a charging voltage of 10 kV/stage and ending with 80 kV/stage. When there was no flashover, the peak voltage reached more than six times the charging voltage due to the circuit ringing. No flashover was observed for charging voltages up to 30 kV/stage (~200 kV peak).

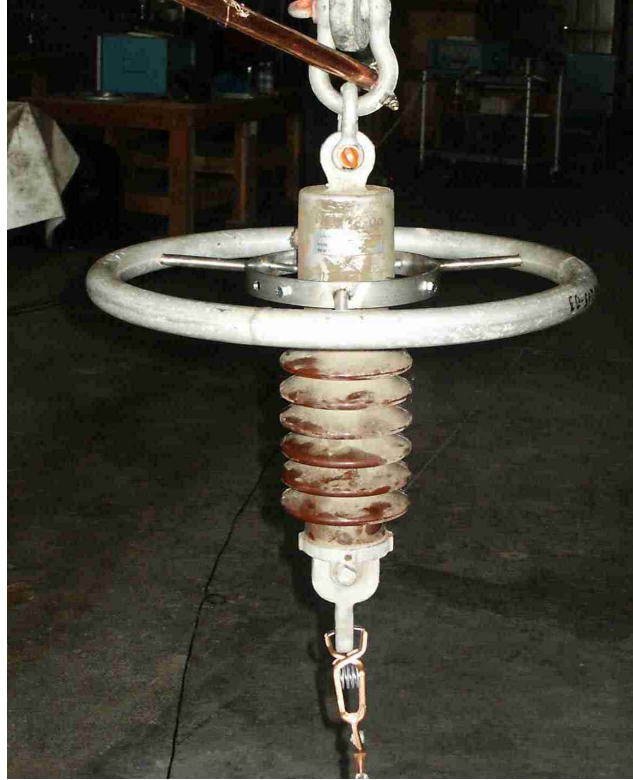
Figure 8. Insulator with bottom ring removed.

We removed the bottom ring from the insulator to see if the flashover path would then move to the surface of the insulator (Figure 8).

This configuration was hit with pulses starting with 10 kV/stage charging voltage and ending with 80 kV/stage. At 30 kV/stage ( $\sim 200$  kV peak), the insulator flashed over on roughly half the pulses, and it flashed over consistently at 35 kV/stage ( $\sim 230$  kV peak). When the voltage reached 50 kV/stage ( $\sim 333$  kV peak) and above, the flashover appeared to be along the insulator's surface.

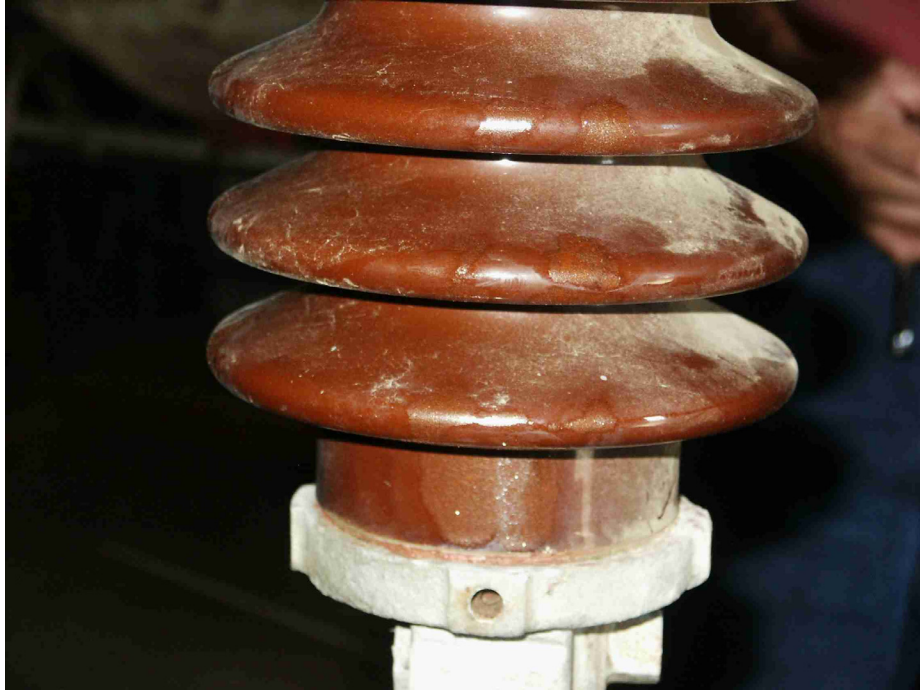
Figure 9. Insulator showing damage to glaze.

After shutting down and grounding the apparatus, we inspected and found the flat area near the lower end casting and a fingertip-sized area on the tip of each rain shed where the porcelain's glaze appeared to have melted and re-solidified. This is shown as slightly lighter-colored brown areas on the right-hand side of the bottom sheds shown in Figure 9.

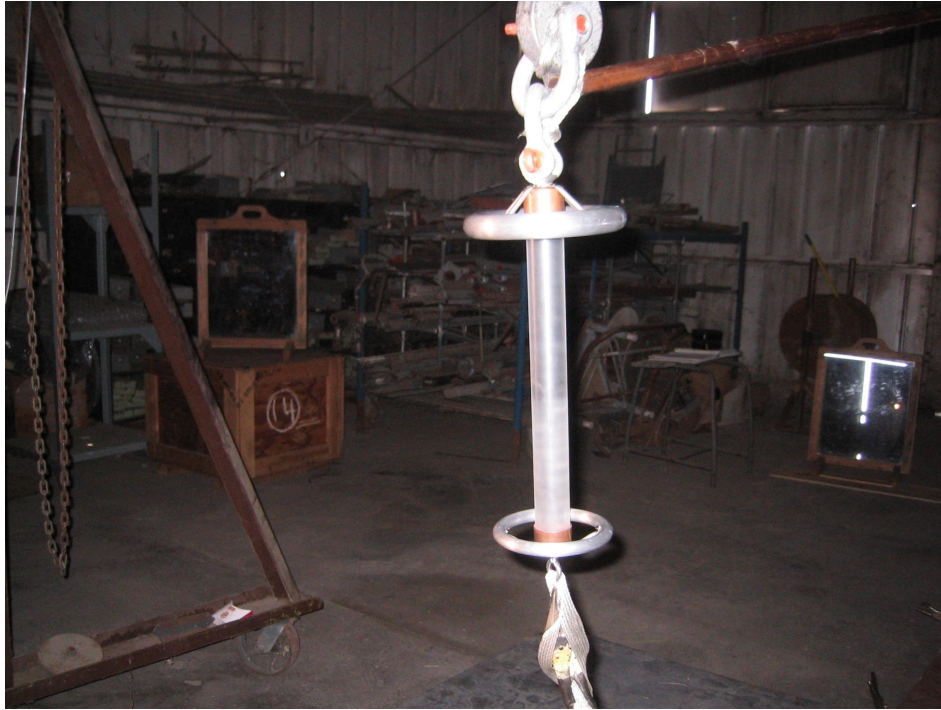
Figure 10. 1/7<sup>th</sup> Scale model of the Cutler safety core insulator.

Model insulators were constructed using a scale factor of 1/7 that of the Austin Insulators Inc. safety core insulators in place at Cutler. During the first test period, we did preliminary tests with a scale model of the Cutler insulator made from a hollow PVC pipe (1 inch diameter), with copper end fittings, aluminum rings, and attaching hardware. With high dV/dt pulses, this model flashed over inside the PVC pipe, blowing off the end-caps.

For that reason, we constructed the remaining scale model insulators using similar copper end fittings and aluminum rings and attaching hardware but replacing the hollow PVC pipe with a solid polycarbonate rod. The polycarbonate plastic rod makes an excellent insulator. This material is similar to the material used for the see-through body of the full-scale insulator tested at Hydro Quebec (Figure 2). The specifications for the plastic in this insulator are given in Appendix A: Polycarbonate Plastic Specification. The scale model of the Cutler insulator suspended in place for testing is shown in Figure 10.

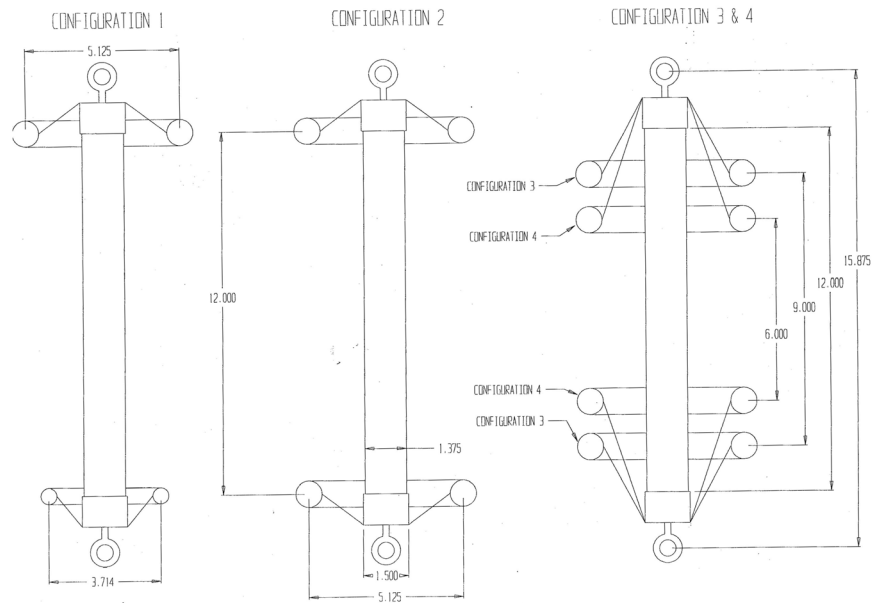
Figure 11. Scale model insulator configurations tested.

Configuration 1, on the left in Figure 11, is a drawing of the scale model Cutler insulator pictured in Figure 10. Configuration 2, in the center of the figure, is similar, but the small ring at the grounded end has been replaced with a larger ring, making it symmetric. This configuration has only slightly less air gap than configuration 1.

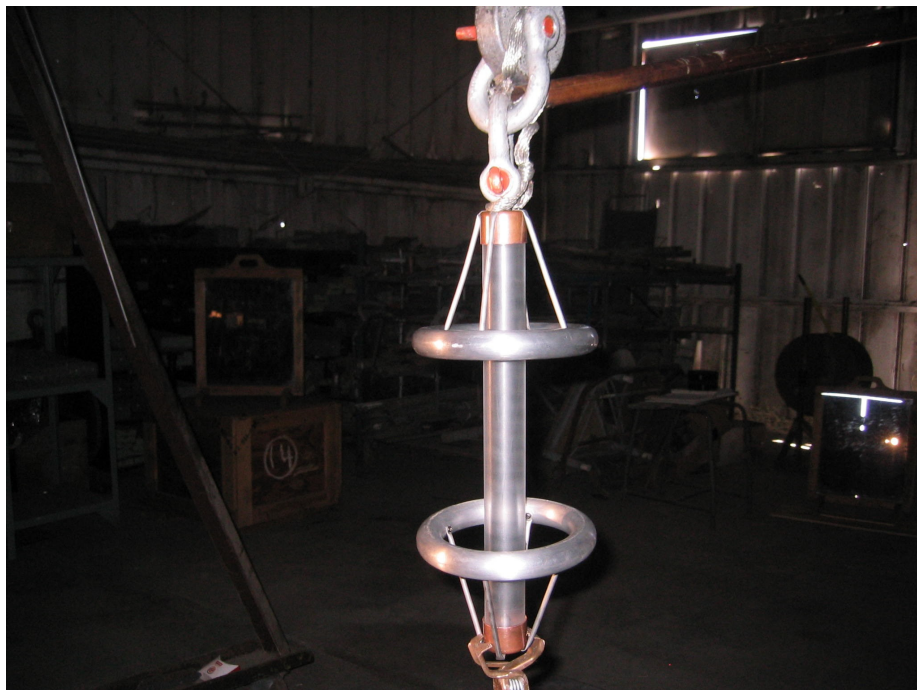
Figure 12. Configuration 4 test sample in place.

Configuration 4 is similar to configuration 3 except that the rings are moved closer together so that the air gap is reduced to 1/2 that of configuration 2. A test sample of configuration 4 is shown in Figure 12.

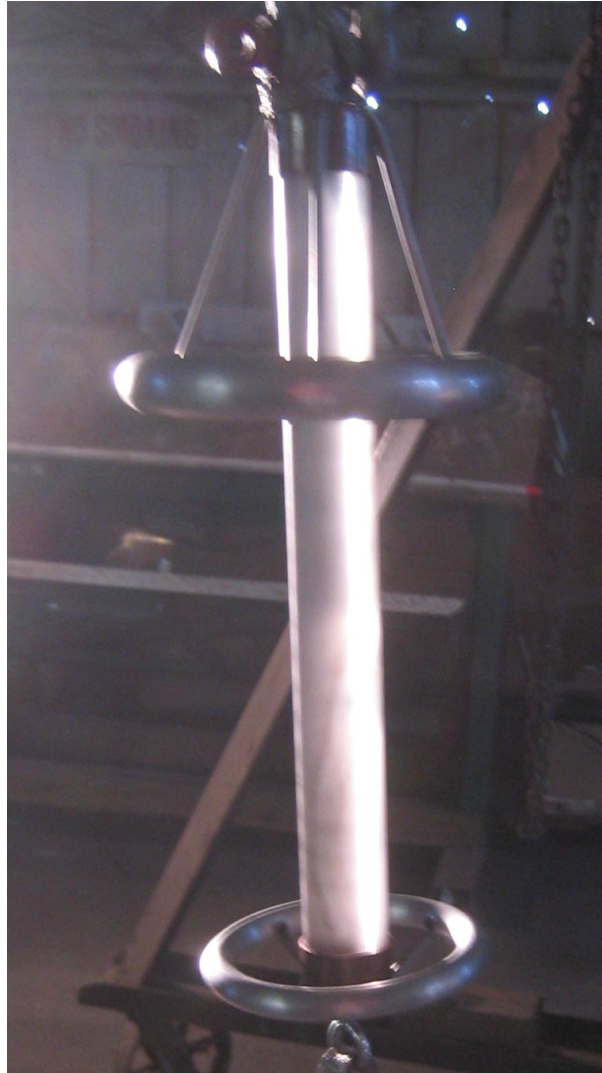
Figure 13. Configuration 5 showing the effect of surface flashover.

A fifth configuration was tested (not shown in Figure 11) using the high-voltage end ring of configuration 4 and the low-voltage end ring the same as that on original Cutler insulators. The air gap distance for this configuration is reduced by approximately 1/4 that of configuration 2. This configuration is shown in Figure 13.

By serendipity, we discovered there was a slight modification of the surface of the plastic when flashover occurred along the surface. This was not a carbon track but a slight distortion of the surface, probably caused by surface melting that could be seen upon close examination of the polycarbonate plastic. The surface distortion was apparent when the polycarbonate rod was viewed up close with the back lighting in the test cell, and it can be seen by close examination of Figure 13. The test procedure was modified after this was discovered.

Configuration 5 is shown in Figure 13 and Figure 15. This configuration performed similar to the configurations 1 and 2 in that as the charging voltage ( $dV/dt$ ) increased, the flashover path transitioned from being in the air to going along the surface. However, in this instance the surface path was only along a portion of the insulator, a partial surface flashover.

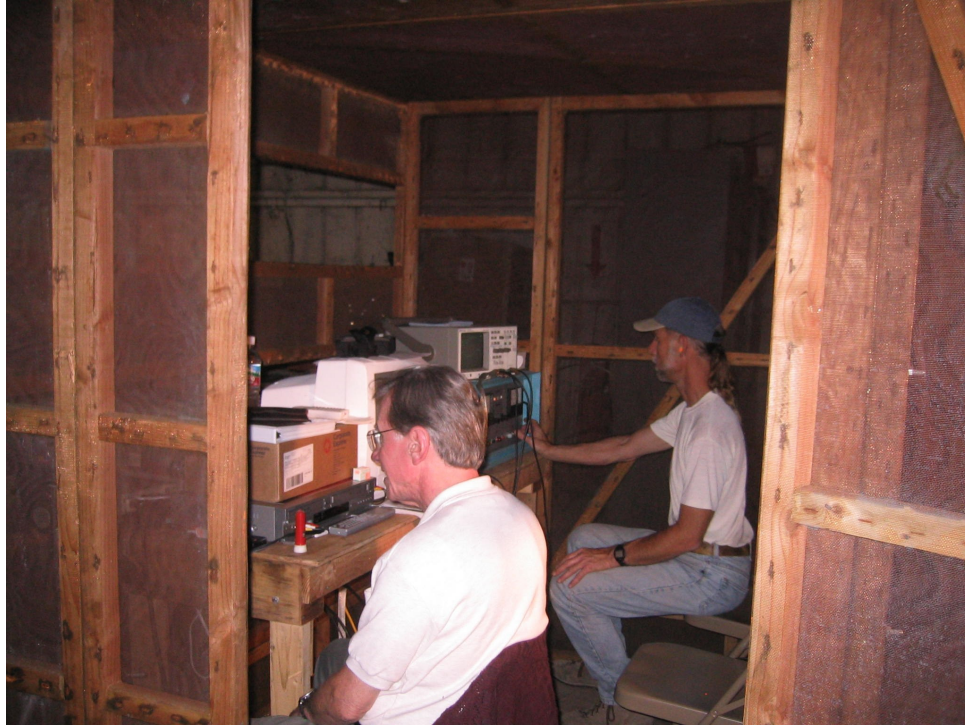
Figure 14. Portable screen room used for testing.

During the first test period, we had some trouble with induced voltages from the large current flashovers getting into our equipment. In particular, we damaged a special Lecroix storage oscilloscope and had to revert to a Hewlett-Packard® digital storage scope. Also, the noise from the larger current flashovers was very loud. For the second test, we set up a portable screen room about 50 feet away from the test object and grounded all our equipment carefully. Earplugs were provided to all the observers. The portable screen room is shown in Figure 14. The Hipotronics control console and the digital scope can be seen on the right-hand end of the table. The video recording equipment can be seen at the left-hand end of the table.

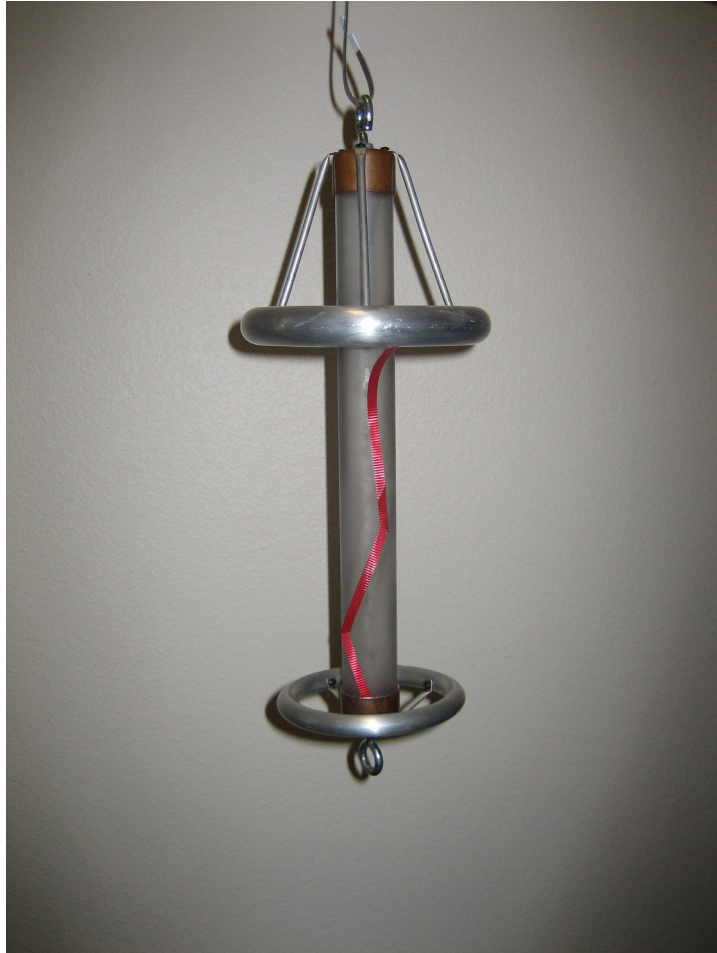
Figure 15. Configuration 5 insulator model with highlighted flashover path.

The flashover path for this insulator started on the large ring and went from there through the air to the surface of the polycarbonate rod and then down the rod to the grounded end, terminating at the triple point formed by the edge of the copper end-cap. The lower portion of the surface flashover path can be seen on the insulator surface in Figure 13. Figure 15 shows the model insulator with the flashover path highlighted by a ribbon.

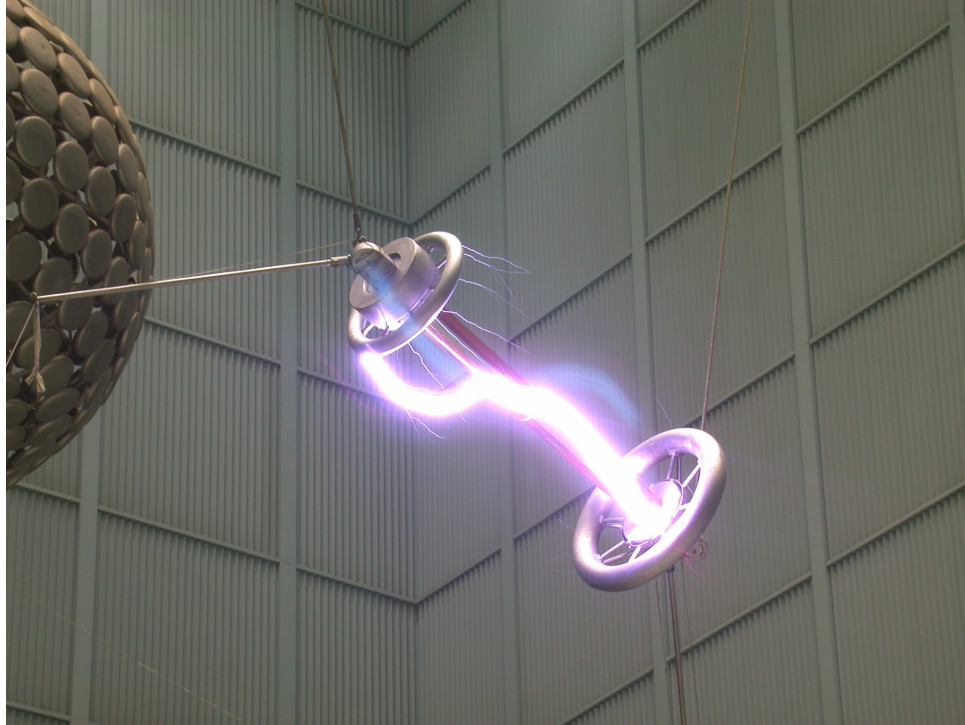
Figure 16. Cutler insulator at Hydro Quebec showing partial surface flashover.

Note that on the high-voltage end the arc starts on the ring and then goes to the insulator surface, terminating on the triple point at the low-voltage end of the insulator. This same type of behavior was observed in the full-scale testing at Hydro Quebec. During that test, at  $dV/dt$  levels where the flashover path was transitioning from being in the air to going completely along the surface, some flashovers seemed to start from the big ring and then dive down to the surface of the insulator body. An example of this is shown in Figure 16.

It is interesting to note in Figure 16 that the surface termination point of the arc is at the triple point on the high-voltage (large ring) end of the insulator.

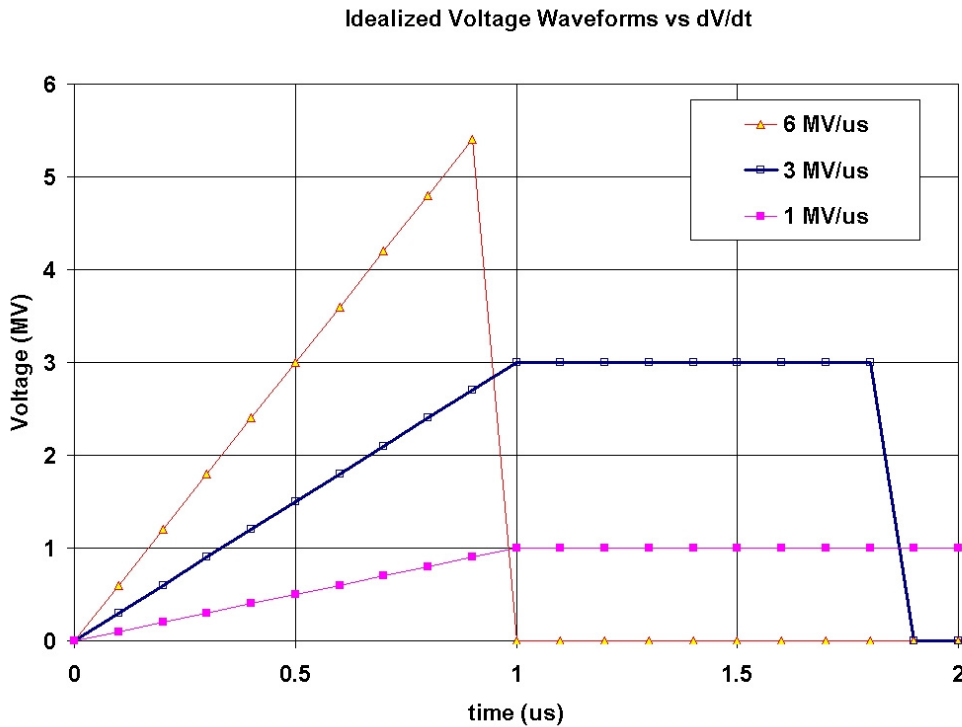
Figure 17. Flashover phenomena for low  $dV/dt$  waveforms.

Figure 17 shows several idealized waveforms that illustrate what happens when the insulator is hit with a voltage impulse. The waveforms are labeled in terms of the slope of the leading edge ( $dV/dt$ ) in  $MV/\mu s$ .

At low values of  $dV/dt$ , flashover occurs well after the peak of the waveform. The  $1 MV/\mu s$  curve has a peak voltage of 1 MV. This was the threshold for flashover in the Hydro Quebec tests. At that level, flashover did not occur until almost  $10 \mu s$  after the waveform started (off scale to the right in the figure). As  $dV/dt$  increases, the delay to flashover in air reduces. This can be seen in the curve for  $3 MV/\mu s$  curve, which is similar but the delay is less, with flashover occurring at  $1.8 \mu s$ . When  $6 MV/\mu s$  is reached, flashover occurs on the leading edge of the pulse and the peak pulse voltage is reduced over what it would be if flashover had not occurred.

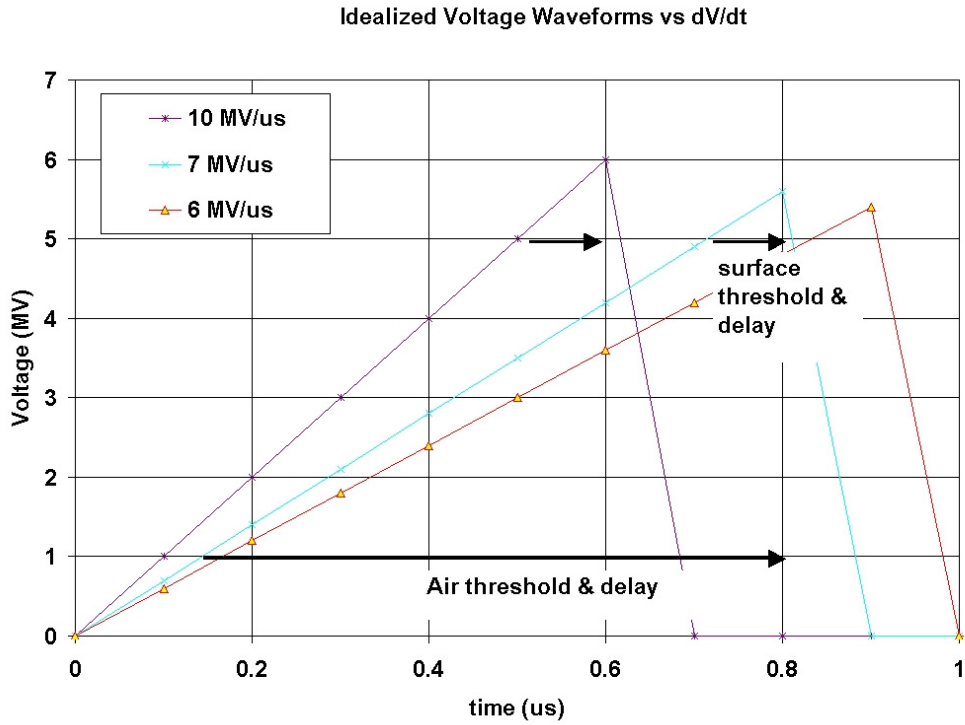
Figure 18. Flashover phenomena for high  $dV/dt$  waveforms.

Figure 18 shows similar waveforms, but with high values of  $dV/dt$ .

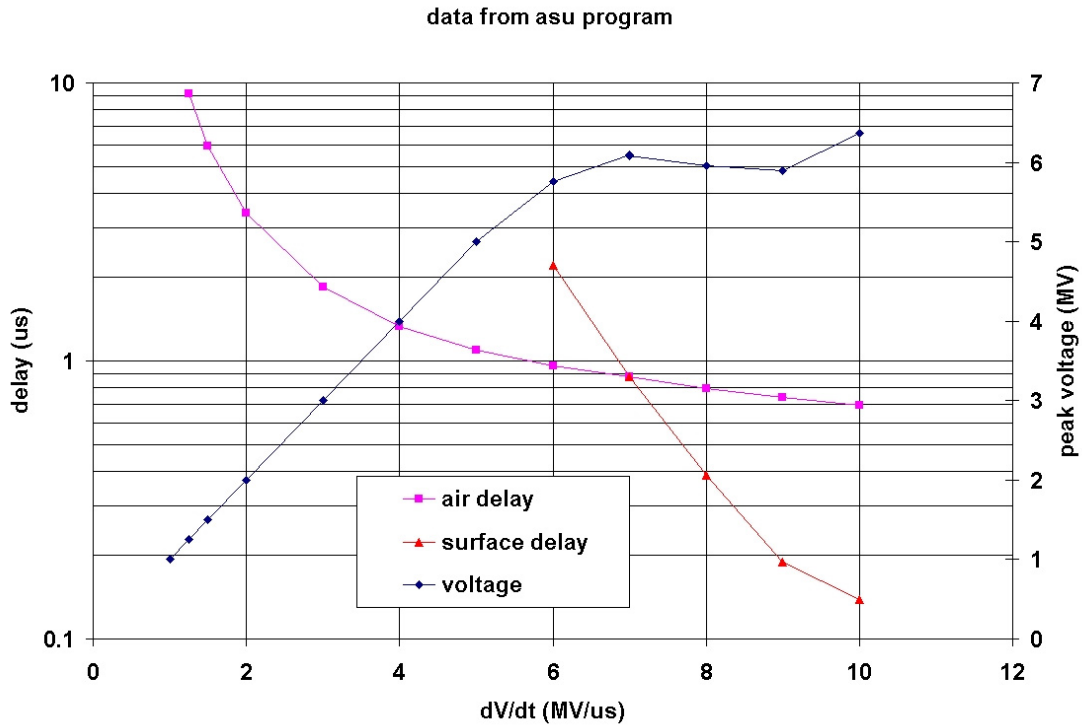
Figure 19. Delay and peak voltage for air and surface flashover.

The time delay of the leaders across the gap is a function of voltage. The delay decreases with increasing voltage until it reaches a minimum determined by maximum leader velocity. Figure 19 shows the delay for the air gap flashover from pulse initiation as a function of  $dV/dt$ . The data were generated using the computer program written by Monga [11].

The threshold for air breakdown was a peak pulse voltage of 1 MV, corresponding to  $dV/dt$  of 1 MV/ $\mu$ s. The delay curve in the figure shows a corresponding time delay of 9  $\mu$ s. As the voltage increases, the delay decreases, asymptotically approaching a value of 0.6  $\mu$ s. The figure also contains a speculative curve for surface flashover assuming a threshold of 5 MV and an assumed delay curve. When  $dV/dt$  is less than 7 MV/ $\mu$ s, the delay of the air flashover is less than that for surface flashover and flashover occurs in the air. The voltages for air flashover are those from the program. However, when  $dV/dt$  is greater than 7 MV/ $\mu$ s, surface delay is less and flashover occurs on the surface. For this region, the peak voltage shown was estimated using the postulated threshold and delay curve shown. Under these assumptions, the peak voltage actually decreases in a range of  $dV/dt$  just above where surface flashover starts. This reduction in peak voltage was observed in the Dixon scale model tests.

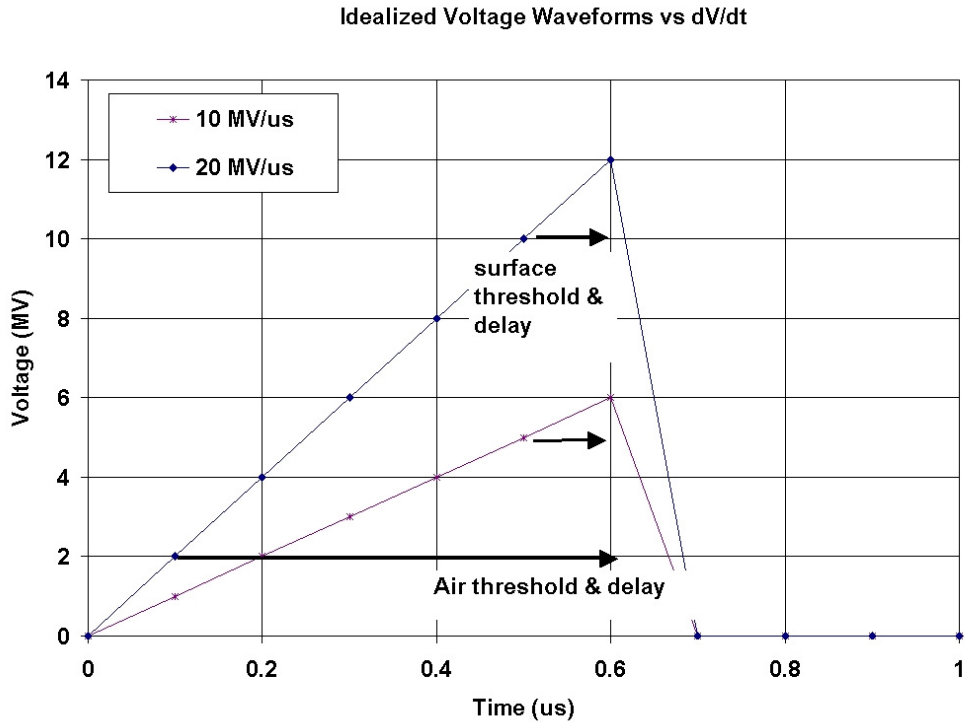
Figure 20. Flashover phenomena with increased surface flashover threshold.

The above explanation of the  $dV/dt$  surface flashover threshold phenomena leads to one potential method for increasing the surface flashover threshold by adding shielding around the triple points to increase the surface flashover initiation voltage. An example is shown in Figure 20, where the threshold for surface flashover has been increased to 10 MV. In this case, using the previously postulated delay, surface flashover will not occur until  $dV/dt$  reaches 20 MV/ $\mu$ s.

Note that very high dV/dt rates lead to very large voltages across the insulator. For example, in Figure 20 the peak voltage experienced would be 12 MV. This voltage does not last long but there may be failure mechanisms that can result from this voltage. For example, dielectric punch-through happens fast, and this could result when the voltage is high enough even though it was there for a very short period. Computer analysis of the cutler safety core insulator interior was done to examine the possibility that breakdown could occur on the pin inside the high-voltage end-cap if enough oil leaked out to expose a portion of the pin to air [20].
