## The Northwest Tropical Atlantic Station (NTAS): NTAS-4 Mooring Turnaround Cruise Report

### Technical Report

Upper Ocean Processes Group  
Woods Hole Oceanographic Institution  
Woods Hole, MA 02543  
UOP Technical Report 2006-04

WHOI-2006-09

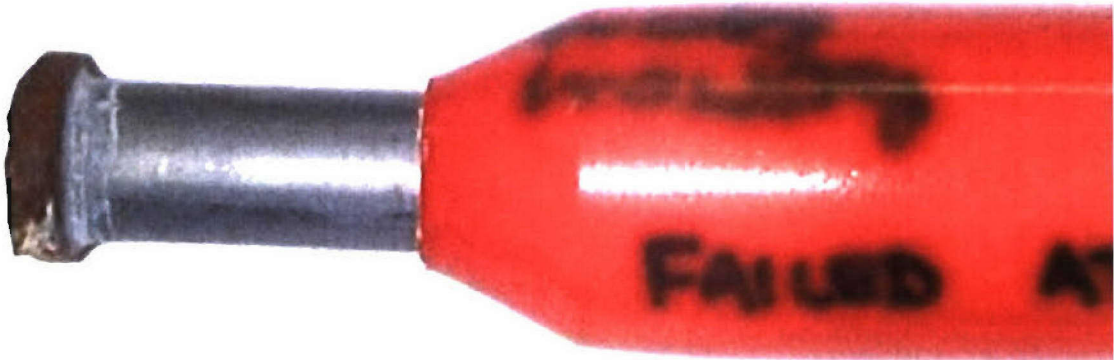
Figure 2. Photograph showing the shank section of the fractured swage socket.

(1) Visual/Macroscopic Examination: The returned swage socket consisted of the shank section still contained on a piece of covered wire rope with a special jacket (Enclosure A, Figures 1 and 2). The eye section of the socket was not returned. The fracture had occurred in the section below the eye and approximately 3/8 of an inch above the shoulder where the shank section terminates. The fracture surface was corroded and did contain evidence of fatigue (Enclosure B). The observed beach marks on the fracture surface had progressed through more than 1/2 of the cross sectional area before the final fracture occurred. The fracture had initiated on one side below the eye and propagated perpendicular to the plane of the eye. There were no legible markings observed on the returned section of the socket. The shank section was not corroded and still contained the galvanize coating. A measurement taken on the outside diameter revealed that it had been swaged to the specified catalog maximum dimension for a 1/2 inch socket.

Discussion: The analyses performed on the shank section from the fractured socket revealed that it had been forged from the specified steel type and had been properly heat treated. The fracture surface from the socket contained evidence of a fatigue fracture. The beach marks indicated that the final fracture had occurred when there was less than  $\frac{1}{2}$  of the original cross section remaining. It appears, based on the beach marks, that the socket had been subject to a high cycle, low stress loading condition. The location of the fracture also appears to indicate that the socket was subjected to some side loading, possibly from restraint in a clevis attachment. The eye section of the socket was not returned. The pertinent markings are located on the eye section of the socket. Without a product identification code, the age of the socket could not be determined.
