<b>4. TITLE AND SUBTITLE</b>  Fabrication and Evaluation of Ceramic Microtubes by Extrusion of Pre ceramic Polymers	<b>5a. CONTRACT NUMBER</b> FA8655-04-1-3055
	<b>5b. GRANT NUMBER</b>
	<b>5c. PROGRAM ELEMENT NUMBER</b>

**European Office for Aerospace Research and Development**

**Final Report  
Report 4**

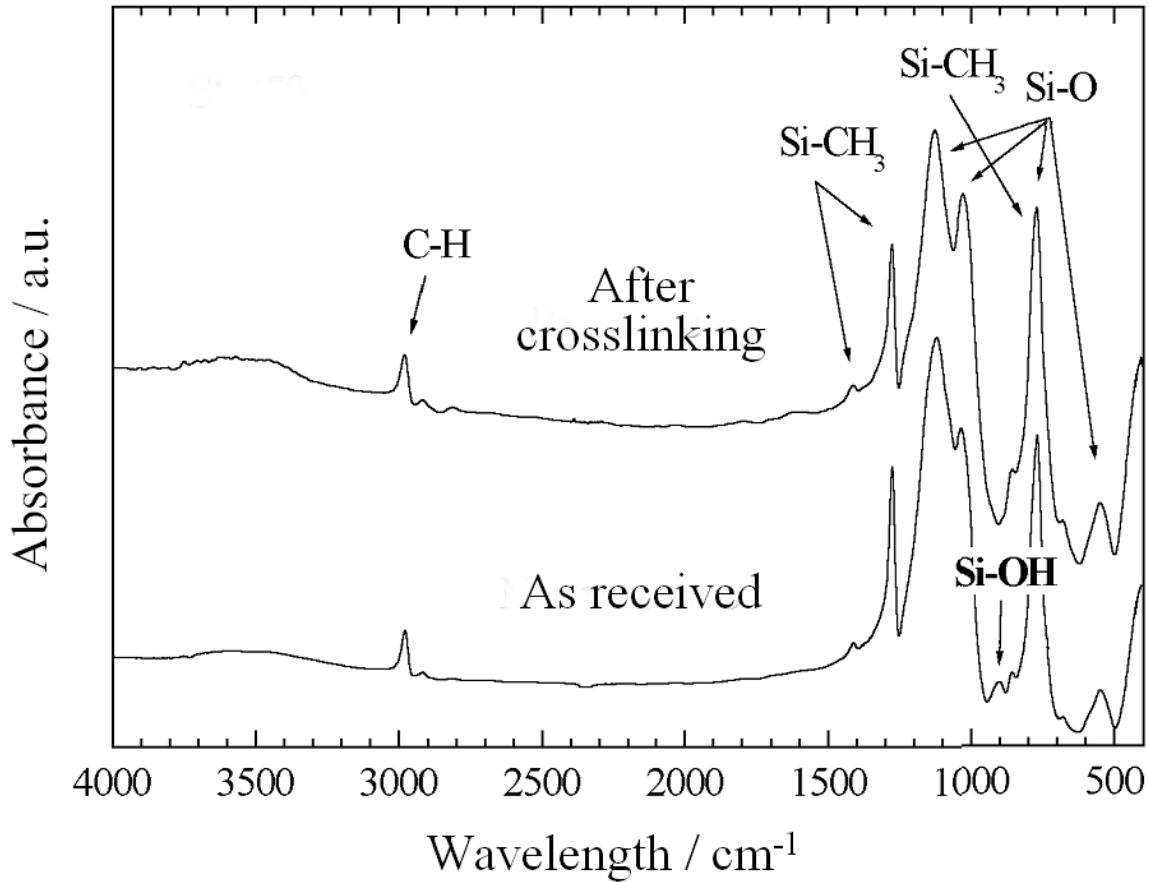
Figure 22. FTIR spectra of a silicone resin microtube before and after cross-linking. Note the disappearing of the Si-OH band.

The silicone resin chosen can crosslink via the condensation of Si-OH groups (which are contained in the amount of about 5%), and the achievement of the cross-linking can be monitored for instance by FTIR. In Figure 22 are reported the FTIR spectra for the as received preceramic polymer and after cross-linking (crushed microtubes, after elimination of the Filler #2 core), showing the elimination of the Si-OH band at about  $900\text{ cm}^{-1}$ , which is present in the fresh silicone resin. As a general comment, it has also to be observed that this class of silicone

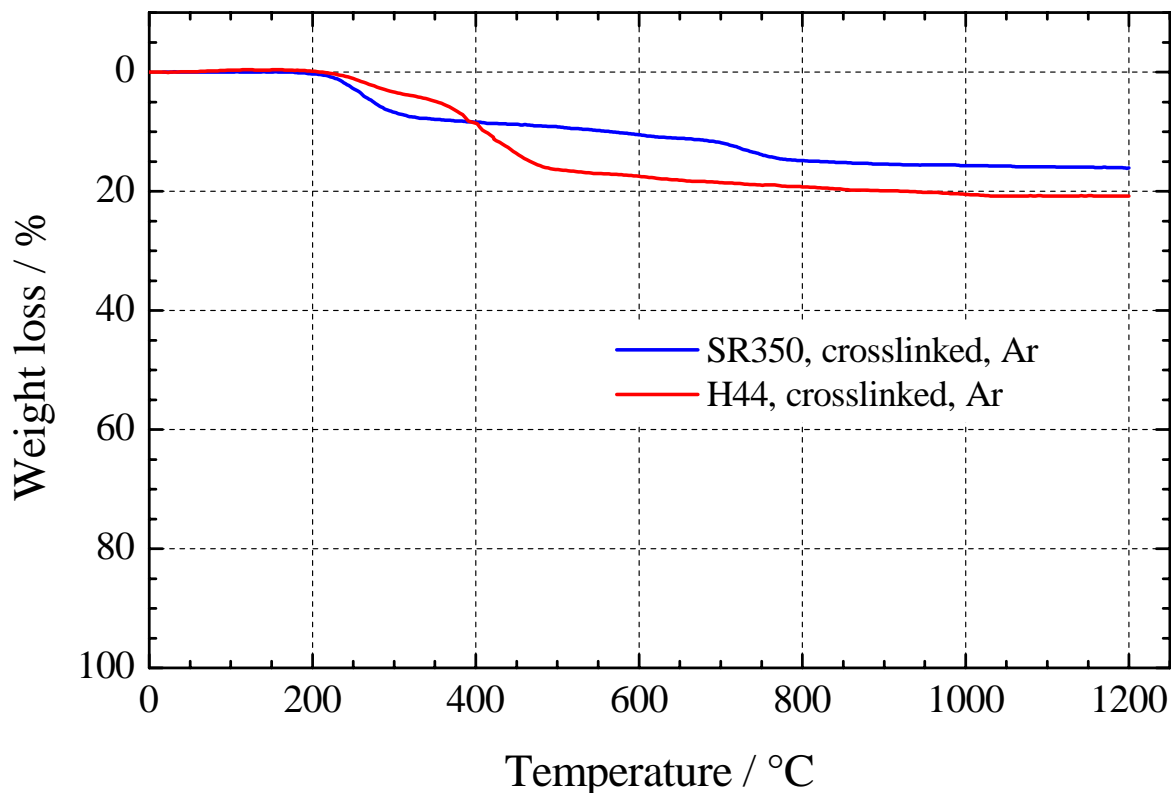
Figure 25. TGA curves for the various preceramic polymers

The TGA data for the preceramic polymers used (SOC-A35 and H44) is as well of great importance, and was obtained under the same conditions on powders that were cross-linked following the procedure adopted for the microtubes. The results are reported in Figure 25.

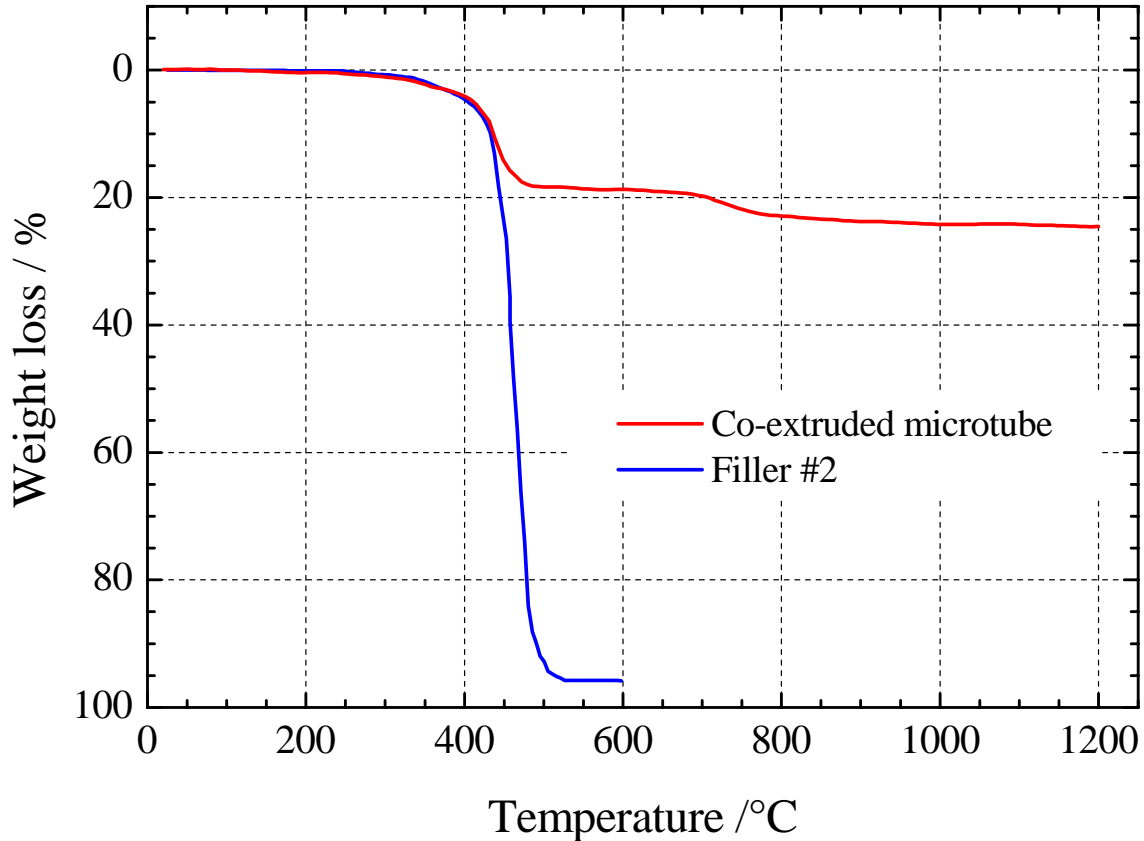
Figure 26. TGA curves for a co-extruded microtube and the filler used (#2)

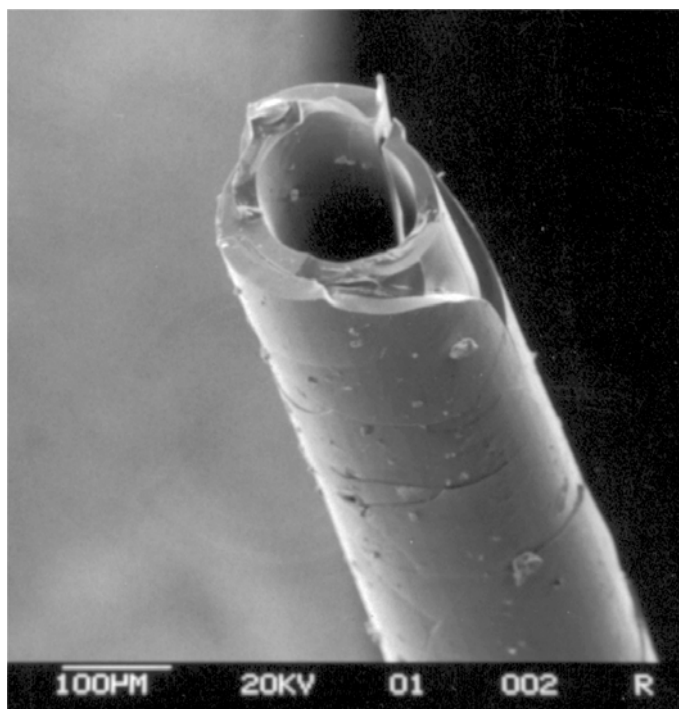
Figure 28. SEM image of a co-extruded microtube not well cross-linked, after pyrolysis (SOC-A35 and filler #2)

As it can be seen, depending on the cross-linking conditions, some defects would be generated upon pyrolysis, including swelling (see Figure 27) and the presence of layers separated by cracks (see Figures 28 –30). Swelling is due to partial bloating/melting of the insufficiently cross-linked polymer upon pyrolysis, while the presence of layers is probably due to the fact that, if only the external surface of a preceramic polymer microtube is sufficiently cross-linked, one can expect a different behavior upon pyrolysis, leading to a differential shrinkage between external surface and the rest of the component. All these defects lead to cracks and unusable ceramic components.

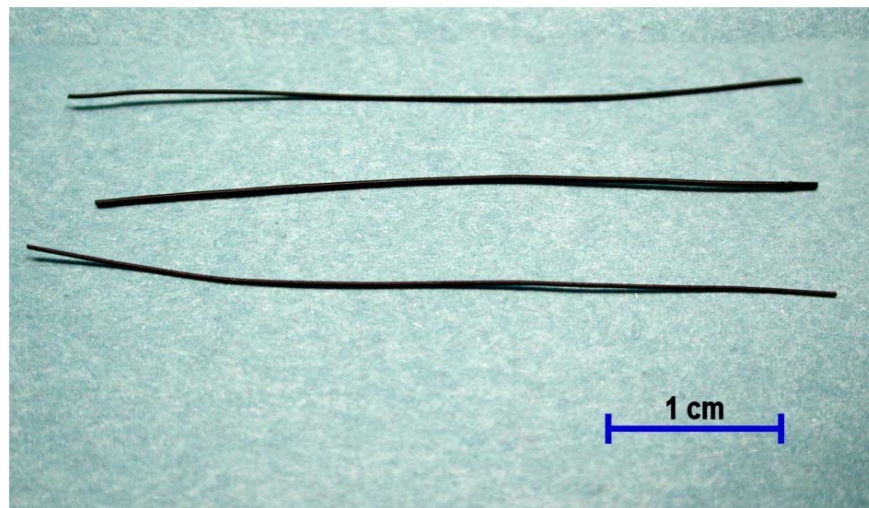
Figure 31. Digital picture of co-extruded single-lumen microtubes after pyrolysis (SOC-A35 and filler #2).

The pyrolyzed samples were characterized using digital photography, and optical or SEM microscopy. All the analysis reported here refer to samples obtained using SOC-A35 and Filler #2, pyrolyzed at 1200°C, as no morphological difference was observed among samples pyrolyzed at lower temperature (800 or 1000°C). In figures 31 and 32 are reported some images of pyrolyzed, single-lumen, co-extruded microtubes. Their black color is due to the fact that they're made of a silicon oxycarbide ceramic material (see later).

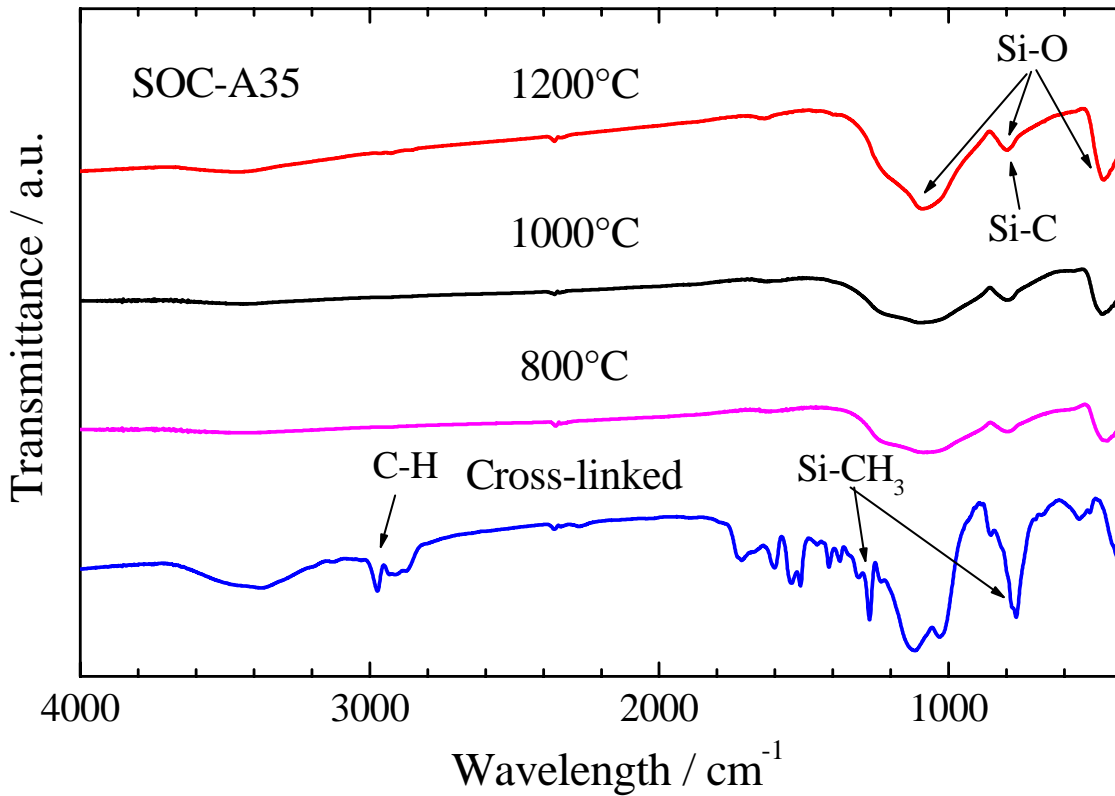
Figure 48. FTIR spectra of co-extruded single-lumen microtubes after pyrolysis (SOC-A35) at various temperatures.

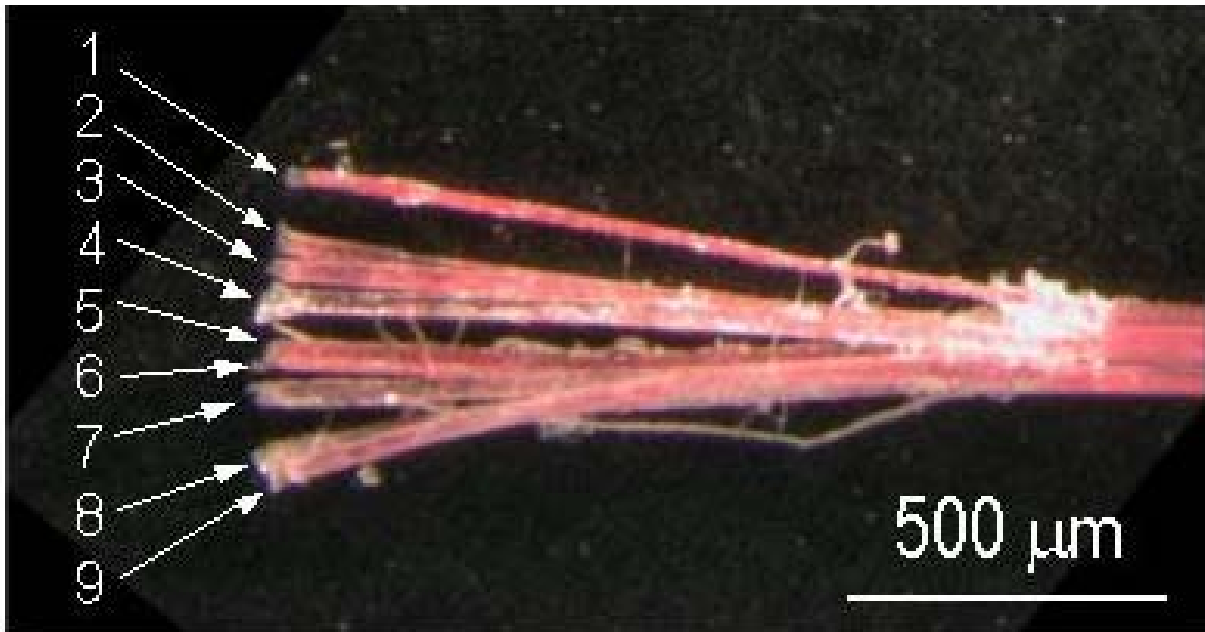
Figure 61. Optical stereo-microscopy image of a multilumen preceramic silicone resin microtube (SOC-A35, Filler #2, red coloring agent)

In this image, it is possible to distinguish 9 separate, individual sacrificial filler filaments embedded in the silicone resin microtube. The filaments appear to have a similar thickness, of about 30-50  $\mu\text{m}$ . The overall thickness of the microtubes, before pyrolysis, appears to be in the ~400-600  $\mu\text{m}$  range.

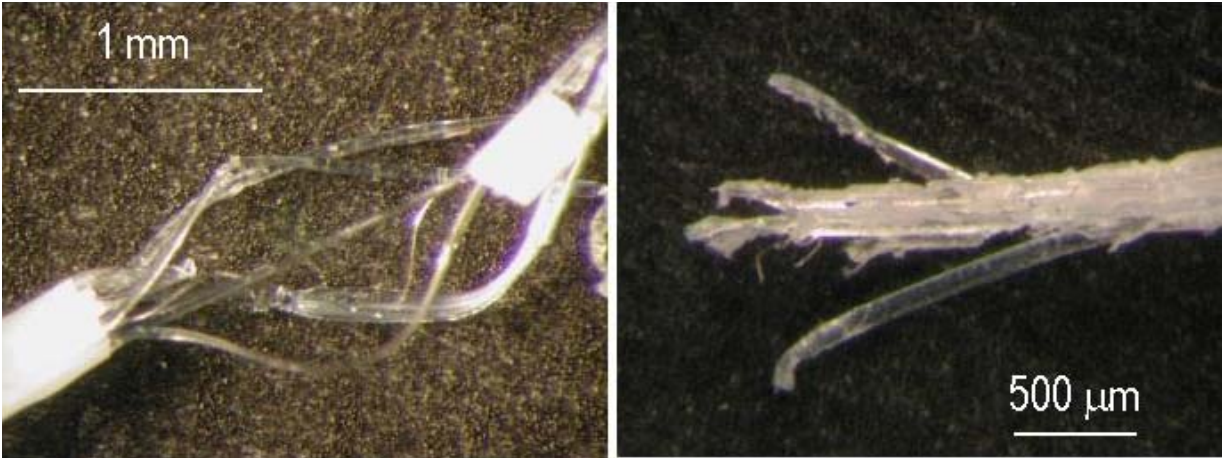
Figure 66. Optical stereo-microscopy image of multilumen preceramic silicone resin microtubes (H44, Filler #2, no coloring agent)

Figure 66 shows how microtubes containing several filaments of the sacrificial filler (Filler #2) were indeed fabricated using the H44 silicone resin. Again, in some cases it appears that some of the strands are partially joined together (see for example Figure 66, left, one of the bottom strands appears to have a size larger than the other filaments).

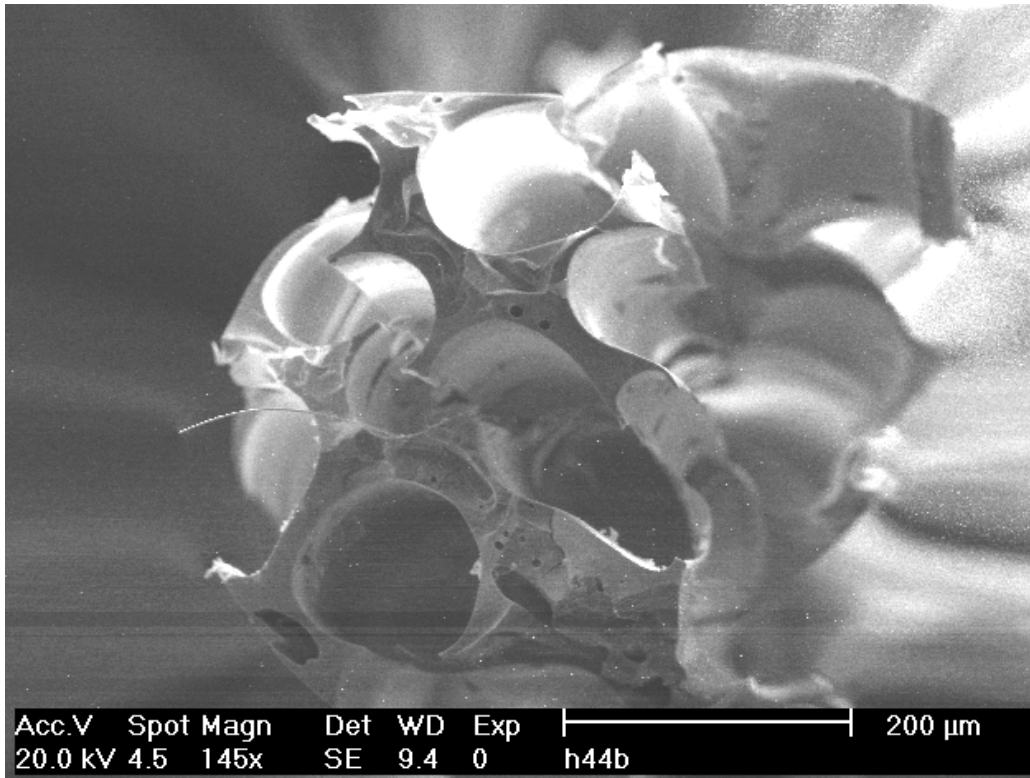
Figure 93. SEM image of a co-extruded multi-lumen microtube, after pyrolysis (H44 and filler #2)

Figure 92 and 93 show an example of ceramic microtubes in which most of the holes deriving from the decomposition of the sacrificial filler filaments were separated from each other, but some were too close to the edge of the microtube to avoid fracturing the surface upon pyrolysis. For the sample shown in figure 94 a similar effect occurred, and thus some grooves are present on the sides of the sample, with the lack of presence of the external layer of SiOC ceramic material. For the sample shown in Figure 95, one can clearly distinguish 9 holes, of different shape and size, with two of them being too close to the edge of the cross-section leading to a fractured surface. In Figures 96 and 97, again, samples in which the holes are clearly distinguishable are shown, with some of them being grouped together. The sample shown in Figure 98 was obtained in a later series of experiments (see paragraph 4.1), and the reported micrograph unmistakably indicates that the grouping of the filler filaments on one edge of the specimen in the preceramic stage led to an uneven distribution of the holes within the microstructure of the ceramic microtube (again, the filaments that were too close to the edge of the microtube led to the fracturing of the surface during pyrolysis).

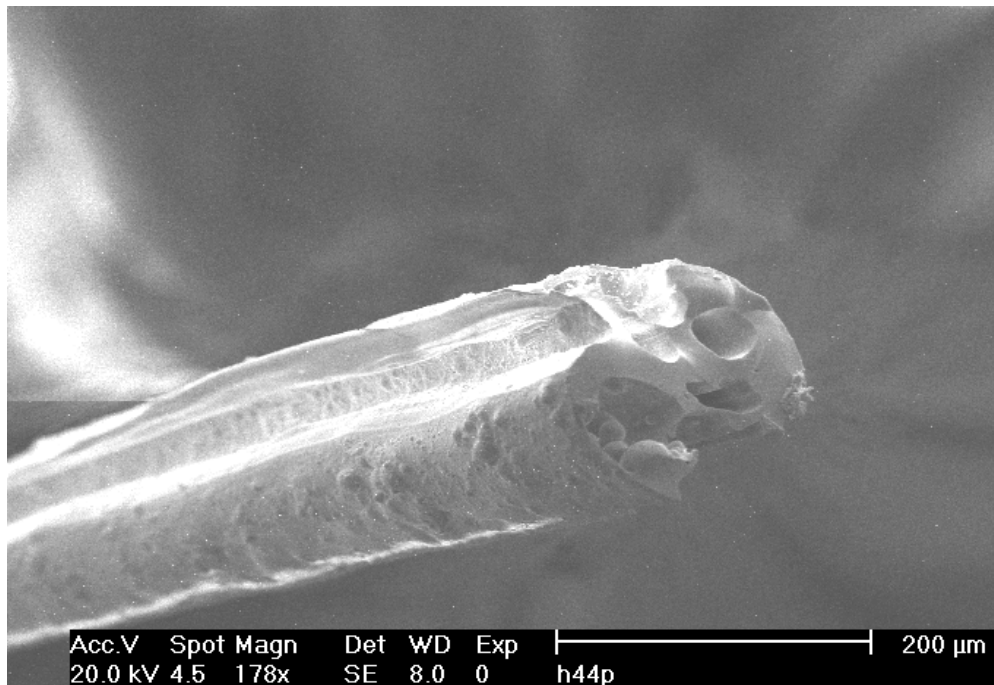
Figure 94. SEM image of a co-extruded multi-lumen microtube, after pyrolysis (H44 and filler #2)
