## Beach Erosion Mitigation and Sediment Management Alternatives at Wallops Island, VA

Andrew Morang, Gregory G. Williams, and Jerry W. Swean

September 2006

Final report

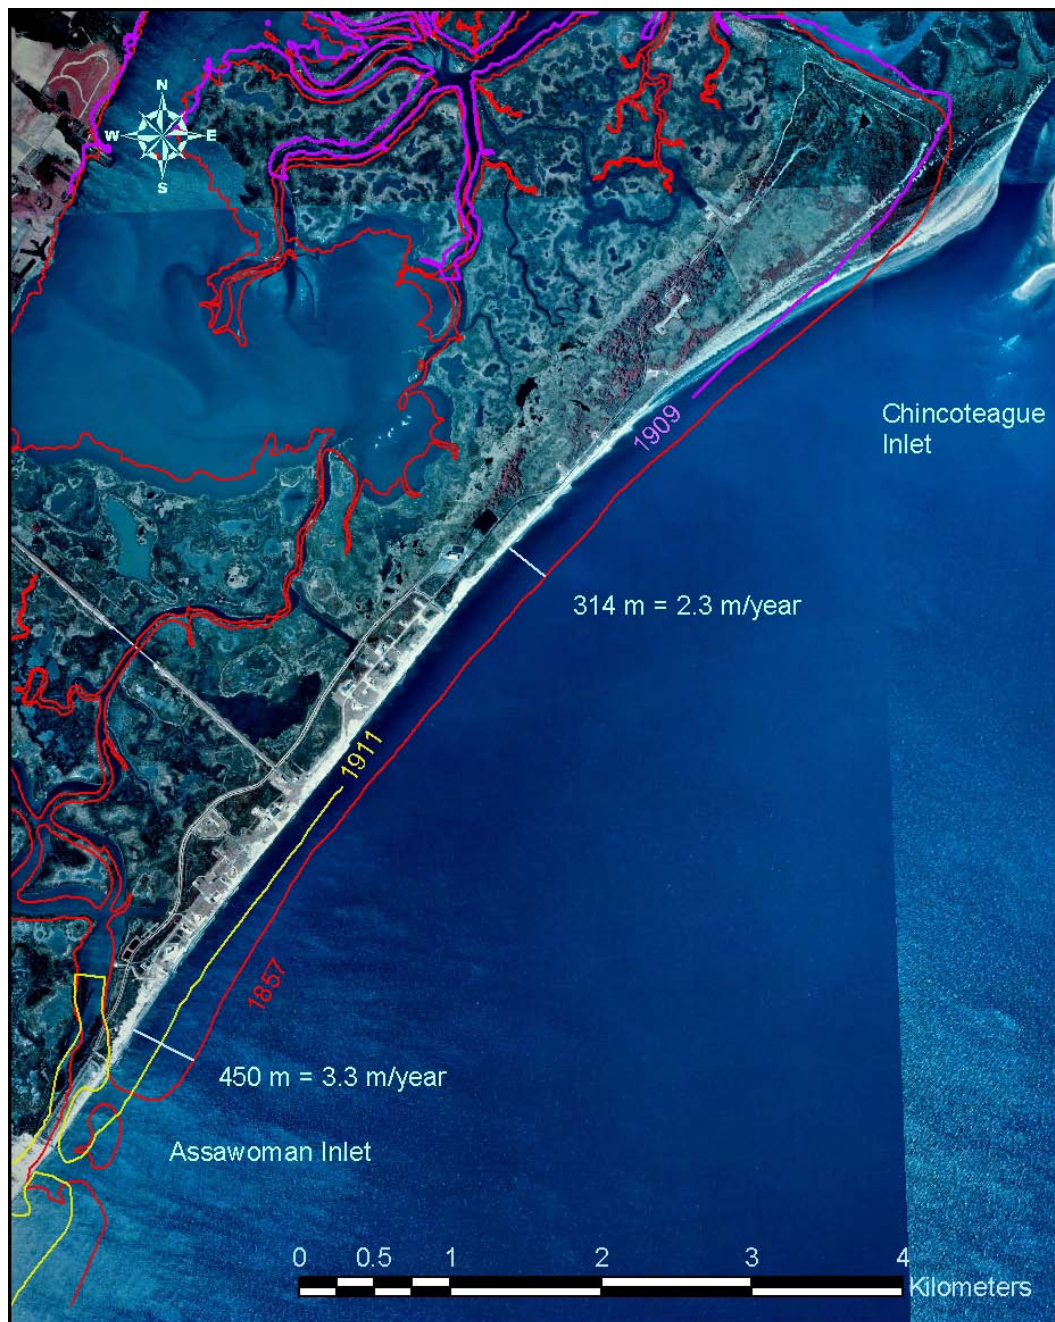
Figure 4. Shoreline changes at Wallops Island from 1857 to mid-1980s. Shoreline data from NOAA and state of Virginia. NASA's facilities are located on narrow sand strip. Aerial photograph: 1994 Digital Ortho Quarter Quadrangle downloaded from Virginia Economic Development Partnership.

From 1857 (the date of the first USC&GS shoreline) to 1994, the southern part of Wallops Island has retreated about 400 m (Figures 4 and 5). Based on this 1857 survey, the shoreline retreat rate near Pad 0B has been about 3.7 m/year, while further south, near Assawoman Inlet, the rate increased to  $\approx 5.5$  m/year. When using the USC&GS 1911 survey, the retreat rate near Assawoman Inlet was less, about 2.5 m/year. The reduction might be natural, due to a change in storminess or possibly because of the sheltering effect of the growing Fishing Point. It may also be a mapping artifact, depending on what feature the surveyors mapped in the field or positioning error.

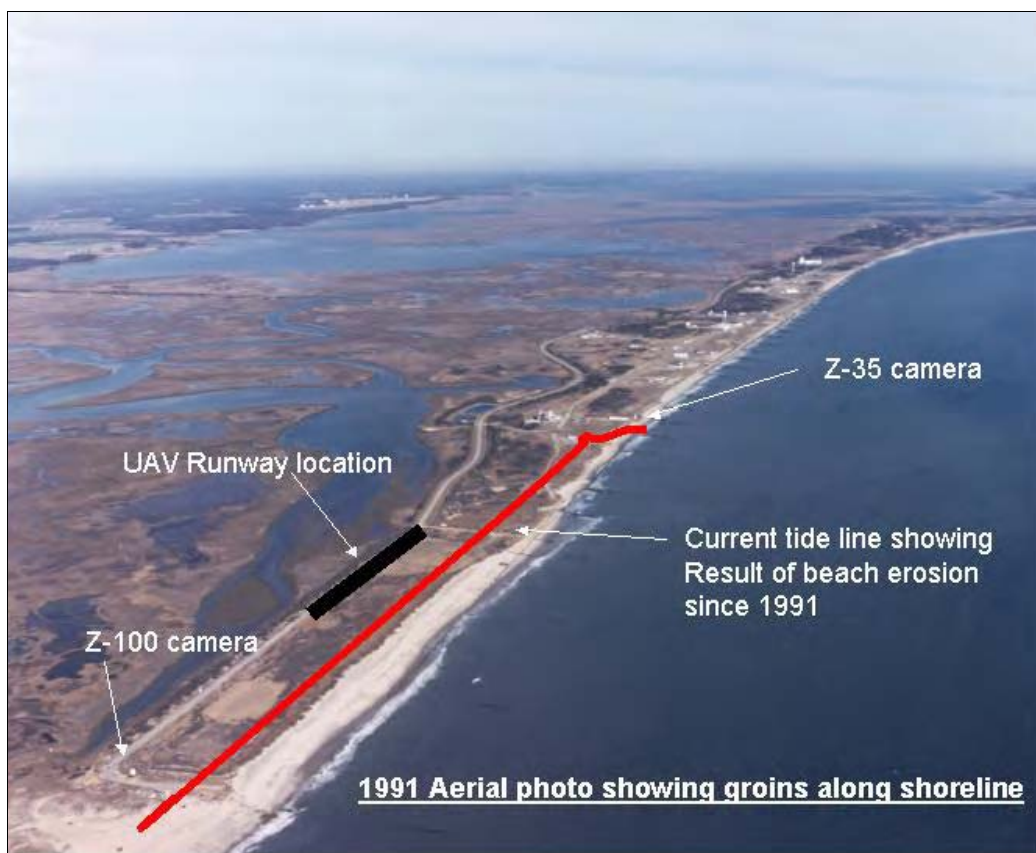
Figure 5. Oblique 1991 aerial photograph of south end of Wallops Island showing approximate position of 2005 shoreline. Photograph courtesy of Goddard Space Flight Center.

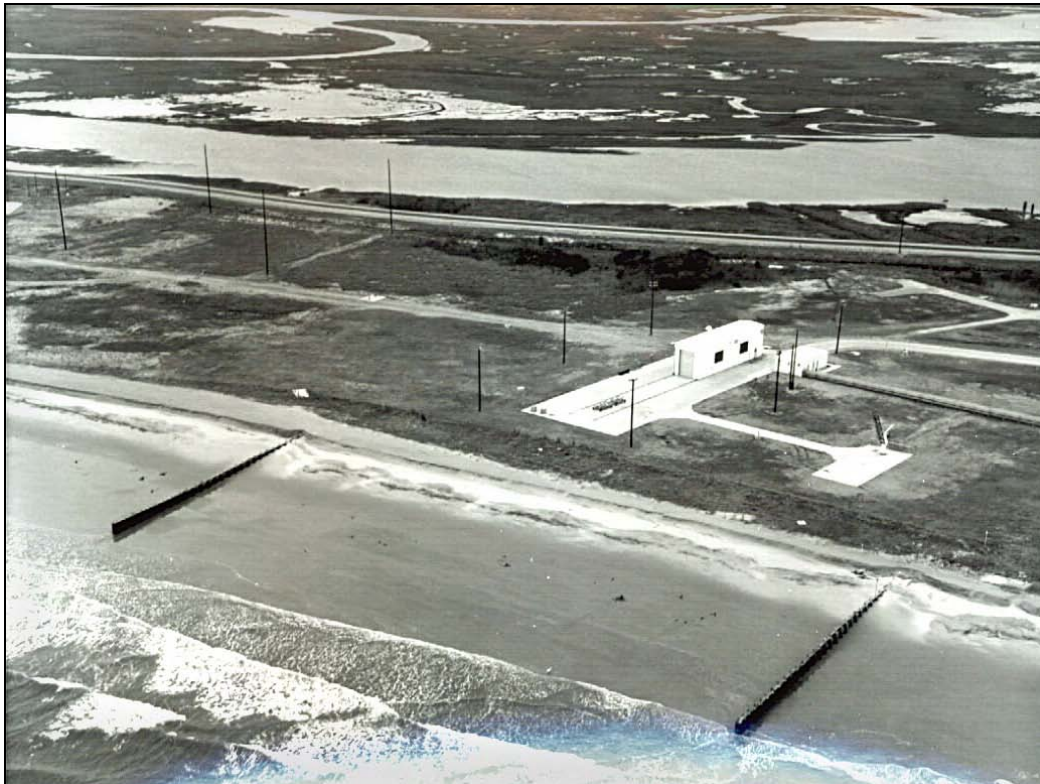
Figure 7. Wallops Island near Pad 1, date assumed to be 1970. NASA photograph 70-210, courtesy of Goddard Space Flight Center.

In the early 1960s, the shoreline was near the seaward end of the groins. A 1970 photograph still shows the groins to be largely intact (Figure 7). By 1976, the shoreline had moved to about the halfway mark on the groins (Figure 8). By 1983, the groins were in poor condition with many collapsed sections (Figure 9). The beach in each cell had retreated almost to the landward side of the groins or had disappeared entirely, and waves were lapping against the remains of the wood seawall (Figure 10). Therefore, the shoreline retreated about 75 m in 20 years, averaging about 3.75 m/year. In Appendix A of M&N (1998), Williamsburg Environmental Group noted, "In the absence of periodic beach nourishment, however, the majority of the groins and seawall failed." The groins failed because, as

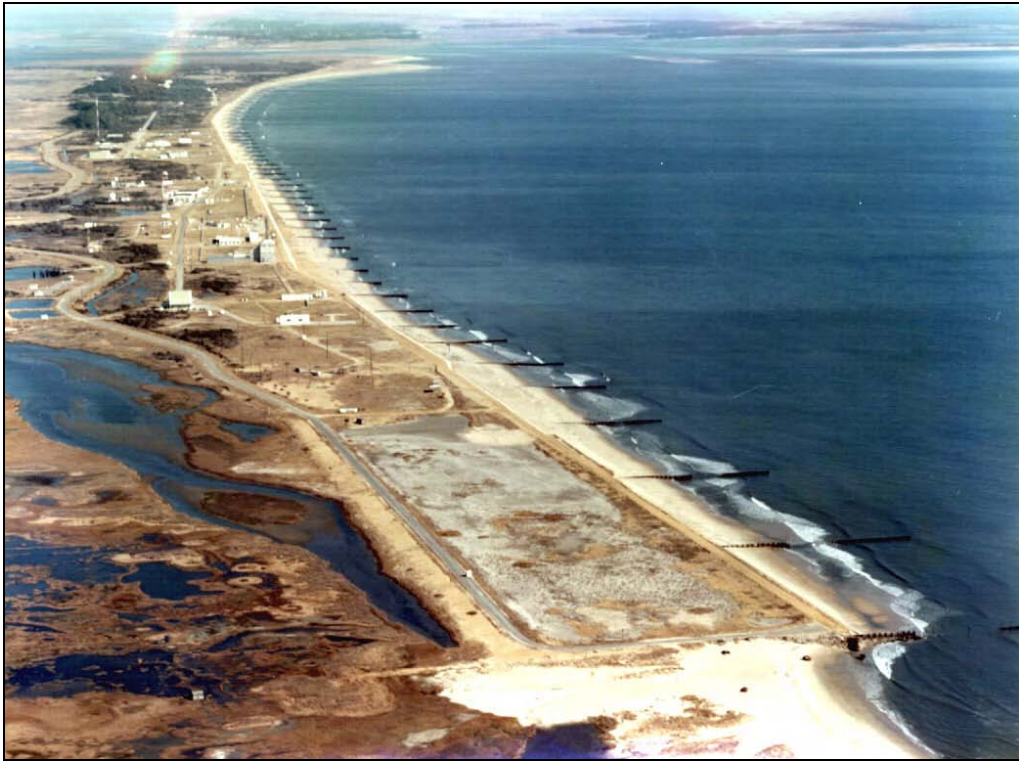
Figure 8. By 1976, shoreline had moved to approximately halfway mark on groins. Chincoteague Inlet and Fishing Point can be seen in upper part of frame. NASA photograph 76-142, courtesy of Goddard Space Flight Center.

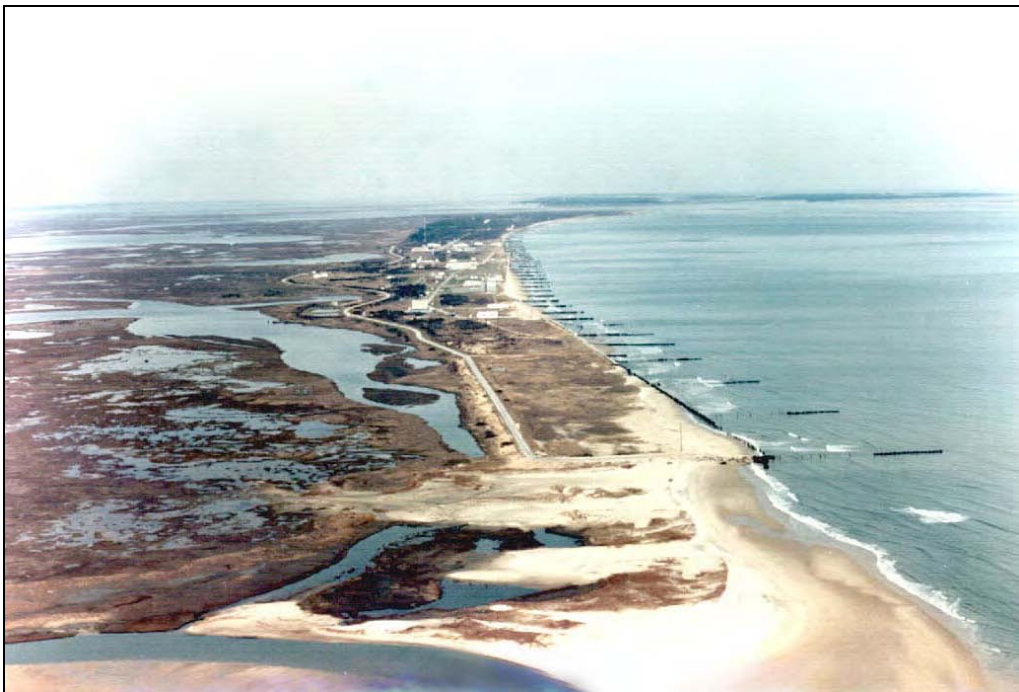
Figure 9. 1983 view looking north along Wallops Island showing poor condition of southern groins. NASA photograph 83-102-14, courtesy of Goddard Space Flight Center.

the beach retreated, the seaward portion of each structure was exposed to water of increasing depth. The groins did not have deep enough king-piles to remain anchored in the increasing depth water and, coupled with direct impact of waves, they unraveled and sections collapsed. The damage was most prevalent at the seaward end, in the zone where troughs and bars form on the seabed, and at the inner ends of the groins, where waves broke against the vertical seaward face of the seawall (M&N 1986). In the early 1990s, NASA hired a contractor to remove the remains.

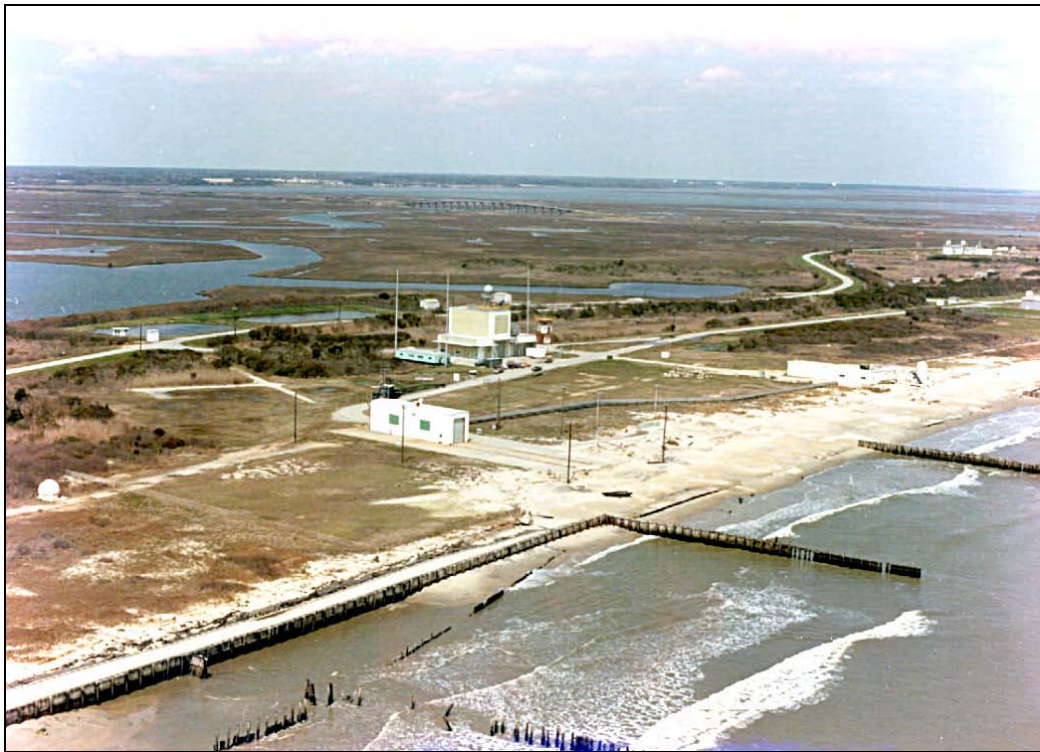
Figure 10. 1983 view taken in same area as Figure 7. Part of wood seawall has collapsed. NASA photograph 83-102-14, courtesy of Goddard Space Flight Center.

The fundamental reason that many sections of the wood seawall failed was that it, too, was dependent on the existence of a protective beach strand to prevent waves from undermining the toe.

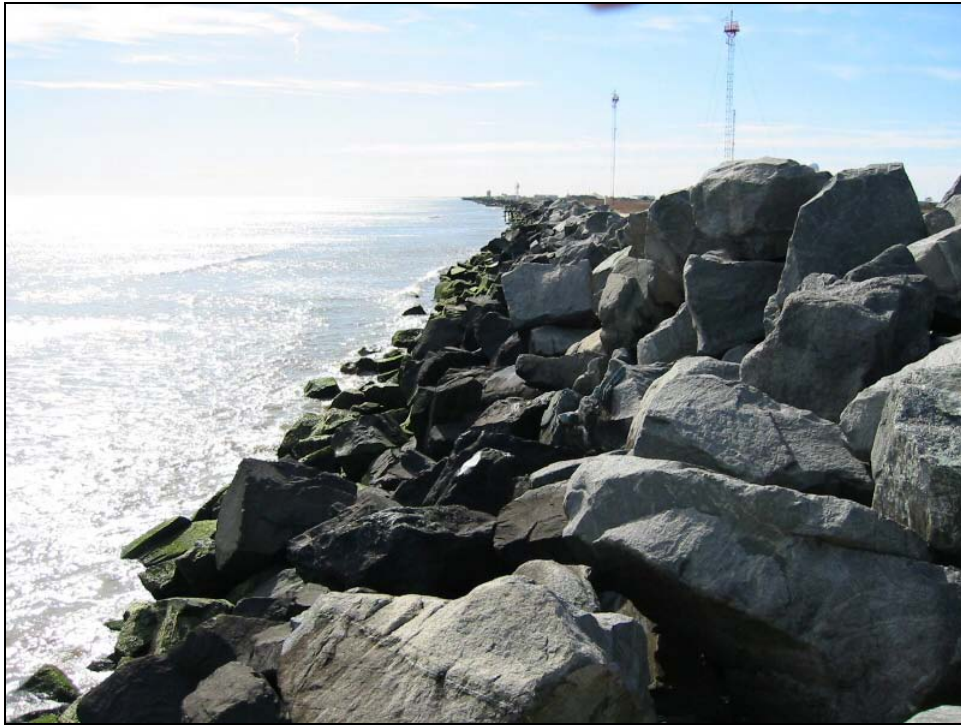
Figure 12. Contemporary stone seawall, near Aegis training facility, view looking south (photograph 11 February 2005).

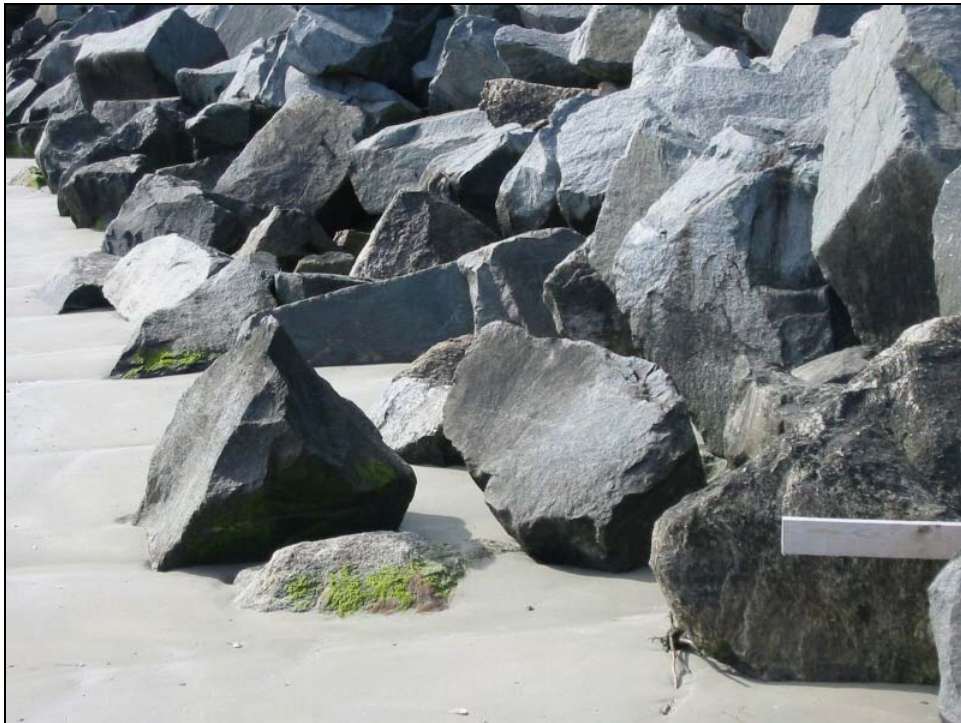
Figure 13. Photograph near north end of seawall, 11 February 2005. Individual stones have been displaced during storms.

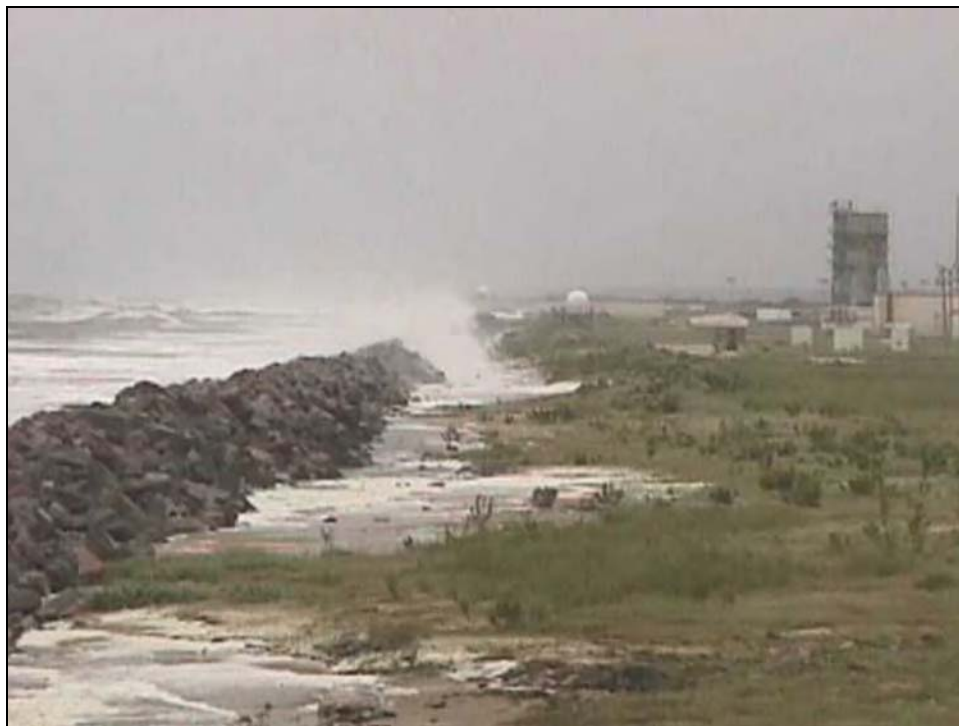
Figure 14. Waves from Hurricane Dennis overtopping the seawall (photograph taken approximately 1-4 September 1999).

During a site visit in March 2006, it was observed that the crest of the seawall was irregular in height and stones had fallen into the shallow water on the ocean side. Along some areas, sand has been scoured from behind the structure, forming depressed areas that have standing water. M&N (1998) noted that this was already occurring in the late 1990s, as sand was progressively lost from the system. Photographs taken during Hurricane Dennis show significant standing water behind the seawall (Figures 14 and 15).

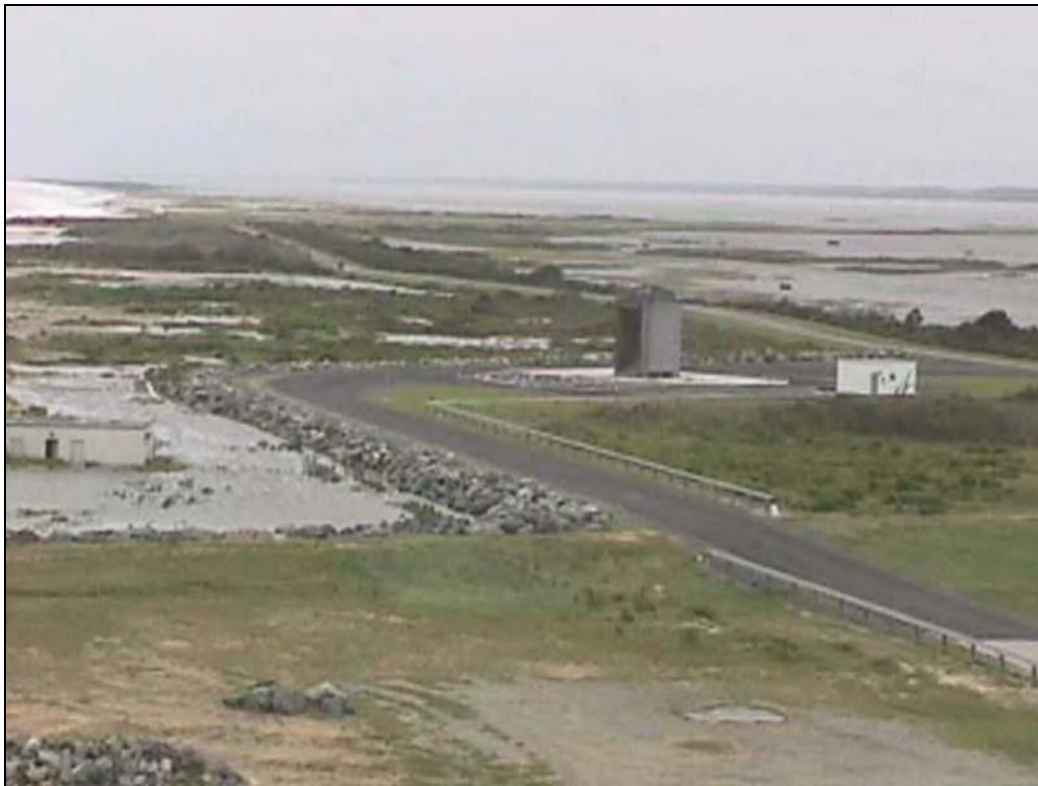
Figure 15. South end of Wallops Island during Hurricane Dennis (photograph taken approximately 1-4 September 1999. Standing water has reached the revetment in front of Pad 0B.

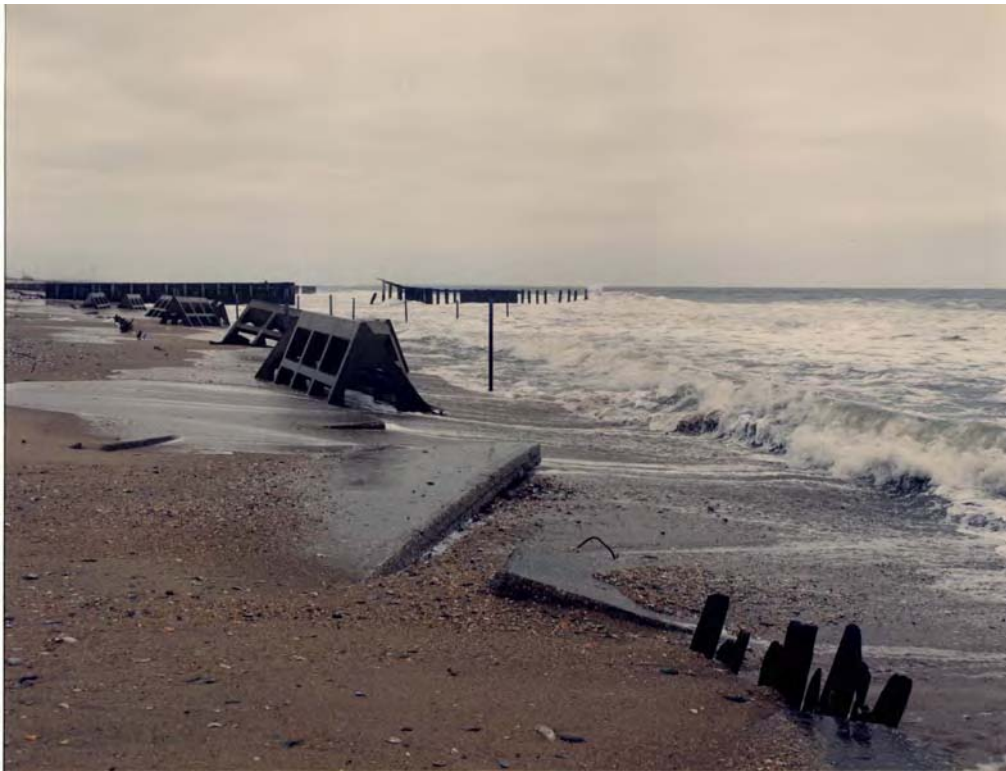
Figure 18. Experimental "Beach Prism" sand retention units moved out of alignment during an April 1988 storm (photograph courtesy of NASA).

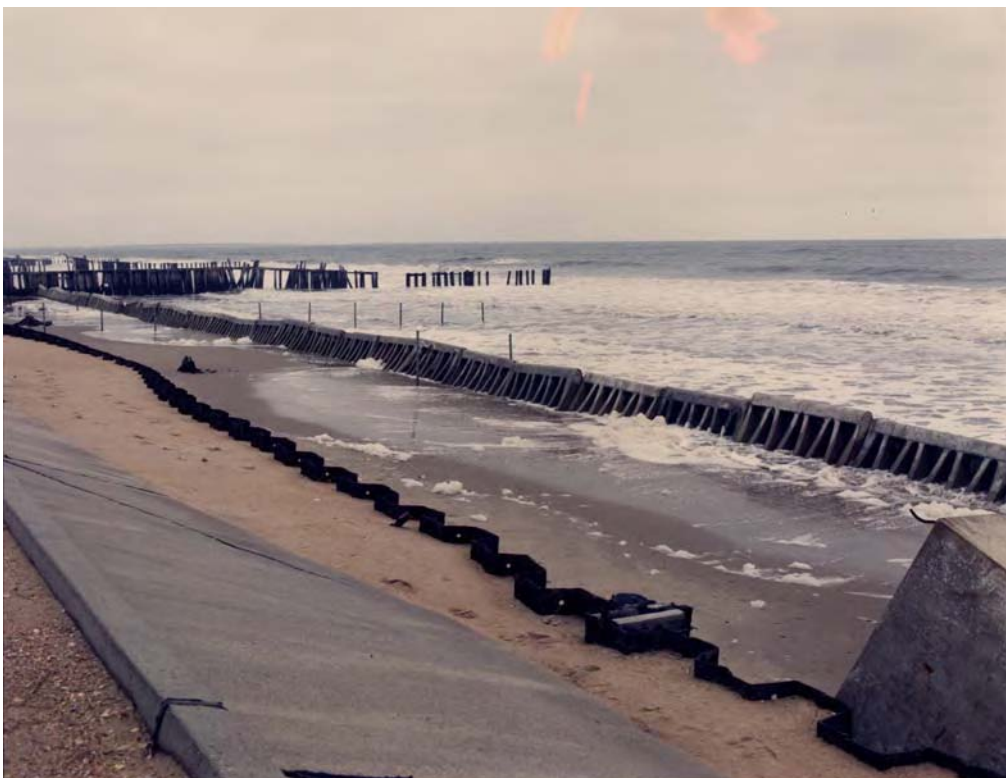
Figure 19. "Beach Beam" units partially sunken into seabed during an April 1988 storm.

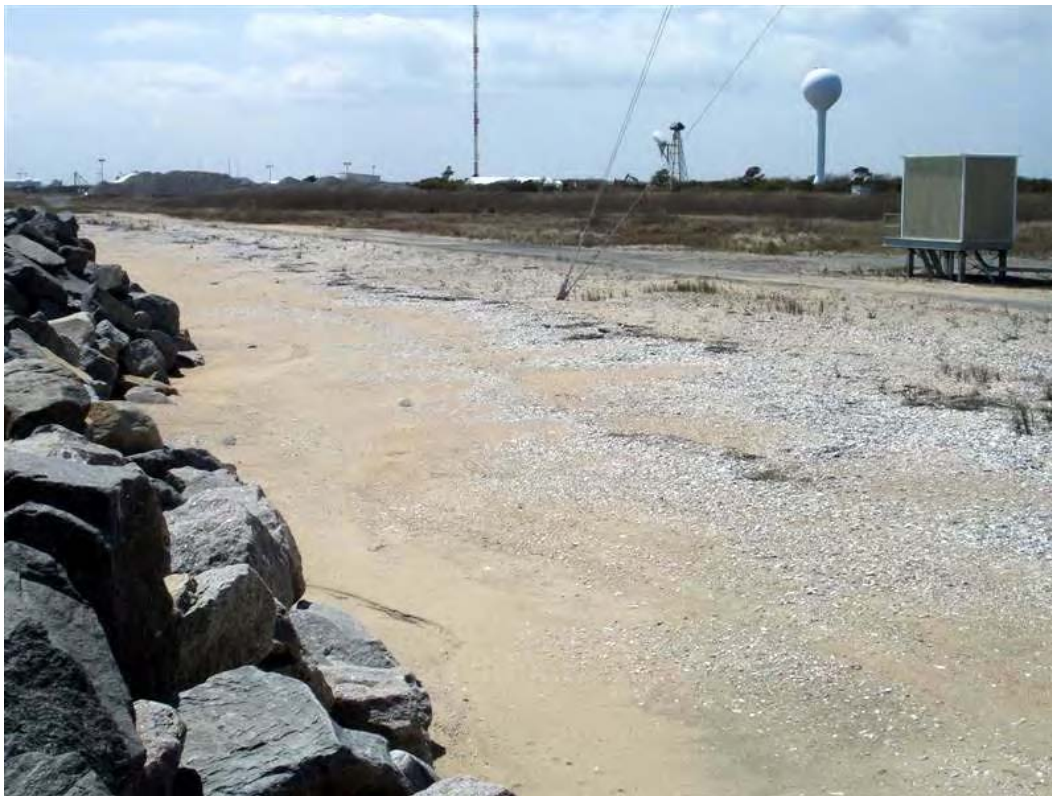
Figure 20. Back side of seawall south of U.S. Navy Aegis facility (Building V10/V20), 18 April 2006. Shell fragments and seaweed debris show approximate limit of wave uprush. View looking south.

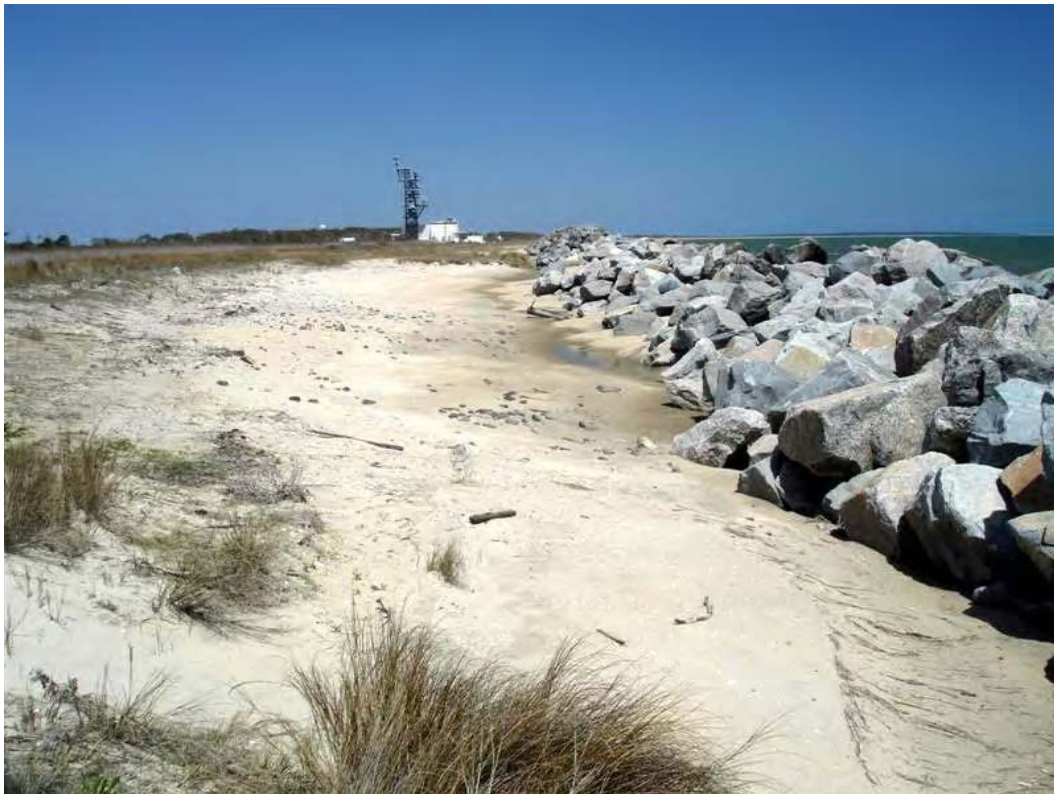
**Figure 21. View north from U.S. Navy Aegis facility (Building V10/V20) toward Building V-24, 18 April 2006. Sand has been lost through seawall, and lowest areas contain standing water even on a calm day.**

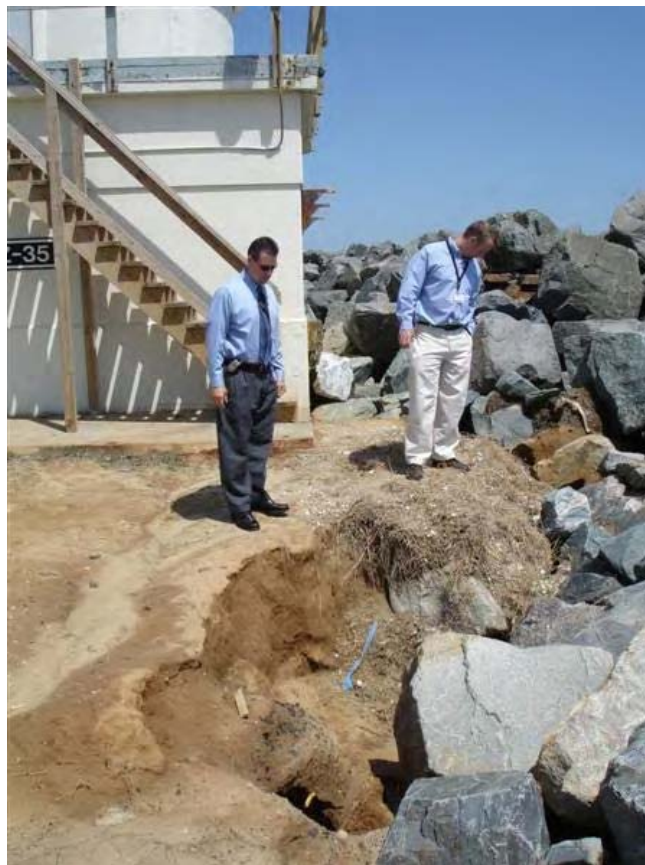
Figure 23. Sand loss at base of camera sta Z-35, 18 April 2006. To prevent foundation damage, NASA will install sheet pile and backfill, ocean is only 7 m to right beyond seawall.

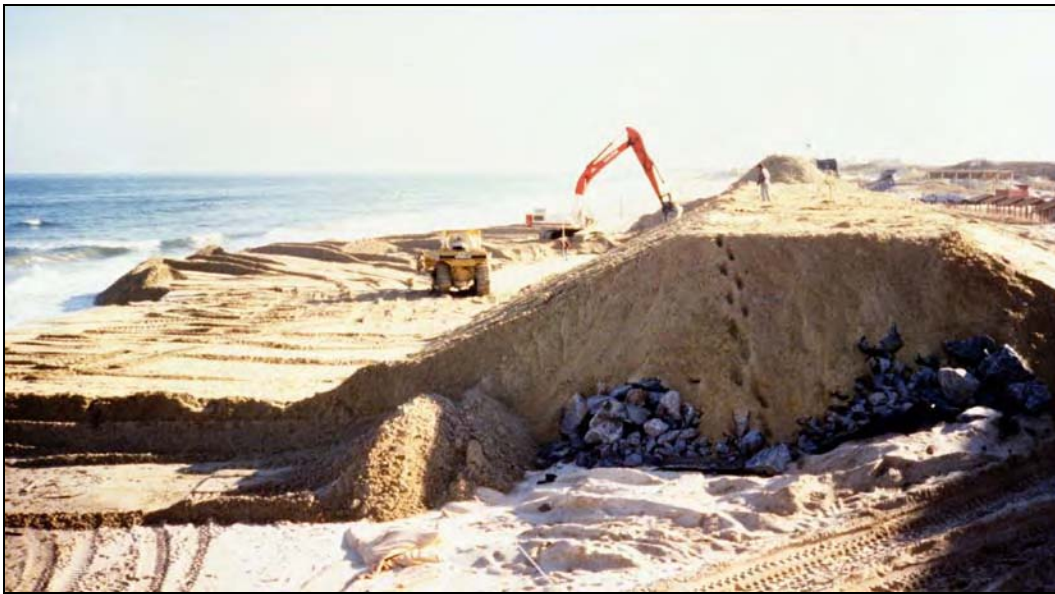
Figure 26. Construction of rock core dune at Dam Neck, VA (from Basco 2006)

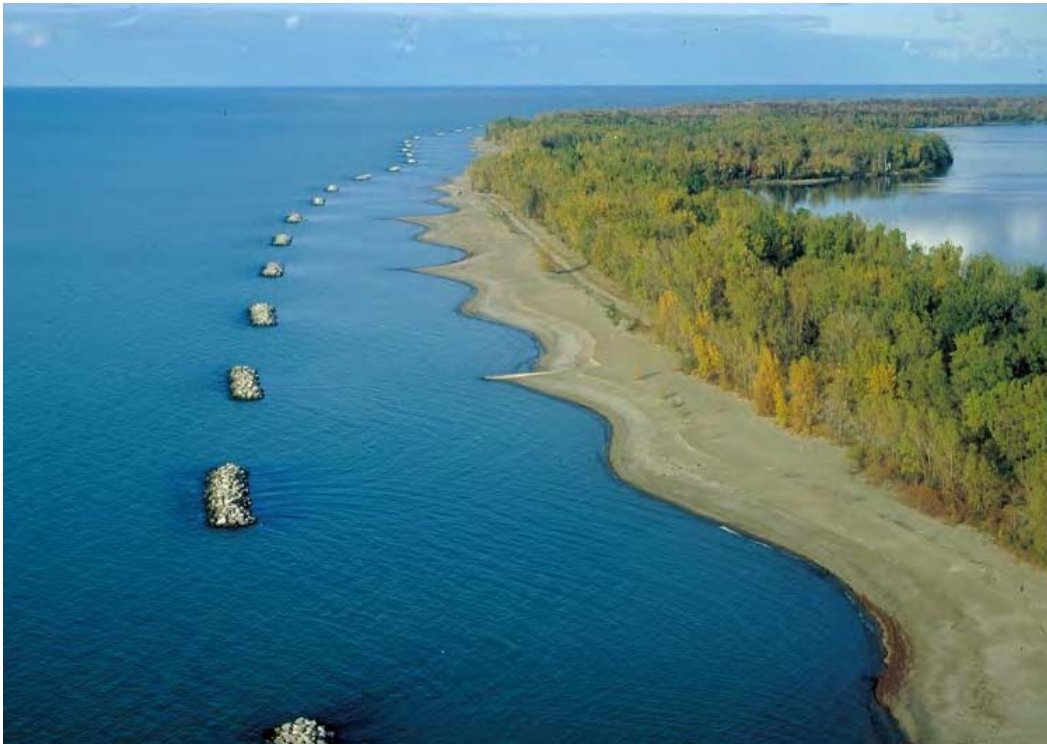
Figure 29. Detached breakwaters at Presque Isle, PA, in Lake Erie (from Mohr 1994). Since this photograph was taken in 1994, many of tombolos have grown out almost to breakwaters.

breakwaters is Presque Isle, PA (Figure 29). A second successful example is Fort Story, VA, where the breakwaters were built from land, using land-based equipment (Figures 30 and 31). Breakwaters at Wallops Island will probably be similar to those at Fort Story because both sites have similar wave exposure. The specific design, spacing between units (width of the gap), and location offshore will have to be determined during the engineering design of the project. One option to consider is that possibly some stone from the existing seawall can be used in the offshore units if the size of individual armor stones is suitable.

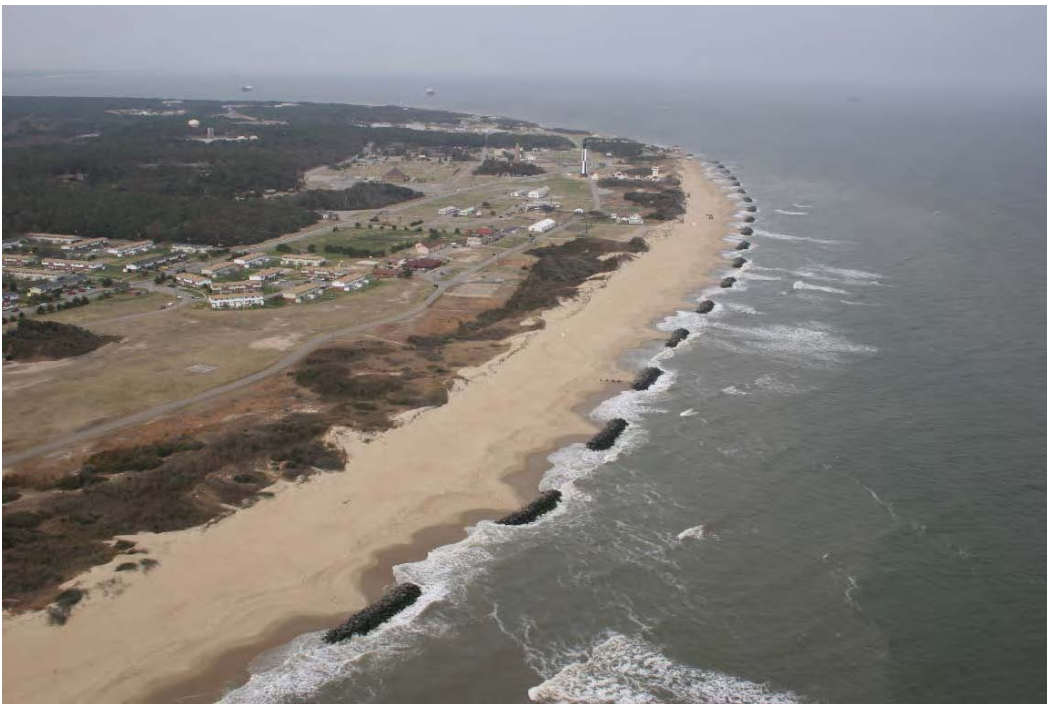
Figure 30. Breakwaters at Fort Story, VA, 31 March 2005. These were designed as headland breakwaters and built from land.

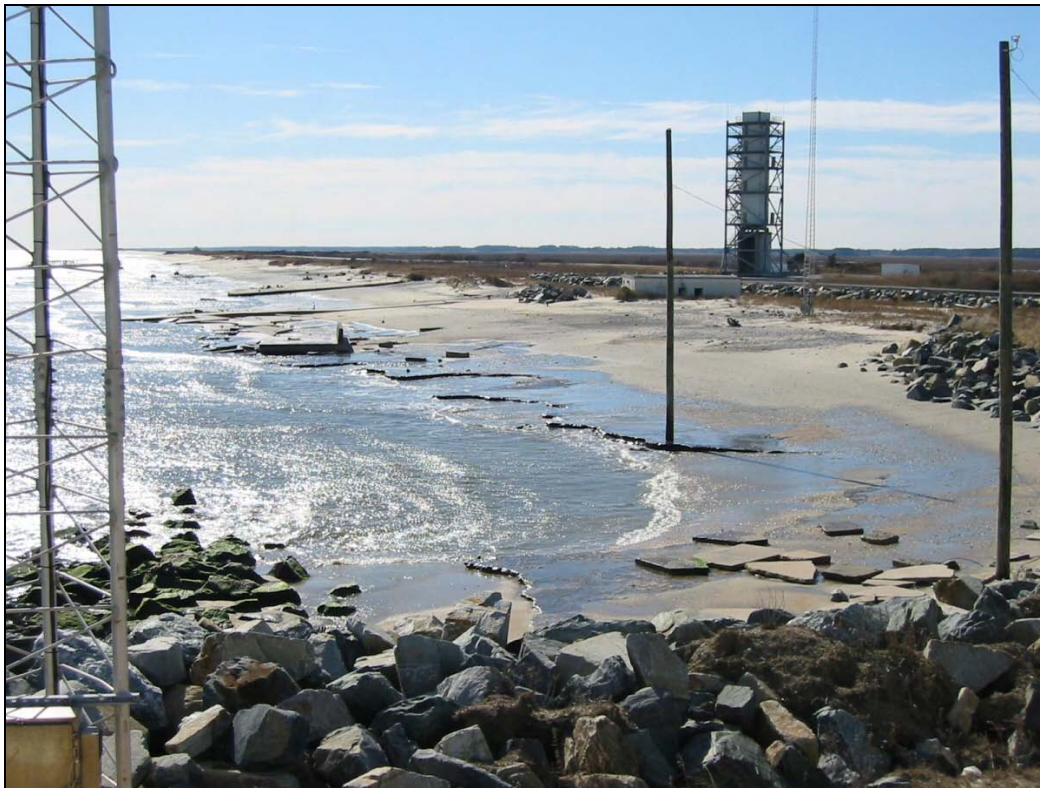
Figure 32. The MARS space flight facility (tower in upper right) is located just south of southernmost limit of seawall. Concrete rubble in surf zone is debris from former launch pads (photograph, 11 February 2005).
