# Aircraft Fuel Cell Repair Equipment

After Initiative Report  
AMB-05-005

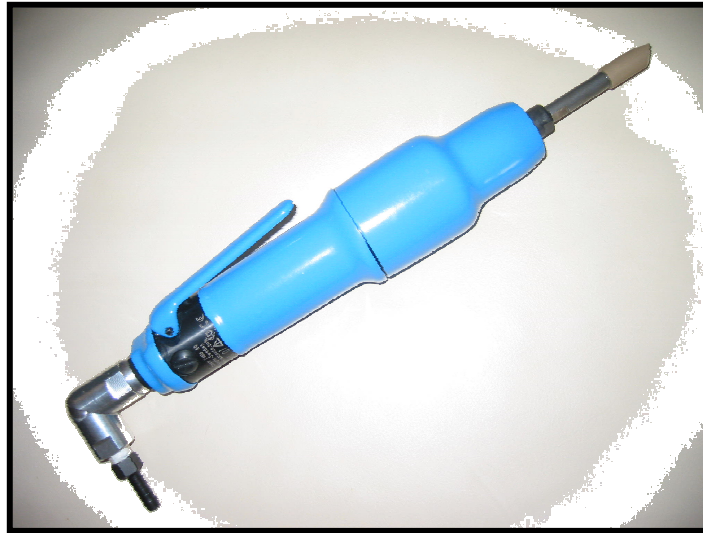
Rapid Desaler on work bench

**2.3.2. Results.** The RDS was very efficient. Sealant was removed from a seam in 30 seconds. Normally it would have taken an hour using current methods to remove this sealant. The RDS is a pneumatic, reciprocating hand tool approximately 16 inches in length. A replaceable plastic tip threads onto the arm. This tip has a point with two different angles. These can be sharpened for reuse, until worn past a certain threshold.

The access panel for the wing tip tank was removed from the aircraft and desealed on the workbench. A training board was also used. Sealant was removed from a .25 inch wide horizontal seam, a corner with rivets, a vertical seam on a horizontal joint and a 6 inch test strip. After all areas were desealed, only minor areas around fasteners and corners required conventional cleanup.
