# **DEVELOPMENT AND TEST OF THE HUMANITARIAN DEMINING SIFTING EXCAVATOR**

Christopher Wanner  
Night Vision and Electronic Sensors Directorate  
October 2003

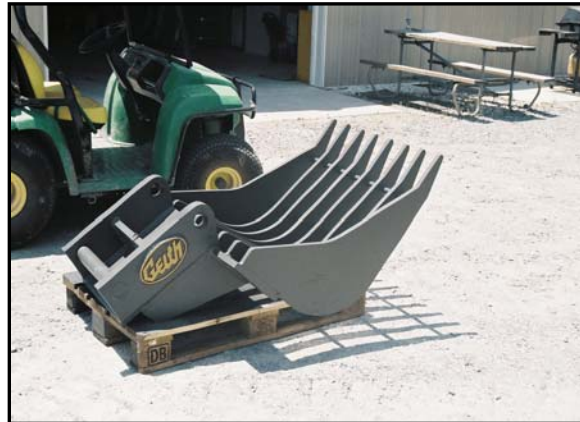
**Figure 1. Vaned Bucket**

In addition to the standard quick release digging bucket, four special purpose tools have been designed and fitted for use with the Sifting Excavator. Three of these require a hydraulic power source to separately power the attachment. The one tool not requiring hydraulic power is the Vaned Bucket (see Figure 1) which is to be the main excavating tool employed. The Vaned Bucket fits on the excavator arm and curls outward, away from the vehicle in contrast to standard digging tools made for the excavator. This action is required to pick at the base of the trench wall facing the vehicle and perform all digging on the upward stroke from underneath the mine. The Vanes are spaced 4.25" to enhance the utility of the bucket for picking/sifting large items from the residuals pile such as AT mines which have dropped from the bank. The Vaned Bucket features a nearly flat bottom for straight insertion into the base of the bank with an aft to front taper of 3". The low side walls, and the open appearance of the bucket are designed to enhance the operator's vision of the workspace and identification of mines. The Vaned Bucket requires no separate power source and is manipulated solely with the existing Liebherr controls. The bucket was designed by Radian in consultation with Night Vision, and fabricated by Geith Inc. of Petersburg, Virginia.

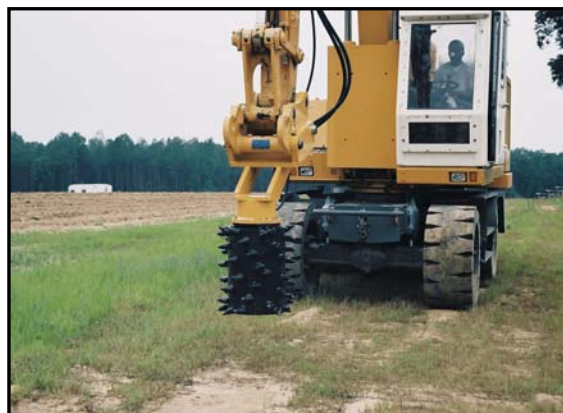
**5 Figure 2. Vertical Mill**

The second excavation tool is the Vertical Mill shown in figure 2. Like a machinist's mill, it is designed to shave the bank with a horizontal milling action. Although the cutting speed is much higher and the digging action more abrasive to the mines than the Vaned Bucket, the mill has the advantage of approaching the mine from the side, away from fuze triggers in normally oriented mines, much as the manual deminer's digging action. The Vertical Mill is intended as an alternative to

the Vaned Bucket for use in heavily rooted soils, hard soils which are resistant to the Vaned Bucket, or locations where precise control of the digging action is required. The mill rotates up to 170 rpm and features carbide tipped chisels. The chisels are “wear items” and can be replaced for \$450 per set. The mill is converted from a Bobcat Asphalt Planer with 24" drum. The mechanical interface for the mill was designed by Radian and fabricated by Night Vision. The Vertical Mill is manipulated with the existing Liebherr controls. Power for the mill is supplied by the Shinn HPU, and milling speed is set from the Shinn system joystick in the operator cabin. Approximately 60 kW of power is consumed by the mill in operation.

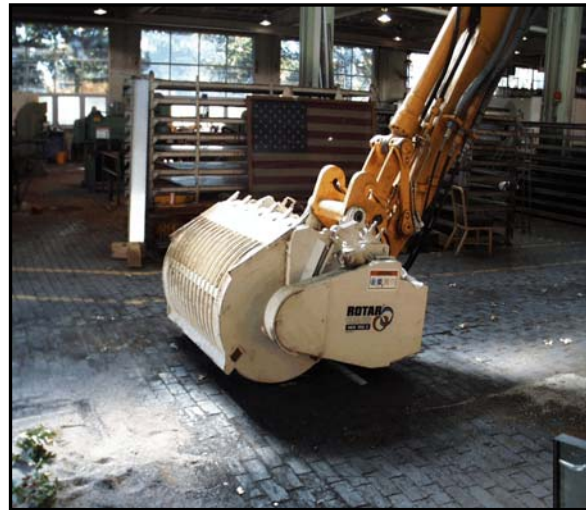
**Figure 3. Rotar Sifting Bucket**

The primary sifting tool for the excavator is the Rotar sifting bucket (see figure 3). The Rotar is basically a drum shaped cage. The drum can be opened to allow the operator to scoop loosened soil into the cage, then closed and spun at speeds up to 30 RPM. Soil will crumble and pass through the cage walls, dropping to the ground. Mines and other large objects are retained and emptied for inspection at the end of the sifting cycle. The Rotar is a commercially available attachment built and sold by Rotar International b.v. of Genemuiden, Netherlands, for separating debris from soil in trash areas. It was first adapted for mine clearing by MGM of Namibia.

The HEX 700 model used on the Sifting Excavator has a capacity of 650 liters and fully loaded weight of 1850 KG. The Rotar hydraulic system was custom designed for this application by Rotar Inc. according to Night Vision specifications to make the system compatible with the Shinn HPU and Liebherr controls. The Rotar is manipulated with the existing Liebherr controls; in addition, the mechanical locks which control the opening and closing of the bucket are integrated with the Liebherr control system and operated from buttons on the operator's left joystick. The power for spinning the cage is supplied by the Shinn HPU and rotational speed is controlled from the Shinn system joystick on the operator's right side. The mechanical interface with the excavator will permit the Rotar to be mounted for either forward scooping (away from the vehicle) or rearward scooping (toward the vehicle). For use consistent with the operation concept, the Rotar faces away from the cab, and the operator uses a forward stroke to pick up the residuals in the bottom of the trench against the trench wall.

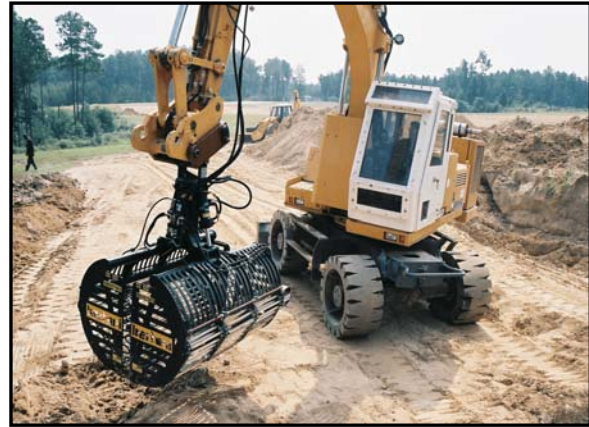
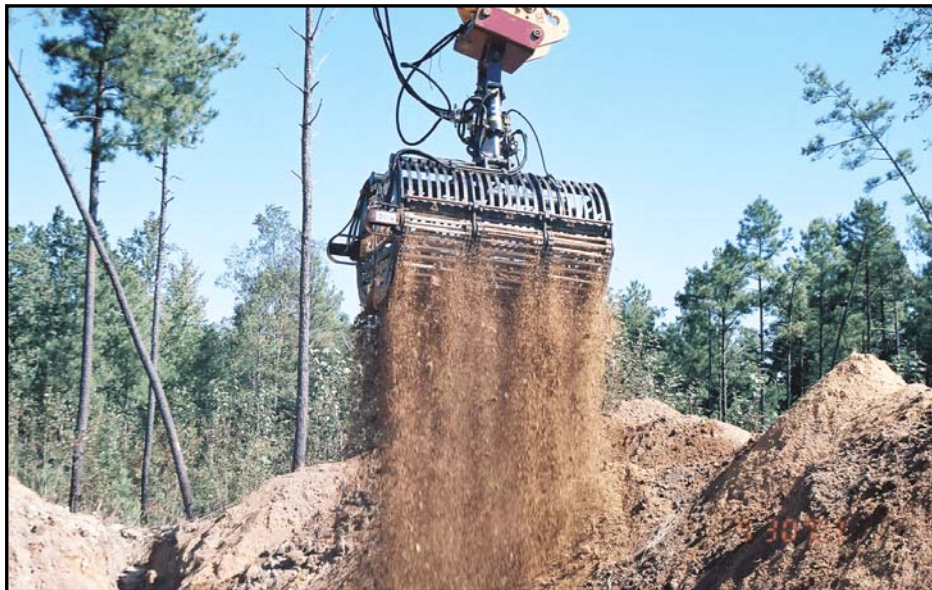
**Figure 4. Bertani Sifting Bucket**

The second sifting implement for the excavator is the Bertani Bucket, originally designed and sold commercially by Bertani & Donelli of Castelnovo Sotto, Italy for harvesting beets. The Bertani Bucket hangs from the end of the excavator boom and opens like a clamshell bucket for picking up loosened soil in a pile (figure 4). When the clamshell is closed, the operator activates the sifting action which consists of moving, slotted belts in the bottom of the bucket. Soil passes through the slots in the belts and mines and other large objects are retained and emptied in an inspection area (figure 5). The Bertani FBS 1500 used on the Sifting Excavator has a capacity of 1500 liters and weighs fully loaded 1770 KG. Because of the larger volume and the more aggressive sifting action, the Bertani is capable of reducing piles faster than the Rotar, however it does not pick up material as cleanly, nor does it have provision for retaining all materials inside the bucket until the sifting action has begun. This can be a problem when trying to clean the trench completely and when moving from the excavation location to the sifting location. The Bertani Bucket is manipulated with the existing Liebherr controls, and the opening and closing of the clam is integrated with the Liebherr control system and operated from buttons on the operator's left joystick. The power for running the sifting belt is supplied by the Shinn HPU, and belt speed is controlled from the Shinn system joystick on the operator's right side.

The Bertani Bucket is a lighter and simpler design than the Rotar Bucket. It has a larger volume and very aggressive sifting action. For these reasons it is capable of sifting through a pile more quickly. The scooping action is not as clean as the Rotar, nor is the construction as robust. The Bertani tends to leave a 0.1 meter high trail of soil where the jaws come together and for this reason, the operators tend to dig a little deeper with the Bertani in order to ensure that all mines have been picked up. In the dry, powdery conditions prevalent during the practice operations, there was no method of retaining all the soil in the bucket until the sifting action was started. Although no mines would be lost, the spilled residuals can create uncertainty for the operator and observers as to where the sifter has been when a small pile is left at the pickup location. The Bertani Bucket was originally designed for harvesting beets from cultivated soil. Thus the construction is somewhat fragile and the drive motors lightly powered. One or two back and forth

movements of the sifting belt are sometimes needed before continuous sifting action is sustained in heavy, wet, or heavily rooted soils. The sifting bars on the belt are constructed of 22 mm nylon bars. The bars are somewhat pliant and can be sprung from their mounting pins on the drive chains. On average 1 bar dropped out for every 8 hours of operation. Although losing 1 bar is not a crisis, each lost bar must be replaced eventually. A tool will have to be designed to assist with this, as few people possess the strength needed to deform the bars enough to spring them back into place.

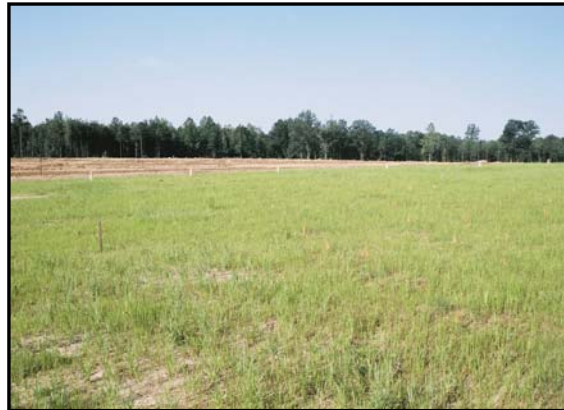
**Figure 6. Practice Minefield**

The first test initiated with the system was in fact a “scored practice”, in which operators developed their digging techniques with the equipment and records were kept of their clearance efficiency. A small part of the test was devoted to practice with the two sifting implements. A practice minefield was placed employing fuzed antitank mines in a regular known pattern. The mines used would detonate a smoke generating charge indicating when the mine had been triggered. The mine pattern was 5 marked columns spaced 5 feet apart.

Within each column all mines were buried at a single depth. The spacing of the mines within each column was also 5 feet. Thus the operators would know when to expect mines as they were digging. The first column had mines buried 10 centimeters, the second had mines buried 20 centimeters, and so on with the fifth column having mines buried 50 centimeters. The AT mines were buried approximately 8 months prior to the start of testing in order to allow the soil to settle and vegetation to grow over the surface. In areas where the sifting implements were used AP mine surrogates were buried in 6 columns interlaced with the AT mine columns. The AP surrogates were designed to replicate the PPMiSrII and PMN mines in weight and physical dimensions. Since these mines do not represent as serious a threat to the equipment and personnel inside as AT mines, these surrogates were not fuzed, nor was the long lead time provided for the soil to settle around these mines.

A starter trench was dug with the standard digging bucket approximately 2.5 meters wide and 1.5-2.0 meters deep. The trench was oriented to lie adjacent to the ends of all of the

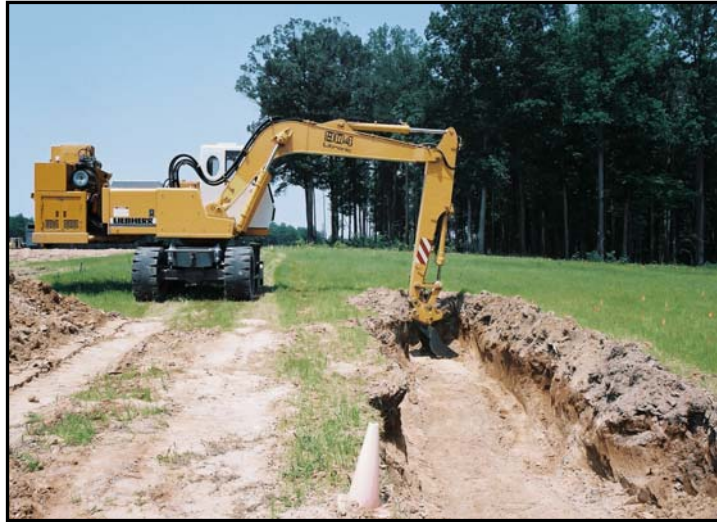
**Figure 7. Working Across Trench**

After completion of the starter trench the excavator was positioned adjacent to the trench on the “safe” side. The operator would reach across the open trench and down into the hole to perform the excavation (figure 7). The undercarriage was positioned parallel to the long dimension of the trench so the excavator could continually drive straight along the wall of the trench as the operator progressed down the length of the hole. The digging was performed with the undercarriage positioned approximately 1.2 -1.4 meters from the edge. Multiple passes made in this manner widened the trench to 5-6 meters at which point the excavator could no longer reach across.

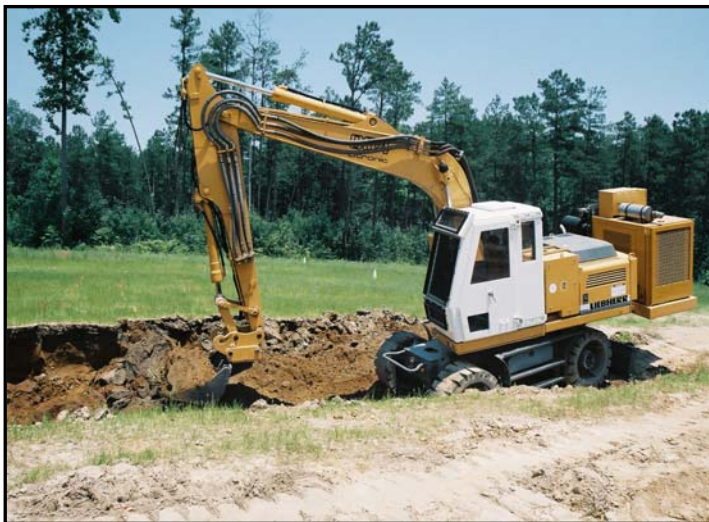
**Figure 8. Working Inside Trench**

The digging bucket was again used to further excavate the safe side until the trench width was 7.5-9 meters and the excavator could drive down in the trench and have sufficient

width to pivot the upper carriage 360 degrees (figure 8). As it turned out this width left insufficient room to adequately maneuver the excavator. Considerable time was wasted repositioning the excavator each time the machine needed to move, as just a little bit of drift in the positioning of the carriage as the operator moved along the trench would result in his becoming “tangled” with a wall. As the clearing operations widened the trench to 10 meters, the maneuver room was no longer an issue.

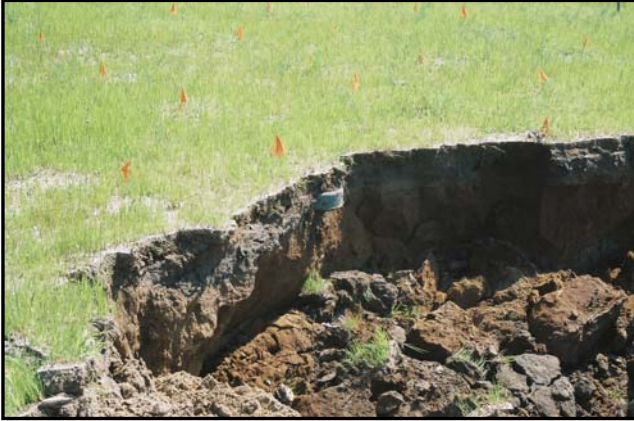
**Figure 9. AT Mine Exposed In Bank**

Appendix 1 maps the location of each mine and records the observations made as each mine was excavated, retrieved, and examined/tested for functionality. In the operational procedure planned for the Sifting Excavator each mine encountered would have 3 separate opportunities to be visually detected and recovered. The first is when the face of the trench is excavated and the mine is left exposed in the face as in figure 9. The second is when a portion of the bank collapses and the mine is visible in the spoils at the base of the mined face. The third opportunity is when the pile is picked up by one of the sifting buckets. Best practice would demand that a given mine be recovered at the first opportunity at which the mine was visually detected. For the purposes of gathering information on the efficiency of each step in the process, AT mines which presented

themselves visually in the bank were not recovered, but instead were permitted to stay in the process and be detected again in the pile. At the point at which each AT mine had fallen into the spoils, each AT mine was recovered and examined to determine whether or not the fuze had functioned in the excavation process. AT mines which appeared not to have triggered were set aside and sufficient pressure was applied to the pressure plates to cause triggering and verify that the mine was in fact able to function.

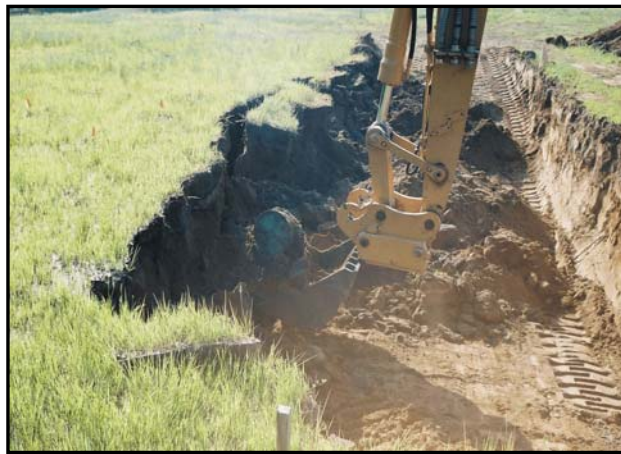
**Figure 10. Fracture In Bank**

The most effective and safest digging technique compatible with the Vaned Bucket was found to involve working on approximately 3-4 meters of bank at a time from a given location. The excavator would be positioned with the carriage 4-5 meters from the wall and the wheels parallel with the wall. The bucket would approach the wall from a vertical orientation with the tines penetrating the surface of the trench floor 0-7 centimeters to provide a very light raking of the materials embedded in the bottom as the bucket is moved toward the base of the wall with the stick. As the

tines approached the wall the operator would curl the bucket up while dropping the boom to bring the bottom of the vanes nearly horizontal as the tines made contact with the base of the wall. As the tines continued to penetrate the wall the operator used a combination of upward curl of the bucket combined with lowering of the boom to move the bottom cord of the bucket along an upward arc through the soil, without significant lifting. The object was to create a fracture from the base of the trench up to the soil surface without lifting the face of the bank. Once the fracture was created the operator would withdraw the tines along the same path by which they were inserted. This technique was developed

to avoid bringing the bucket up and catching the edge of a mine still embedded on the solid side of the fracture. The tines could penetrate 0.40 - 0.60 meters and create a correspondingly thick slice. Usually when the bucket is withdrawn the bank collapses downward under its own weight leaving the majority of AT mines exposed in the face of the bank. (See the fractured, uncollapsed bank face in the background of figure 10.) When a single pass was completed on a given section of wall the excavator would move forward 4-5 meters and begin again.

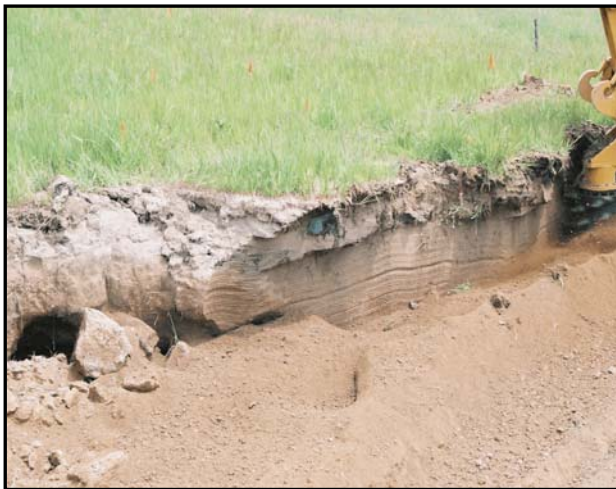
**Figure 11. Mine Exposed in Bank with Vertical Mill**

The Vertical Mill was perhaps the most operator skill intensive tool developed on this project. With additional practice time it is believed that the 88.9% bank exposure efficiency in table 2 could be made to approach 100% in homogeneous soils without large rocks or tree roots. As it was, 2 of the 18 mines encountered were excavated from the bank without first becoming visible. Structural damage to mines still embedded in the bank but visible on a side was light to moderate, and in normally oriented mines safely isolated from the fuzing portions of the mine. One such mine is pictured in the center of figure 11. All mines were

base of the trench. The structural damage to the mines after extraction from the bank was in most cases moderate to substantial. Again, most of the damage was on the sides and bottom of the mine, away from the fuze. 1 of the 18 mines did trigger upon extraction from the bank with the Vertical Mill. Acknowledging the statistical problem of reporting efficiencies to two or three significant digits on the basis of 18 test objects, we expect the Vertical Mill to eject 11.1% of the mines from the trench wall without first exposing them. 5.6% of those mines which are ejected may be expected to function, giving a theoretical ability to safely detect 99.4% of the all AT mines and trigger the remaining 00.6%. Again with the low number of test objects in this test, the composite score for all of the AT mines being safely recovered was 100% (because the 1 mine that was triggered was visible and recoverable when it first appeared in the bank before being triggered).

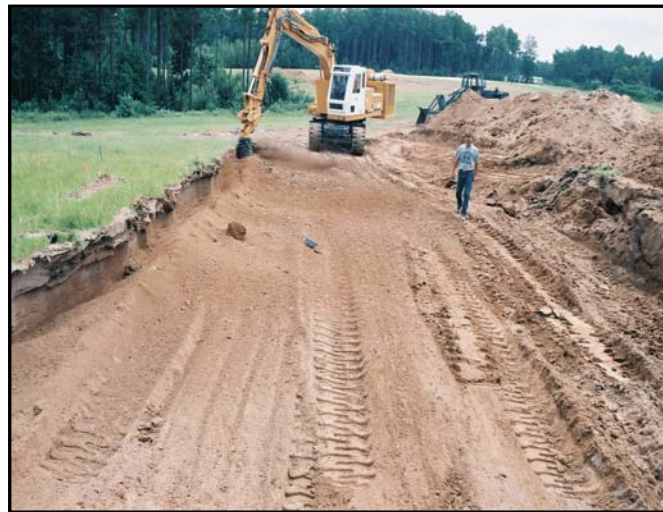
**Figure 12. Vertical Mill Completing a Rearward Pass**

A rearward stroke, that is moving the mill against the direction of spin produces a very aggressive cutting action. It is believed to be gentler on the mine cases because the maximum angle the mine must be transported through the soil is 1/4 of a rotation before reaching a free surface. Unfortunately this direction also produces a wide dispersion of materials coming off of the wall (see figure 12). The excavated soil layer although thin (<0.1 m beyond 1 m from wall), extends to 4.5 m from the wall and overlaps with the path of the excavator. A forward stroke, on the other hand, produces a very well behaved pile which lays in tight against the wall. The disadvantage to moving in this direction is a slower cut and a perceived rougher treatment of the mines since they must be pushed deeper into the bank for 1/4 of a revolution before movement toward the free surface for another 1/4 of a revolution. Mainly owing to the better dispersion of excavated soils, the forward stroke was chosen as the preferred direction for the majority of the testing. It is possible to envision a usage SOP with very tight monitoring of the

vehicle path which would make the rearward stroke more attractive, however, the secondary problem of picking up the thinly dispersed soils spread far from the wall for sifting represents another inefficiency which would need to be overcome.

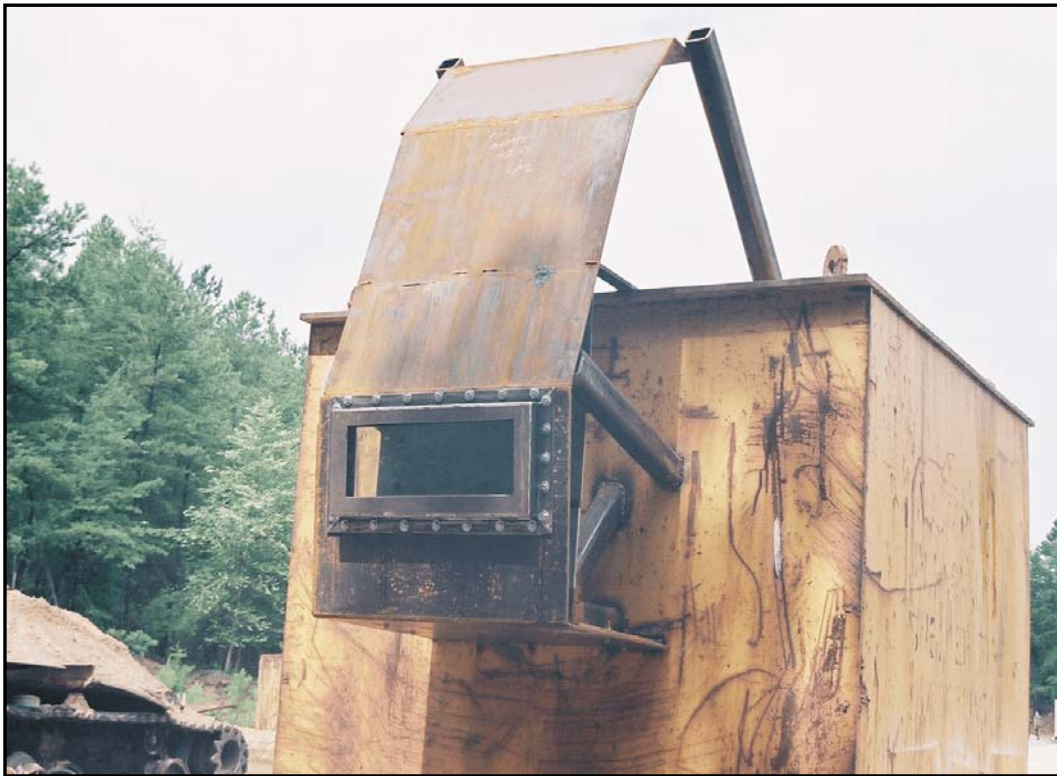
**Figure 13. Blast Shield**

For the purposes of conducting the tests a simplified replica of the blast shield was constructed. The test shield had the same geometry and materials as the actual shield; however, only one of the three windows in the shield was installed (see figure 13). The actual shield has three windows stacked in a column on the shield face. Only the lowest window (which is closest to the blast site) was in place on the replica. Placed on vertical columns approximately 0.25 meters behind the shield were 4 aluminum witness plates of varying strength. The plates were bolted at each end to the columns and spanned a

distance approximately 1 meter. The lowest plate on the columns was 0.5 inches thick (12.7 mm), the second plate was 0.25 inches thick (6.4 mm), the third plate was 0.125 inches thick (3.2 mm), and the top plate was 0.0625 inches thick (1.6 mm). The purpose of the plates was to provide evidence of the destructive strength of the blast behind the shield as well as any fragmentation penetrating or spalling on the interior of the shield.

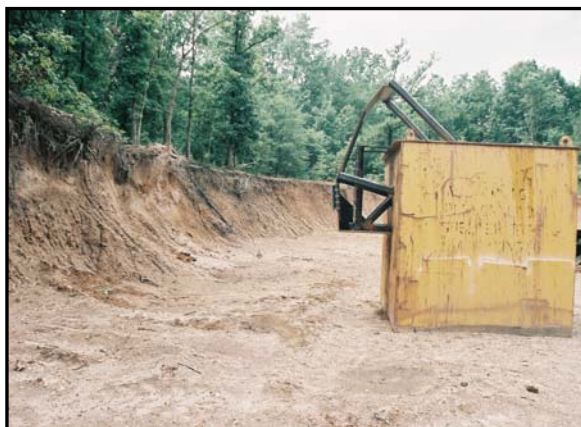
**Figure 14. Shield Before Blast**

The shield was mounted on cantilevered beams welded to a heavy metal structure to hold it in place for the test. The shield was mounted so that the height above ground matched the height of the actual shield installed on the tractor. The shield was placed 4.0 meters from the base of the 3 meter high embankment shown in figure 14. A 14.0 kg explosive charge TNT equivalent was placed at the base of the embankment to replicate the blast of a very large antitank mine detonating in the trench wall facing the excavator.

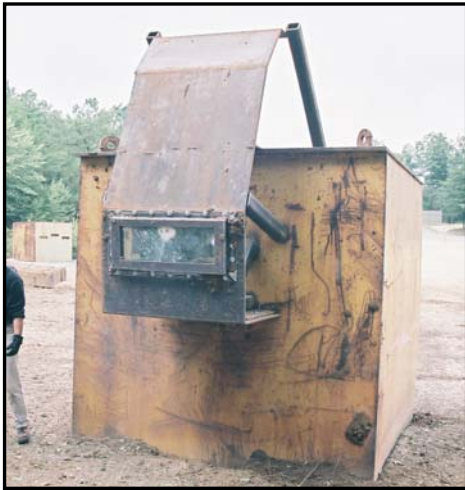
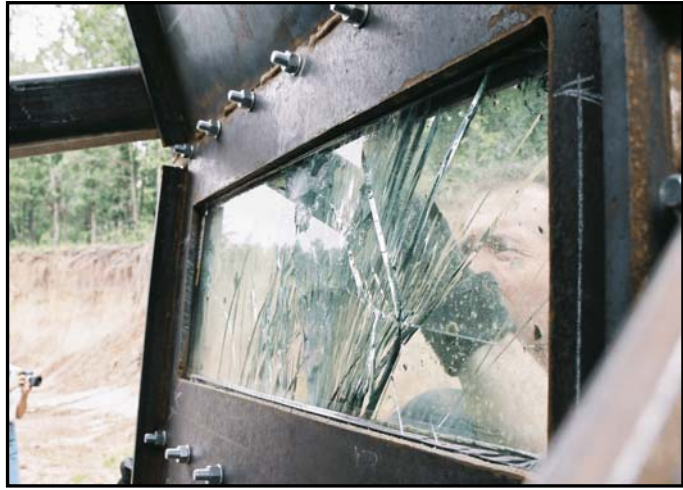
Figures 15 and 16 show the effects of the blast on the shield. The outer surface of the shield was pitted with impact marks from flying debris but none of the fragments penetrated the thickness of the metal more than 0.5 mm. There was no perceptible deformation to the shield structure or cracks visible in the surfaces. The glass cracked extensively and two rock fragments embedded in the outer surface. No evidence could be found of any materials penetrating through the glass. An icecube sized chunk of glass did spall on the inner surface; however the evidence suggests that it came off at low velocity. There were no scratch marks on the soft aluminum witness plate directly behind the glass surface, less than 0.2 meters away. The glass chunk itself was lying intact about 0.1 meter from the spot where it originated.

The shield performed well and is believed to be capable of adequately protecting the structures behind it from blasts originating in front of the cab, provided the minimum 4.0 meter standoff from potential mine hazards is maintained. The cab construction of 12.7 mm 6061 aluminum plate has over ten times the strength of the thinnest witness plate (6.4 mm) which did not deform in the blast test. The blast protecting glass also performed well and did not permit any through penetrations when twice blasted.

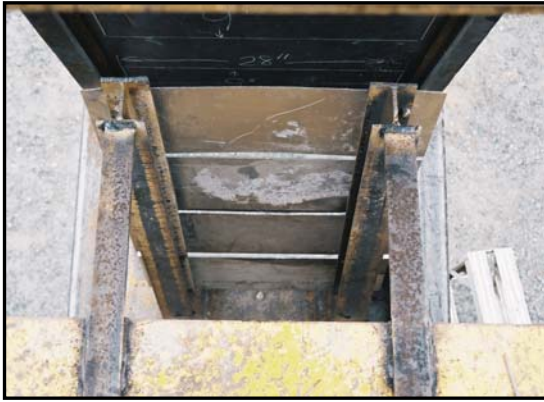
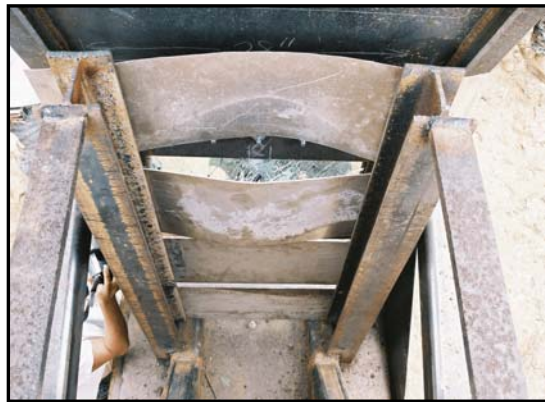
Figures 17 and 18 provide an overhead view of the witness plates standing behind the shield before and after the blast. As commented above, no scratches or impact marks of any kind were found on any of the witness plates. The 1.6 mm plate did deform significantly as did the 3.2 mm plate below it. No perceptible deformation occurred to either the 6.4 mm or 12.7 mm plates.

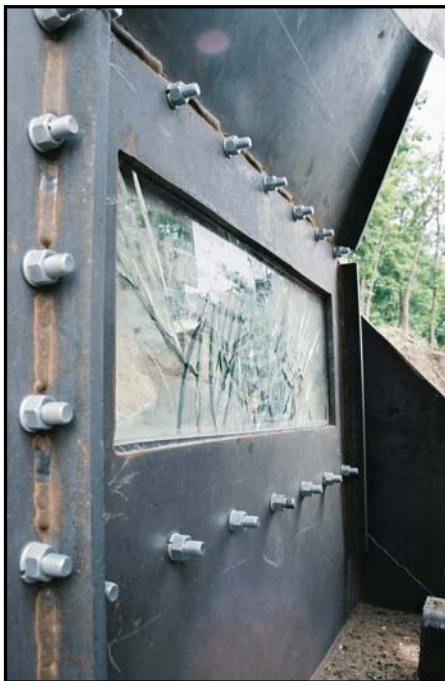
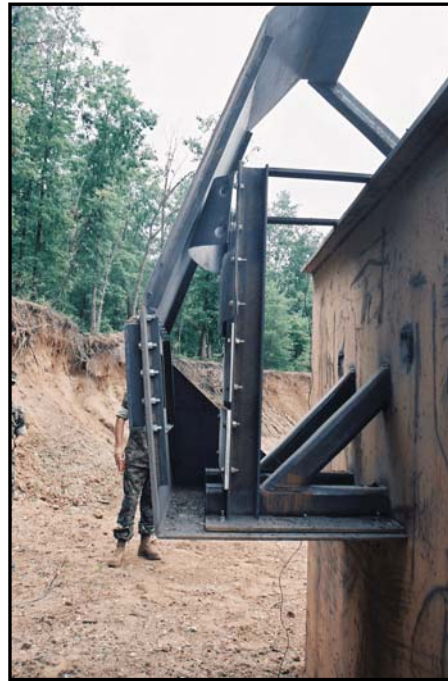
The shield was blasted a second time with conditions identical to the first. As can be seen from figures 19 and 20 no further damage was done to the shield beyond additional cracking of the glass and further bending of the 1.6mm and 3.2 mm witness plates.

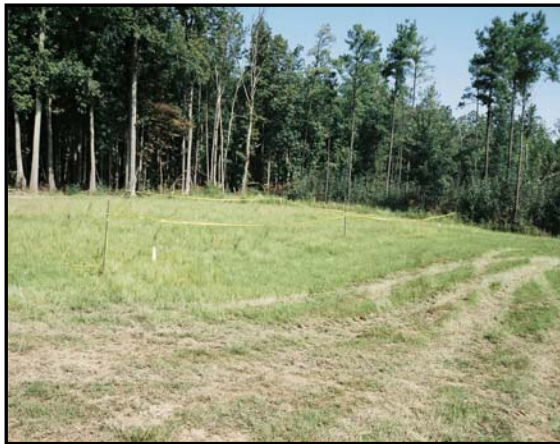
**Figure 21. Blind Test Minefield**

The proof of concept test was performed in a randomly laid, mixed minefield. Procedures similar to those which might be used in an actual mine clearance operation were employed and the operators had no knowledge of the mine locations. The same mine simulants as were used in the practice area were employed in the blind test: smoke fuzed antitank mines, PMN size/weight replicas, and PPMiSrII size/weight replicas. The size of the mined area measured a little over 12 by 28 meters. The mine locations within the field were randomly assigned and 50 of each type were emplaced. The antitank mines were buried 10 months in advance of the test to allow the soil to settle and vegetation to grow. 20% of the AT mines were buried 50 centimeters, 20% at 40 centimeters, 20% at 30 centimeters, 20% at 20 centimeters, and 20% at 10 centimeters. The AP simulants were buried one month in advance, approximately 10 to 20 centimeters. The minefield layout and mine locations are shown in appendix 2.

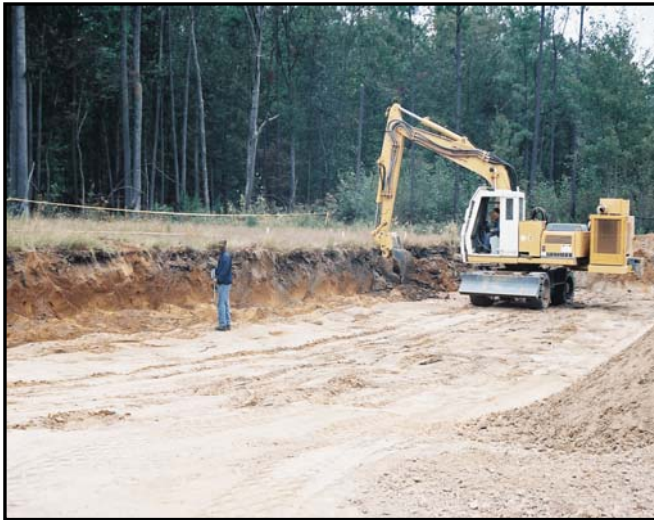
**Figure 22. Blind Test - Excavation**

The tools chosen to use to perform the test were the Vaned Bucket and the Bertani sifter. The Vaned Bucket was chosen as the faster more robust approach for safely excavating AT mines. The per pass cut from the Vaned Bucket is about twice the recommended cutting penetration with the Vertical Mill. In addition, the mill was judged to require additional practice time in order to develop sufficient confidence that operators could bring the detonation risk down to an acceptable level. In contrast, the Bertani Bucket was chosen mainly on the basis of speed. It is believe that either the Rotar or Bertani could

The starting trench was dug with the excavator immediately adjacent to the minefield boundary. The trench was dug 9 - 10 meters wide and 32 meters long. A drainage ditch was cut at one end 1 meter wide which ran down a slope. The other end had the entrance ramp. Excavating passes were made starting at the “far” end and working toward the ramp. Although test personnel were close by, they were not permitted to influence the operator and only observations made by the operator were recorded during the time the system was in operation. In between passes inspections of the area were made and additional observations

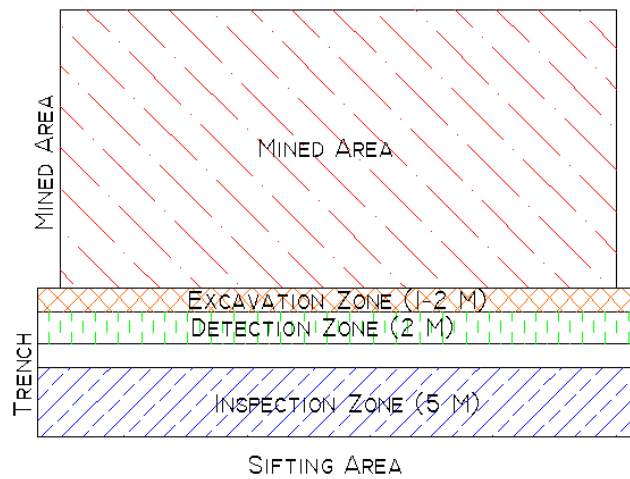
**Figure23. Layout of Working Trench**

When the digging pass was completed, the Vaned Bucket would be removed from the excavator and the Bertani Bucket would be installed. Soil which had accumulated at the base of the wall would be picked up with the Bertani. Use of the Bertani was determined to require the operator to run with the boom nearly perpendicular to the wall. Thus he could pick up soil from a zone approximately three buckets wide before having to move the excavator. After a load was picked up, the cab would rotate 180 degrees with the Bertani over the edge of the pile on the “safe” side. The rotation would always be done to the rear so that the Bertani Bucket never traveled over the path of escape for the

excavator. The sifting action would be started and would continue until only large solid materials (heavy soil clods, roots, mines etc) remained in the bucket. The sifting action required approximately 15-30 seconds. When the sifting was completed, the bucket was again swung in the rearward direction and the contents emptied in the trail behind the excavator. Initially we had hoped to confine the residuals to a narrow band following the excavator tracks; however, experience dictated a wider spread to the residuals to keep the layer thin. In the end the area from the wheel track on the mined side of the trench over to the base of the clean soil pile was used for inspection of residuals. When the sifting pass was completed, the inspection team would again enter the trench and inspect the residuals with metal detectors. In addition to inspecting the residuals pile, a 2 meter zone beginning 1 meter from the wall out to the 3 meter point would be given a final check with the metal detector to ensure no mines had slipped by the process. The overall layout of the working process is diagrammed in figure 23.

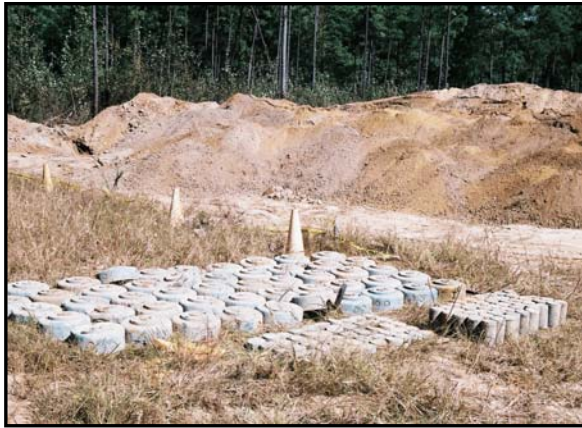
**Figure 24. Mines Recovered In Blind Test**

true failure of the process to separate mines from a hazardous area. In the final analysis the process reliability estimates resulting from the blind test in theory leave no mines unfound, although reliance on good manual detection for 00.9% of the AP mines is implied and acknowledgment is made of the untested threat to equipment from the 00.7% of AT mines which the sifting tool must encounter. All test results were obtained with operators having no previous experience using a digging excavator; this speaks well for the prospects of training indigenous equipment operators in the techniques developed.

The two most undesirable aspects of the mine clearance process with the Sifting Excavator are the pace of operations and the complete rearrangement of the landscape resulting from the excavation. The pile of sifted soil seen in the background of figure 24 is a substantial testament to the operations completed. As slow as the excavation process is, there is no known alternative for finding mines so deeply buried in mineralized soil. There is also every reason to believe that as experience with the system continues to grow, there will be better control of digging unnecessarily deep in places to ensure complete coverage, better control of the equipment motion, and streamlining of the process to speed up the advance rate from the 9 minutes per square meter of surface realized during this program.
