# **All-Purpose Remote Transport System (ARTS)**

## **Capabilities Demonstration**

24-26 September 2001

Night Vision & Electronic Sensors Directorate (NVESD)  
DoD Humanitarian Demining Research & Development Program

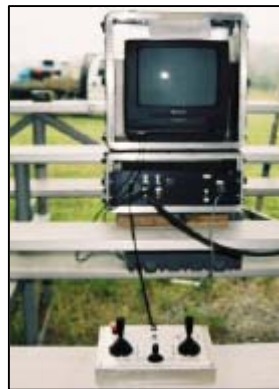
Picture 2 – OCU

The ARTS consists of a prime mover (a Posi-Track™ MD70 tractor, picture 1), the Operator Control Unit (OCU, picture 2), and various tools. Tool attachments include a brush cutter (picture 1), a bucket (picture 4), pallet forks (picture 4), and a backhoe (picture 5). There are more tools available for this system such as a plow, a range clearance blade, and a water cannon, which were not demonstrated. Two cameras on top of the tractor (one camera faces forward (picture 6) and the other rearward (picture 7)) provide operational visibility when operating the vehicle remotely.

The OCU is developed by ARA and provides remote operations of all tractor functions, including engine start/stop, propulsion, lights, and all tool operations. The OCU is comprised of a radio for transmitting command signals to the tractor, a receiver for audio/video signals transmitted from the tractor, a joystick control box, a television monitor with built-in videocassette recorder, an antenna (picture 3, which can be mounted on a portable tripod), and an external generator (minimum of 1kW, not included with the system). The OCU (without the antenna) is packaged in a heavy-duty, weather-tight, shock-isolated case for rugged durability. Additionally, the OCU case contains operator manuals and calibration cables.

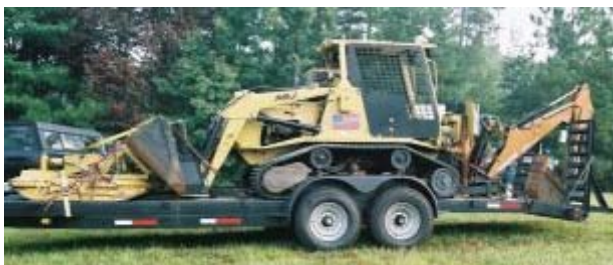
Picture 12- ARTS with tools on trailer

The system was transported on a 24ft trailer that was towed by a commercial Ford F-450 heavy-duty truck to the NVESD/CM test site. The ARTS with all of its tools loaded on the trailer is shown below in picture 12. For better utilization of trailer space and limiting the number of support vehicles required, the tools were stacked upon one another, see picture 13 below. The system does not have any transportation restrictions and does not require highway permits to be transported over land.

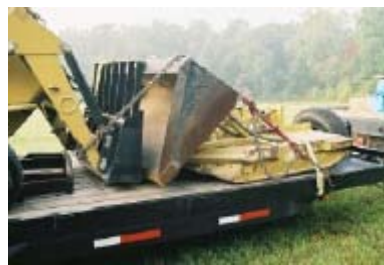
Picture 13- Stacked tools

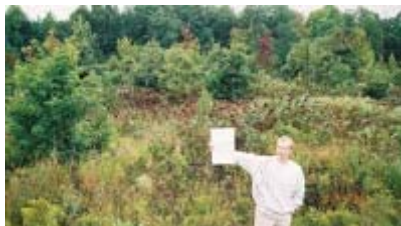
Picture 26 – Category 3 vegetation

The demonstration site consisted of dense sumac brush (up to 2m in height) and various trees on a slightly sloping terrain, see pictures 26 and 27. The variety of trees consisted of gum, maple, and oak and the majority of the trees were 10cm in diameter or less. The site contained one maple tree that was 23cm in diameter, which is considered to be a category 4 vegetation. The site was damp from the previous night's heavy rain, which made a lot of the mulch cling to the cutter rather than being blown away from the cutter. The ARTS cut an area of 36m x 28m in 60 minutes, achieving a cutting rate of 16.8m<sup>2</sup>/minute. Pictures 28 and 29 show the site after the ARTS cleared the vegetation. The ARTS left the majority of the site with a layer of mulch ranging from 2.5 to 7.5cm thick and a few spots with mulch piles ranging from 15cm to 23cm thick. Also, the ARTS left vegetation stumps intermixed with the mulch. The 2.5cm diameter stumps were left as tall as 30cm in height and the 5cm diameter stumps were left as tall as 1m in height. The 23cm maple tree was cut down to 1m, see picture 30. The brush cutter, at times was underpowered because the cutter was overpowered by the amount of foliage and brush that were in the cutter. About 30 minutes into the operation, the foliage that came in contact with the ARTS depressed the emergency stop button. The stop button had to be manually pulled out in order for the ARTS to continue with operations, see picture 31. If this was an actual minefield, this situation could be a dangerous situation for the operator. The contractor recommended that mounting a cage around the stop button would prevent future accidental stops of the ARTS. The ARTS demonstrated clearing category 3 vegetation.

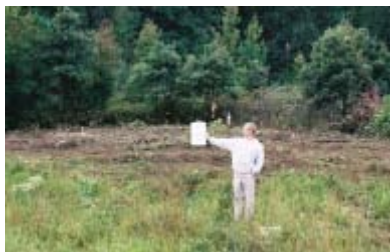
Picture 29 – Cut category 3 vegetation

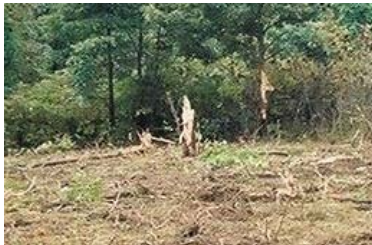
Picture 30 – 23cm diameter maple trunk

The ARTS performed well in clearing vegetation and navigating through terrain from category 1 (easy) through category 3 (difficult). A 23cm diameter tree was cut during category 3 operations. The brush cutter does not have floating capabilities, but with a trained operator, adjustments were made to control the cutter height to allow the cutter to follow the contour of the terrain. The operator's visibility of the ARTS was limited to only what the cameras were

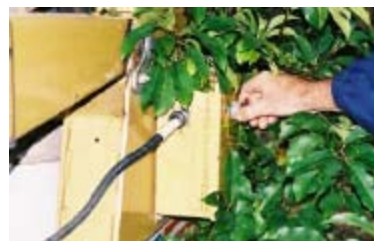
Picture 31 – Resetting emergency stop button

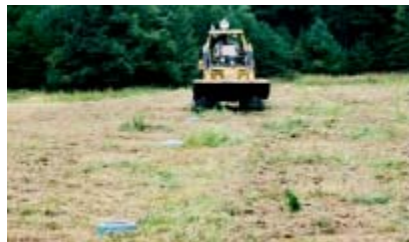
Picture 36 – Surface laid AT mine lane

Three AT mines with smoke fuzes were surface laid in a 25m by 3m lane, see picture 36. The operator manually drove the ARTS over the mines, see picture 37. The track activated all three smoke fuzes. The result demonstrated that the track applied sufficient force to activate the surface laid AT mines.

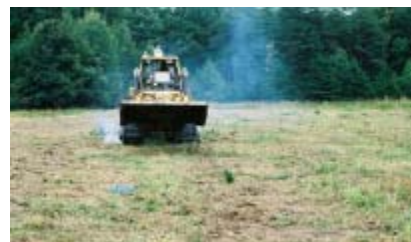
Picture 37 – ARTS activating a smoke fuze

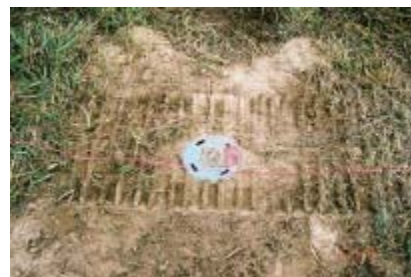
Picture 39 – AT mine not activated

Three AT mines with smoke fuzes were buried flush to the ground. The operator manually drove the ARTS system over the flush laid mines with the rubber track. Only one mine was activated when the ARTS teetered back on the mine while the track encountered a mound on the ground, picture 38 shows the functioned AT mine. Picture 39 shows a non-activated AT mine that was run over with the track.

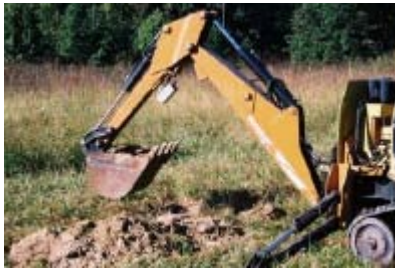
Picture 41 – Backhoe moving dirt

ARA personnel demonstrated the backhoe operation by excavating some dirt. Pictures 40-42 show the backhoe in operation. The excavator can dig as deep as 2.5m deep. The excavation was operated remotely through the OCU. ARA personnel gave each Humanitarian Demining team member an opportunity and instructions on how to operate the backhoe. Every member was successful in learning how to operate the backhoe within 5-15 minutes. However, to become a proficient operator would require additional 8-20 hours of hands-on time, dependent on the trainee's ability.

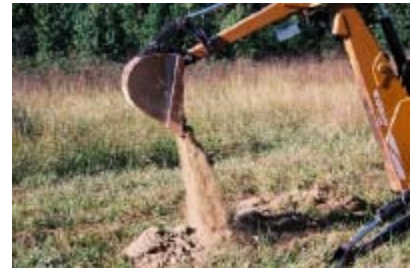
Picture 42 – Backhoe dumping dirt

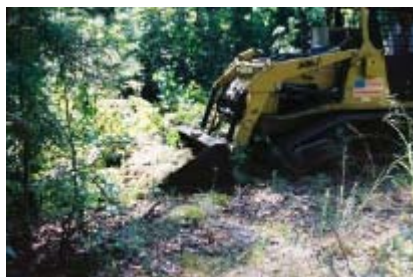
Picture 46 – Bucket moving debris

A tree, approximately 50cm in diameter, was used as the obstacle in the breaching operation. The tree had fallen across the dirt trail (see diagram, above) and started to dry rot. The ARTS with the bucket was operated manually and completed the breaching operation in 5 minutes. The operator used the weight of the ARTS and the hardness of the bucket to tear the tree up and then used the bucket to move and push the tree trunk around until the tree was no longer an obstacle. Picture 46 shows the bucket moving the dirt to the side of the trail and picture 47 shows the passage cleared of the obstacle.

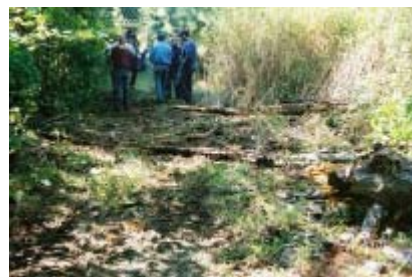
Picture 47 – Passage cleared of obstacle
