# Aardvark Mark IV Joint Services Flail Unit (MKIV)

## Capabilities Demonstration

1-10 October 2001

Night Vision & Electronic Sensors Directorate (NVESD)  
DoD Humanitarian Demining Research & Development Program

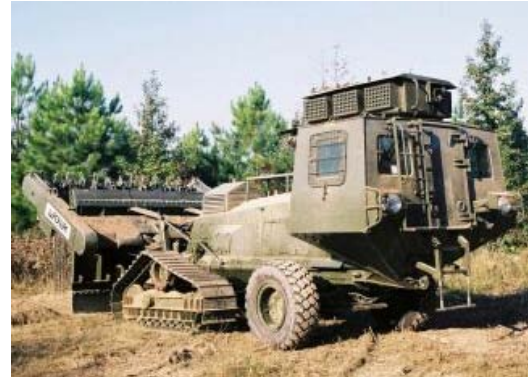
The MKIV system consists of an armored New Holland tractor and a specialized flail assembly. The tractor has a 160hp 6-cylinder in-line turbo charged diesel engine and a 3-speed power take off (PTO). The flail assembly is mechanically driven via a heavy-duty gearbox. The flail can clear a path 3m wide and consists of 72 chains with striker tips.

Picture 1 – Mark IV Joint Service Flail Unit

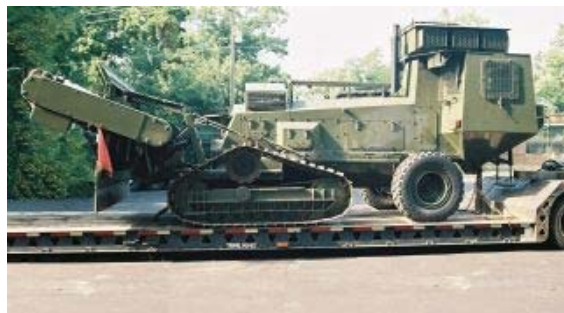
The system was transported by a sea vessel, then by a commercial truck and finally by a government truck to the NVESD/CM test site. Picture 6, below, shows the MKIV on a trailer. The system is transportable by truck, rail, vessel and C-130 aircraft (or other larger aircraft). Due to the width of the flail unit, over road transport restrictions are imposed, and some restrictions may be imposed for rail as well. For transport via a C-130 aircraft, the system must be broken down somewhat (the flail removed from the tractor and the cab roof filter removed, etc.). These procedures are documented in the system technical manual. The system has NATO standard tie down and lift points. The system can maneuver via track or tire configuration and can be changed from one configuration to another within a couple of hours. The tire configuration is better suited for long distance travel as compared to the track configuration for short distances. During mobility and maneuverability tests, the system performed very well. The MKIV system demonstrated the capability to be transportable by truck, sea vessel and aircrafts.

Picture 6 – MKIV on trailer

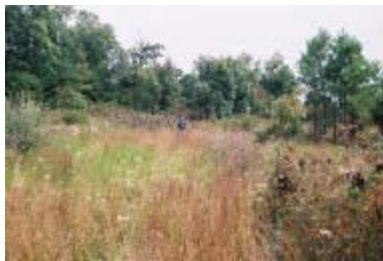
This site consisted of moderate vegetation with brush and saplings (up to 6cm in diameter and ~2.5m in height) on light rolling hard ground. See picture 10, below. The Aardvark MKIV operated at two different speeds while cutting category 2 vegetation. For the first two passes, the MKIV traversed the site at a 1200m per hour and the last pass was traversed at a 191m per hour. At 1200m/hr, the ground penetration depth was ~14cm and at 191m/hr, the ground penetration depth was ~20cm. Picture 11 shows the MKIV cutting category 2 vegetation. The ground was completely mulched and powdery with occasional stubbles ranging from 5cm to 7.5cm in height. Picture 12 below shows the site after the MKIV cut the vegetation. The MKIV cut 479.7m<sup>2</sup> in 26 minutes with a cutting rate of 18.45m<sup>2</sup> per minute. The MKIV lost two chains and one flail head while cutting category 2 vegetation. The MKIV demonstrated the capability of clearing category 2 vegetation.

Picture 10 – Cat. 2 prior to flailing

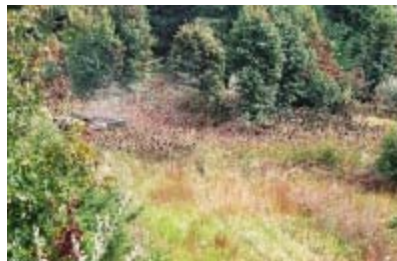
Picture 11 – Initial flailing of category 2

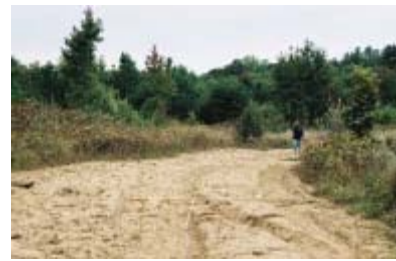
Picture 12 – Cat.2 after flailing

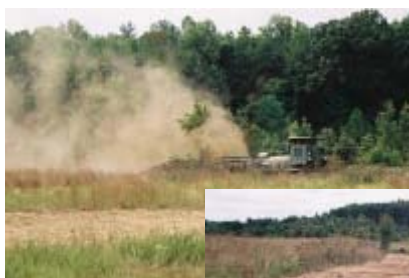
Picture 14 –  
MKIV cutting  
Category 3  
vegetation

See picture 14. In a 30-minute time

frame, the MKIV cut an area of 80m x 6m, with a cutting rate of 16m<sup>2</sup> per minute. The ground was turned into powdery mulch, see picture 15. Ground penetration was between 20cm to 30cm. The MKIV left occasional tree trunks and scattered pieces of trees in the lane. The tree trunks were ~7.5cm in height. During this vegetation clearance operation, the MKIV lost one chain, seven chain links and two cutting heads. The MKIV demonstrated the capability of clearing category 3 vegetation.

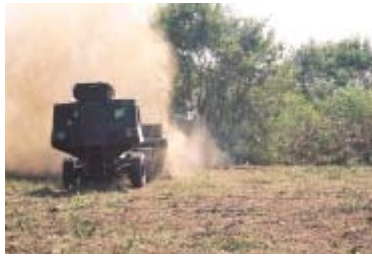
Picture 17 – MKIV cutting category 4

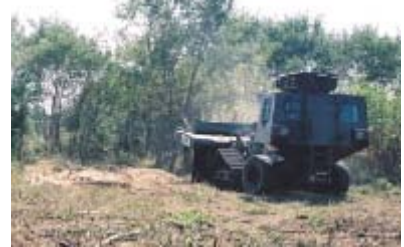
Picture 18 – MKIV's second pass of cat.4

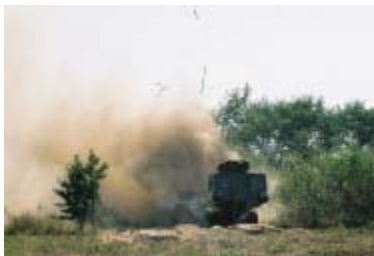
Picture 19 – MKIV throwing debris

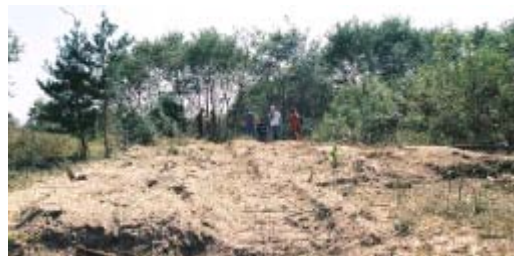
Picture 20 – Category 4, after flailing

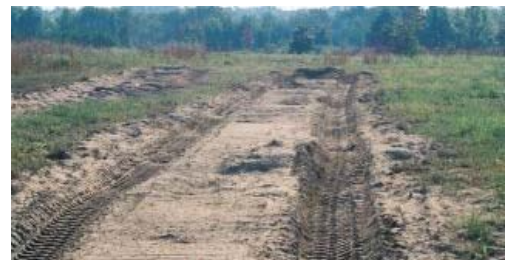
Picture 29 – Lane flailed by MKIV
