**Incident, Action, Recovery, and Recommissioning for  
the 4.5-MJ Pulsed Power Supply Located at the  
Electromagnetic Gun Facility, Barricade C,  
Aberdeen Proving Ground, MD**

**ARL-TR-4088**

**April 2007**

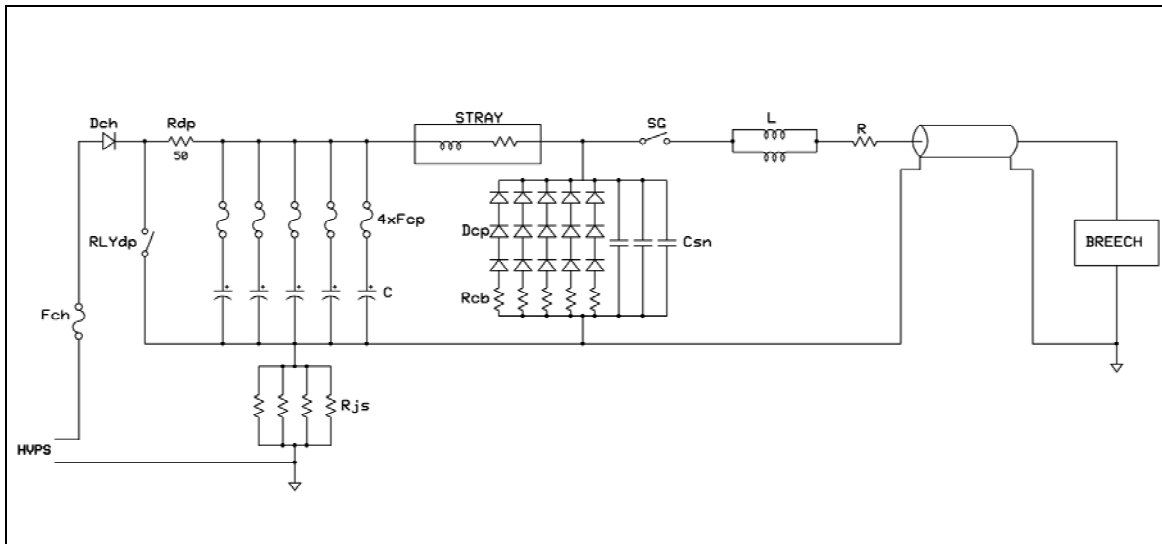
A circuit schematic for one module is shown in figure 2. Capacitors (C) are charged via fuses ( $F_{cp}$  and  $F_{ch}$ ) to an initial voltage. When the discharge is initiated, the output switch (SG) closes, and the current is shaped by the series inductor (L, R). Additional shaping is provided by diodes ( $D_{cp}$ ) placed essentially parallel with the capacitors. The resulting shape of the current in the load has a sinusoidal rise time and an exponential decay. This type of waveform, when used in conjunction with additional similar waveforms, has been found to be advantageous for railgun operation.

Figure 2. Module schematic.

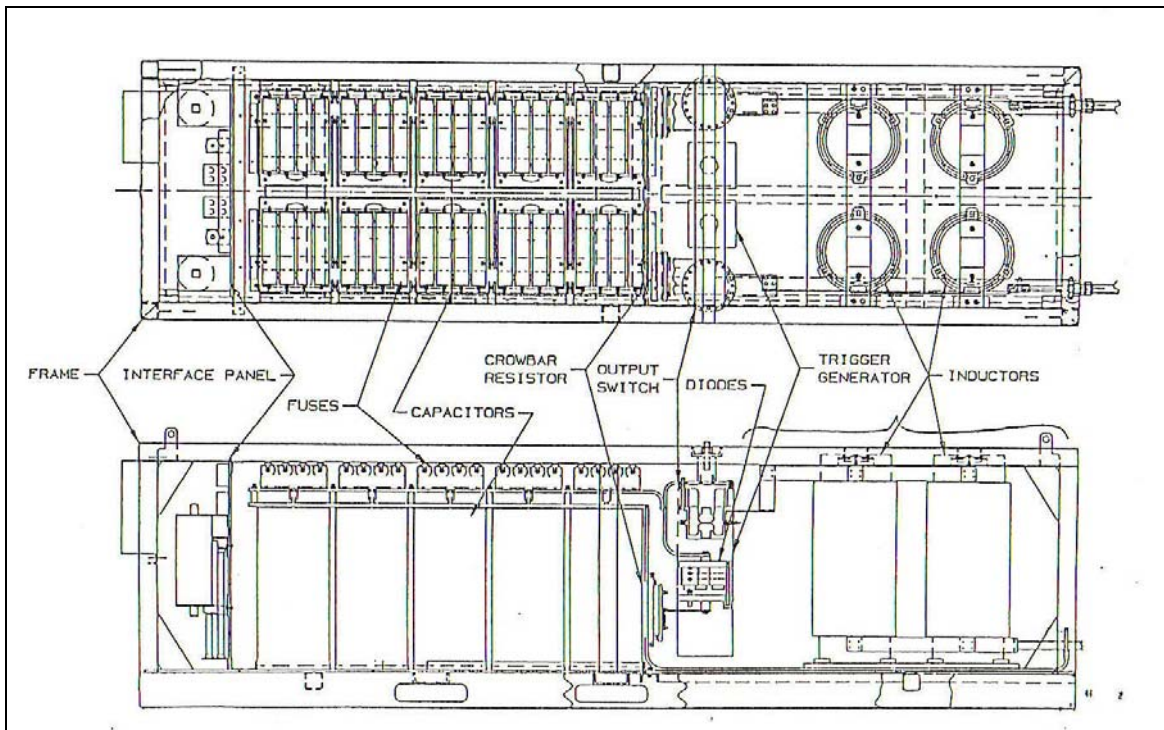
An illustration of the component layout in each rack is shown in figure 3.

Figure 3. Component layout for one rack ( $2 \times 250$  kJ).

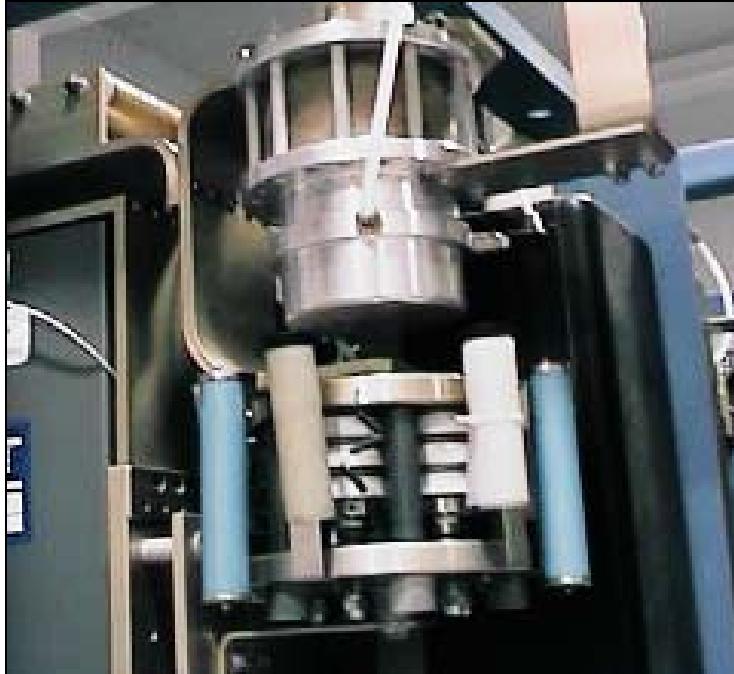
Crowbar diodes are the second most important component in the pulse forming network. Fifteen Brown Boveri avalanche diodes (DSA 908-44 AG), arranged in five parallel stacks with three diodes in series in each one, form a crowbar diode set that protects the capacitors of each module from damaging voltage reversals and provides pulse-forming relevant for railgun operation. Each diode is rated at 4.4 kV and 50 kA for 1-ms half-sinusoid surge currents. Each crowbar diode set is clamped together and evenly distributed between two identical 1-in-thick circular aluminum plates (see figure 4).

Figure 4. Crowbar diodes (lower image) and output switch, ST-300 (upper image).

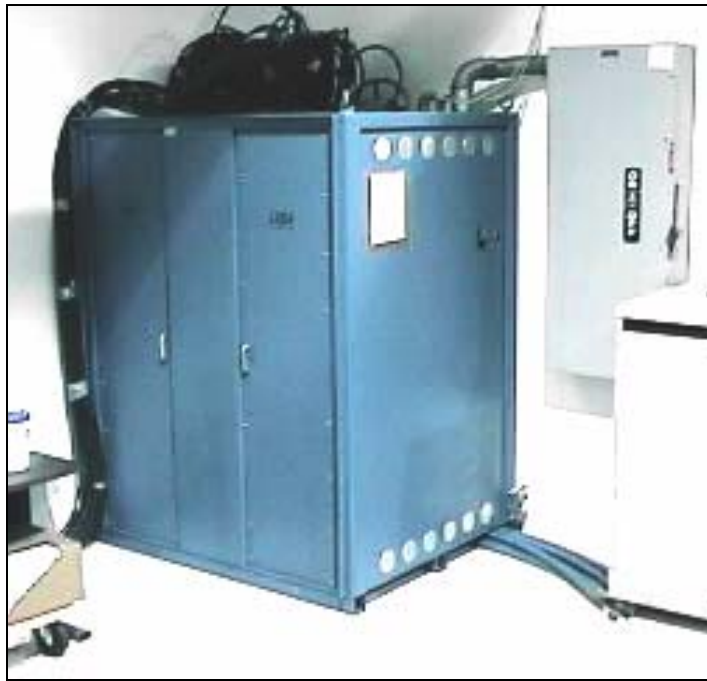
The HVCPS (Hipotronics Inc., Brewster NY, model no. 811-15A) shown in figure 6 is rated for 11 kV and 15 A DC. It is located in the same room as the 18 modules. The charging time for the PPS to reach full voltage (11 kV) can be as short as 60 s, with a maximum current of 15 A. Lower currents are used when charging to lower voltages and/or fewer than 18 modules. The capacitors are charged through a 50- $\Omega$  resistor ( $R_{dp}$ ) located in each module (see figure 2).

Figure 6. HVCPS.

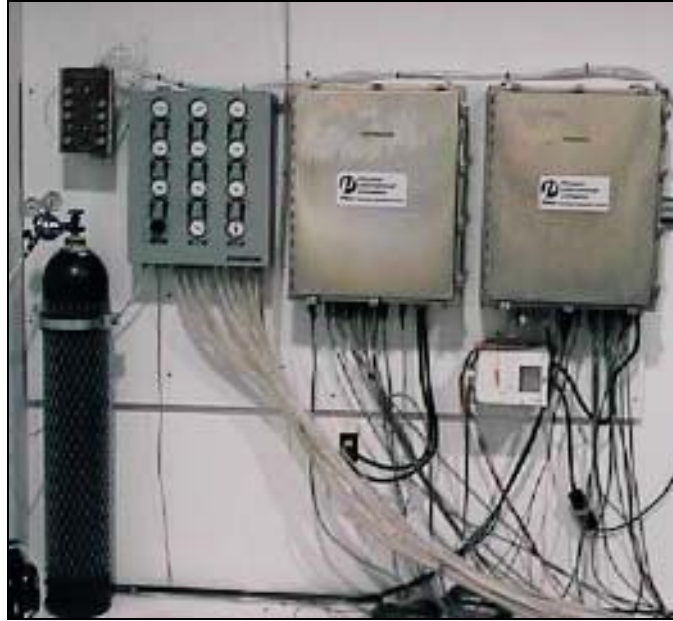
communication between the HVCPS and the consol control via the interface J-box (figure 9). All communications to and from the control console, to the interface J-box, and to the control boxes at each module are via fiber optics.

Figure 9. Dry gas bottle and its distribution panel, interlock box, and interface J-box (left to right).

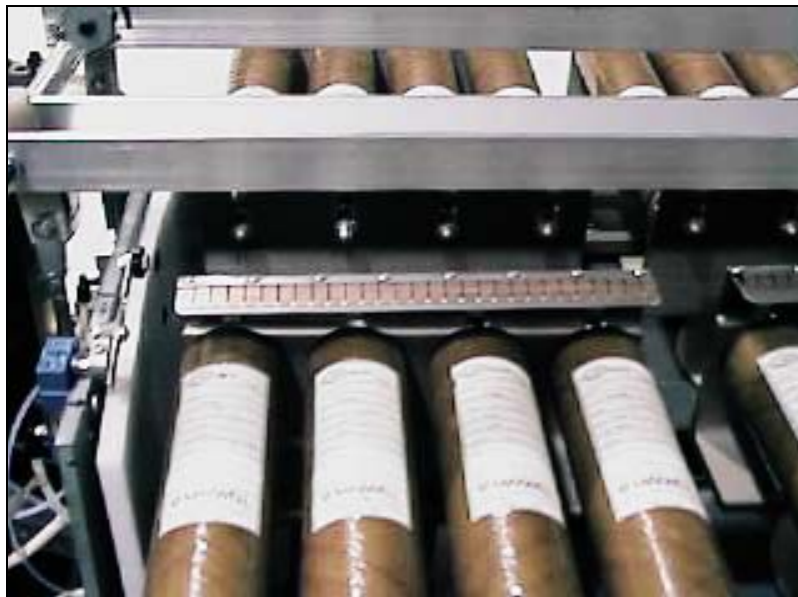
A pneumatically actuated shorting mechanism was added to each of the 18 modules. Each mechanism consists of an aluminum channel and two air cylinders positioned at opposite ends of the rack. In the shorted position, the channel makes contact on an array of copper “finger” contacts (see figure 10) secured to each of the five mounting brackets on each capacitor's output terminal. A control lever, centrally located behind a concrete barrier, allows all of the capacitors to be shorted.

Figure 10. Shorting system.

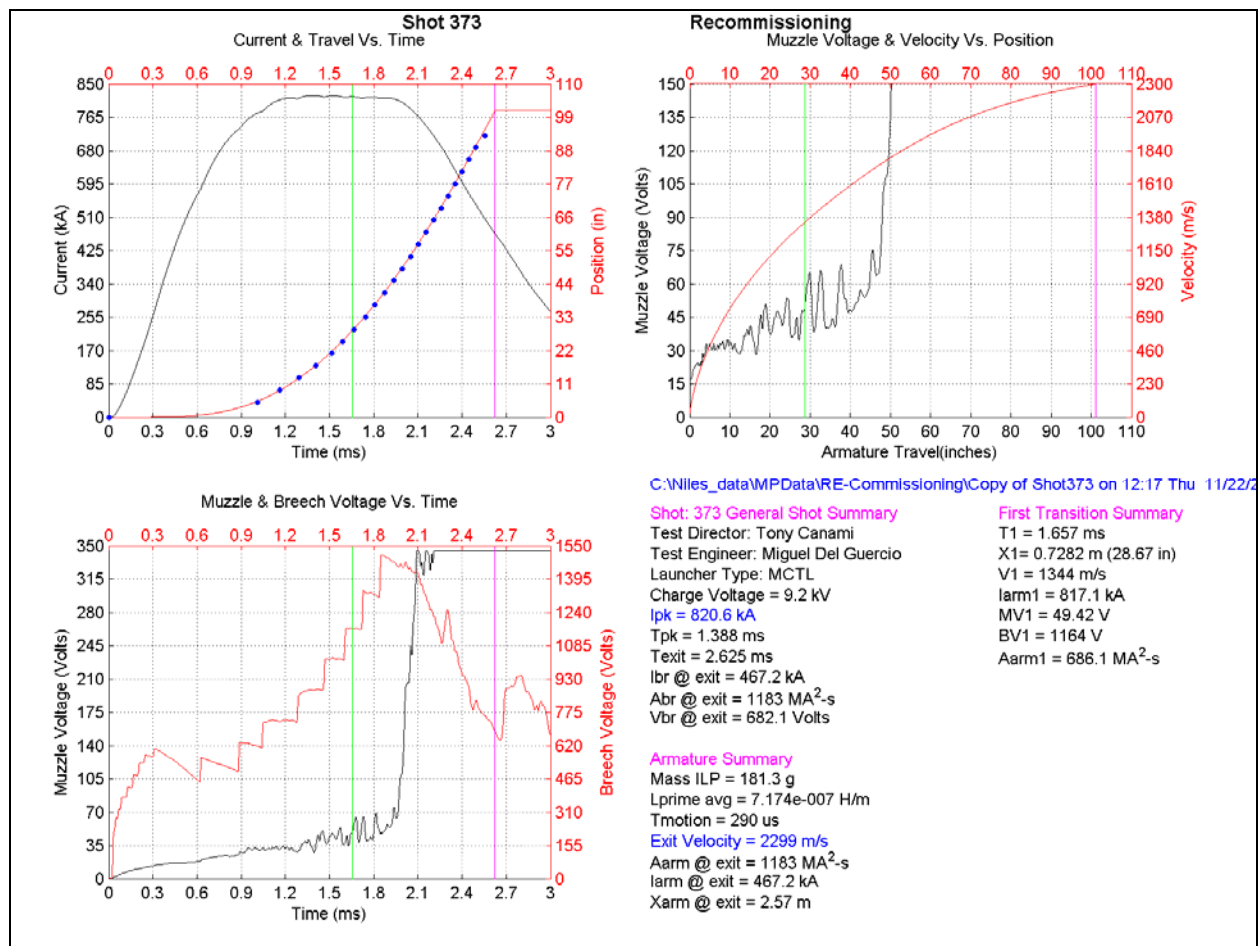
The final shot of the commissioning tests was executed at a charge voltage of 9.2 kV. The summary page from the data acquisition system is shown in figure 21. All data were successfully captured and analyzed without incident.

Figure 21. Data summary page from commissioning shot at 9.2 kV (mCTL 373).
