**AFRL-ML-WP-TP-2007-418**

**INCREASING THE LASER INDUCED  
DAMAGE THRESHOLD OF SINGLE  
CRYSTAL ZnGeP<sub>2</sub> (PREPRINT)**

# Increasing the Laser Induced Damage Threshold of Single Crystal ZnGeP<sub>2</sub>

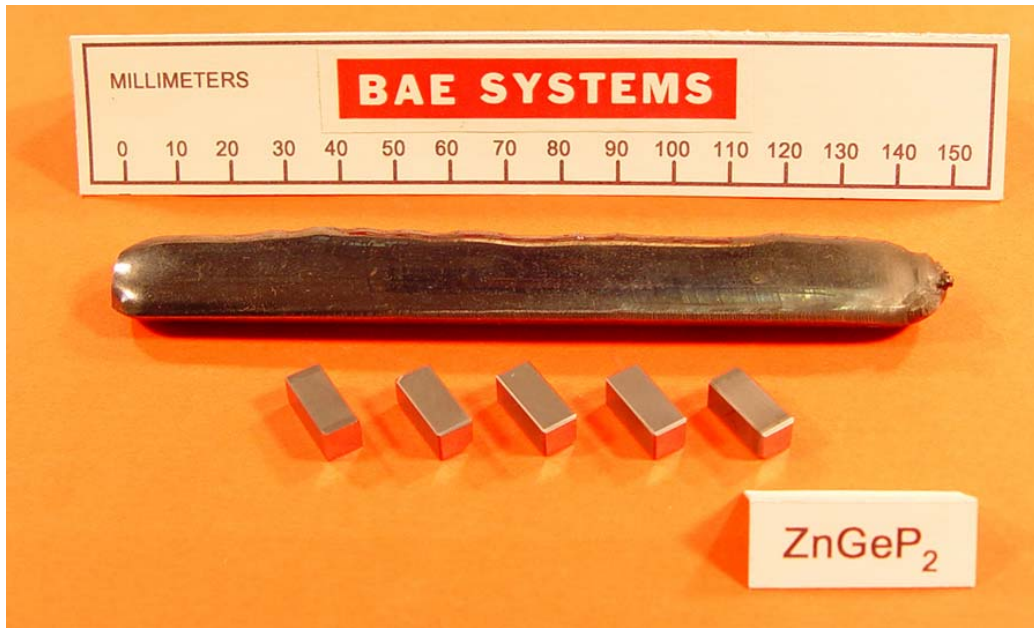
Fig. 1

Figure 1. Photograph of ZGP single crystalline boule and OPO samples.

ZGP OPO samples were fabricated from single crystal boules grown by the horizontal gradient freeze (HGF) method in transparent furnaces under low temperature gradients as described by Schunemann et al.<sup>2,8</sup> A picture of a typical ZGP single crystal boule along with typical OPO samples is shown in Fig. 1. Samples were cut from several different boules and measured 6 mm x 6 mm x 13 mm. The 6 mm x 6 mm faces were polished to a laser optic quality finish using either an
