# FINAL TECHNICAL REPORT

## FIELD DEMONSTRATION OF THE HOT GAS DECONTAMINATION SYSTEM

*Report No. SFIM-AEC-ET-CR-95011*

February 1995

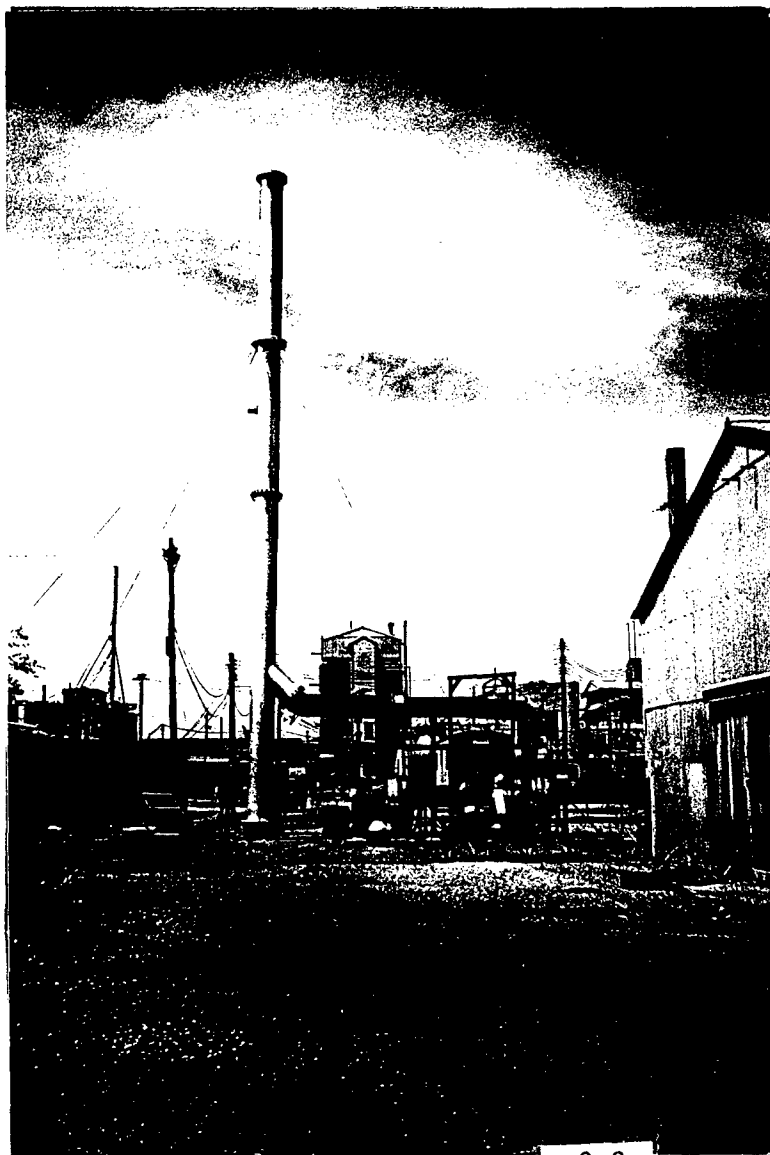
STACK ASSEMBLY
