## **Grout Impregnation of Pre-Placed Recycled Concrete Pavement (RCP) for Rapid Repair of Deteriorated Portland Cement Concrete Airfield Pavements**

Travis A. Mann, Reed B. Freeman, and Gary L. Anderton

April 2007

Final report

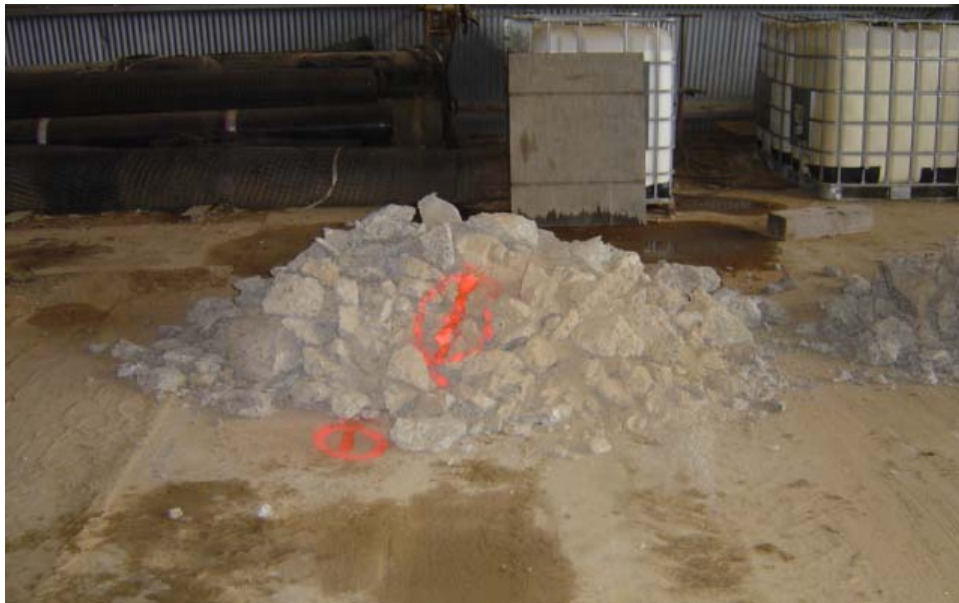
Photo 1. RCP material after demolition and excavation from the repair hole

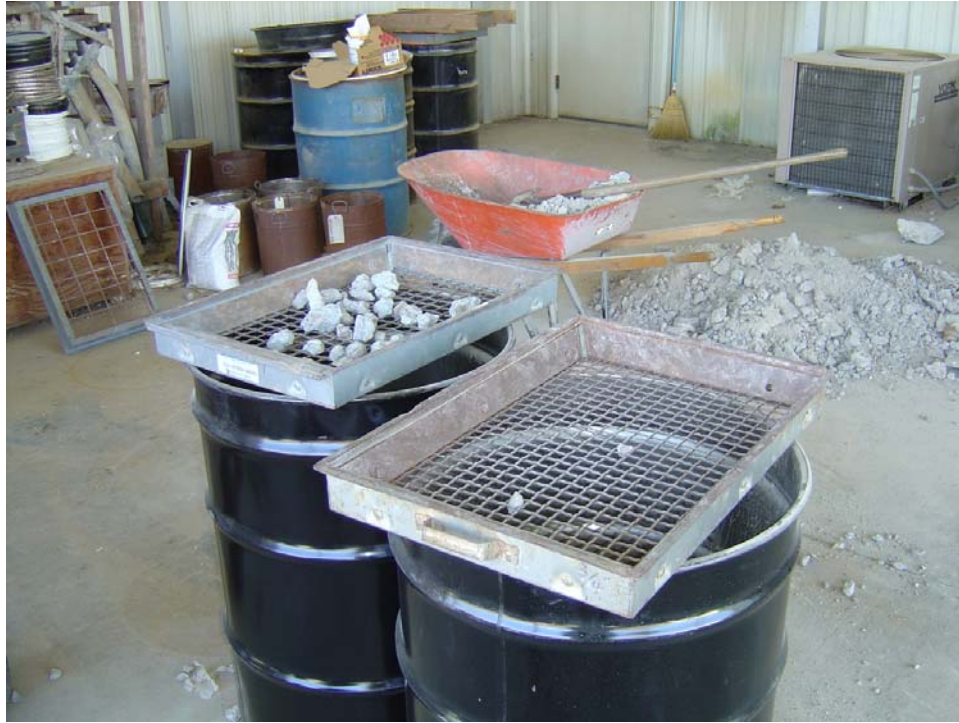
Photo 2. Processing the RCP to determine gradation

The material was processed to determine the particle size distribution after demolition and excavation from the repair hole. After removal, the material ranged from large chunks 150 to 225 mm (6 to 9 in.) in diameter to fine particles passing the 0.075 mm (No. 200) sieve. Initially, the material was separated into four categories using three sieve sizes (Photo 2). The largest fraction of material consisted of the large chunks that were retained on a 76.2 mm (3 in.) sieve. The second fraction passed the 76 mm (3 in.) sieve and was retained on the 25.4 mm (1 in.) sieve. The third fraction passed the 25.4 mm (1 in.) sieve and was retained on the 19.1 mm (3/4 in.) sieve. The fourth fraction

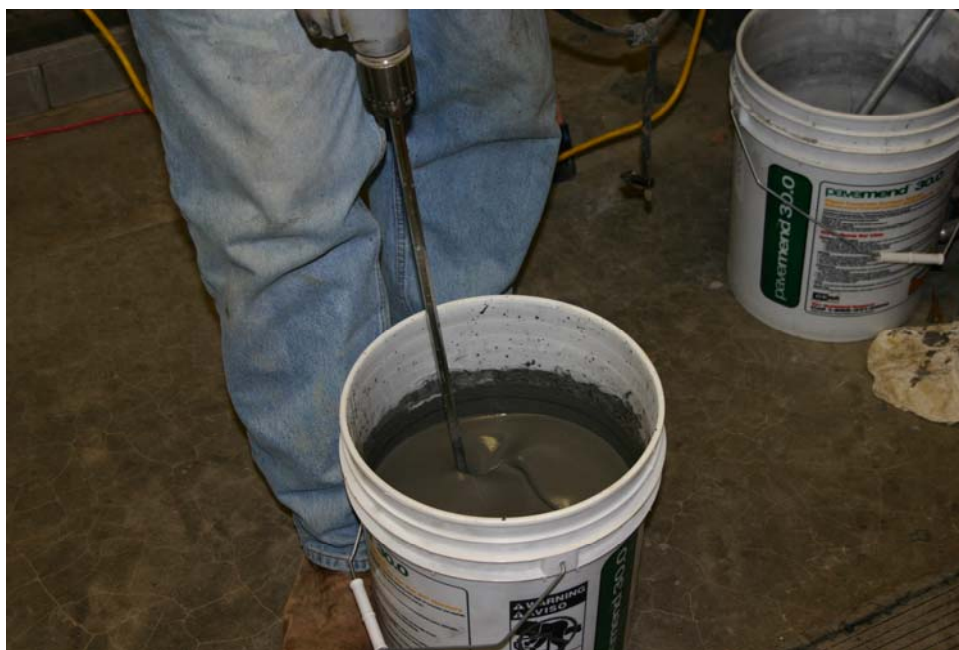
Photo 3. Mixing a single batch of Pavemend™ in its own container with a drill and paddle mixer

Pavemend™ is mixed in small quantities by using a standard drill with a paddle mixer capable of at least 300 rpm. Single batches are mixed by adding 3.8 liters (1 gal) of water to the 20.4-kg (45-lb) buckets and mixing in the original container until a target temperature of 35°C (95°F) is reached (Photo 3). The temperature is best monitored using a hand-held infra-red thermal gun with a digital display, as per the manufacturer's instructions. Under normal conditions (21°C or 70°F), this mixing process requires approximately 9 to 10 minutes.

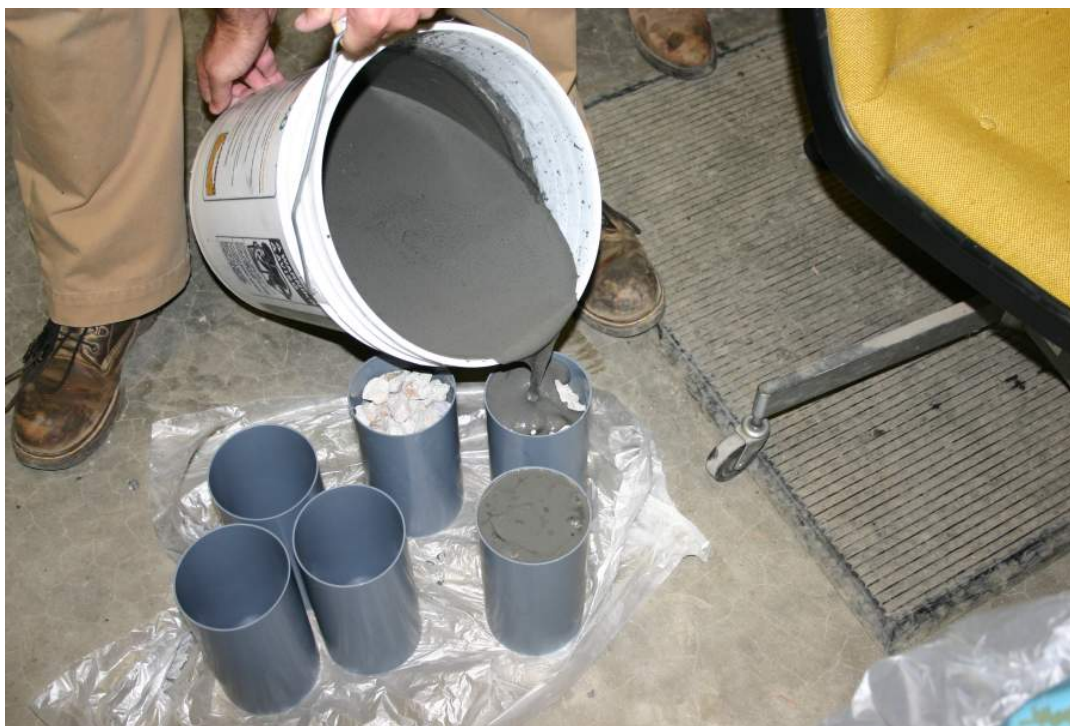
Photo 4. Pouring the Pavemend™ 4-in. by 8-in. samples for unconfined compressive testing

Three replicates of 102- by 203-mm (4- by 8-in.) samples were cast (Photo 4) for each of four test ages (3 hours, 24 hours, 7 days, and 35 days) to determine the rate of strength gain. The samples were stored in a temperature and moisture controlled facility in accordance with ASTM C 192. The average results of the compressive testing are shown in Figure 2.

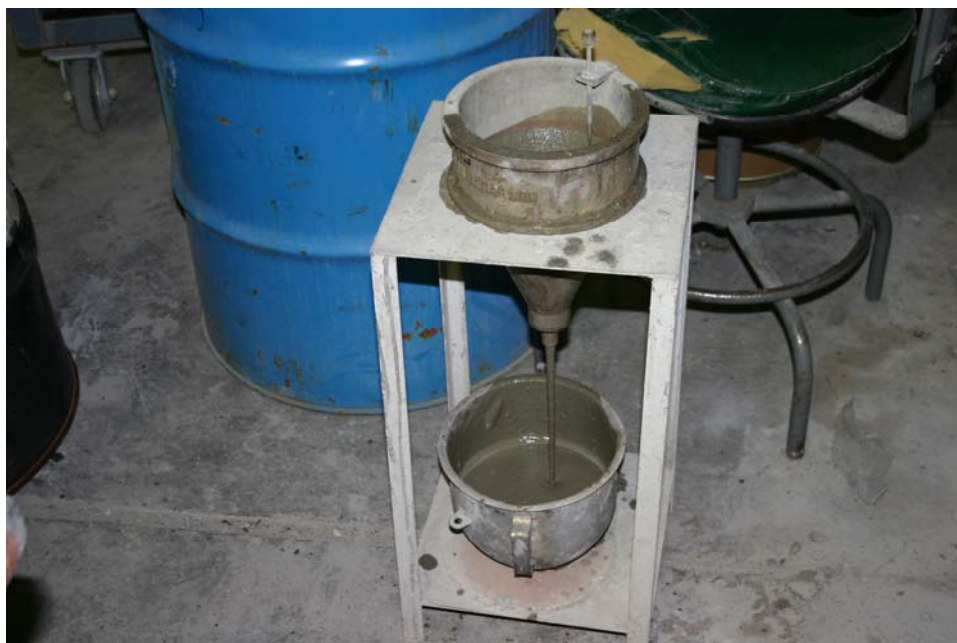
Photo 5. Flow cone test used in ASTM C 939 procedure

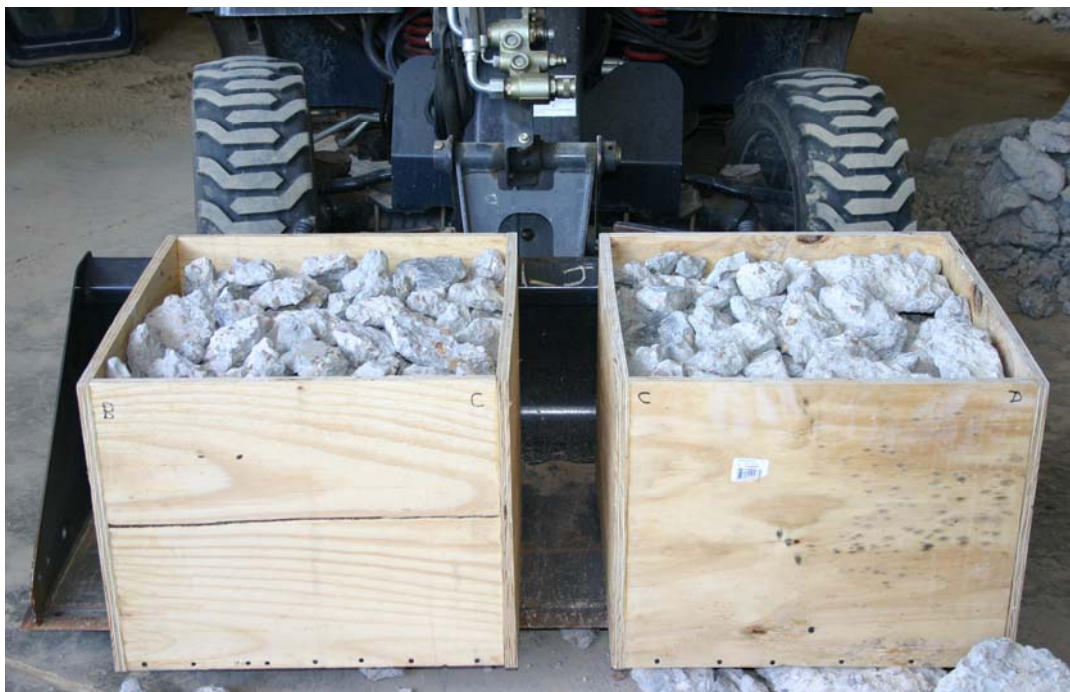
Photo 6. Plywood boxes used for impregnation tests filled with Recycled Concrete Pavement (RCP)

this chapter. The boxes were filled to the open top and a straightedge was used to ensure that no particles extended above the surface of the box. The boxes are shown in Photo 6.

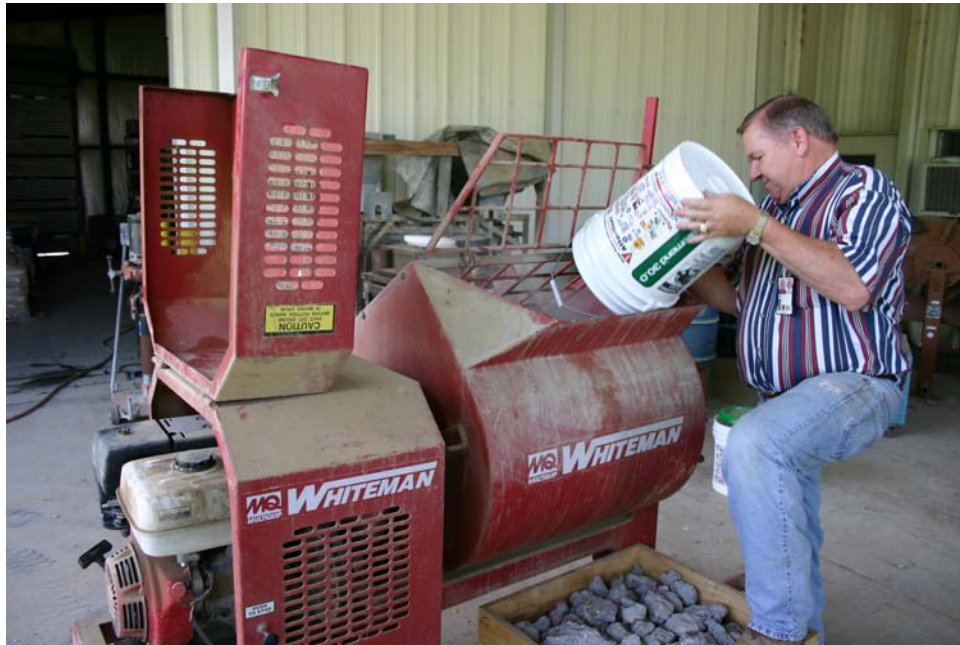
Photo 7. Mixing Pavemend™ material in portable grout mixer

Box 1 contained 152.4 kg (336 lb) of RCP material and was filled with Pavemend™ as the grout material. The Pavemend™ was mixed using a portable grout mixer (Photo 7). Two batches were mixed, with each consisting of four buckets of Pavemend™ and 15.1 liters (4 gal) of water.

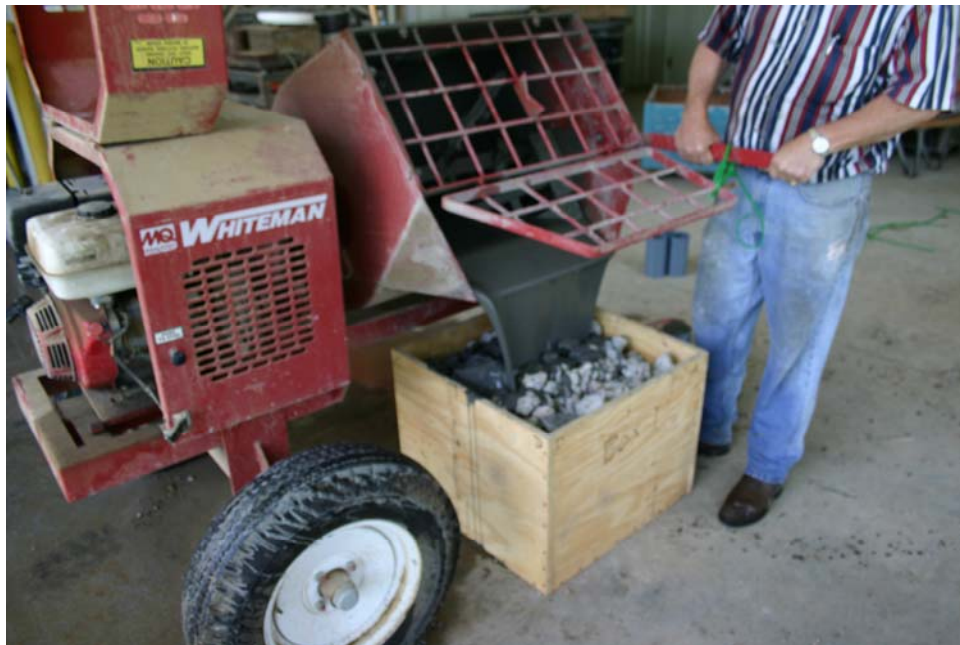
Photo 8. Pouring the Pavemend™ 30 material in the plywood boxes after mixing

Once the mixture reached the target temperature, it was poured into the box (Photo 8) and the mixer was immediately washed with water to eliminate material from setting inside the mixer. Once clean, the second batch was added to the mixer and completed in the same manner. Both batches started with material temperatures of approximately 21.1°C (70°F), and it took 13 minutes of mixing for each batch to reach the target temperature.

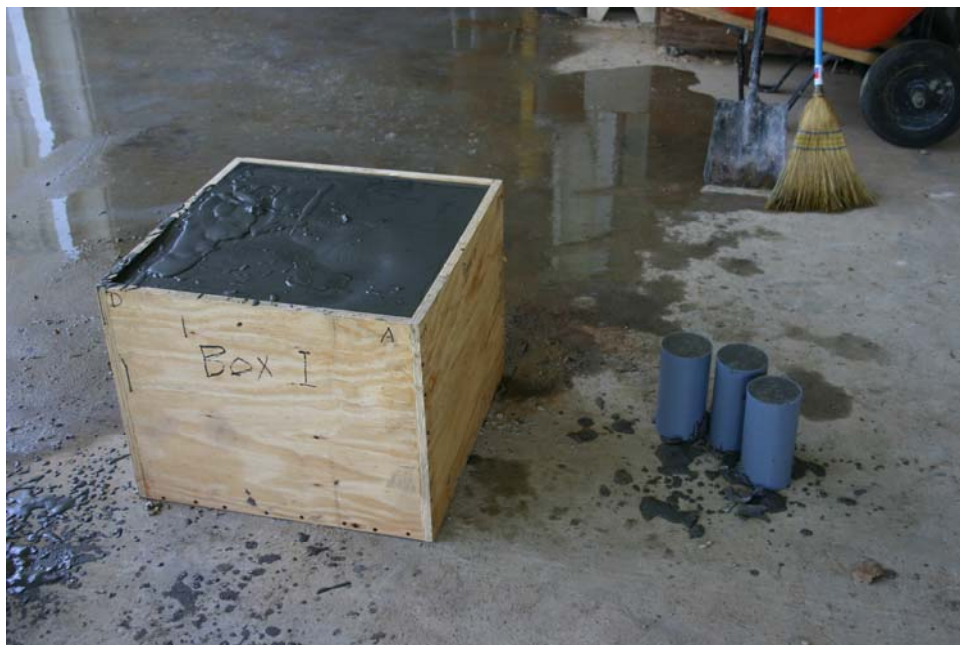
Photo 9. Box 1 filled with PaveMend™ 30 and Recycled Concrete Pavement (RCP)

After pouring the majority of the second batch into the box, care was taken to achieve a smooth surface on the top of the sample. As the last of the material was leaving the mixer, the material became very thick and difficult to pour. Some imperfections can be seen on the surface of the Box 1 sample (Photo 9) due to the material setting prior to finishing the pour.

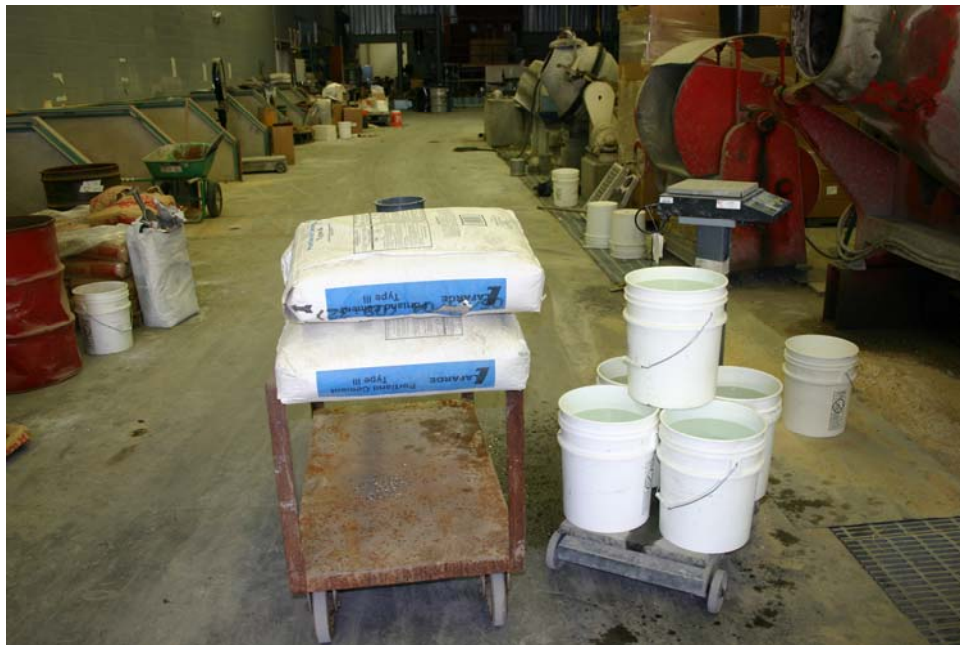
Photo 10. Obtaining the correct amount of water for proportioning the Type III portland cement grout

Box 2 contained 165 kg (364 lb) of RCP material and was filled with Type III portland cement grout. In order to ensure that there would be enough material to fill the box as well as conduct several other laboratory tests, a mix of 0.14 m<sup>3</sup> (5 ft<sup>3</sup>) of material was batched. The grout was obtained by mixing 173.0 kg (381 lb) of Type III cement with 86.5 kg (191 lb) of water in a large cylindrical grout mixer that contained a pneumatic paddle type agitator located in the bottom of the mixer. The materials were weighed out on portable scales (Photo 10) and then mixed in the grout mixer for approximately 10 to 12 minutes. The material was then poured into Box 2 via a spigot in the bottom of the mixer until the box was completely filled (Photo 11). Some bleed water was observed on the surface of the Box 2 sample within several hours after the initial set of the grout.

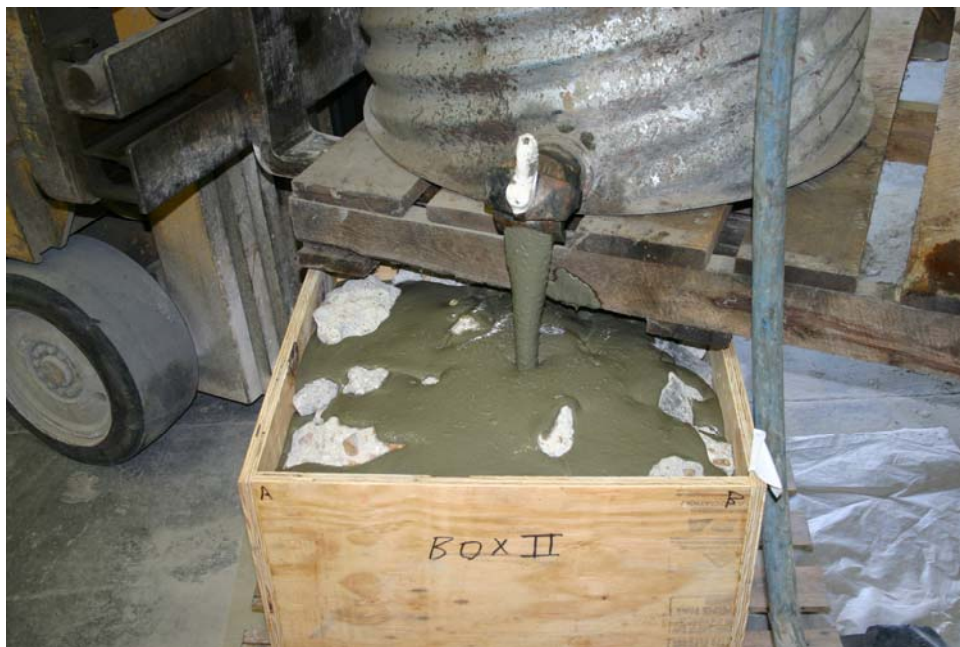
Photo 11. Pouring the Type III grout into Box II after mixing

A flow cone test (ASTM C 939) was conducted on the Type III grout and had a measured flow time of 35 seconds. Although the ASTM C 939 standard states that this test method may not be appropriate if the time of flow exceeds 35 seconds, it was used anyway due to the lack of another quick, easy, and repeatable test to measure how well a grout will penetrate voids in this type of repair. Although the grout had a faster flow time than Pavemend™ 30 (which is normally around 45 seconds), it didn't appear to penetrate the voids as easily and seemed to cling to the debris as it flowed down causing it to penetrate slower than the Pavemend™.

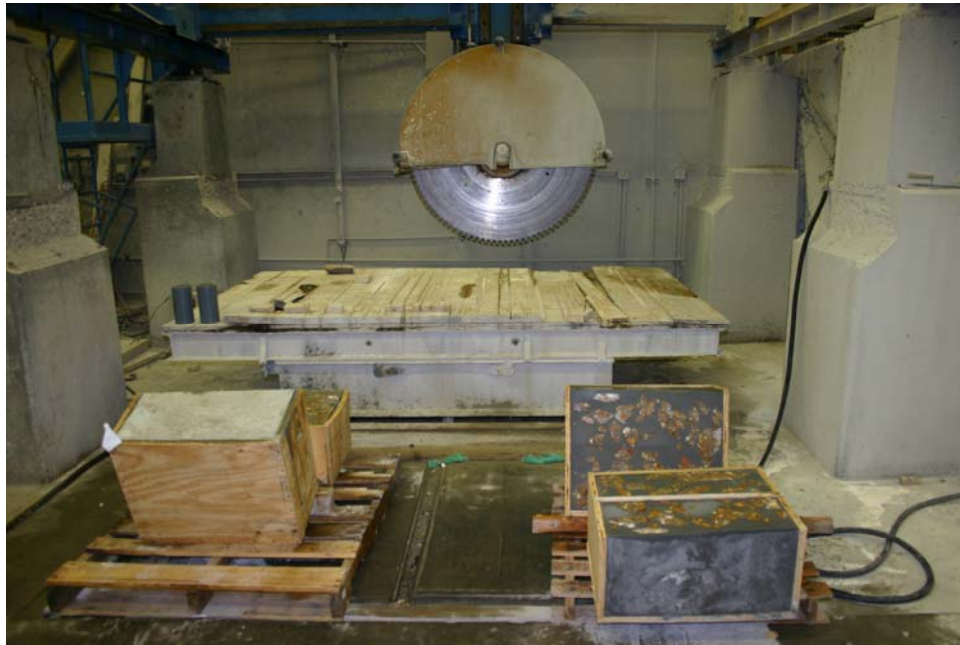
Photo 12. Large diameter concrete saw used to slice the box samples for inspection

After curing for several days, the boxes were placed under a large diameter concrete saw and were cut down the middle into two pieces for inspection (Photo 12). The grout materials successfully penetrated both box samples all the way to the bottom. The Pavemend™ material in Box 1 appeared to bond very well with the RCP in the box and no noticeable inconsistencies were observed (Photo 13).

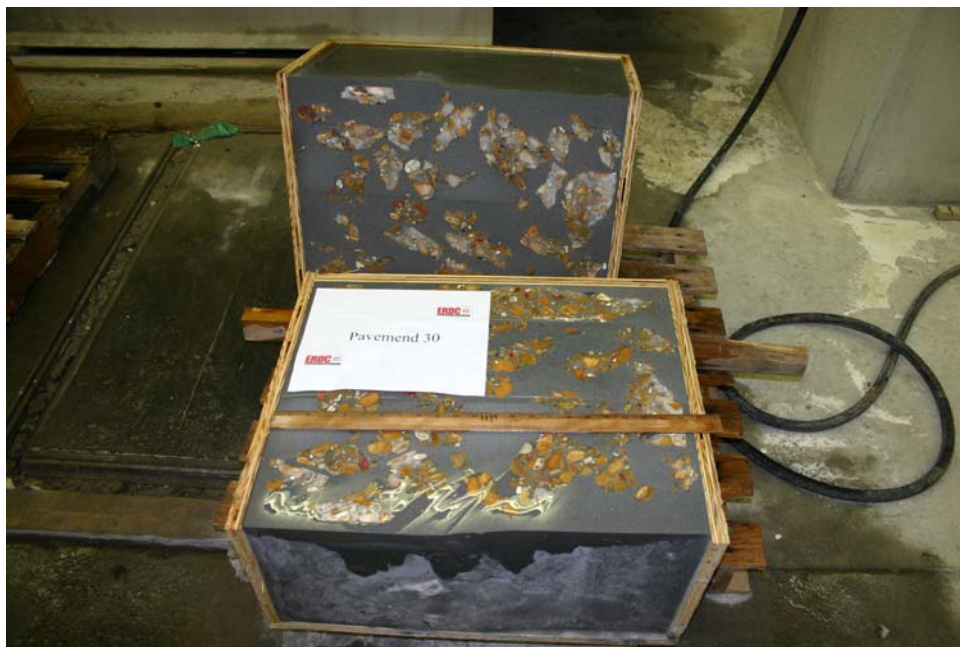
Photo 13. Box 1 cut in half to permit inspection of impregnation

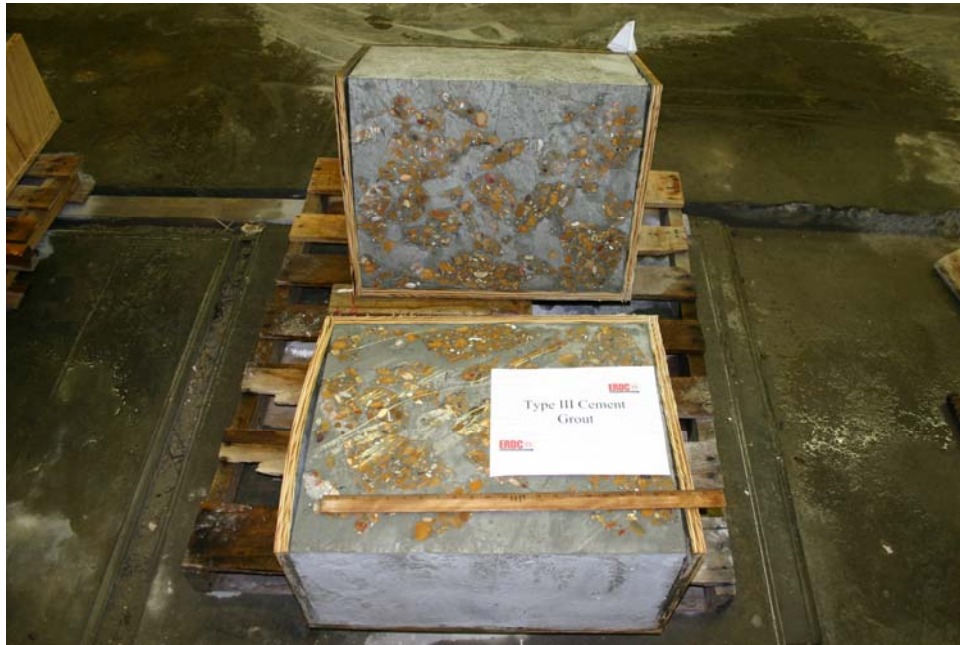
Photo 14. Box 2 cut in half to permit inspection of impregnation

The Type III grout in Box 2 appeared consistent throughout the box as well; however, some air voids were noticeable on the underside of several pieces of RCP aggregate (Photo 14). This is due to a combination of the slow-moving grout encapsulating the aggregate and trapping air bubbles underneath as well as bleed water which gets trapped underneath the aggregate as it rises to the surface. These air voids could be expected to weaken the bond between the grout and the aggregate; however, they appeared to be rather sparse and the impact is therefore expected to be negligible.

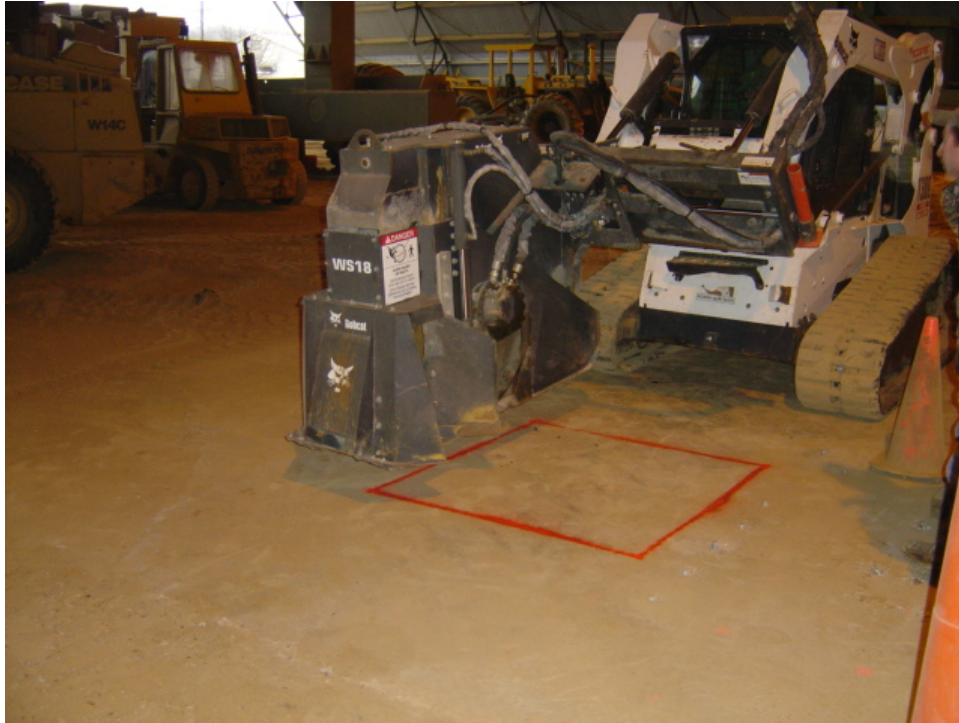
Photo 15. The outline of the repair marked with fluorescent paint

The first step in the rapid repair process is to identify the area of failed pavement and mark the area to be repaired. ETL 02-19 (Headquarters, Air Force Civil Engineering Support Agency, 2002) describes the procedures used to evaluate pavements in a contingency environment and should be used to determine the areas in need of repair. The marked area should extend slightly beyond the visibly distressed area to ensure that the repair will be in contact with sound concrete. It is helpful to mark the outline of the repair with a fluorescent paint so that the repair is visible to operators during the sawing operations (Photo 15). The repairs in this study were excavated using a Bobcat™ skid steer type loader with several attachments.

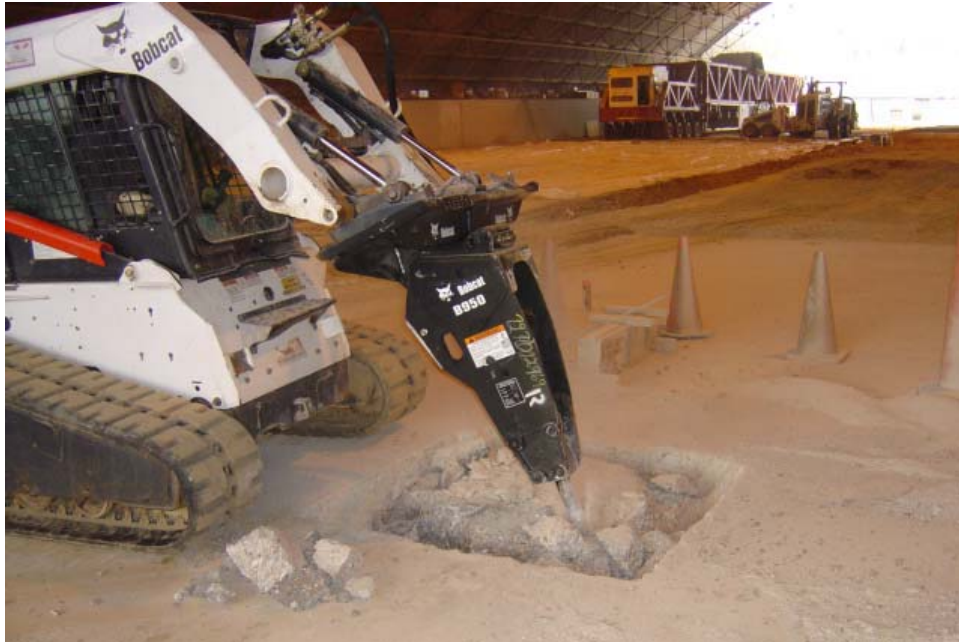
Photo 16. Pavement breaker attachment breaking the interior of the repair

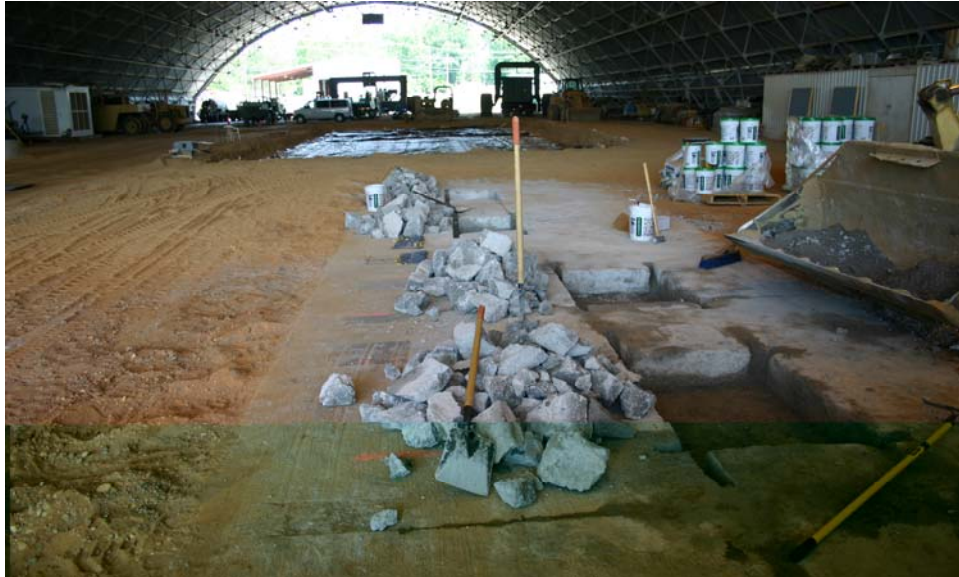
Photo 17. RCP excavated from the smaller slab for Repairs 5 through 8

penetrate the full depth of the slab, which produced much more uniform pieces of RCP that were approximately 152 to 229 mm (6 to 9 in.) in diameter (Photo 17).

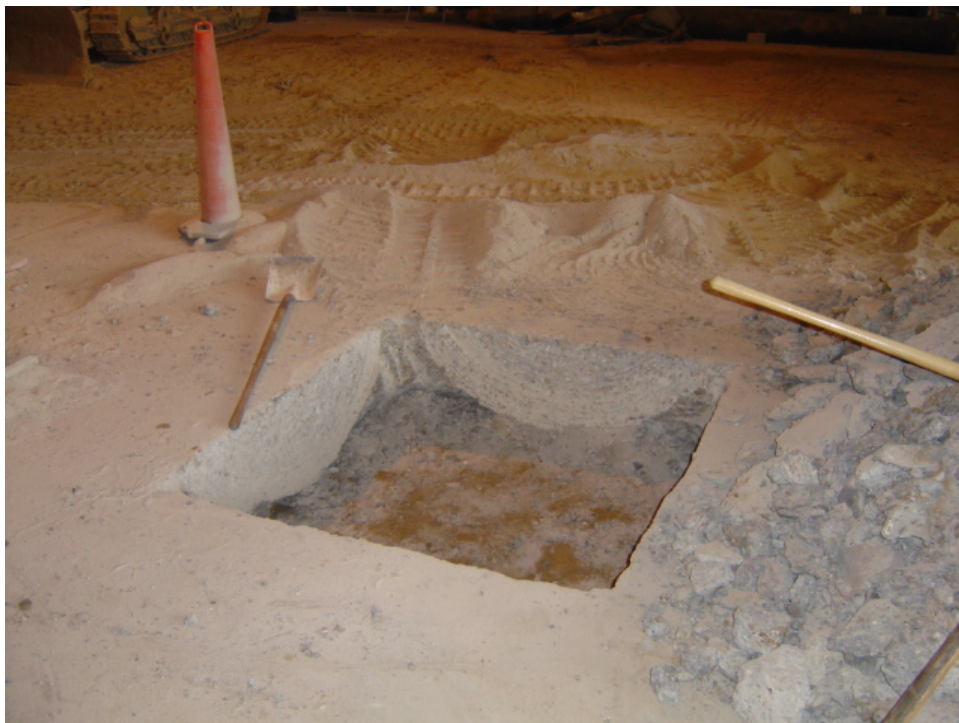
Photo 18. Repair hole after removal of the deteriorated section

Once removed, the loose material was placed next to the repair. Photo 18 shows one of the repairs in the larger slab after the removal of the deteriorated section and Photo 19 shows the pile of material removed from the interior of the repair. The larger slab produced a large amount of material which was smaller than 51 mm (2 in.) and therefore required processing before the material could be placed back into the repair. In contrast, the smaller slab only produced a minimal amount of material smaller than 51 mm (2 in.), and therefore did not need to be processed. The material was simply placed back in the hole once it was properly prepared.

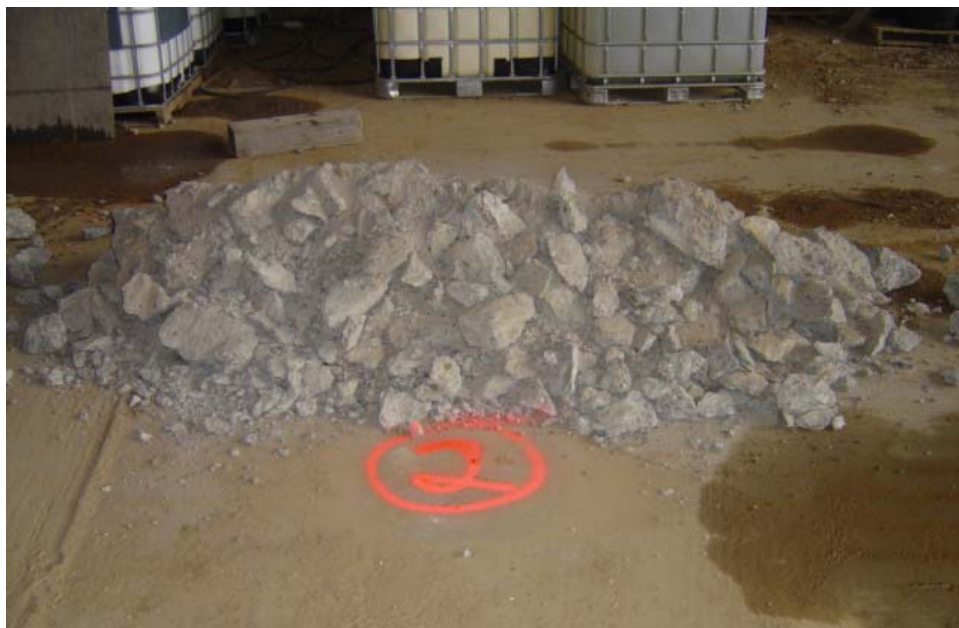
Photo 19. The RCP material removed from Repair 2

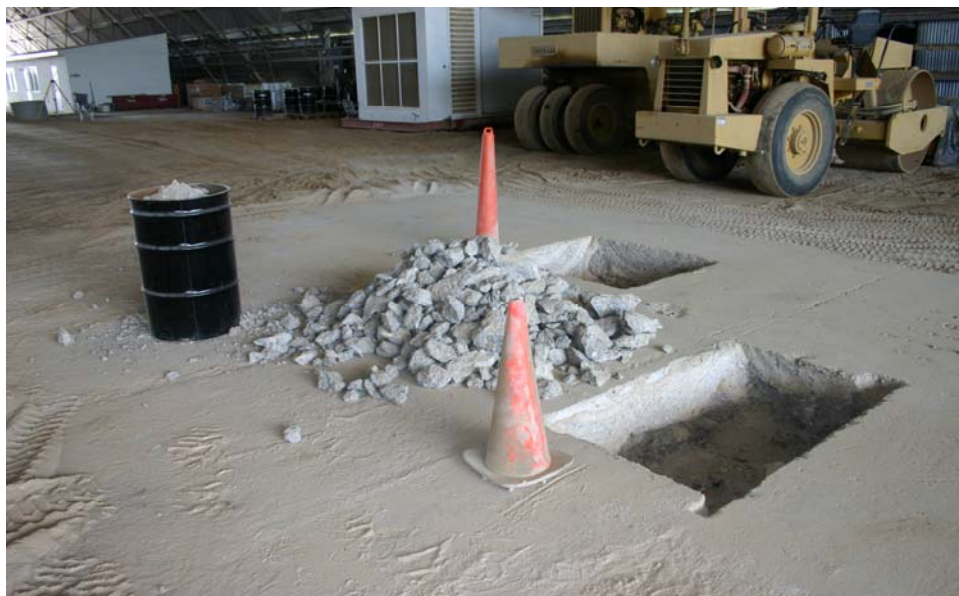
Photo 20. Unusable material screened into large container (black drum)

If the material being removed from the repair contained material smaller than 51 mm (2 in.) in diameter, then it was screened to remove the unwanted smaller fraction before it was placed back in the hole. This ensured a sufficiently porous gradation that allows the grout materials to penetrate the full depth of the repair. This screening process was accomplished as the material was removed so that it was ready to be placed immediately back in the hole and required only single handling. For this study the screen was placed over a large container and the material smaller than 51 mm (2 in.) was allowed to fall into the container for easy disposal once the repair was complete (Photo 20). The usable portion of the RCP was then placed next to the repair and was ready for use. Although not done in this study, if a water source is available and the material is contaminated with soil or dust as a result of the demolition process, it should

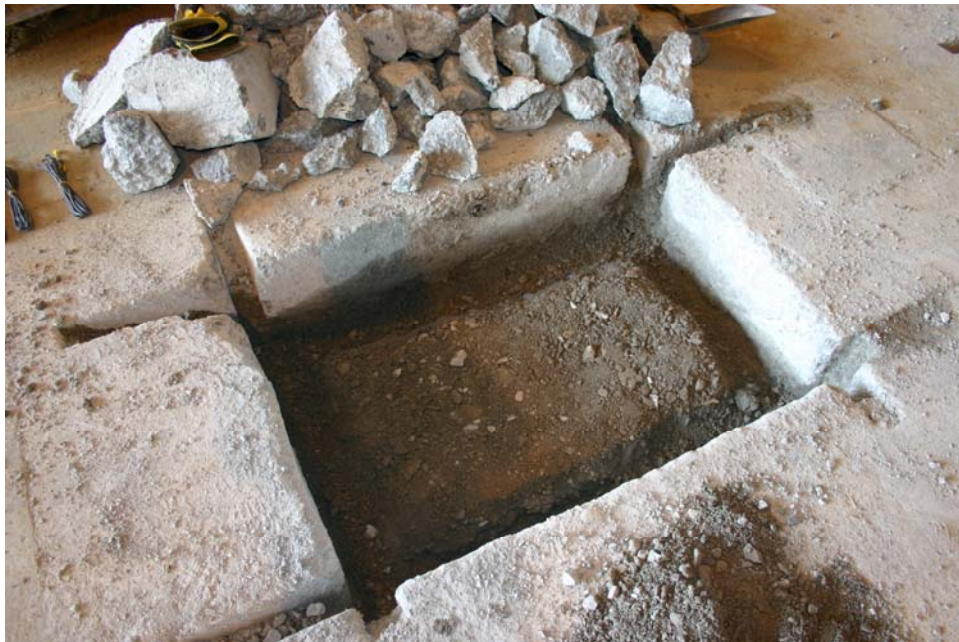
Photo 21. Repair 8 with thickened edge prior to RCP placement

The process of undercutting the existing concrete was attempted with hand tools and was very difficult to achieve due to the small working area and the tendency of the material to roll back into the undercut area. A decision was made to simply install a 102-mm (4-in.) trench around the outside of the repair which would provide a thickened edge on the outside of the repair slab. Photo 21 shows this thickened edge technique for Repair 8. Information relating to the performance of the repairs as a result of the level of preparation is discussed later in this chapter.

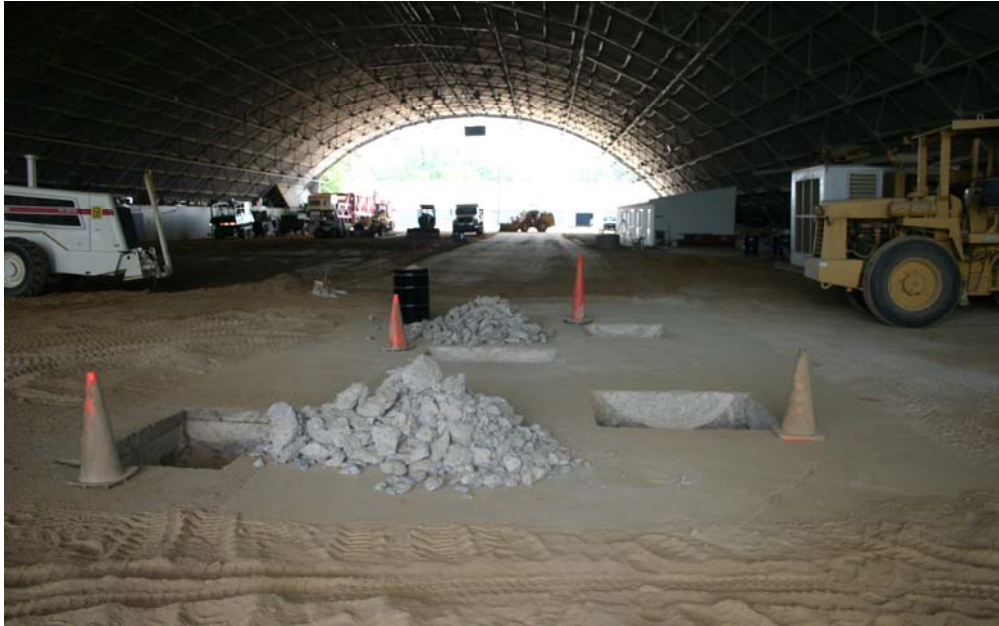
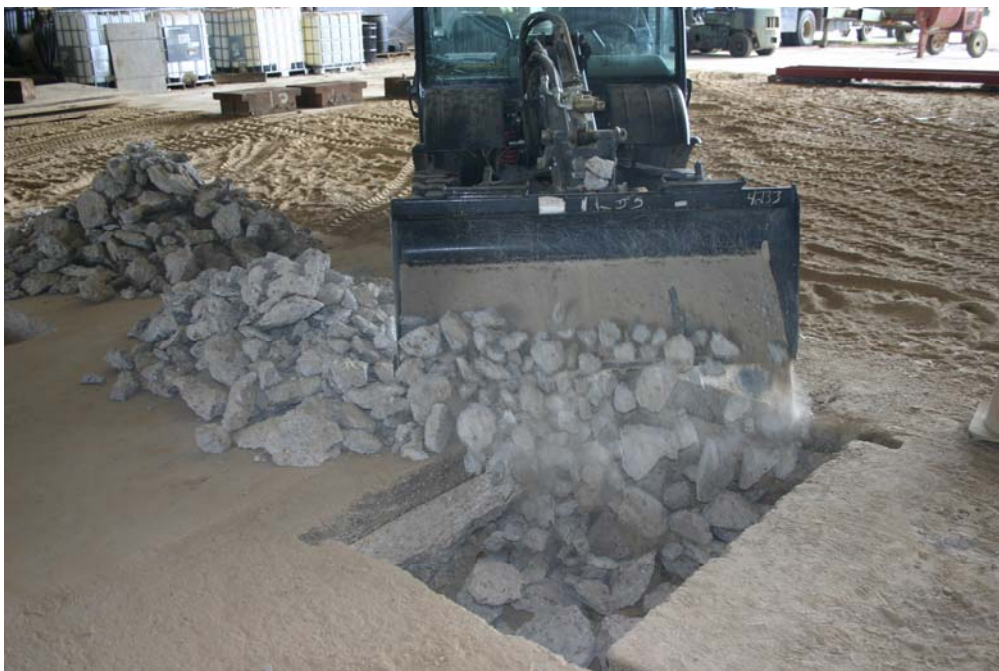
Photo 22. Repairs 1 through 4 with the RCP for Repairs 1 and 2 ready for placement

Photo 23. Placement of the RCP into the repair

Once the hole was prepared and the RCP screened (if required), the RCP was placed back in the hole (Photo 22 and Photo 23). The larger pieces of RCP were placed back into the hole first and the smaller pieces were placed closer to the top of the repair. This allows for larger void space at the bottom where the grout penetration is more critical and the smaller more maneuverable pieces at the top will make for easier finishing. Once the hole was filled with RCP, a straight edge was used to ensure that there were no pieces of RCP protruding above the existing surface of the concrete (Photo 24). The grout materials had a tendency to “float” some of the pieces close to the top of the repair which sometimes resulted in an undesirable rough surface. If this occurred, then the pieces were simply removed during grout placement and the surface void was filled with grout.

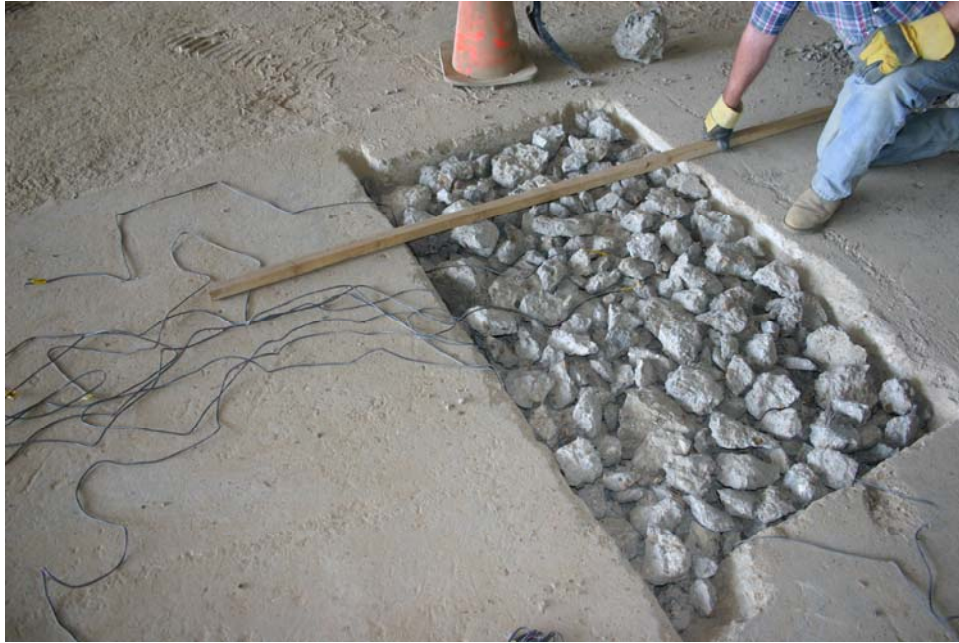
Photo 24. Checking the surface of the repair area to ensure there is no protruding material

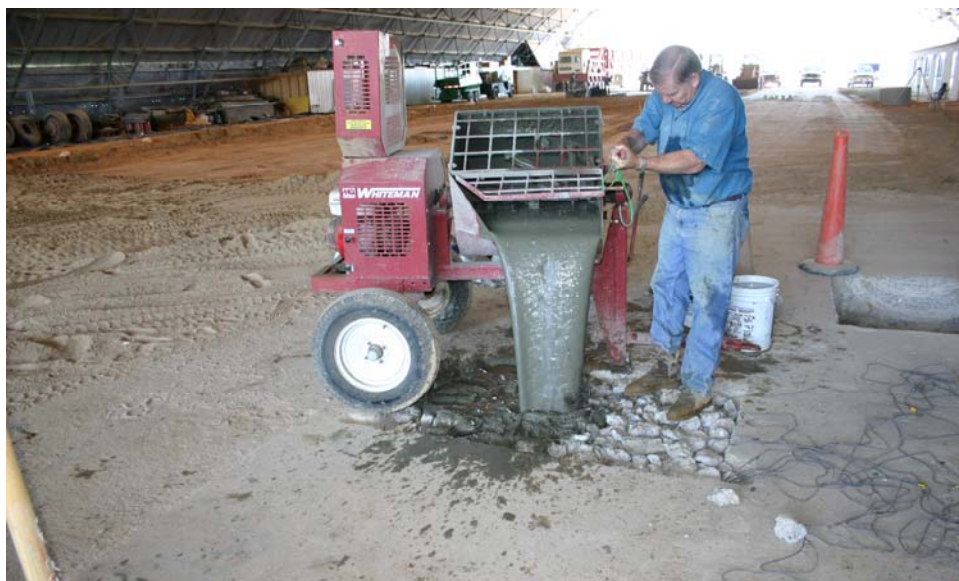
Photo 25. Pouring the Type III grout after mixing

The grout batches were mixed and poured into the hole until the surface of the repair was even with the surface of the surrounding concrete. Photo 25 shows the Type III portland cement grout being poured into the repair. The consistency of the grout was such that it was almost self-leveling; however, some of the grout near the top required finishing to achieve the desired level surface. A screed board was used to strike off the surface and normal concrete tools were used to smooth the surface when

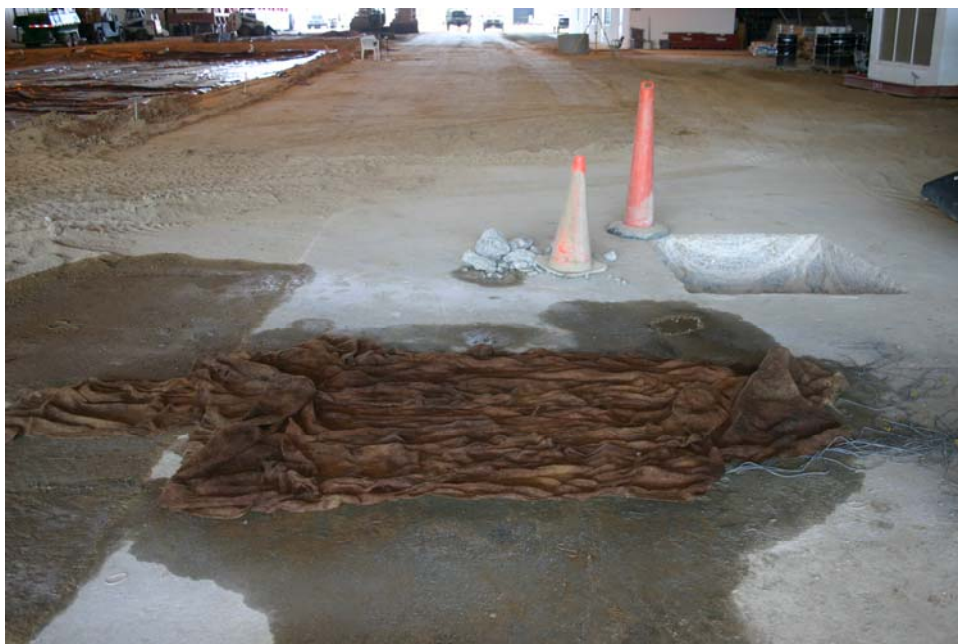
Photo 26. Moist curing of Type III grout using soaked burlap

Due to the relatively high water/cement ratio (0.5) required to provide enough workability for the grout to penetrate the RCP, there was a high likelihood for shrinkage cracking to occur on the surface of the repair, especially if no attempt was made to moist cure the repairs made with Type III grout. For this study, Repairs 2 and 6 were moist cured using soaked burlap placed on the repair after the surface hardened, approximately 4 hours after placement (Photo 26).

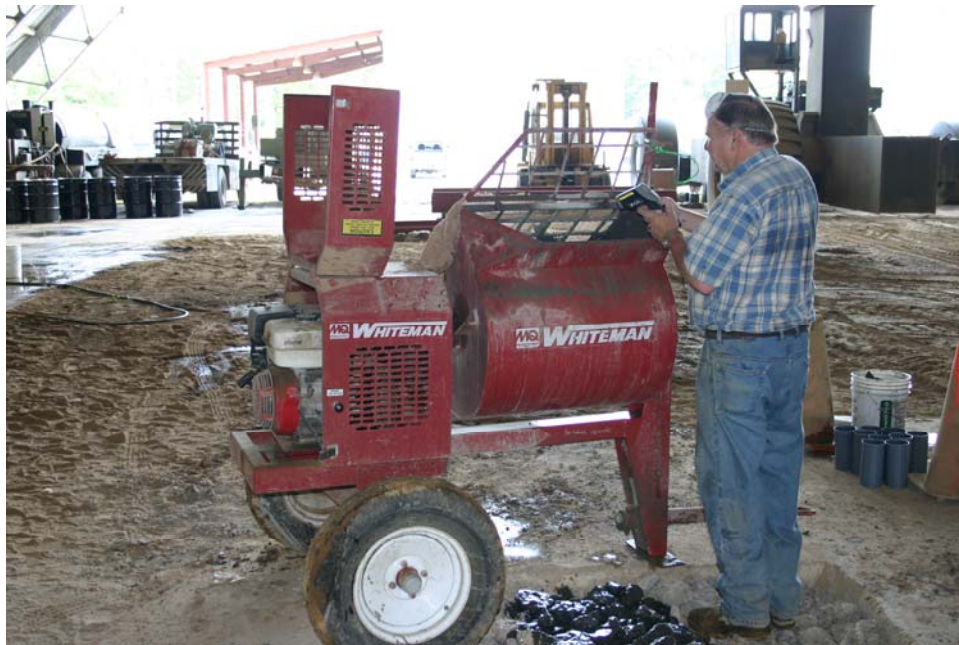
Photo 27. Using the hand-held temperature gun to monitor temperature rise in the Pavemend™ material

The mixing water and Pavemend™ material were added to the mixer and the temperature was monitored using a hand held temperature gun as shown in Photo 27. Once the temperature of the material reached 35°C (95°F), the contents of the mixer were poured into the repair as shown in Photo 28. Batches were made by using 10 buckets of Pavemend™ and 37.9 liters (10 gal) of mixing water. Initially, the mixer was rinsed with water after each mix because of concerns that the material would rapidly set in the mixer. It was later discovered that this could be avoided by always adding 18.9 liters (5 gal) of the mixing water immediately after pouring the previous batch and letting it wash around in the mixer for 1 to 2 minutes before adding the dry materials for the next batch. This procedure kept the inside of the mixer relatively clean and eliminated the need to rinse it out after each batch.

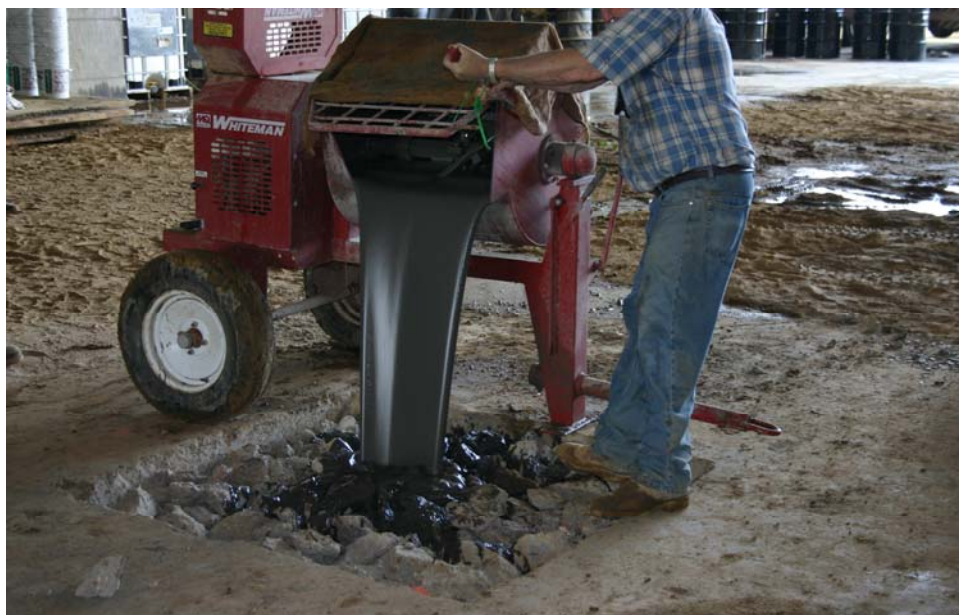
Photo 28. Pouring the Pavemend™ material into the repair

The batches were made and the material was poured into the hole until it was level with the surrounding concrete. Unlike the Type III grout, the Pavemend™ material is completely self-leveling and does not need to be finished. Care must be taken when pouring the last lift of the material to ensure that it does not set too fast. Whenever the material is being placed on a layer that is already at elevated temperatures, it tends to speed the setting process thus causing it to lose its self-leveling properties. This can result in an undesirable and uneven finish. During this study, the mixing time of the final lift was slightly reduced and the temperature was only allowed to reach approximately 33.3 to 33.9°C (92 to 93°F), which provided enough working time for the material to flow and provided a smooth finish. Photo 29 shows a repair just prior to receiving the final lift of material.

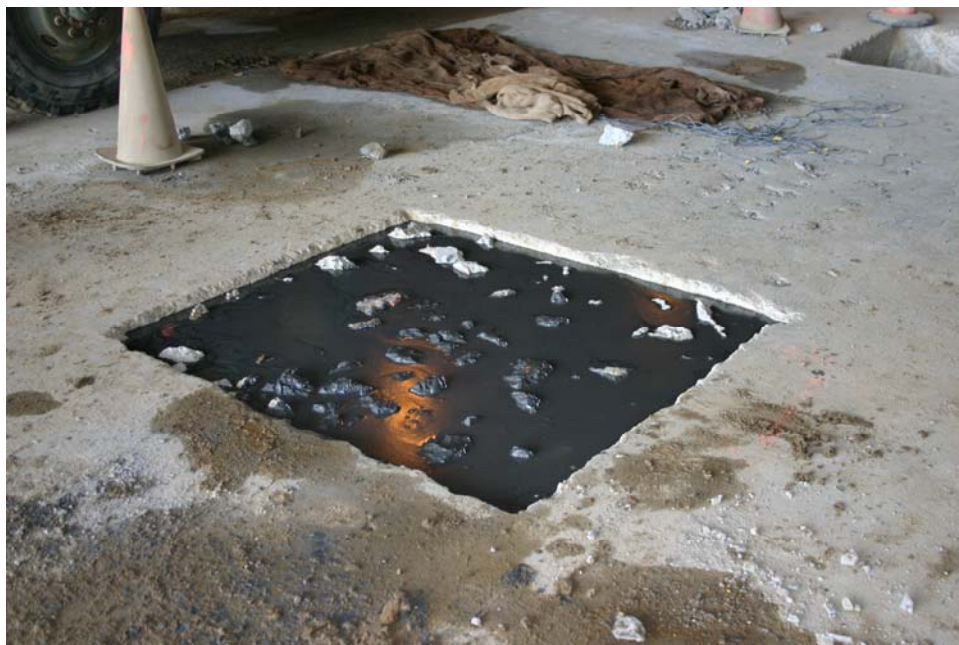
Photo 29. Pavemend™ repair just prior to pouring the final lift

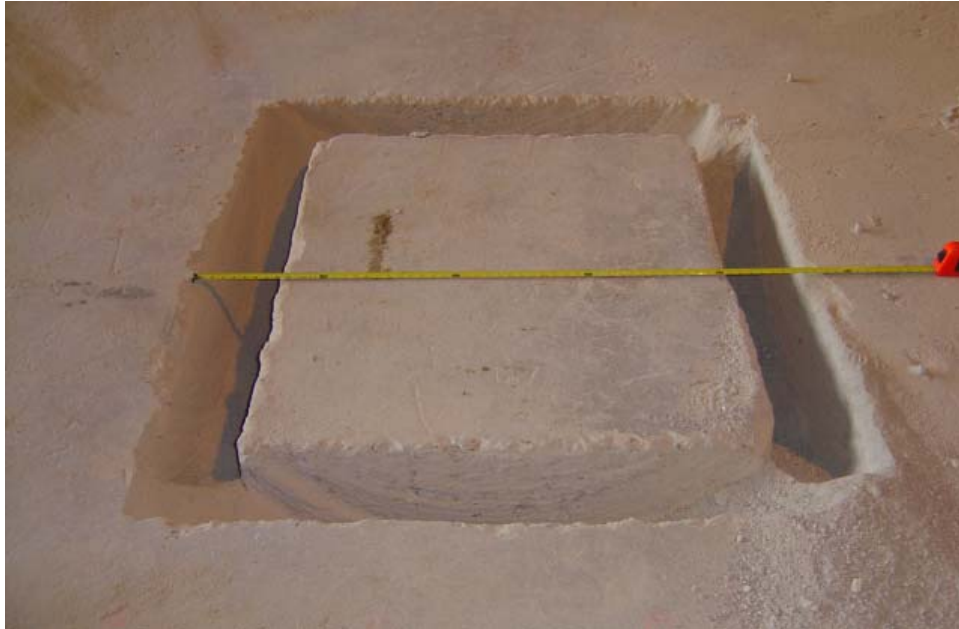
Photo 30. Repair 3 after being cut with the large 458-mm (18-in.) wheel saw
