## **Grout Impregnation of Pre-Placed Recycled Concrete Pavement (RCP) for Rapid Repair of Deteriorated Portland Cement Concrete Airfield Pavements**

Travis A. Mann, Reed B. Freeman, and Gary L. Anderton

April 2007

Final report

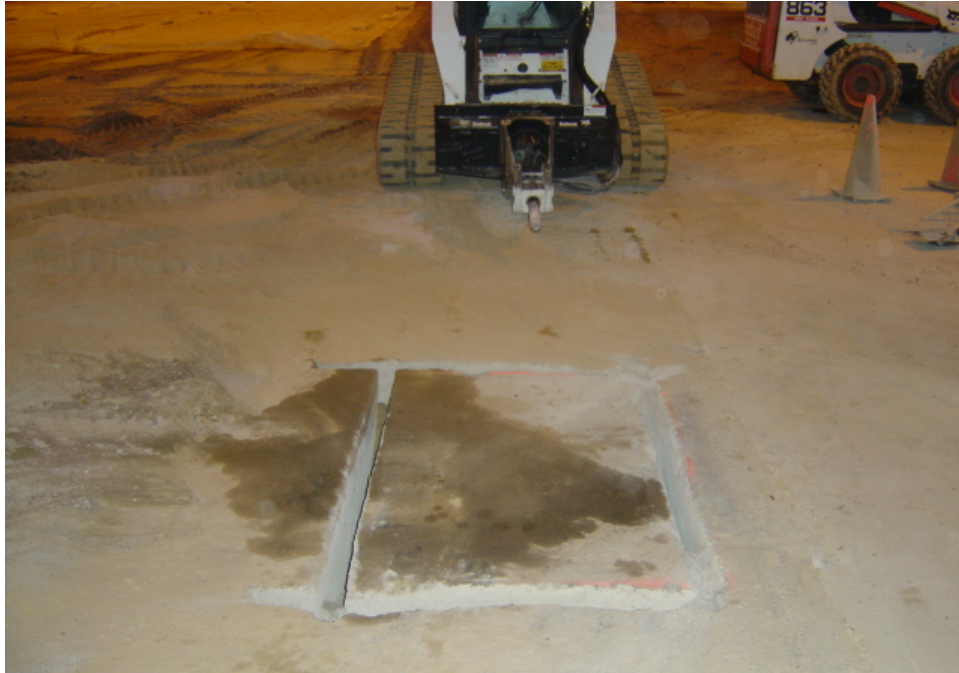
Photo 31. Repair 1 after being cut with the small 305-mm (12-in.) wheel saw

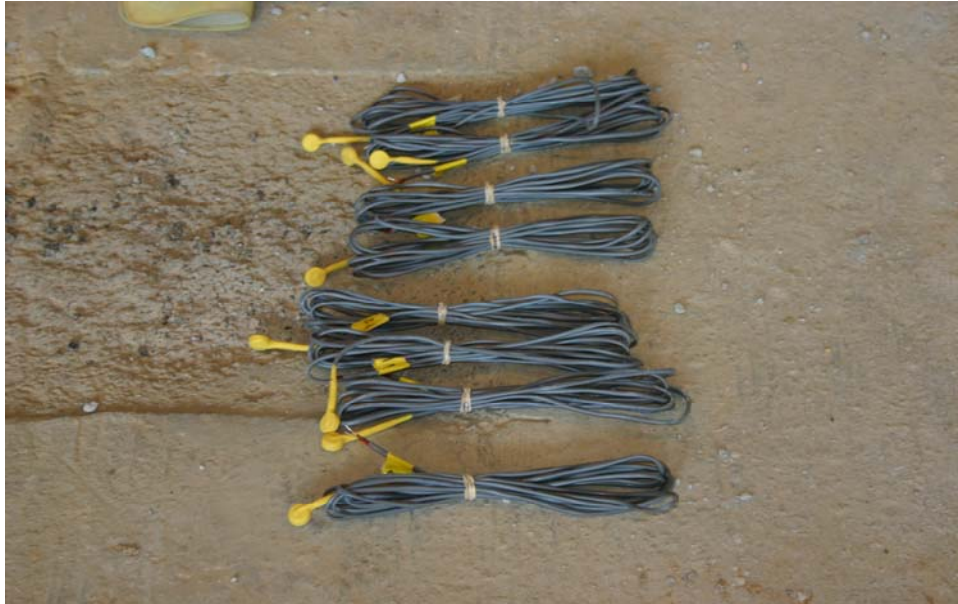
Photo 32. Sensors used to measure and record temperature in the repairs

A number of sensors were used to measure and record temperature data at regular intervals during the curing process of the materials in order to obtain information relating to the amount of heat generation in each of the repairs. The sensors were programmed to record measurements at a variety of time intervals using a simple software program. This particular sensor, manufactured by The Transtec Group, is typically used for maturity measurements in portland cement concrete because of the ease in which data can be obtained and the durability of the sensors. The individual sensors can be connected to a computer via two small electrical leads and a USB connection, which is programmed to record data at intervals determined by the user. The sensors contain internal memory which allows for approximately 2050 readings of time and temperature. Once the sensors are instructed to start recording, the lead wires for the sensors can be reattached to the computer at any time and the recorded data are instantly downloaded via the software installed on the computer. A laptop computer was used during this study and provided a very efficient means to program the sensors just prior to use in the repairs as well as download data once testing was complete. All of the sensors in this study were programmed to record data every 5 minutes for durations of just over 7 days. The sensors are shown in Photo 32. For scale, the button shaped sensors in Photo 32 are approximately 20 mm in diameter.

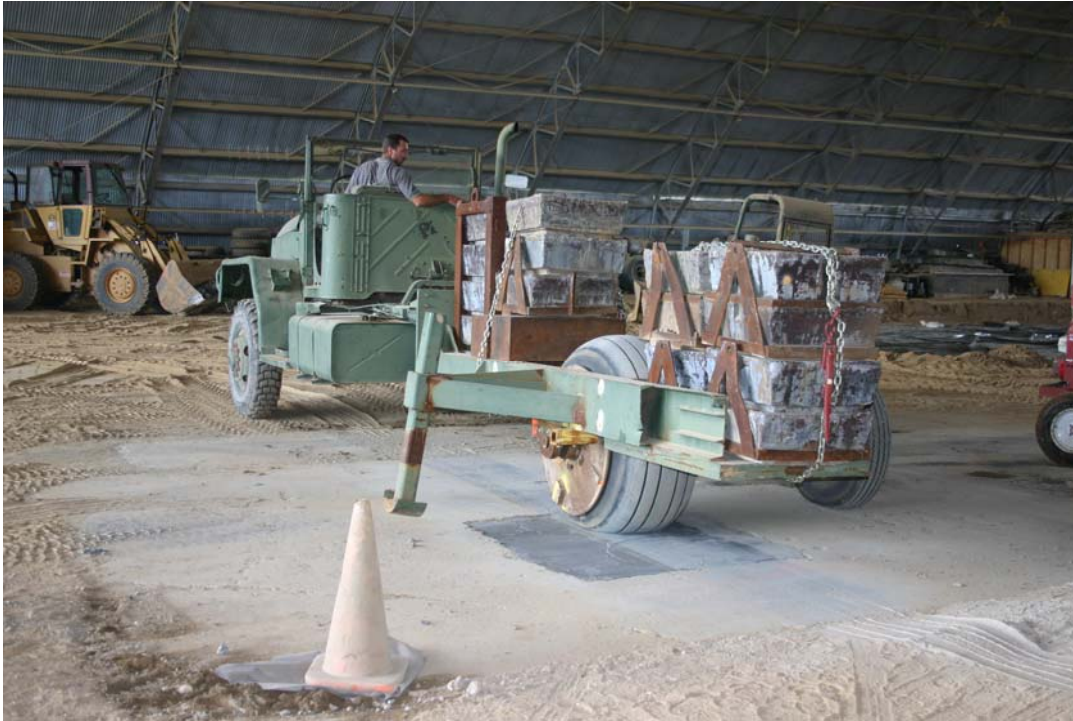
Photo 33. Single-tire C-17 load cart applying 50 passes to Repair 3

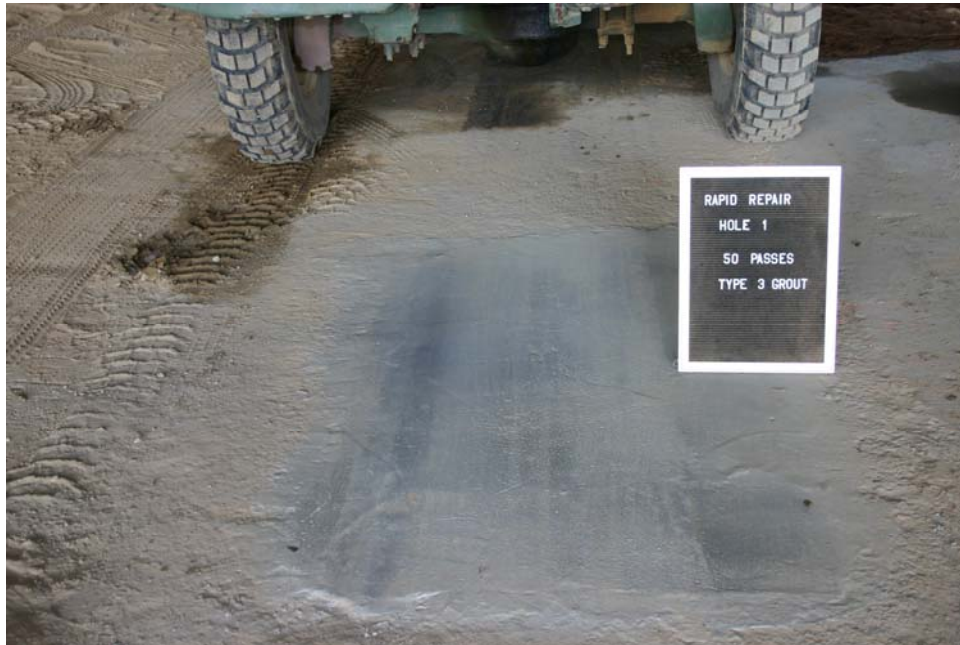
Photo 34. Repair 1 after 50 passes of the C-17 load cart

All of the repairs were successfully trafficked (50 passes) and a visual inspection of the repairs after traffic revealed no significant damage to any of the repairs. Some minimal surface cracking was observed within 24 hours in both the Pavemend™ and Type III grout repairs around the outside of each repair at the interface with the parent slab; however, this cracking is not believed to be structural in nature.

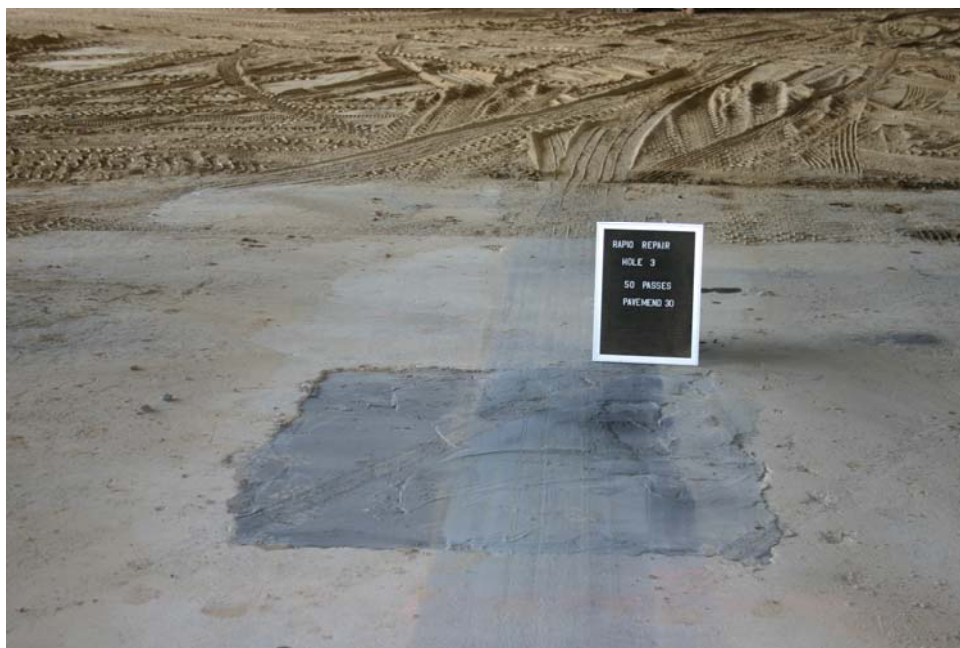
Photo 35. Repair 3 after 50 passes with the C-17 load cart

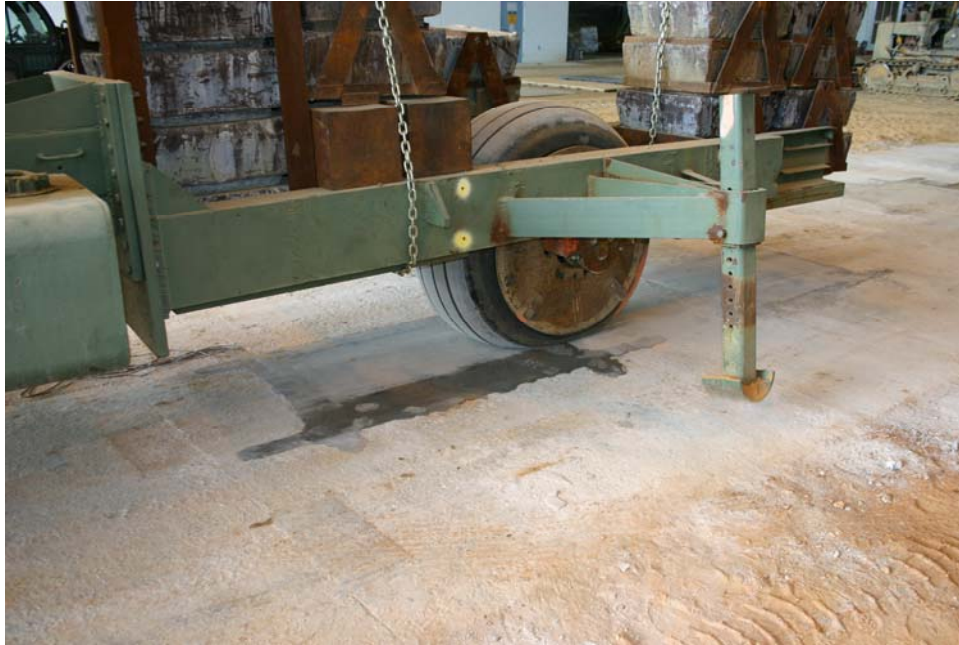
Photo 36. Application of traffic on Repairs 7 and 8

the single-tire C-17 load cart. Photo 36 shows the application of traffic on Repairs 7 and 8.

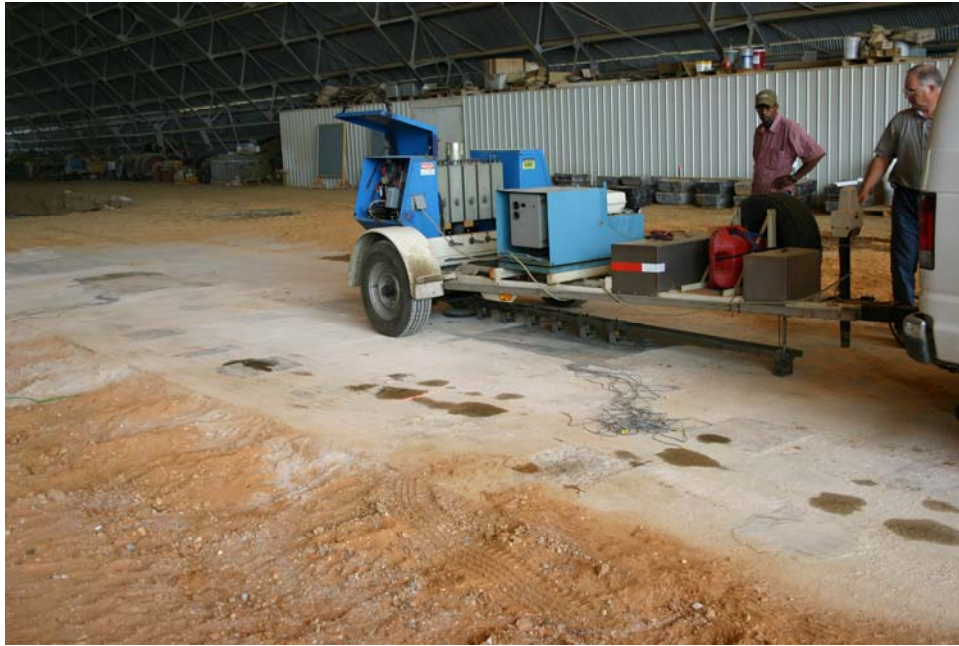
Photo 37. Conducting Heavy Weight Deflectometer (HWD) tests on Repair 8
