# A Review of Australian and New Zealand Investigations on Aeronautical Fatigue During the Period April 2005 to March 2007

DSTO-TN-0747

This document has been prepared for presentation to the 30th Conference of the International Committee on Aeronautical Fatigue scheduled to be held in Naples, Italy, 14th and 15th May 2007. Brief summaries and references are provided on the aircraft fatigue research and associated activities of research laboratories, universities, and aerospace companies in Australia and New Zealand during the period April 2005 to March 2007. The review covers fatigue-related research programs as well as fatigue investigations on specific military and civil aircraft.

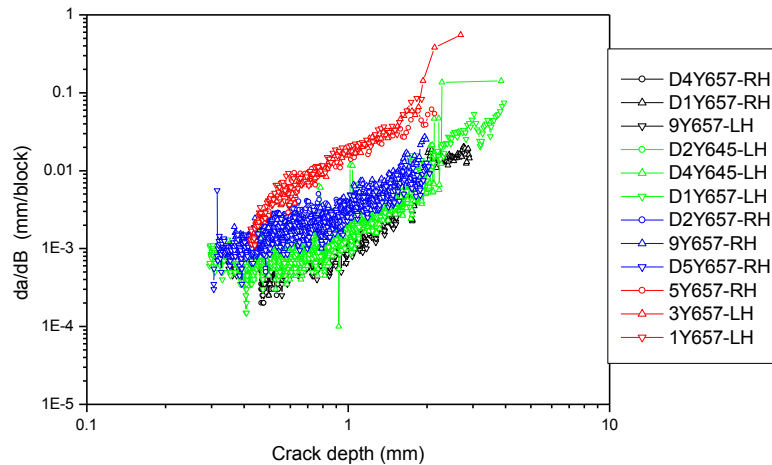
Figure 3: Crack growth rates plotted versus crack depth for un-notched Ti coupons under 4 peak load levels of an F/A-18 manoeuvre plus buffet spectrum

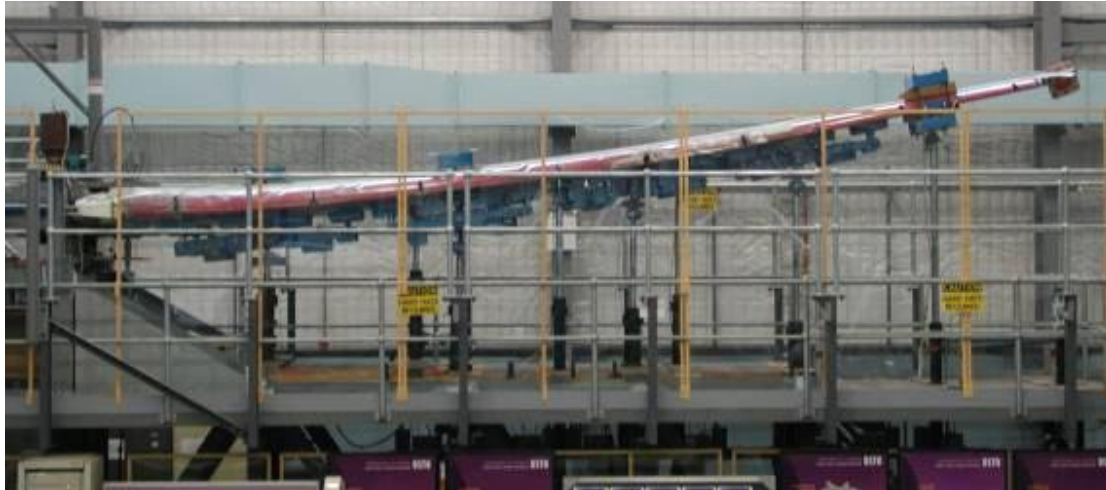
Figure 5: F-WELD Test Article Undergoing Cold Proof Load Test

As a result of the identified certification basis discrepancies, and significant deviation from the test verification basis evident through assessment of USAF usage data, DSTO was tasked to undertake an additional wing test to determine the economic life of F-111F and F-111D model wings. This test has been titled as the F-111F Wing Economic Life Determination (F-WELD) (see Figure 5) and forms part of the F-111 Sole Operator Program.

Testing is being conducted on a short configuration F-111F wing designated A15-80L using a flight-by-flight 1,000 airframe hour spectrum representative of previous USAF in-service operations. The test sequence consists of the application of two blocks of manoeuvre loading followed by Non Destructive Inspection (NDI) followed by the application of Cold Proof Load Test<sup>2</sup> (CPLT) prior to the application of a further two blocks of loading.

<sup>2</sup> CPLT to design limit load at minus 40 Degrees Celsius forms an integral part of the safety-by-inspection program used to ensure the structural integrity of the F-111 aircraft. CPLT is a safety measure to ensure that any critical size defects in high strength D6ac steel components, which may have been missed during NDI, are detected by actual failure of the component part.

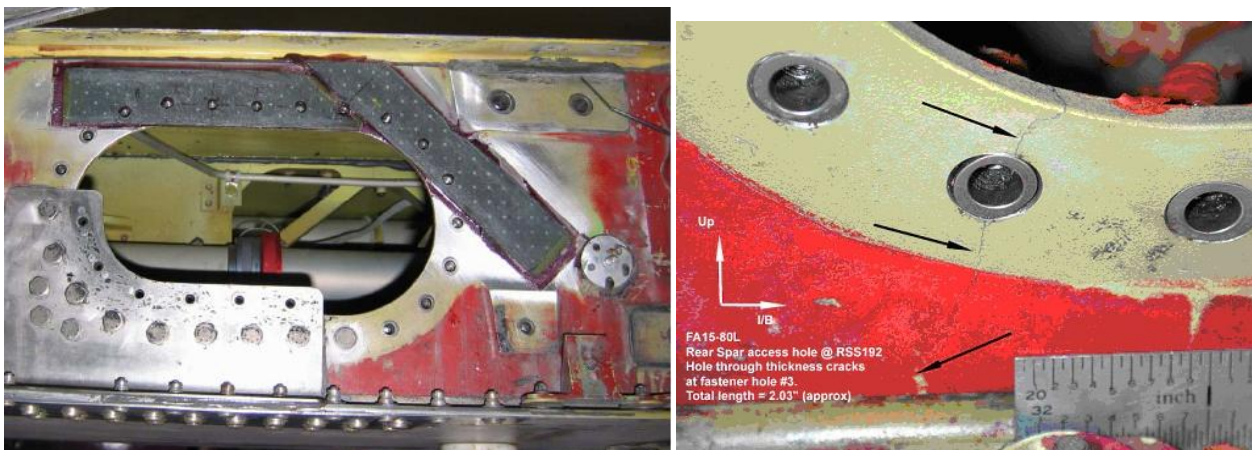
Figure 6: Boron Doublers Fitted to the DI 73 Cut Out to Inhibit Crack Growth

In spite of this the more cracking was found in the lower in board corner of the opening so the decision was taken to remove the remaining Davis nuts and to fit interference fit steel plugs after reaming to remove the crack growth. This strategy has proved to be very successful and has been applied to other regions on the test article where cracking has emanated from Davis nut fastener holes.

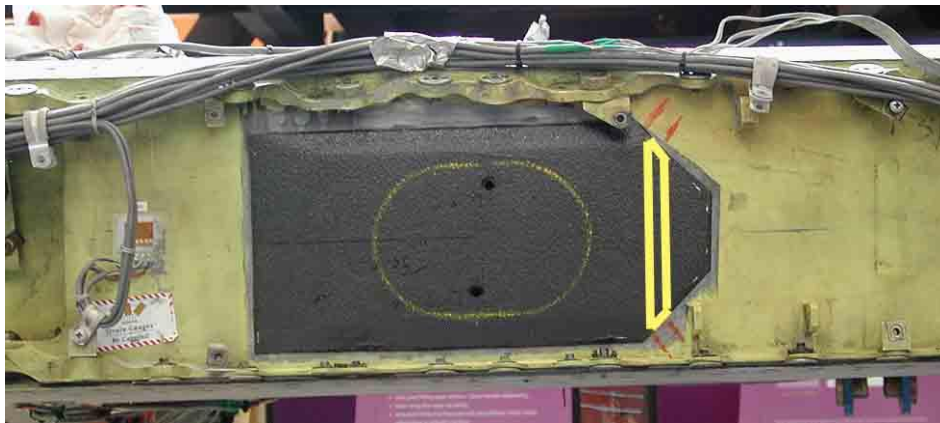
Figure 10: Boron Doubler Repair at Opening in Forward Spar at FSS 163

The crack emanating from Hole 1 had grown into the cut out, several other holes were also found to contain cracks. To guard against further crack growth the Davis nuts at all four corners were removed and the holes reamed to remove cracking and fitted with interference fit steel plugs. The entire opening was then fitted with a boron doubler as shown in concept in Figure 10.

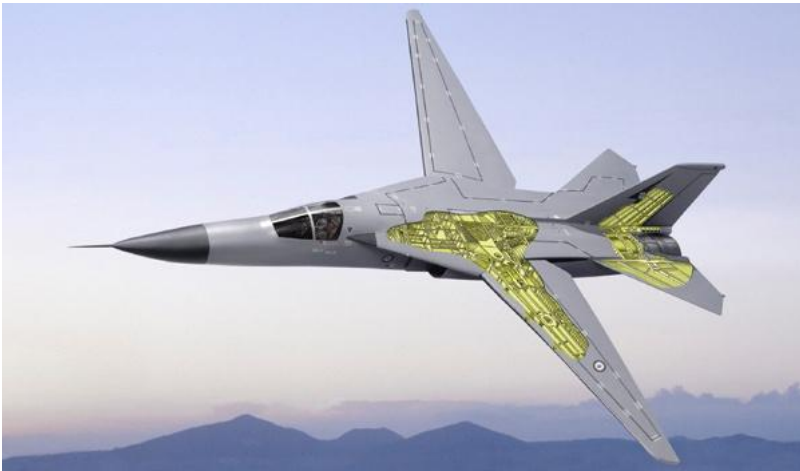
*Figure 11: F111C in RAAF configuration showing critical structural areas*

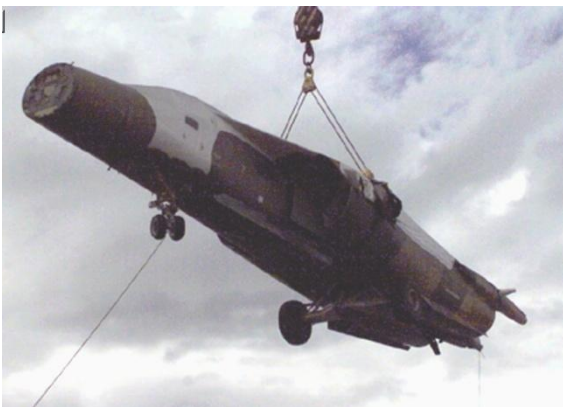
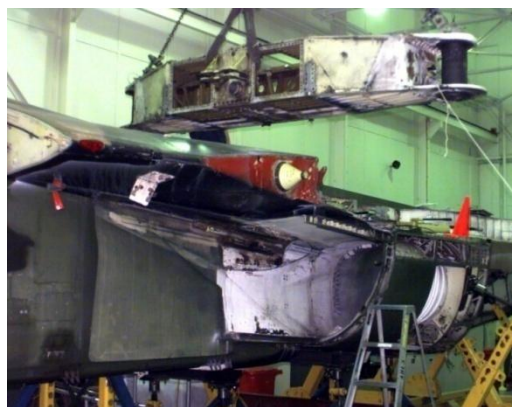
*Figure 12: Arrival of the teardown aircraft, and removal of wing carry-through box*

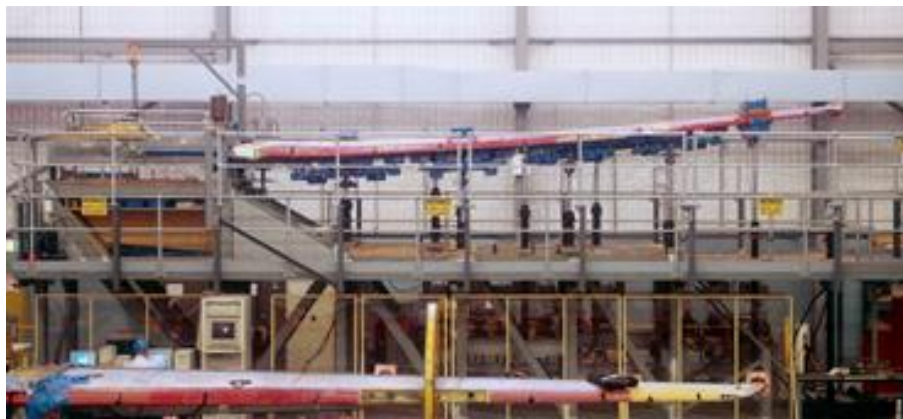
Figure 14: F-111 Wing Fatigue Test Rig

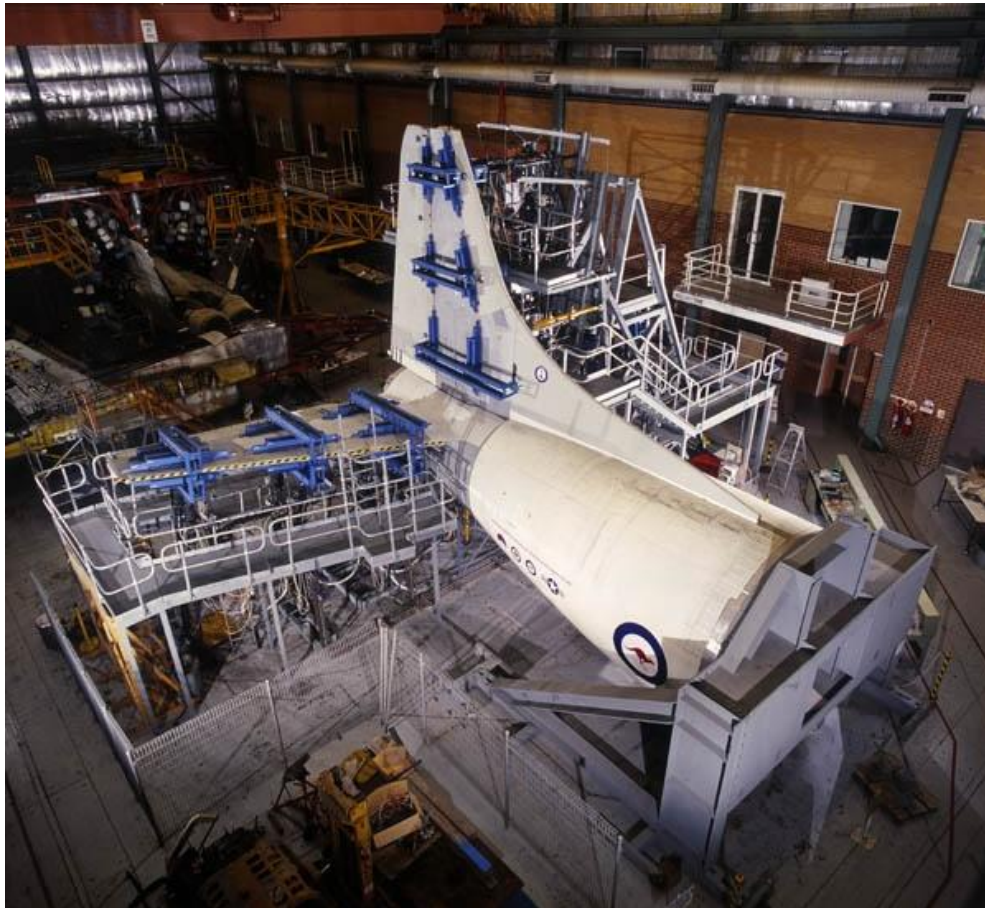
Figure 21: P-3C Empennage fatigue test at DSTO

From 1999 to 2006 DSTO participated in the full scale testing program of the P-3 Orion maritime Surveillance aircraft known as P-3 Service Life Assessment Program or P-3 SLAP. One of the elements of the program conducted at DSTO was the full scale fatigue test of the empennage and its subsequent durability and damage tolerance analysis. The test is shown in Figure 21. Very early in the test program it was recognised that the stress levels in the principal structural elements would mean that the testing time taken to generate representative failures would be long. Increasing the spectrum load levels would reduce testing time and allow exploration of the UK DEF STAN 00-970 SAFE S-N concepts of variable scatter factor. The test subsequently applied an aircraft usage based load spectrum for two lifetimes in order to expose any early failures resulting from design flaws, followed by the same load spectra significantly augmented but with the peak loads clipped to avoid unrepresentative yielding at critical locations, see Figure 20. The test was reported in ICAF2003 and was successful in generating both early failures and failures of the principle elements to which both DADTA and SAFE S-N analyses could subsequently be applied. See Figure 22 and Figure 23 for examples of failures of structural elements.

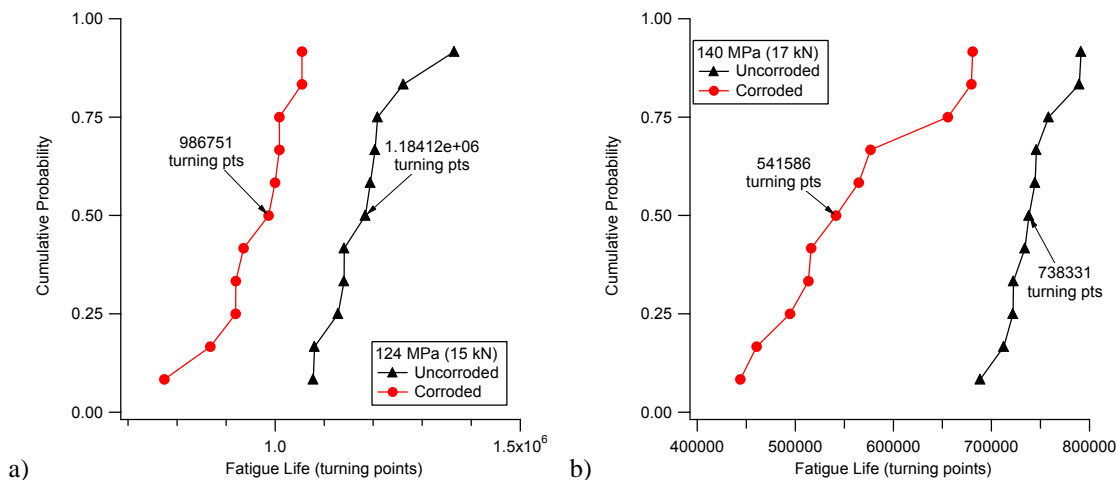
Figure 24: Effect of corrosion on Fatigue Life for (a) 124 MPa and (b) 140 MPa peak stress levels

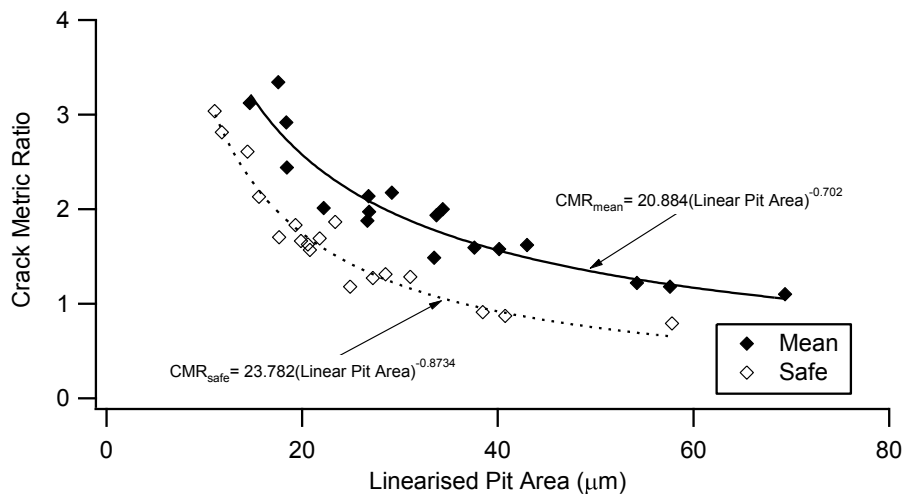
Figure 25: Relationship between crack metric ratio and pit metric

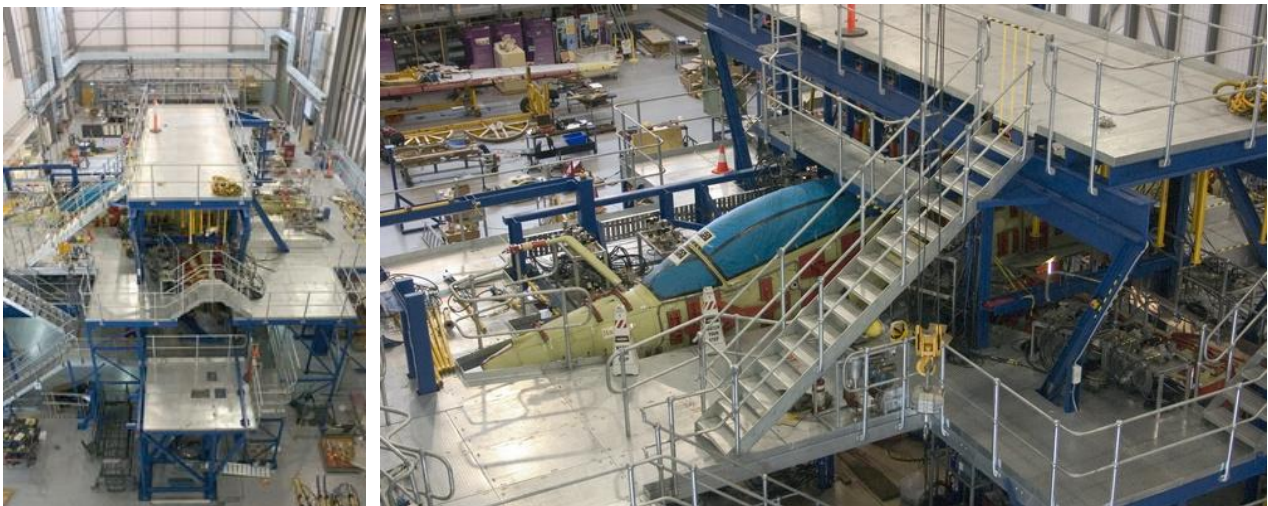
Figure 33: LIF Test Rig (left) under construction, and (right) with aircraft installed.

Once the decision had been made to proceed with a comprehensive full-scale fatigue test, DSTO and BAE SYSTEMS entered a commercial business agreement to conduct the test in Australia. Personnel from both organisations are involved in the test, as are several Australian contractors with a range of backgrounds and expertise.

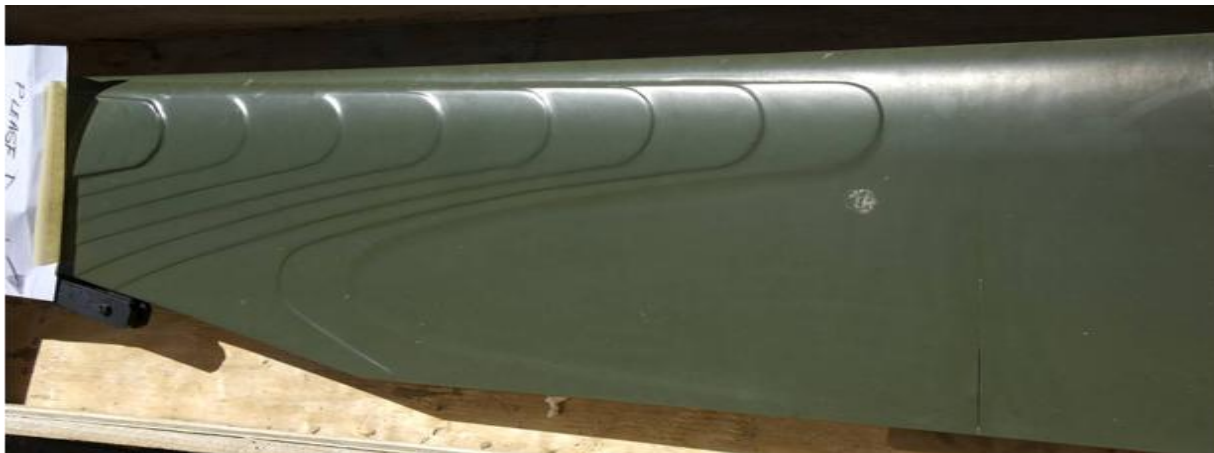
Figure 34: Photograph of the crack (lower right, vertical on page) in the MRB showing its location in relation to the blade root

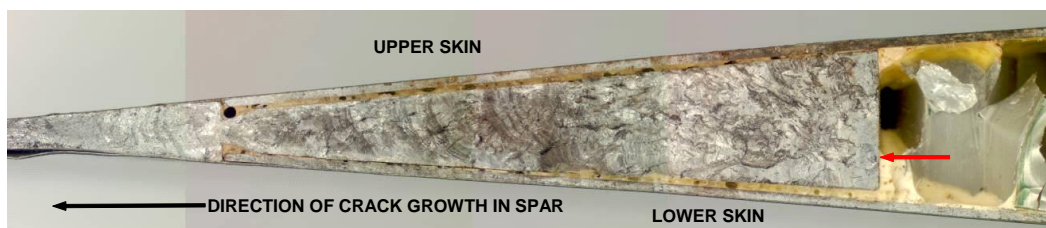
Figure 35: Composite photograph showing an overall view of the fracture surface of the crack in the trailing edge spar. Note the presence of progression marks clearly indicating that cracking was due to fatigue. The origin of the crack is indicated by the red arrow

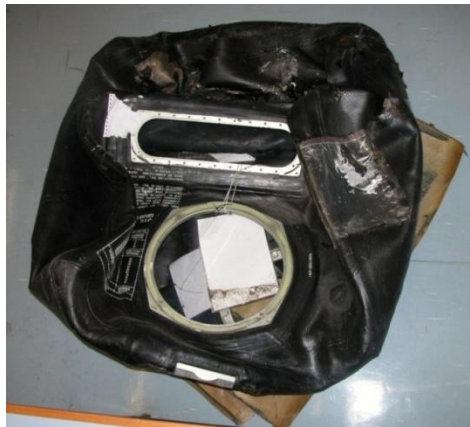
Figure 40: Photograph of the Black Hawk Port Fuel Cell in the collapsed condition with no external cover or packaging. The cell contained a small amount of water and dirt

Subsequent investigation by DSTO revealed a crack through the inner liner thickness of the fuel cell's inboard side. The crack was situated in the middle of a repair patch. The patch was found to be severely degraded and had exposed the inner liner crack to fuel. This allowed the fuel to come into contact with the self sealing sealant (natural gum rubber) causing it to activate and swell many times its normal size. This activation and swelling initiated delamination of the plies of the cell wall, resulting in loss of wall strength and the eventual catastrophic failure of the fuel cell.

The crack in the inner liner material of the cell may have initiated from the surface imperfection that necessitated the repair patch. The cause of the degradation to the patch and crack in the inner liner of the cell was considered to be mostly due to age-related degradation of the elastomers exacerbated by periodic maintenance cycles where the fuel cell would be left dry for extended periods of time.

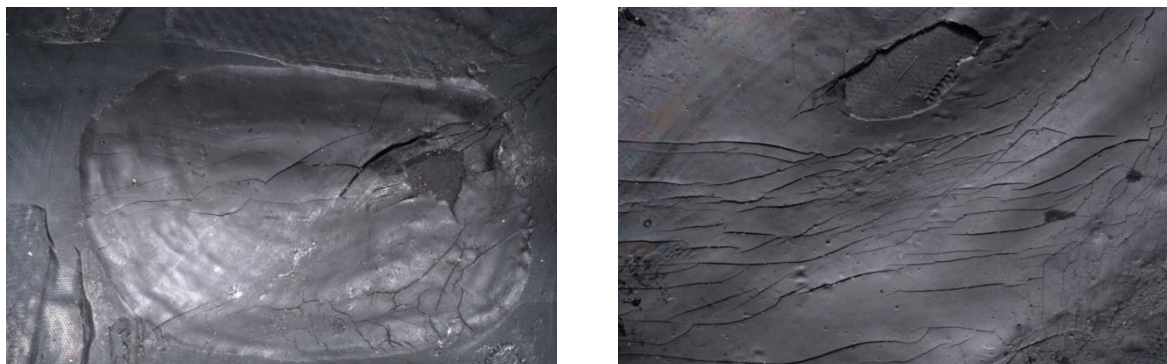
Figure 41: (L) The severely deteriorated repair patch located on the inner liner in a corner of the cell, and (R) typical cracking found on the repair patch

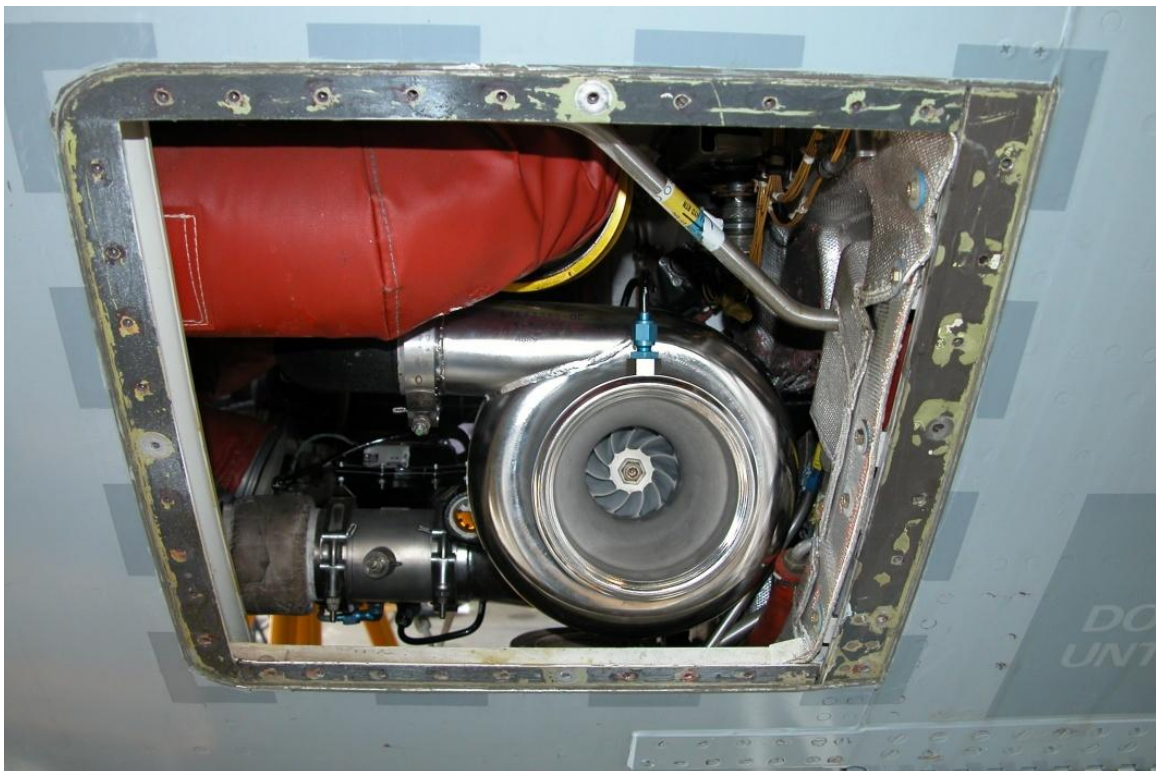
Figure 42: Photograph showing the compressor inlet (arrowed) in situ on the port side of an aircraft

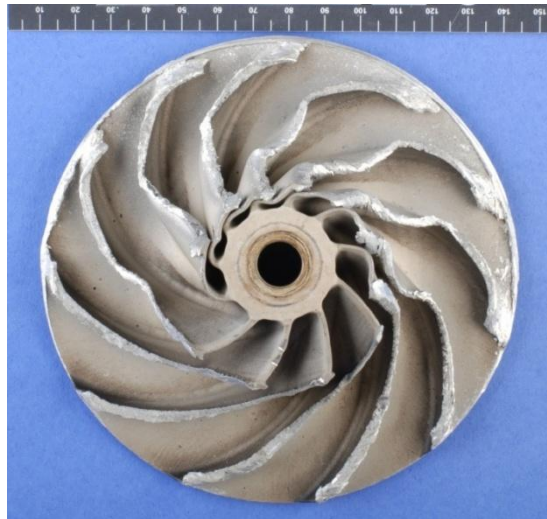
Figure 43: Photograph showing impeller vane damage from Turbo Compressor

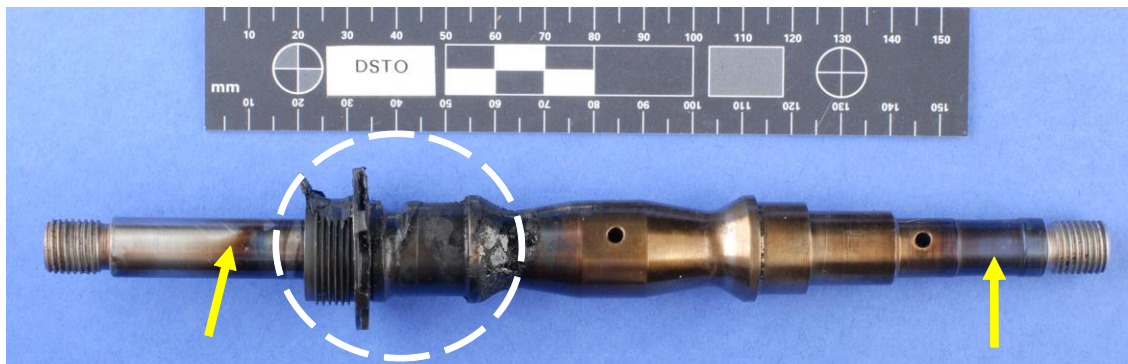
Figure 44: Photograph of severely heat damaged shaft from the Turbo Compressor

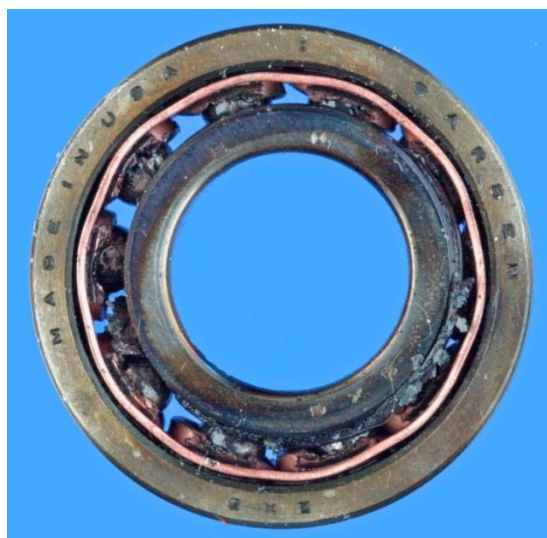
Figure 45: Photograph of a bearing from the Turbo Compressor which had been severely damaged by overheating

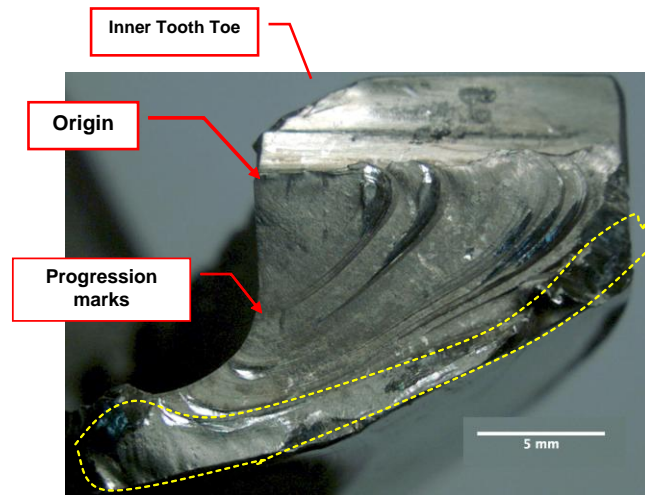
Figure 50: Photograph of the primary fracture surface. The flat almost featureless surface with concentric rings (i.e. progression marks) is typical of fatigue cracking. The direction of the fatigue crack propagation is from top left to bottom right. The approximate location of overload fracture is outlined

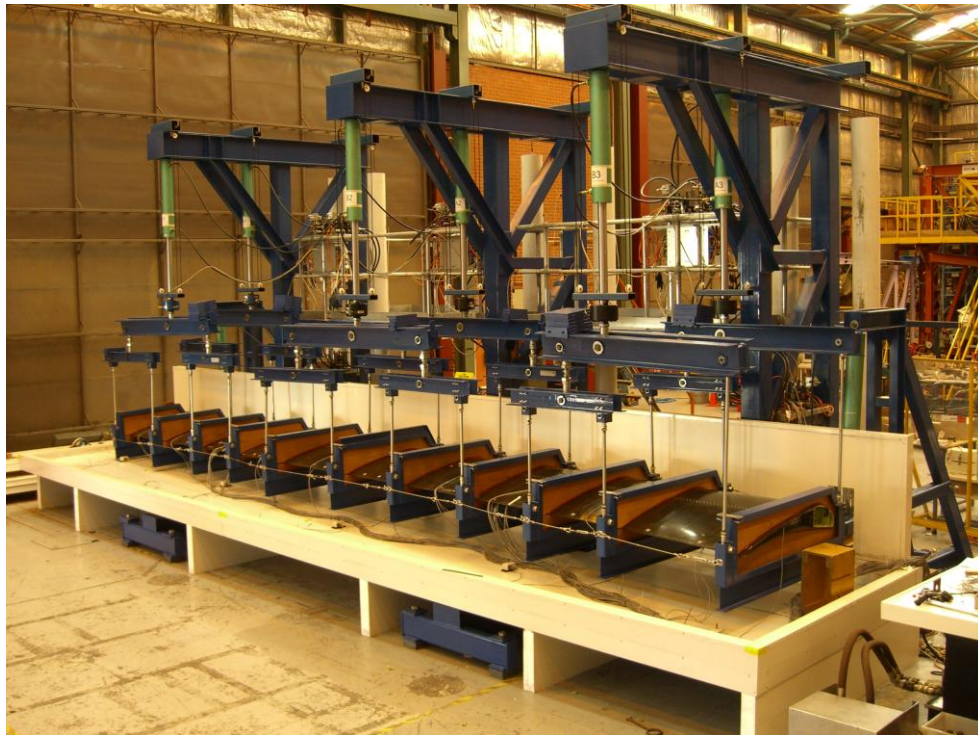
*Figure 53: The Pre-production Outboard Flap Test Rig*

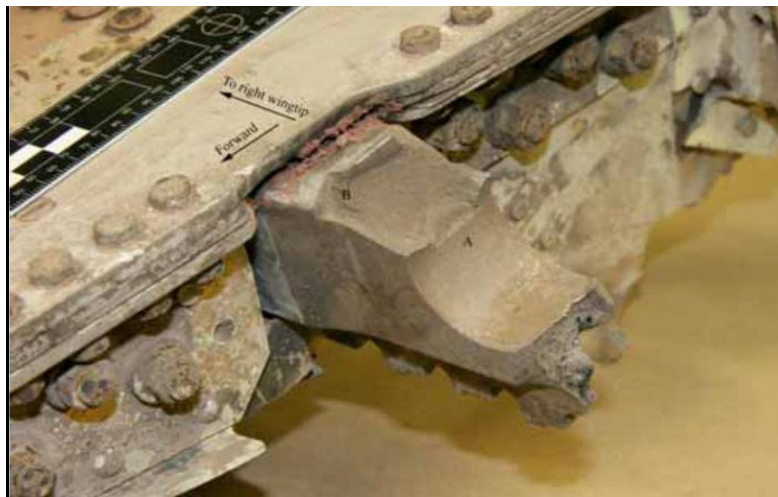
Figure 55: Broken lug on the inboard end of the right wing

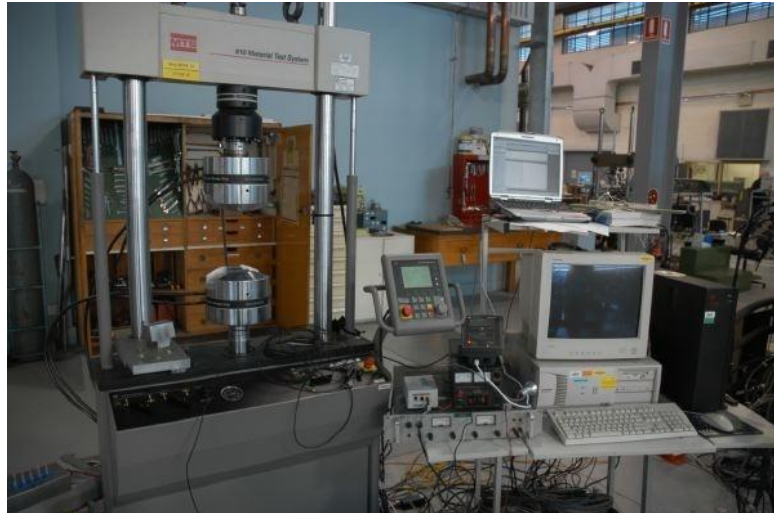
*Figure 62: POD test program setup at DSTO in Melbourne.*

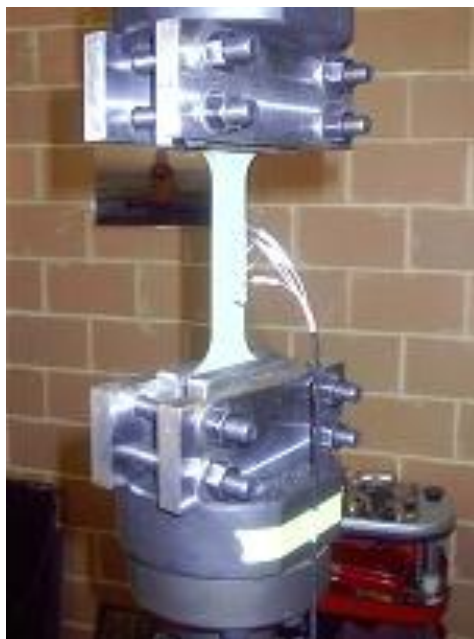
*Figure 63: POD test coupons during fatigue testing*

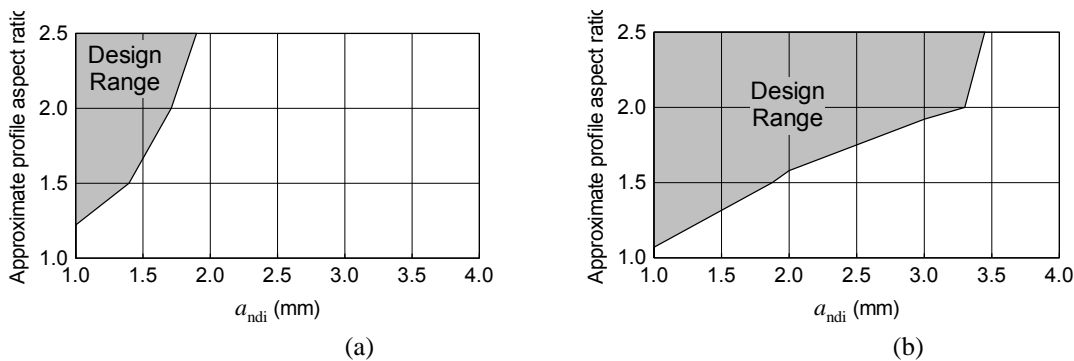
Figure 79: Design range to double inspection interval for optimized hole close to edge in 2D plate: (a) small hole with  $w = 25$  mm, and (b) large hole with  $w = 100$  mm

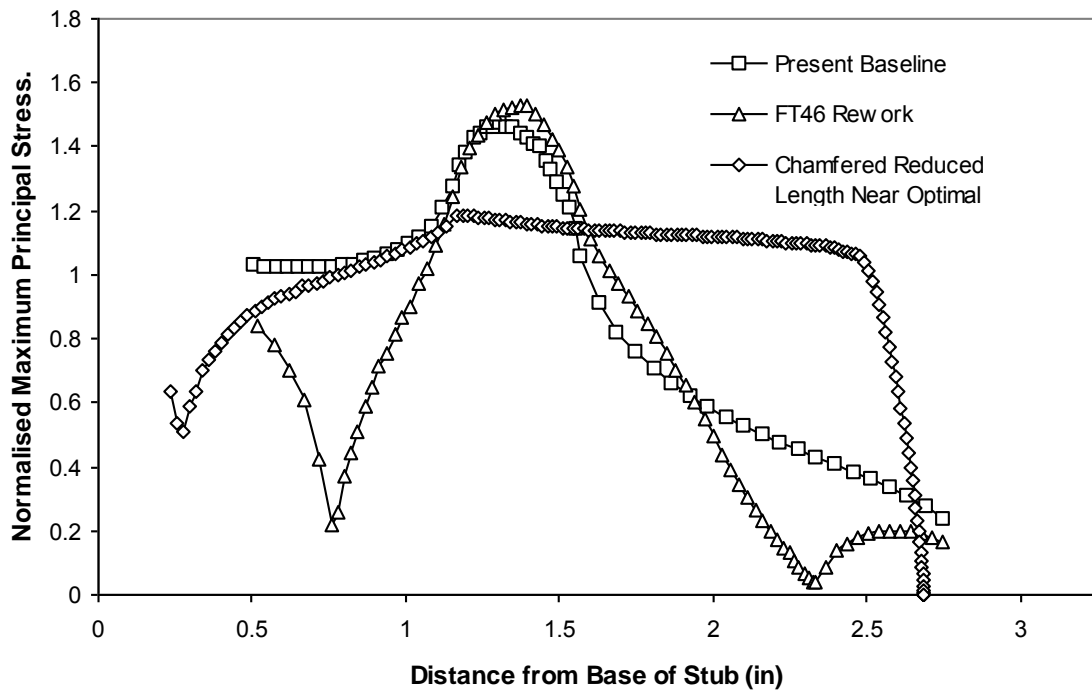
Figure 81: Comparison of predicted stress along edge of the present Baseline, FT46 rework and reduced length near optimal (with chamfer) from finite element analysis

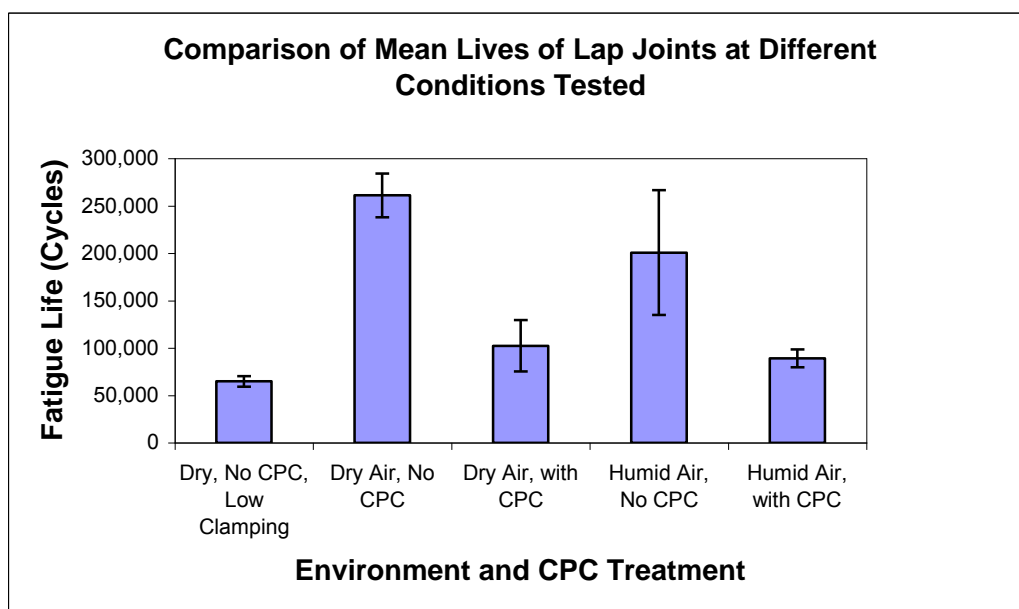
Figure 86: Fatigue test results

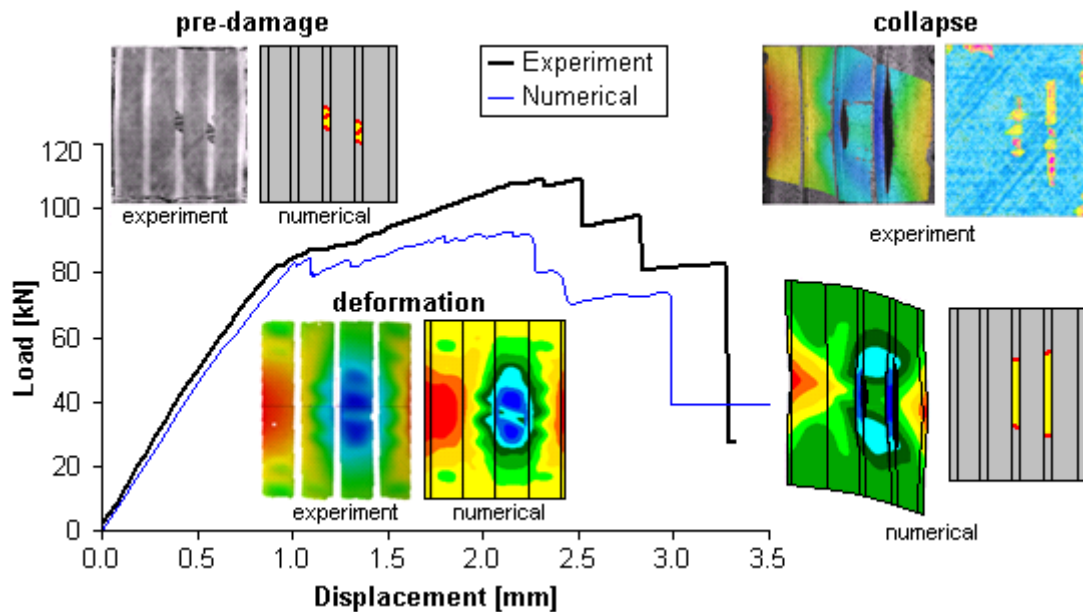
Figure 87: Load-displacement curve of a curved stiffened compression panel showing experimental and predicted postbuckling behaviour and damage development

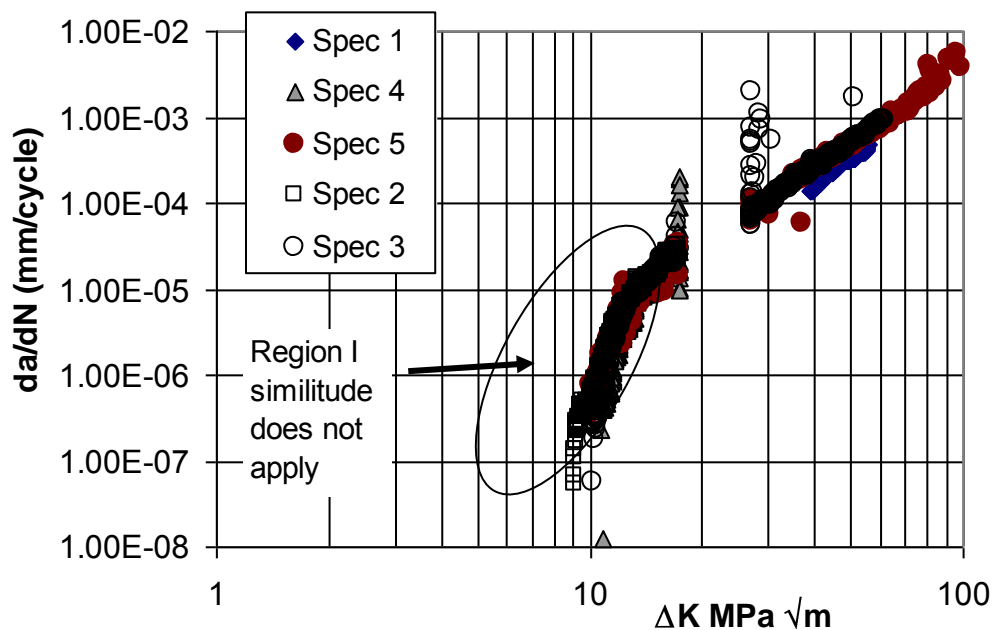
Figure 88: Crack Growth in L6B-2, from [1]

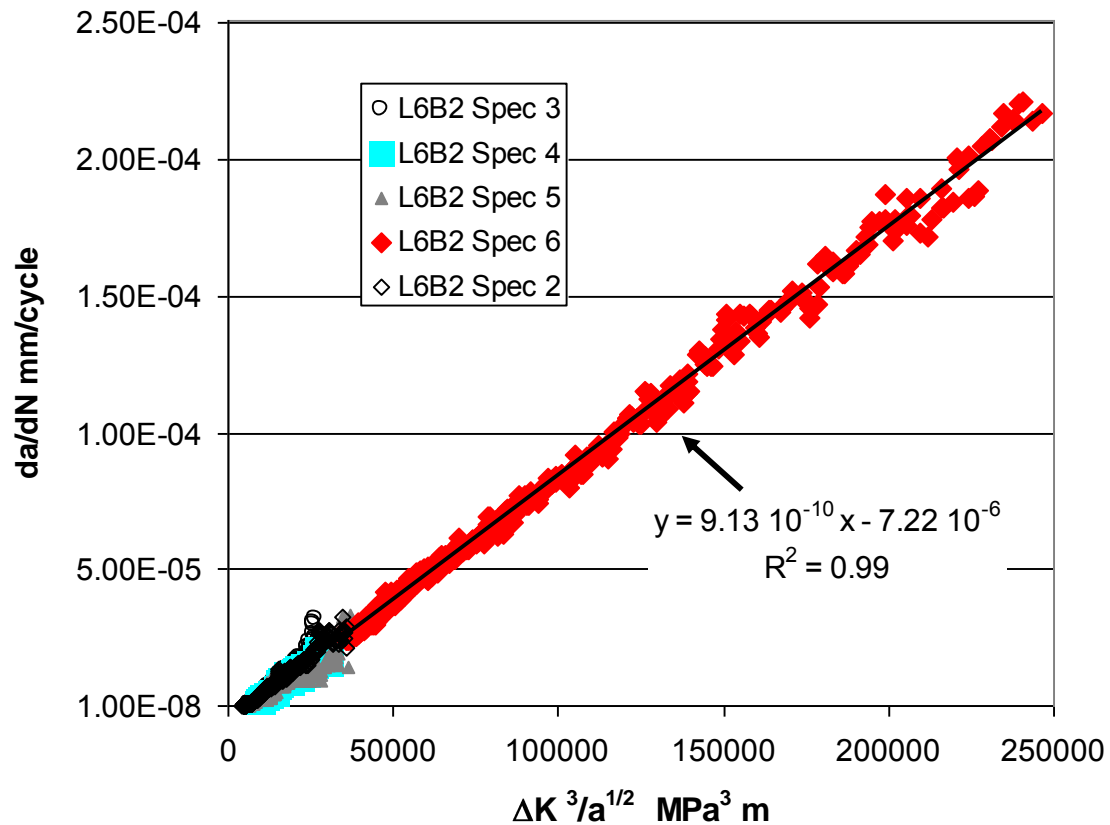
Figure 89: Crack growth in Region I in L6B-2, [1]. Note the linear scale in this figure

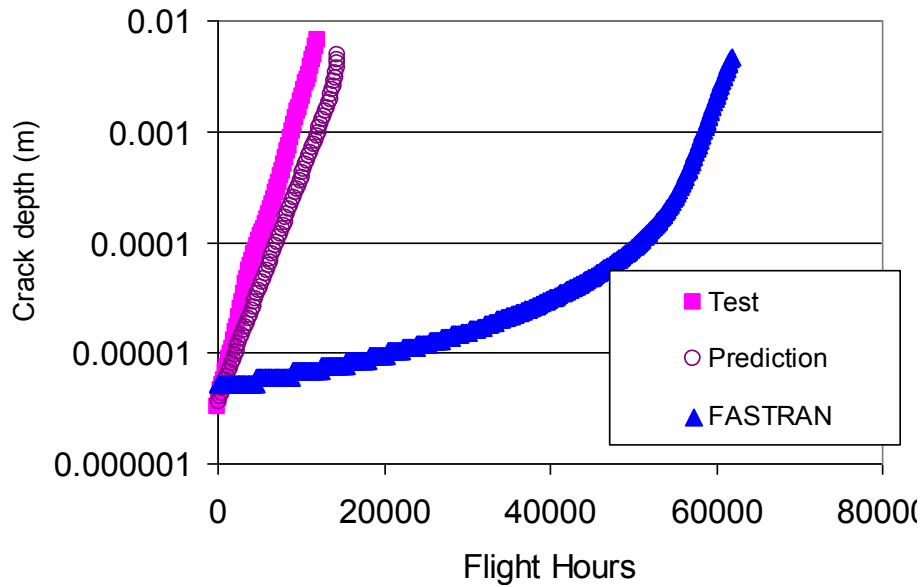
Figure 90: Experimental and predicted crack growth histories in the DSTO F/A-18 Centre Barrel test

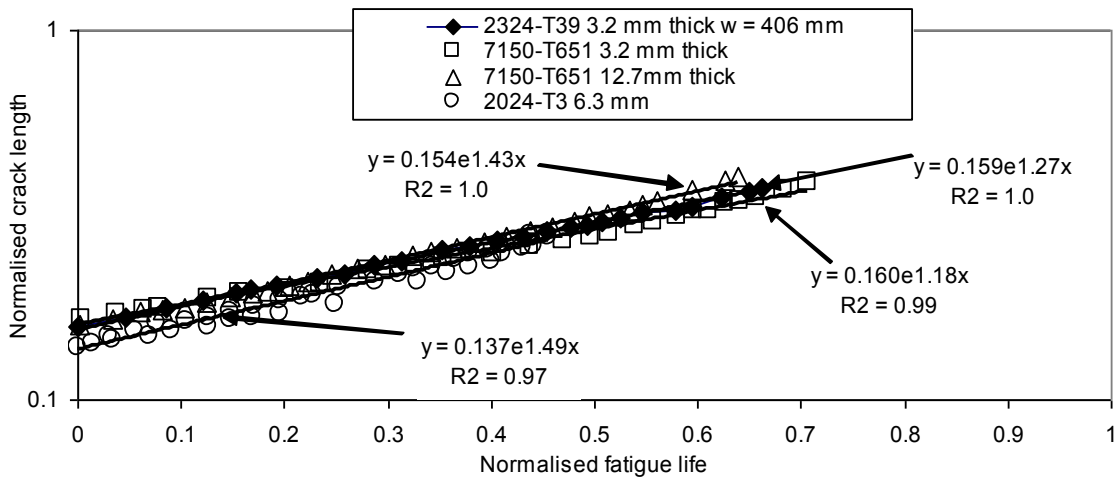
Figure 91: Boeing constant amplitude crack growth data, adapted from [6]

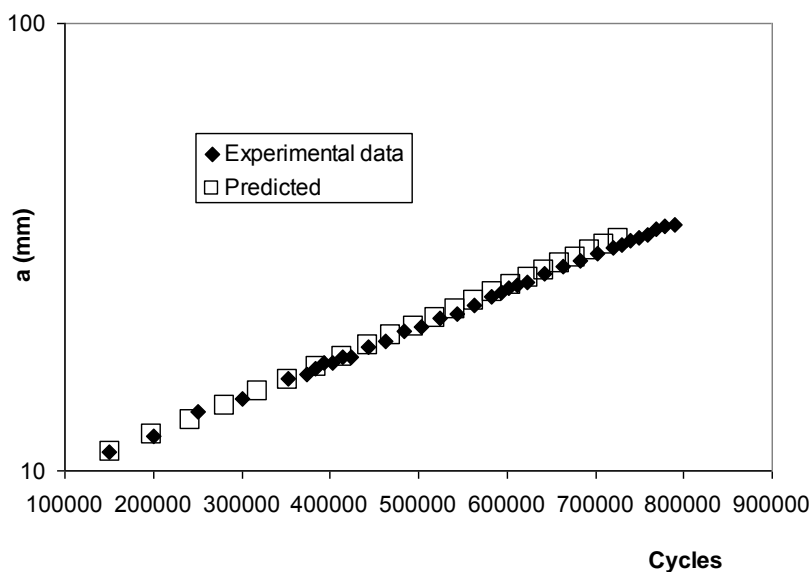
Figure 93: Crack depth versus number of cycles for the edge cracked 2024 T3 aluminium plate, repaired with a seven ply boron epoxy patch, under variable R ratio from [15]

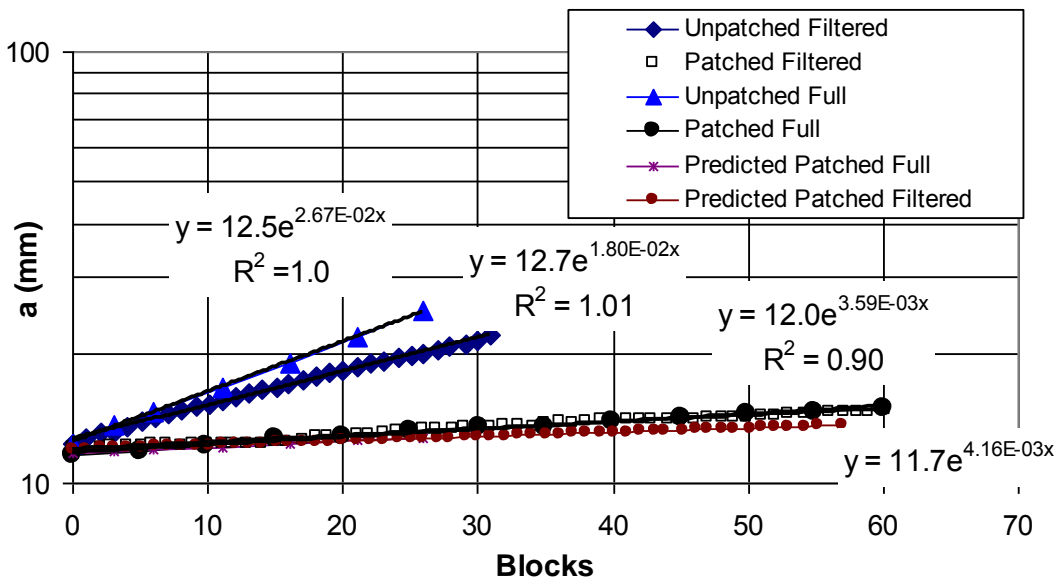
Figure 94: Crack growth under a representative C5A load spectrum, from [17]

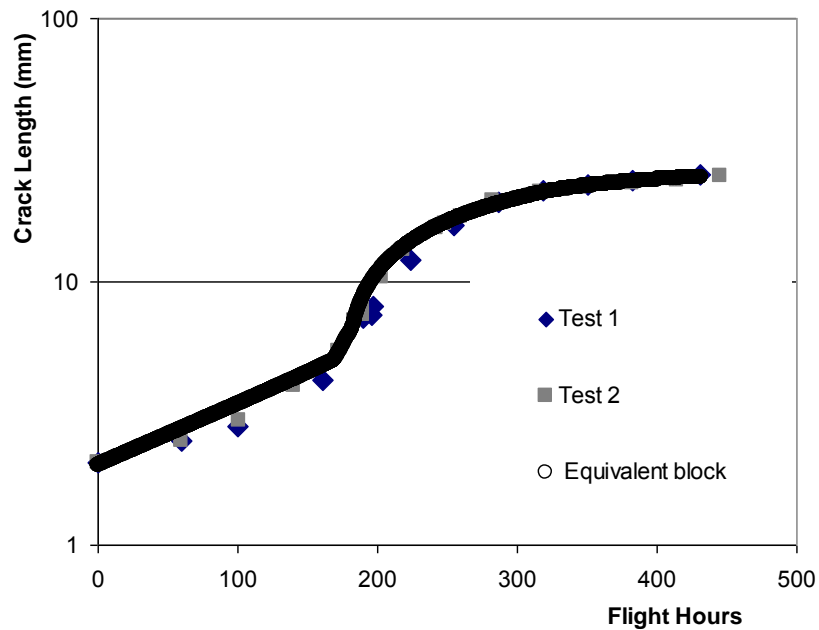
Figure 95: Computed and measured surface crack length histories

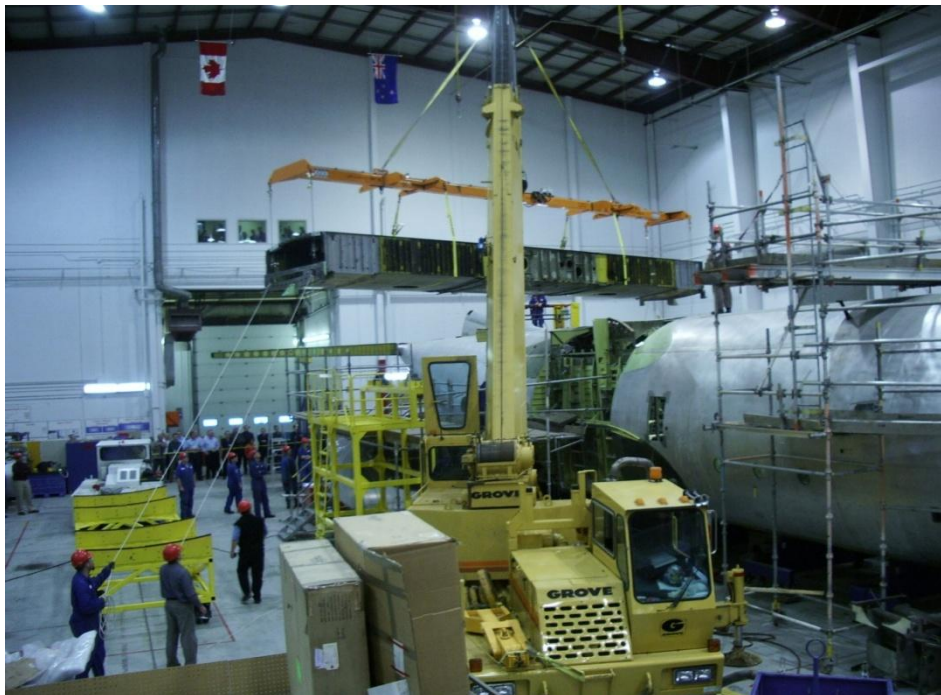
Figure 99: The first RNZAF aircraft undergoing upgrade in Edmonton

One aspect of the LEP that is of specific interest to the aeronautical fatigue community is the replacement of a number of critical wing structural elements and the embodiment of a Fatigue Improvement Modification (FIM) package for those wing components not being replaced. The replaced components include the center wing lower skin, caps and webs of both the front and rear center wing beams and the rainbow fittings. The areas subject to FIM have been designed by Spar to provide increased durability. The FIM includes an extensive fastener hole cold working, the installation of oversized fasteners (damage removal) and an extensive bolt hole and surface scan eddy current inspection programme. The goal of the FIM is to increase the durability of the RNZAF fleet wings and accordingly minimise the likelihood of future fatigue related maintenance.

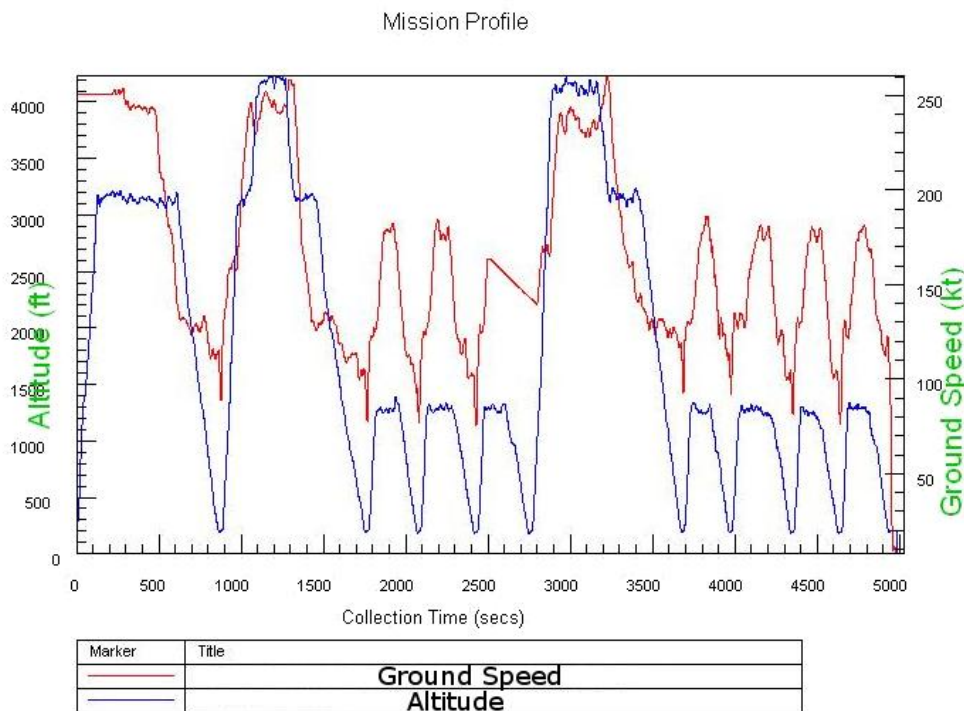
Figure 100: A typical Mission Profile graph showing GPS measured groundspeed (Red) and Altitude (Blue)
