**CHARACTERIZATION OF A HALL EFFECT THRUSTER USING THERMAL
IMAGING**

THESIS

AFIT/GA/ENY/07-M18

AIR FORCE INSTITUTE OF TECHNOLOGY

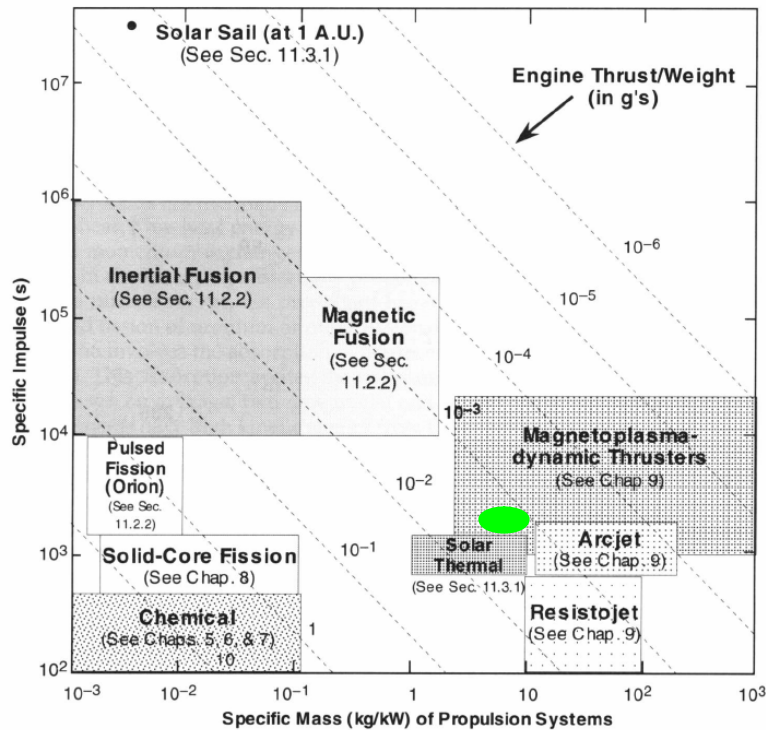
Figure 2: Propulsion technology comparison (2:446)

The area highlighted in green represents the Hall thruster technology with a specific impulse of 1600 to 2000 seconds and a specific mass of just under 10 kg/kW. The specific impulse represents the efficiency of the thruster used by the spacecraft, which impacts the overall operational capability. The Hall thruster is up to 5 times more efficient than chemical energy based thrusters using liquid propellant. The benefit of a highly efficient thruster can be a longer operational lifetime, a larger payload, or a lower launch weight, which has the benefit of lowering launch cost. Table 1 shows the specific impulse of several electric propulsion thrusters, and reveals the Hall thruster as a high performance option (3:702-708).

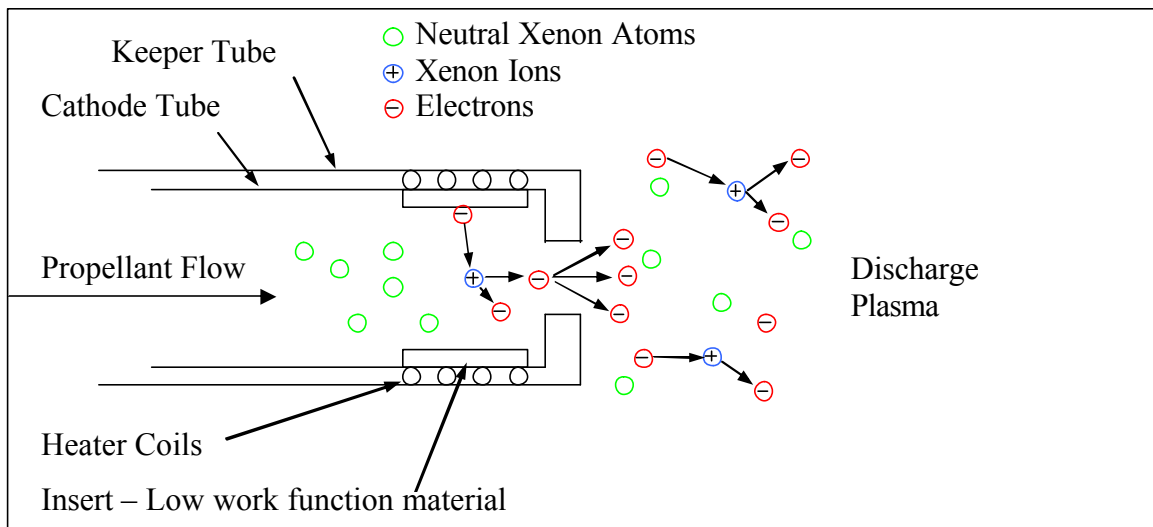
Figure 8: Hollow cathode operation. (10)

Knowledge of the cathode temperature is important because it impacts cathode lifetime. Hollow cathodes employ a process known as thermionic emission. In thermionic emission, a metal such as barium or a ceramic such as lanthanum hexaboride heats in order to allow the electrons' vibrational energy to overcome the electrostatic forces holding the electrons to the surface (9). The material has a low work function, which refers to the minimum energy needed to remove an electron from the material surface. About 10% or less of the propellant used by the Hall thruster passes through the

cathode (see Figure 8) and ionized by the electrons produced by thermionic emission in order for the cathode to perform its function.

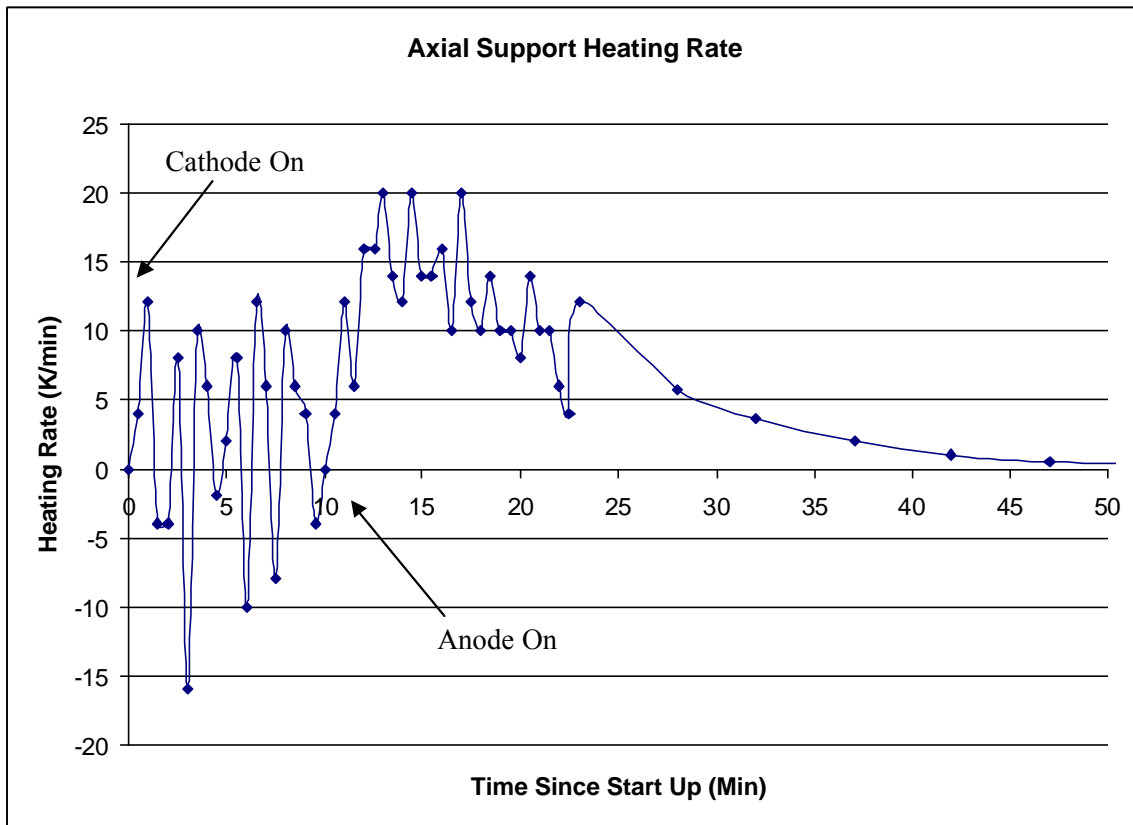
Figure 24: Axial Support Heating Rate

The following heating rate results were taken from the data gathered following thruster start up to 8.5 sccm. Figure 24 shows a plot of temperature change vs. time for the axial support bar near the exit plane, which was spot SP01 in Figure 21.

The time since start up indicates the amount of time elapsed after the cathode was conditioned and anode flow began. The heating rate varies between 0 and 10 degree K per minute for the first 10 min, then varies between 10 and 20 degrees K per minute between 12 and 25 min after start up. The apparent oscillation of the heating rate during the first 10 minutes was due to very small temperature changes over the time interval observed. The heating rate is less than 1 degree K per minute about 42 min after start up. The increase in heating rate at the 10 min mark coincides with an increase in heating rate

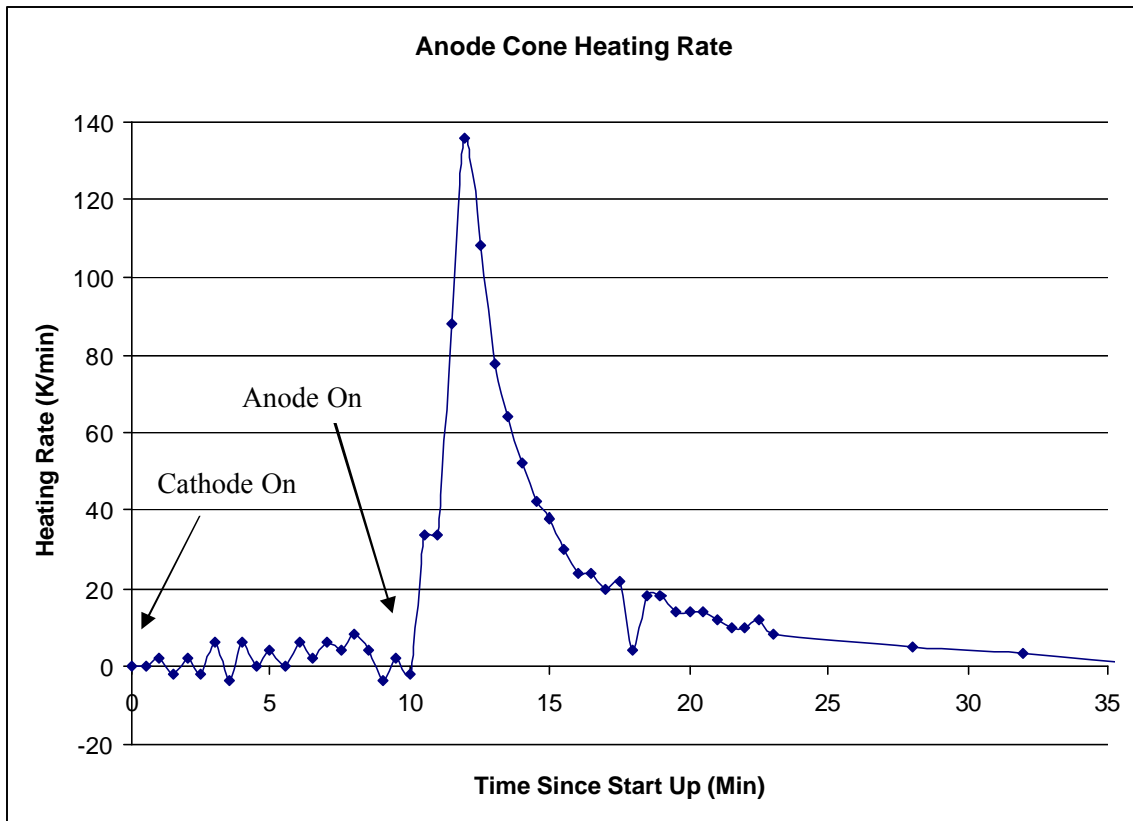
Figure 25: Anode Cone Heating Rate

of the anode cone (Figure 25). This is probably due to the heating of the anode section from the xenon plasma and subsequent conduction from the higher temperature anode section outward to the other areas of the thruster. Another possibility is that as the thruster begins to fire and plasma is formed at the exit, some of the xenon is impacting the alumina plasma sprayed portion of the exit plane of the thruster, which then conducts the heat to the axial support bars. While radial xenon neutral velocity is nearly zero at the exit plane, the velocity increased to an average of 75 m/s just 10 mm (0.39 inch) from the exit plane (25). Therefore, the increase in heating rate of the axial support bar may indicate xenon affecting thruster temperatures. Figure 25 shows the heating rate for the anode cone, which was spot SP02 in Figure 21.

The heating rate appears to be insignificant until 10 min after start up, then increases sharply to 138 K/min before coming back down to less than 40 K/min at about 15 min after start up. The heating rate lowers to about 3 K/min at 32 min after start up, then appears to go to 0 K/min after 30 min. It does not actually reach 0 K/min at this point because the temperature reading reached ~ 773 K, which is the maximum value measurable by the camera. Figure 26 shows the heating rate for the steel portion of the cathode, which was spot SP03 in Figure 21.

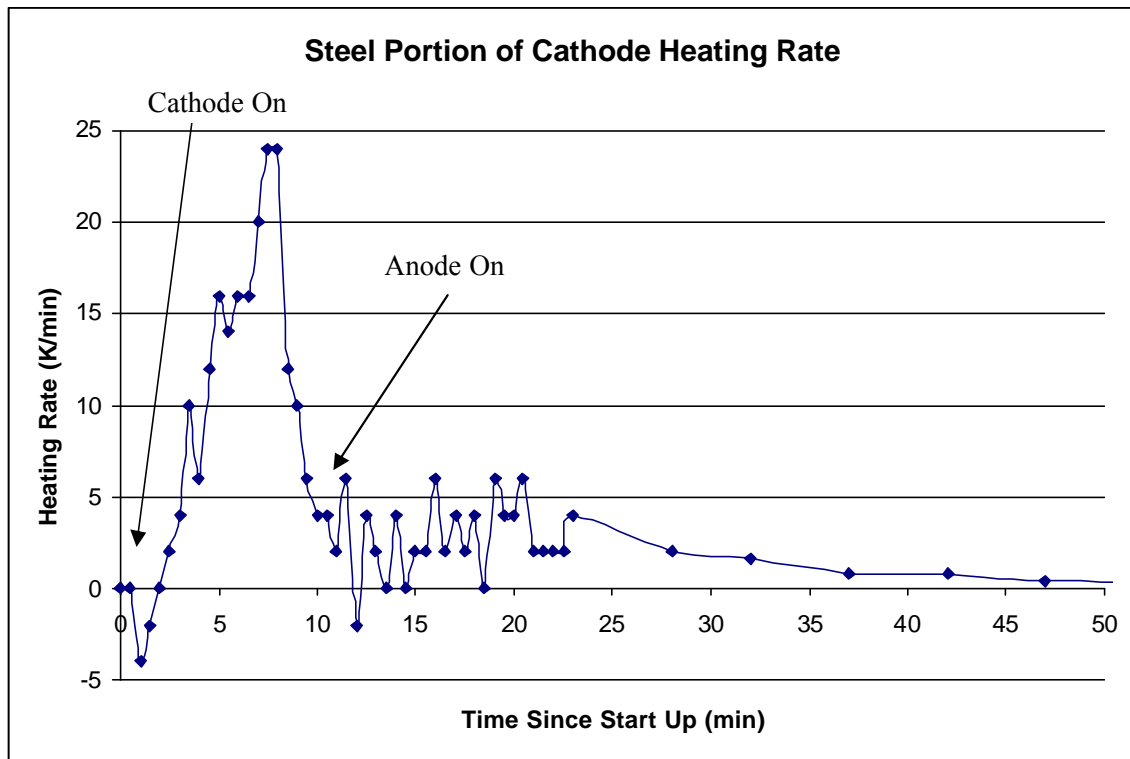
Figure 26: Steel Portion of Cathode Heating Rate

plasma sprayed portion to the steel portion. Interestingly, the heating rate stabilized during the same 10 to 25 min time frame as the anode cone and axial support bar, rather than continuing to decrease. This may be further indication of interaction between the cathode and xenon as discussed earlier. Figure 27 shows the heating rate for the alumina plasma sprayed portion of the cathode, which was SP04 in Figure 21.

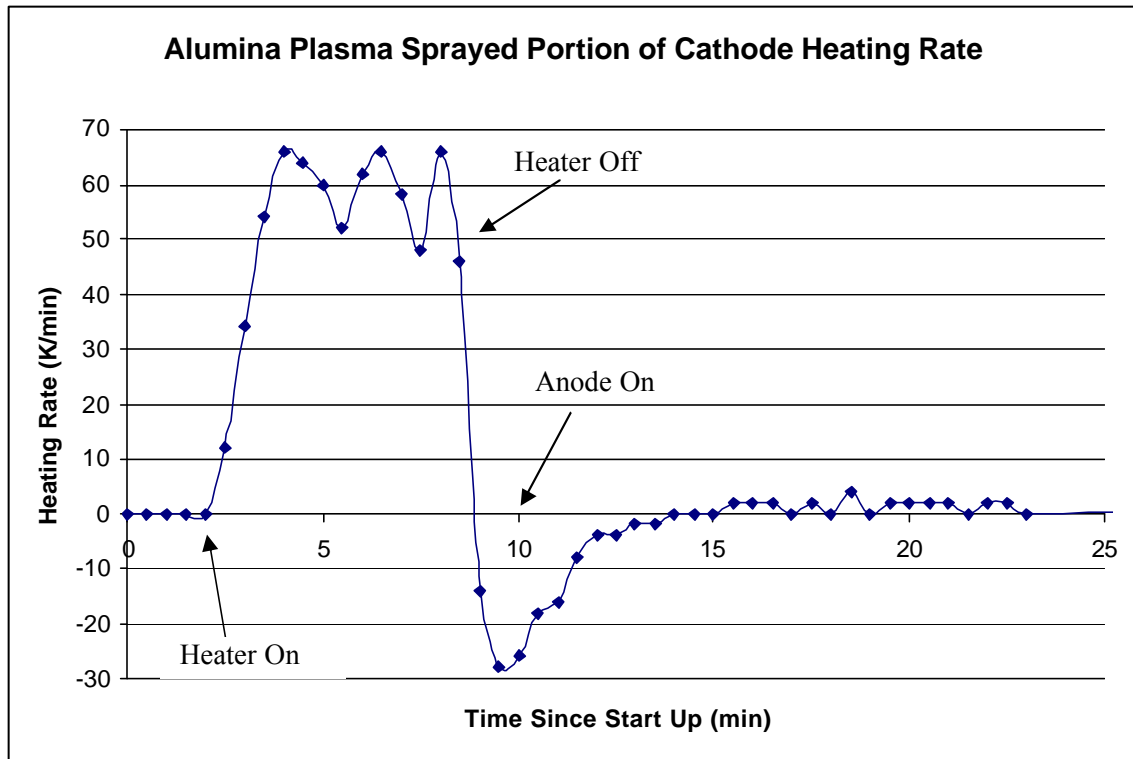
Figure 27: Alumina Plasma Sprayed Portion of the Cathode Heating Rate

The cathode was conditioned and at a temperature of 353 K at the zero time point. The heating rate increased rapidly over a span of 2 min to 60 K/min and remained between 50 and 70 K/min until the 9 min mark. The heating rate then reached negative values until the 13 minute mark. This variation is likely due to keeper heating during the first 10 minutes, followed by cathode flow start. The inverse relationship between cathode flow and keeper temperature caused the cathode heating rate to reach negative values. The heating rate is less than 1 K/min beginning with the 13 min mark.

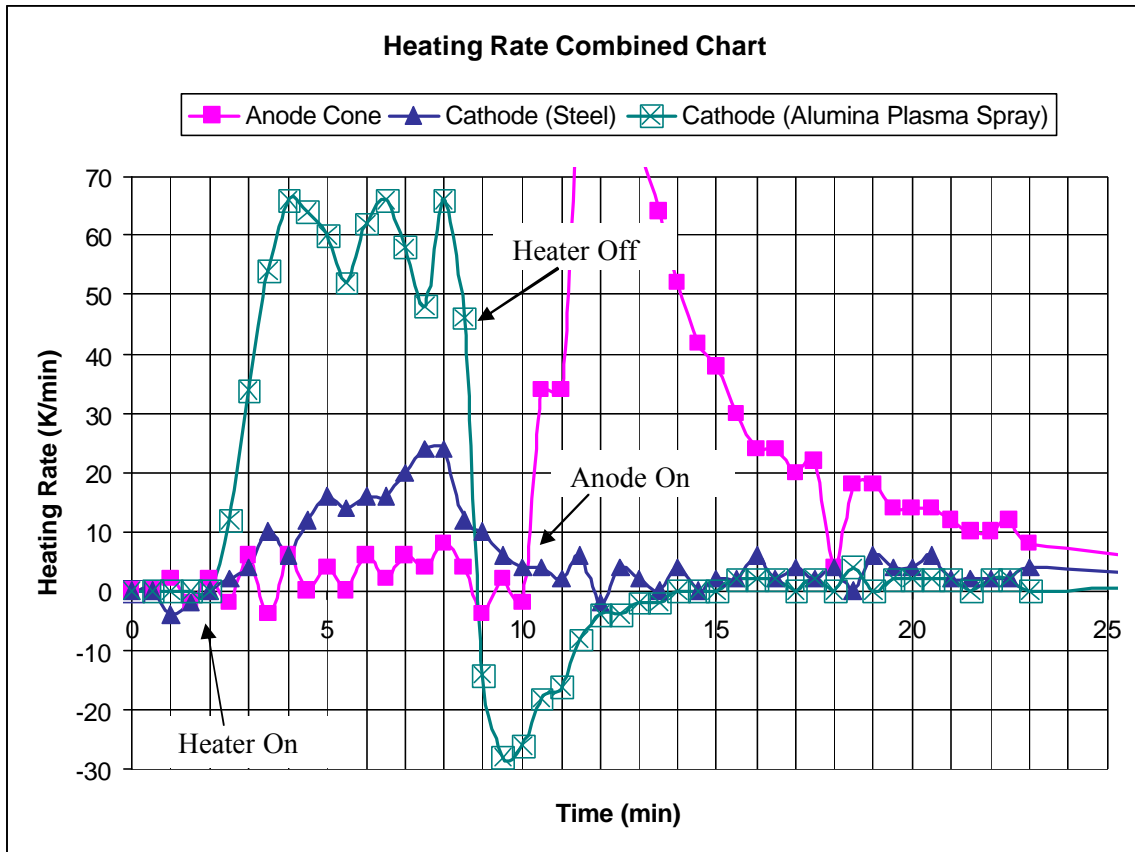
Figure 28: Component heating rates in single chart

Figure 28 shows Figure 25, Figure 26, and Figure 27 on one chart in order to further show the relation between the timing of the heating rates of the various components.

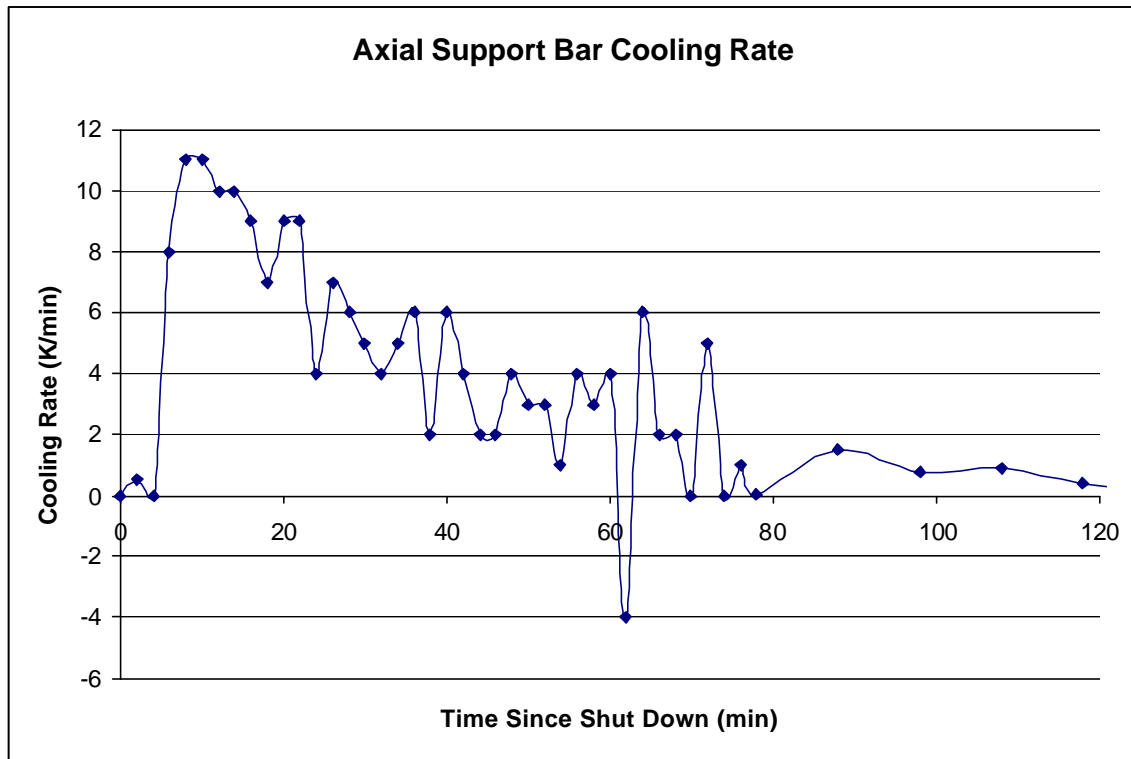
Figure 31: Axial Support Bar Cooling Rate

The next set of data shows the cooling rates during the 5 hours following thruster shut down from operation at 8.5 sccm. For reference, the spot locations are identical to those used to collect heating rate data as shown in Figure 21. Figure 31 shows the cooling rate data for the axial support bar near the exit plane, which is spot SP01 on Figure 21.

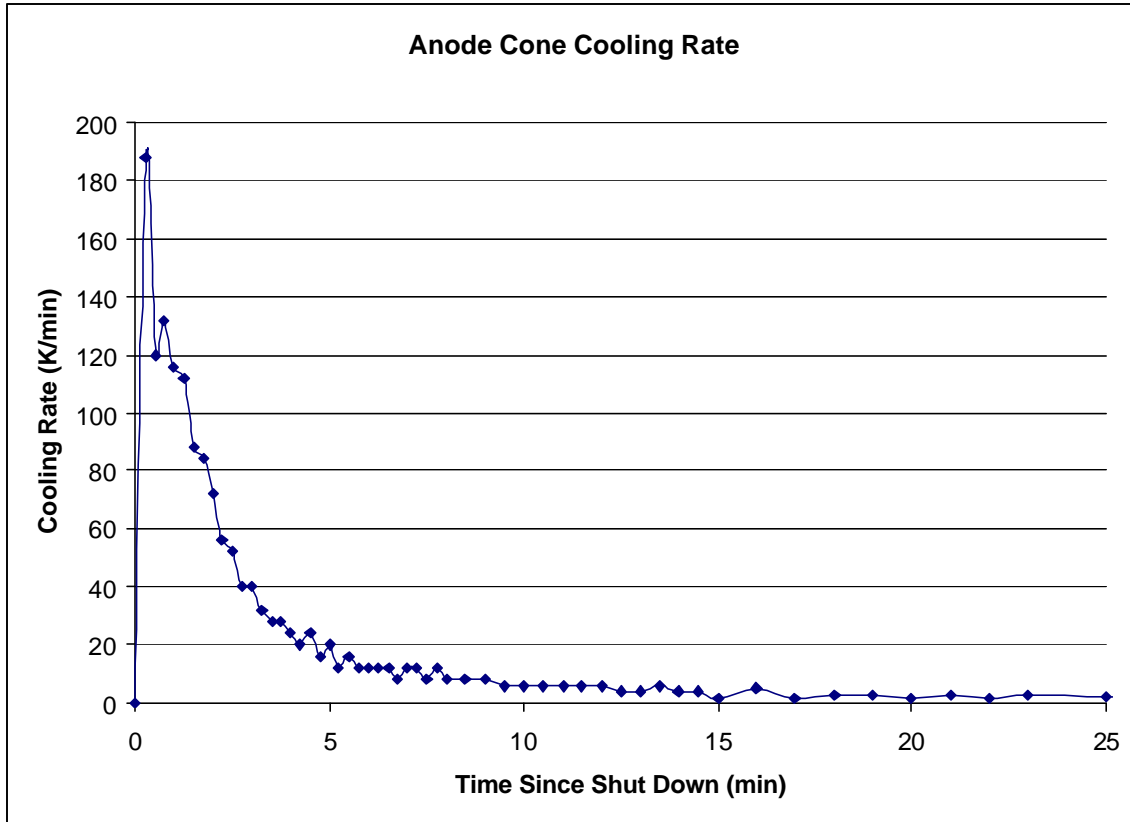
Figure 39: Exit Plane Anode Cone Cooling Rate

The cooling rate data included here originates in the ThermoCam Researcher data files from tc1220.fff to tc3349.fff. The cooling rate for the anode cone is shown in Figure 39, which is SP01 from Figure 22.

The cooling rate was between 188 K/min and 112 K/min in the first two minutes. The cooling rate of the anode cone taken from the side view data was not taken from the exact same spot on the cone and was only 90 K/min suggesting this area of the anode cone was hotter. The cooling rate gradually decreased to about 20 K/min and then remained less than 3 K/min at the 23 min mark. The cooling rate for the rear of the anode channel is shown in Figure 40, which was SP02 in Figure 22.

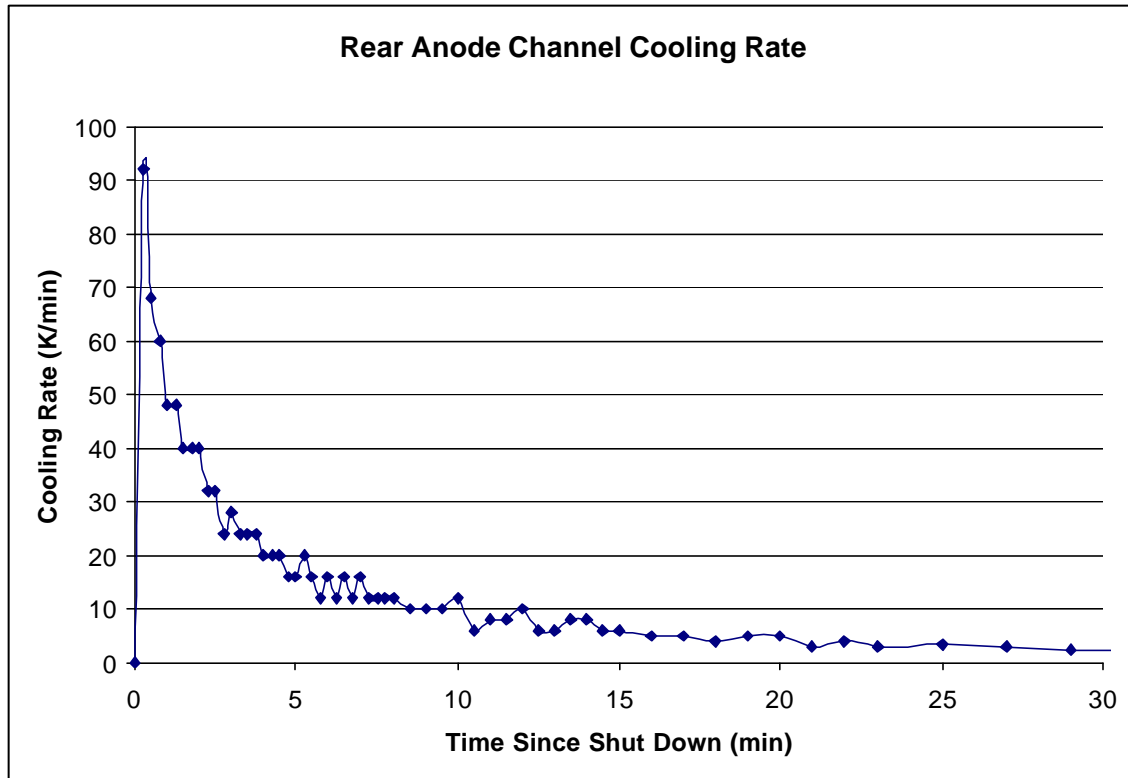
Figure 40: Rear Anode Channel Cooling Rate

The cooling rate began at 92 K/min and fell rapidly to about 14 K/min in the first eight minutes. This cooling rate is lower than the cooling rate of the anode cone, suggesting the anode cone was at a higher temperature. The cooling rate gradually decreased to about 20 K/min and then remained less than 3 K/min at the 27 min mark. The cooling rate data for the rear of the alumina plasma sprayed portion of the exit plane is shown in Figure 41, which was SP03 in Figure 22.
