**DAMAGE DETECTION USING LAMB WAVES FOR STRUCTURAL  
HEALTH MONITORING**

THESIS

AFIT/GA/ENY/07-M05

***AIR FORCE INSTITUTE OF TECHNOLOGY***

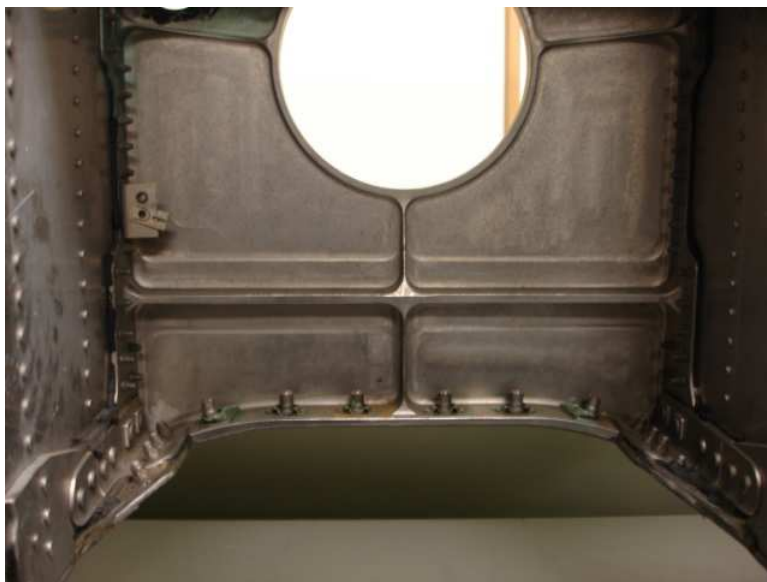
Figure 1.4 F-15 bulkhead: undamaged bulkhead provided to AFIT

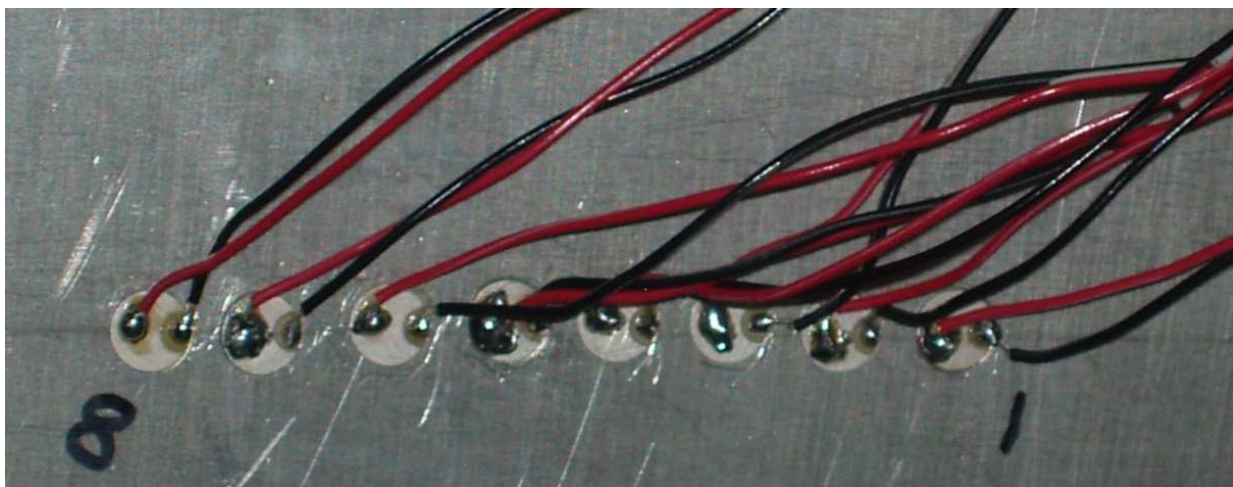
Figure 2.9 MPP: array of middle APC 850 piezos

A total of 26 APC 850 piezos were attached to the MPP. Eight piezos were attached in the center of the MPP and nine were attached in each of the two regions (Figures 2.8 and 2.9). The piezos were attached using M-Bond 200 adhesive.

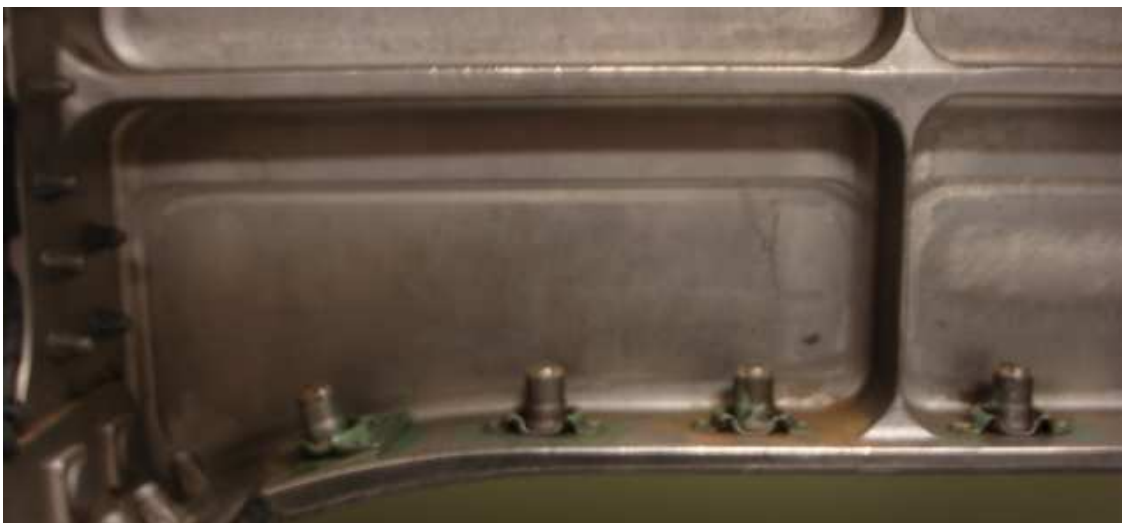
Figure 2.12 F-15 bulkhead: closeup of undamaged bulkhead where damage occurred

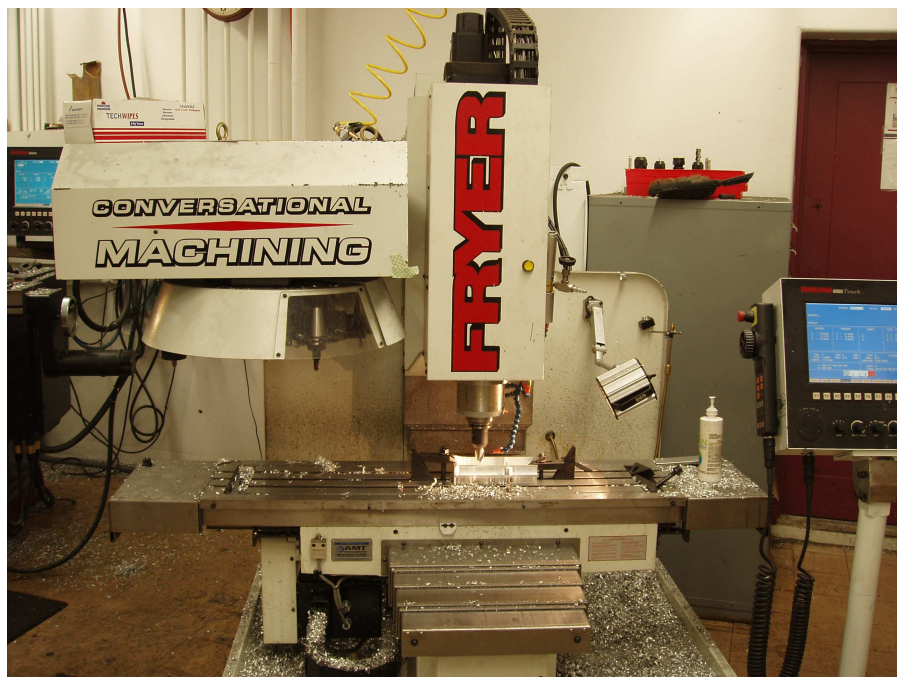
Figure 2.13 F-15: milling using Fryer MB-10

*2.4.1 Milling Process.* The F-15 bulkhead is made of a titanium alloy, but we choose aluminum due to similar dispersive properties (Figures 1.11 and 1.12), availability, and cost. Figure 2.11 shows the dimensions of the scaled F-15 drawing that was provided to AFIT's model fabrication shop for the milling. Sensor 3 through 6 were placed as shown. A closeup of the F-15 section is shown in Figure 2.12. Three test articles were milled from Al 6061-T6 using a Fryer MB-10 CNC Mill, see Figure 2.13.
