AFRL-VA-WP-TR-2007-3042

**VERSATILE MEASUREMENT
TECHNIQUES TO VALIDATE
ANALYTICAL STRUCTURAL
MECHANICAL MODELS**

Experimental Validation Branch (AFRL/VASV)

Final Report for 03 January 2003 – 31 October 2006

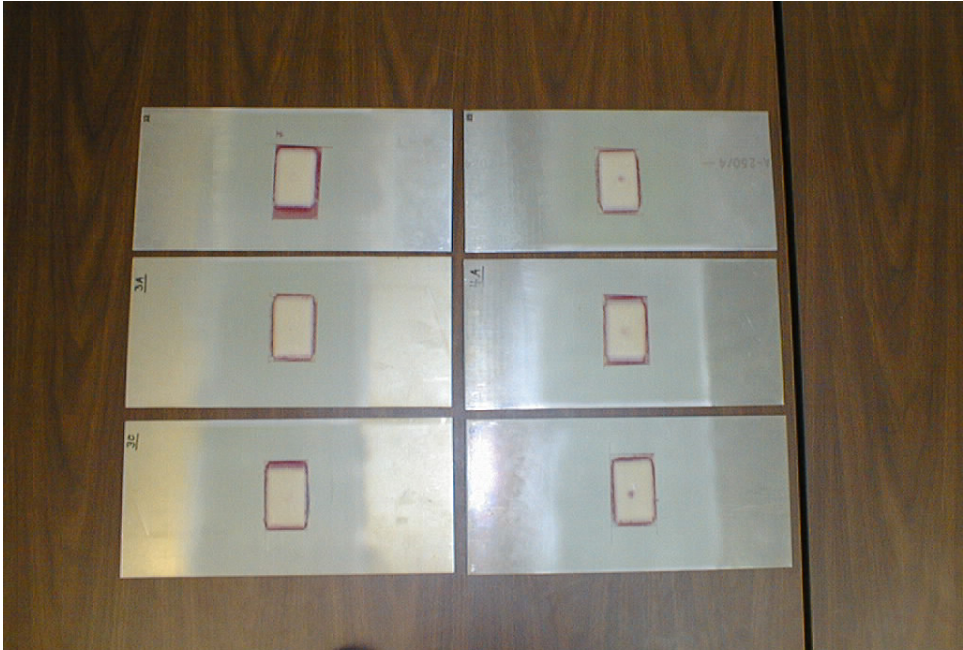
All test specimens were bonded with same size patches irrespective of test specimen size and thickness. Typical small size specimens (180x85 mm) with a bonded repair patch are shown in Figure 4a. The repair patch width is almost the same as the width of the test specimen. Typical repair patches bonded to large size specimens (360x170 mm) are shown in Figure 4b. The repair patch covers only the central portion of the test specimen.

Figure 4b. Large Size (360x170 mm) Test Specimens with Repair Patches

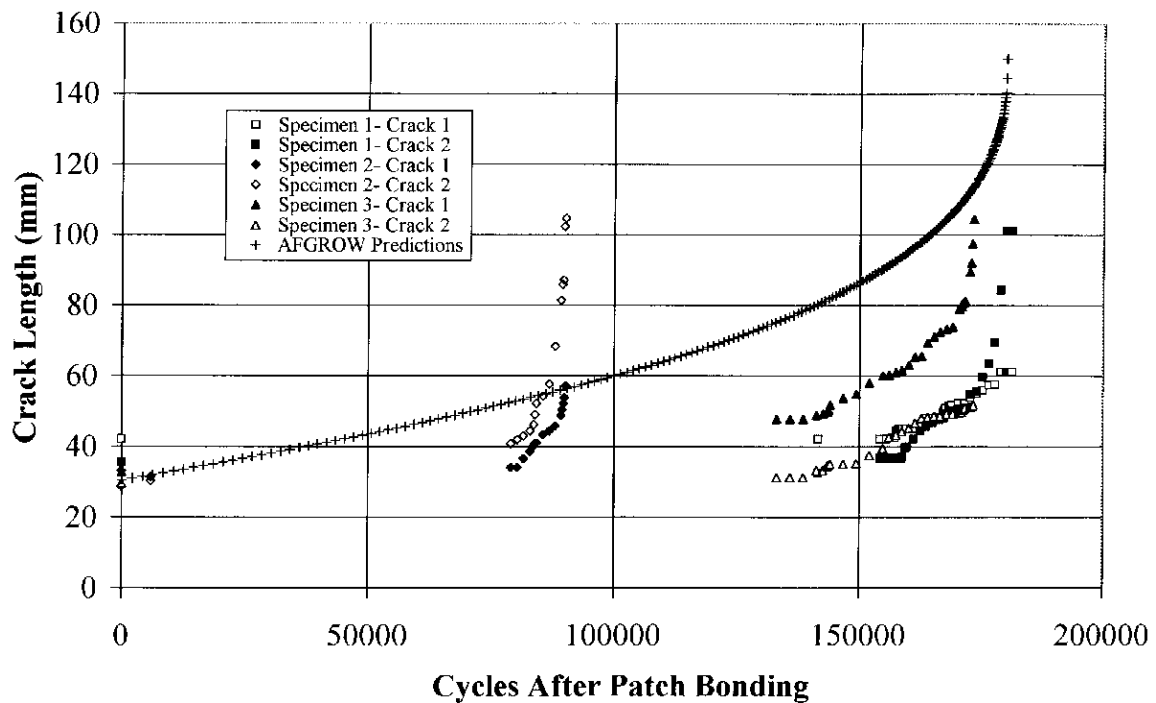
AFGROW code bonded composite patch analysis was used for crack growth predictions. The composite patch stress intensity factors obtained from AFGROW code were modified to account for frequency effects based on Reference 16 analysis, and parallel crack effects based on Reference 17 analysis. Crack growth in Series 3 specimens is shown in Figure 10 along with AFGROW predictions. AFGROW predictions were made accounting for the effect of dynamic loads, parallel cracks and composite patches on SIF. The test data shows a large scatter. One specimen shows very short crack growth life. Total crack growth life of other two specimens agrees well with modified AFGROW predictions.

Figure 10. Observed and Predicted Crack Growth in Test Series 3 (1-mm Thick) Patched Specimen (Cycled at 3g)

A comparison of crack growth behavior in Series 3 specimen without repair patch (Figure 9) and with repair patch (Figure 10) shows significant increase in crack growth life. The number of cycles to grow crack from a length of about 30 mm to 45 mm in specimen without repair patch is about 6,000 cycles. The number of cycles to grow crack by same amount in specimen with repair patch is over 50,000.

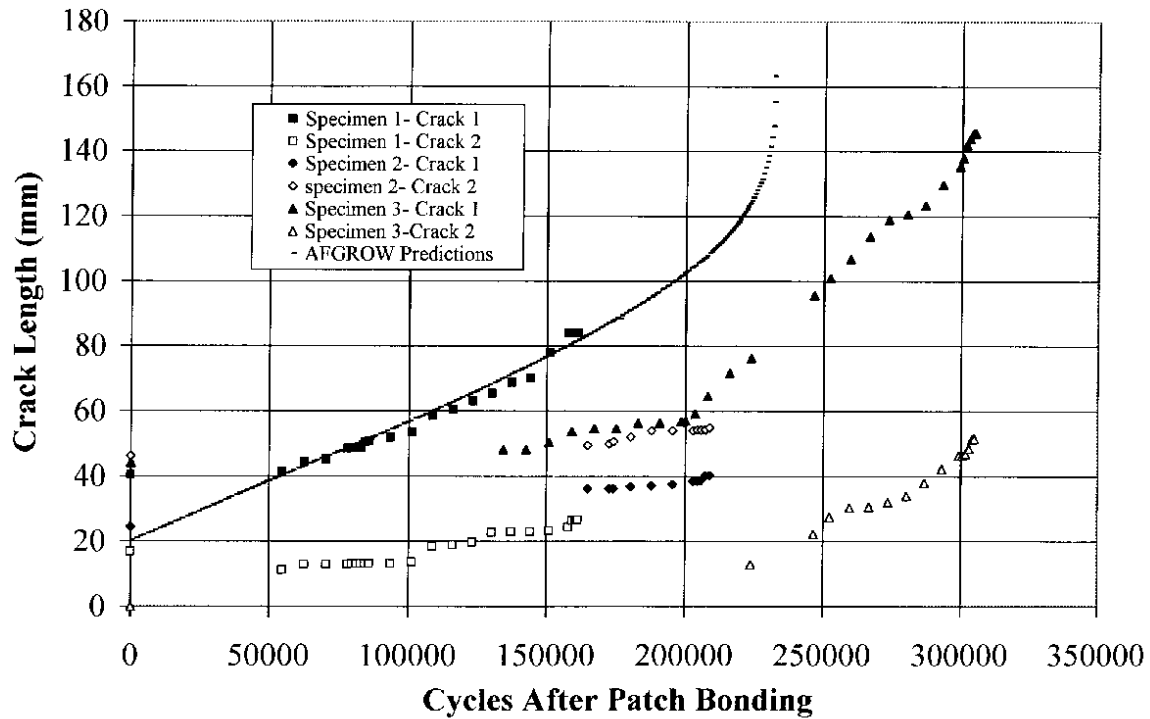
Crack growth in Test Series 4 specimens is shown in Figure 11 along with AFGROW predictions. AFGROW predictions were made accounting for the effect of dynamic loads, parallel cracks, and repair patches. Crack growth test data from one crack of Specimen 1 agrees well with AFGROW predictions. Other cracks show longer crack growth life as compared to AFGROW predictions.

Figure 11. Observed and Predicted Crack Growth in Test Series 4 (3.2-mm Thick) Patched Specimen (Cycled at 3g)

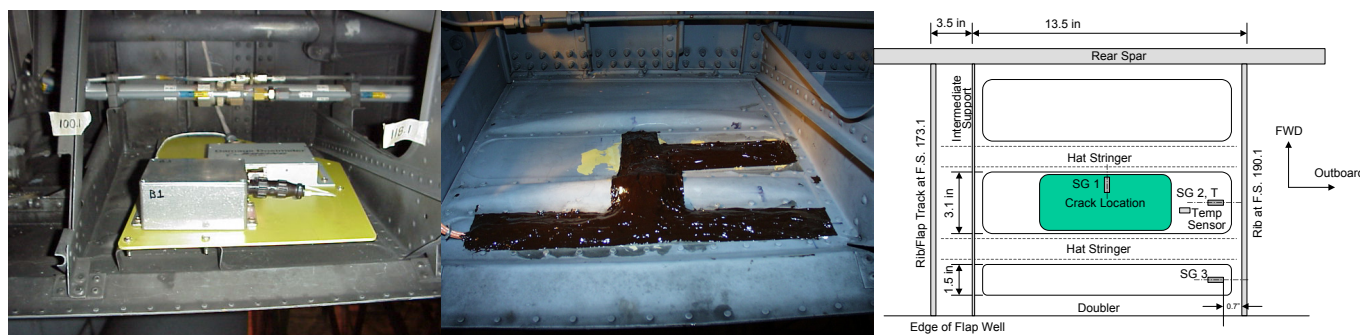
Figure 3. Damage Dosimeter Installation in C-130 as shown by Ikegami, et.al. (2001)

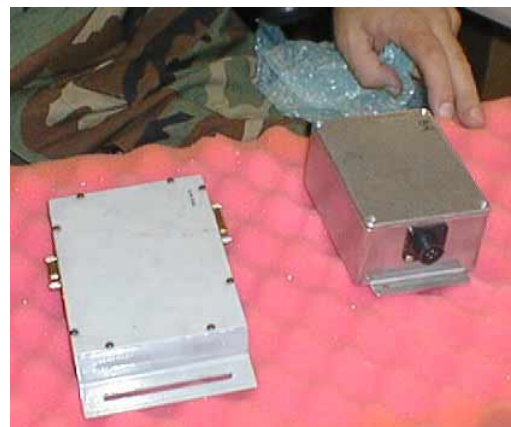
Figure 2. Dosimeter and Battery Pack

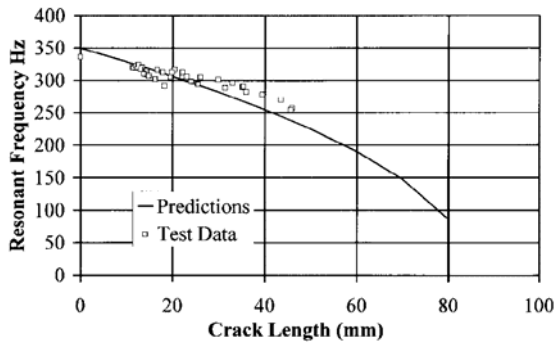
Fig. 4. Comparison of predicted and test resonant frequencies.

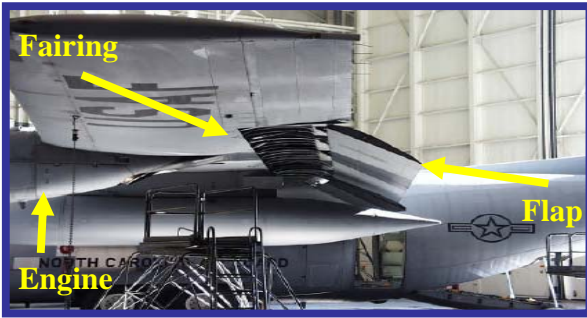
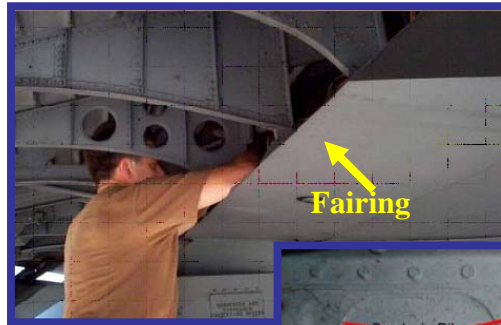
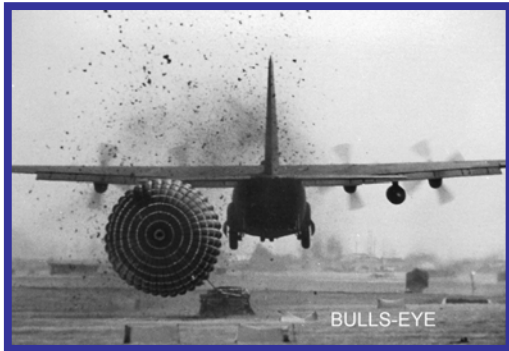
BASELINE STRUCTURE

- Dosimeter
- Context – Annoyance High Cycle Fatigue (HCF) Damage of Secondary Structure – Costly Repair
- 3 Dynamic Strain Gages/ 1 Temperature
- Autonomous – no AC power; sleeps; checks strain every min; when exceed threshold; compute 1/3 octave; store 57 rms 1/3 octaves & 1 temperature.

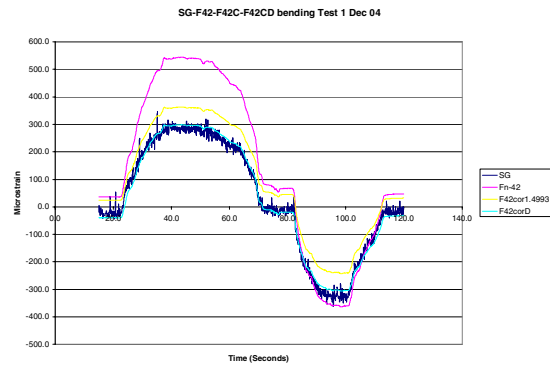
Figure 8: Test Item 2 (CC) Lab Bending fiber F-42 (Corrected) and Strain Gage (1 Dec 04)

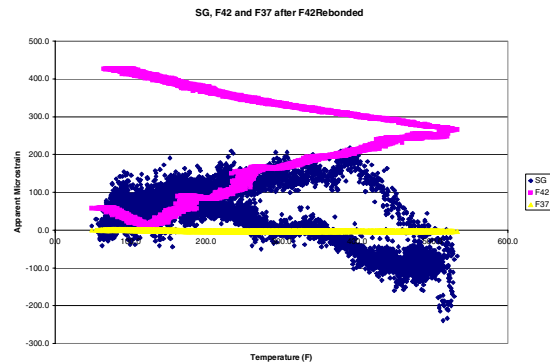
Figure 9: Test Item 2 (CC2) after Heat Gun Test to 500°F Dec 1 05(F42, TC, SG-Center&F37 Hole)

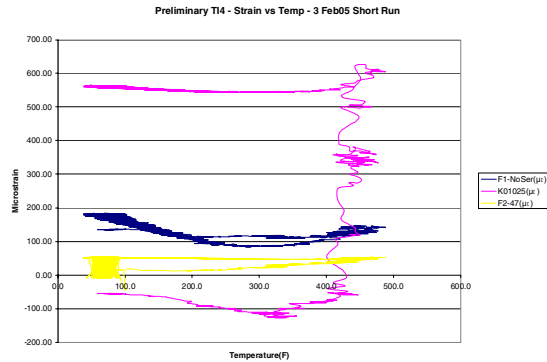
Figure 13: Test Item 4 Apparent Strain versus Temperature during Heat Gun Test (3 Feb 05)

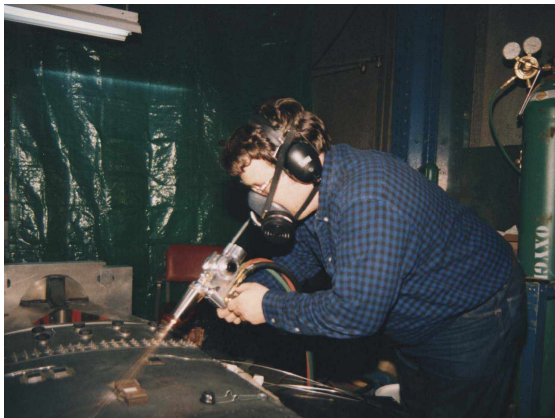
Figure 14: Future Tests Will Use Flame Spray Attachment Technique

As predicted by its manufacturer, Sauereisen 13 adhesive did not bond well to a heated Aluminum specimen. However, further evaluation is needed to understand the physics involved with using Sauereisen 13 adhesive with the CC specimens. AFRL plans to conduct more evaluations by attaching EFPI sensors using the flame spray techniques shown in Figure 14.

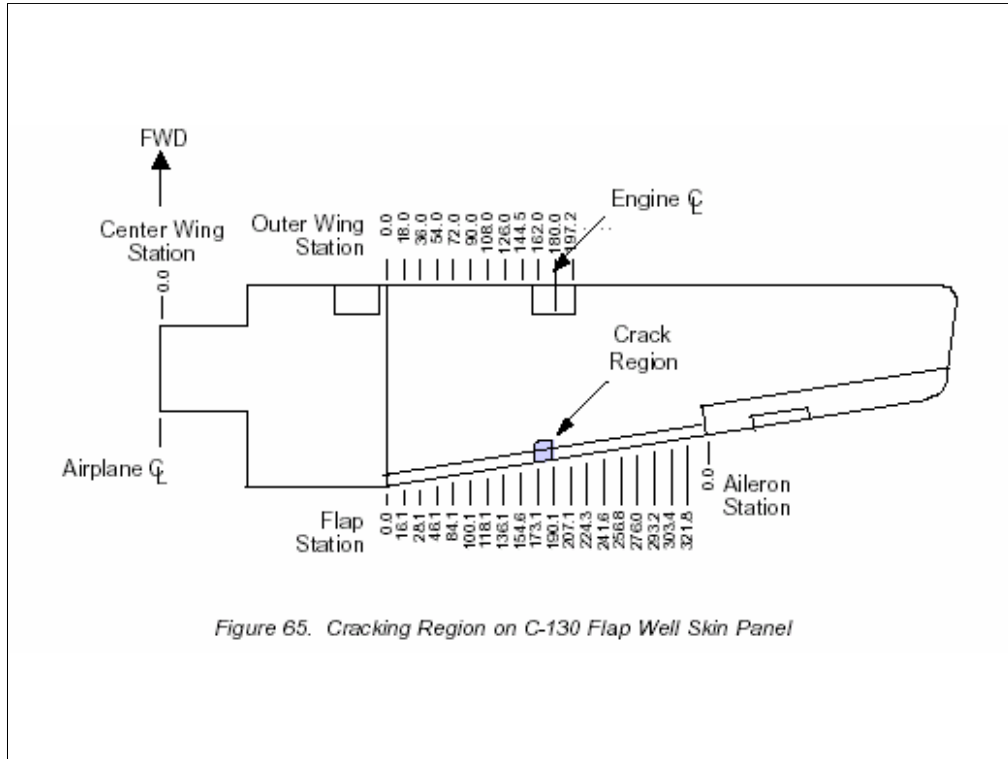
The crack location on C-130 secondary structure is shown in this chart. AFRL finds this information by measuring the structure's operating environment with a compact, stand-alone, electronic device called a damage dosimeter. AFRL conducted five data-gathering flights with the dosimeter on the C-130 without a repair during June 2003 and seven more flights with a repair applied during October 2003.

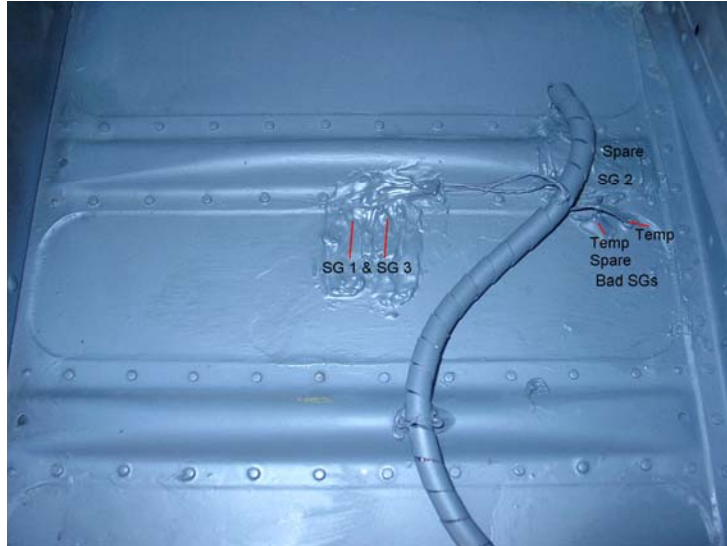
Strain Gage and Temperature Sensor Installation in C-130 During June 2003

An AFRL engineer and technician installed the strain gages and temperature sensor as shown in the chart. First they removed old RTV with Dow Corning OS-2 solvent and phenolic scrapers. The temperature sensor is located near the hat riser. AFRL installed 6 Measurement Group type WK-13-250BG-250 Option W strain gages using M-Bond 600. The gages were covered with Teflon tape then coated with M Coat J since temperature expectations were about 100 degrees Centigrade ($^{\circ}\text{C}$). They also installed 2 Analog Devices two-terminal IC AD590 temperature transducers. Spare gages and temperature transducers were installed as shown. After bonding of the transducer and cable routing, the installers found the two gages on the right side were bad. For the final configuration, strain gage 2 is located on the hat riser and strain gage 1 and 3 are adjacent to each other at the center of the panel.

The dosimeter was located in the wing flap well between wing station 100.1 and 118.1, and the strain gages and temperature sensor were located between F.S. 173.1 and F.S. 190.1. During June 2003, AFRL engineers and technicians and North Carolina Air National Guard (NCANG) personnel installed strain gages and temperature sensors as shown in the chart.

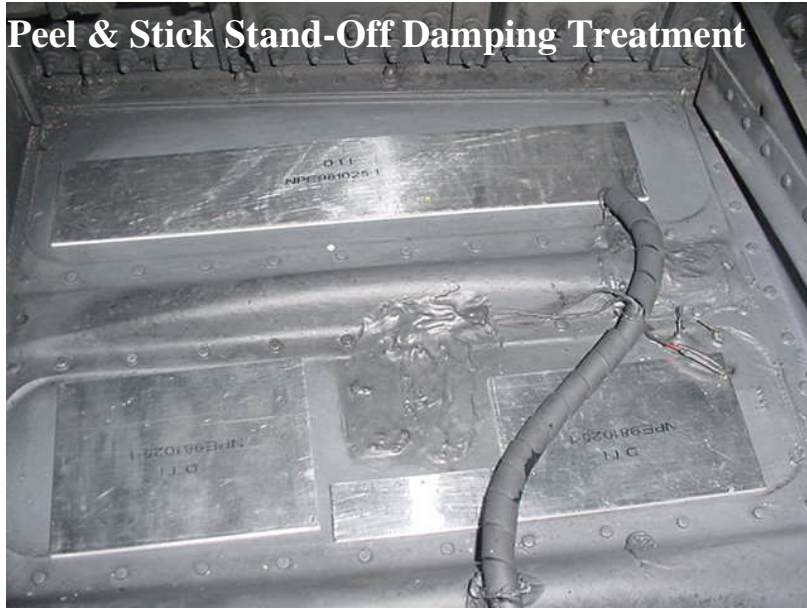
The final Constrained Layer Damping Repair in the forward and middle bays is shown in the photo. A P/N NPE981025-1 damping system measuring approximately 12" x 3" was applied to the forward most bay by removing the protective release liner, eye balled the alignment, pressed it in place, and applied additional pressure using a squeegee. This process was repeated for the aft most bay where a P/N NPE981025-1 part measuring approximately 2" x 10" was applied. Care was taken to lift the instrumentation wiring and position the damping system under it.

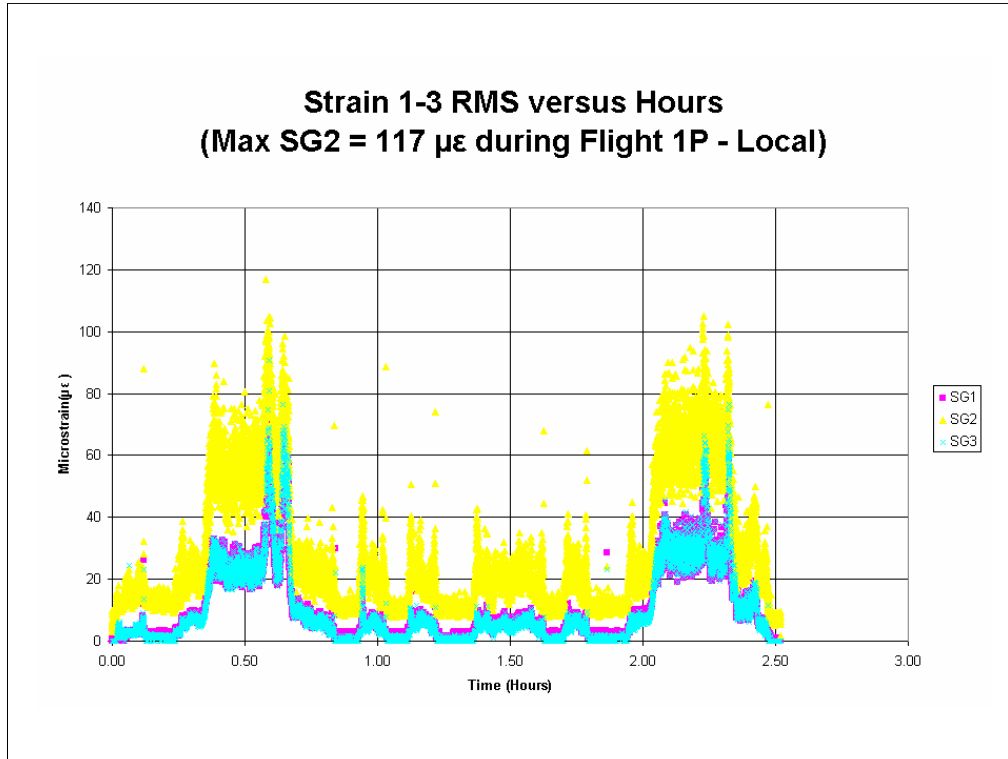
For flight 1P only the strain data is presented since the temperature sensor was not operating properly during this flight. As shown in the chart the maximum strain was about 117 microstrain during this flight.

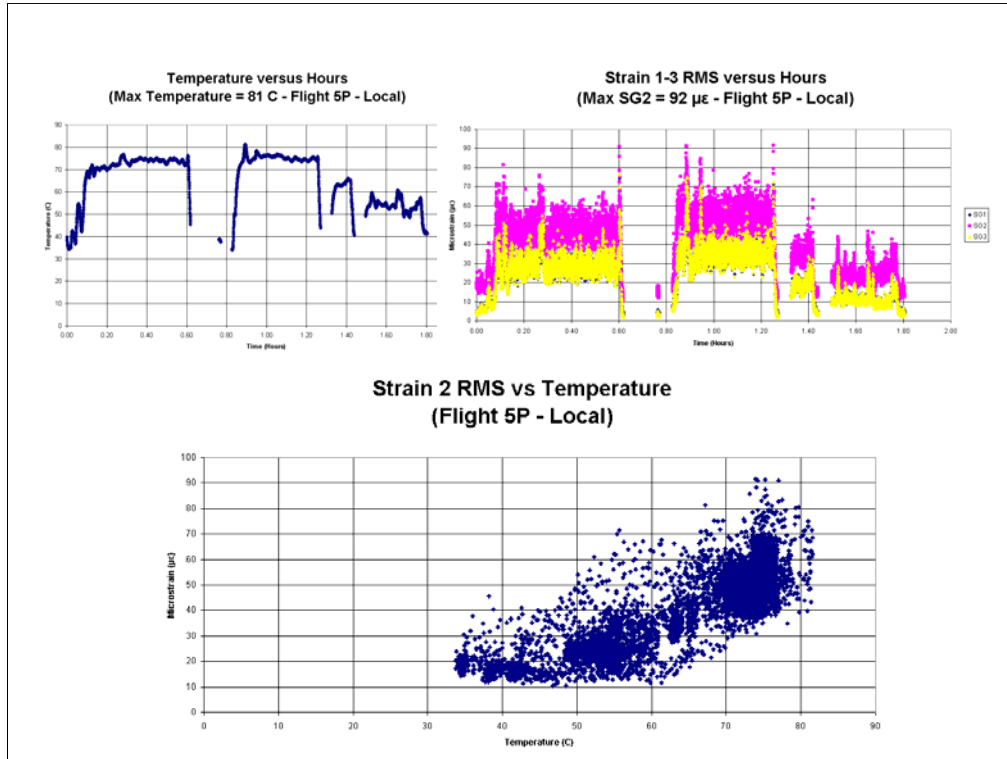
For flight 5P temperature and strain data versus flight time is presented. Also a scatter plot of strain for gage 2 versus temperature is shown. As shown in the chart the maximum strain was about 92 microstrain during flight 5P. The maximum temperature is about 81 C and the minimum temperature is about 33 C.

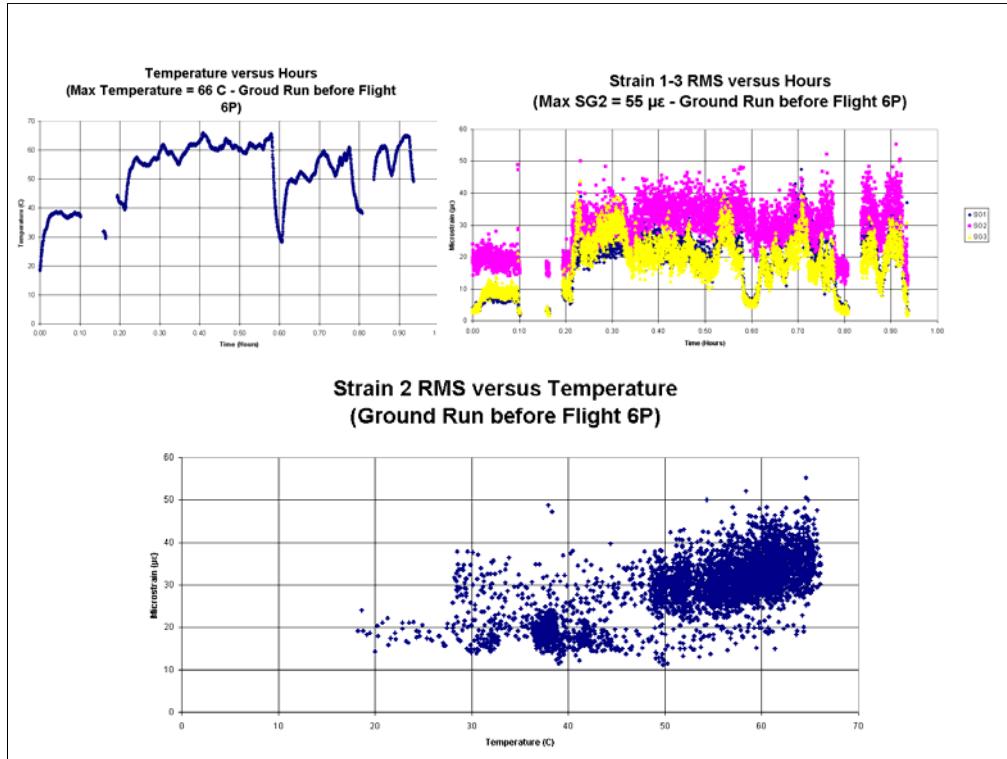
For a engine ground run before flight 6P temperature and strain data versus flight time is presented. Also a scatter plot of strain for gage 2 versus temperature is shown. As shown in the chart the maximum strain was about 55 microstrain during the engine ground round before flight 6P. The maximum temperature is about 66 C and the minimum temperature is about 18 C.

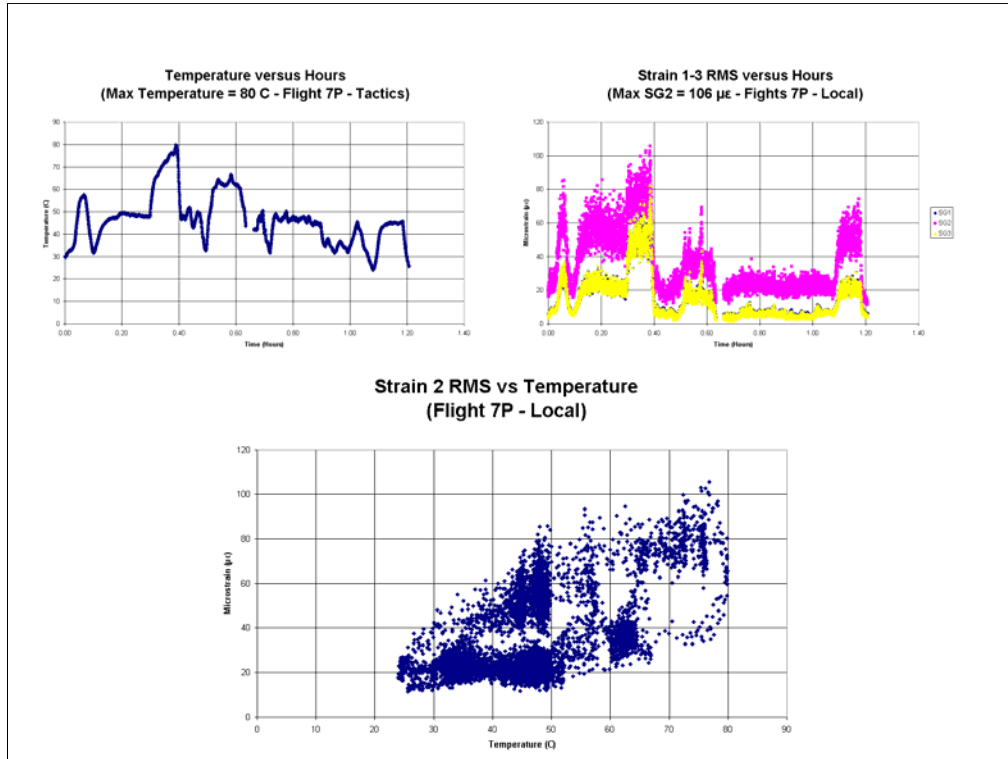
For flight 7P temperature and strain data versus flight time is presented. Also a scatter plot of strain for gage 2 versus temperature is shown. As shown in the chart the maximum strain was about 106 microstrain during flight 7P. The maximum temperature is about 80 C and the minimum temperature is about 24 C.

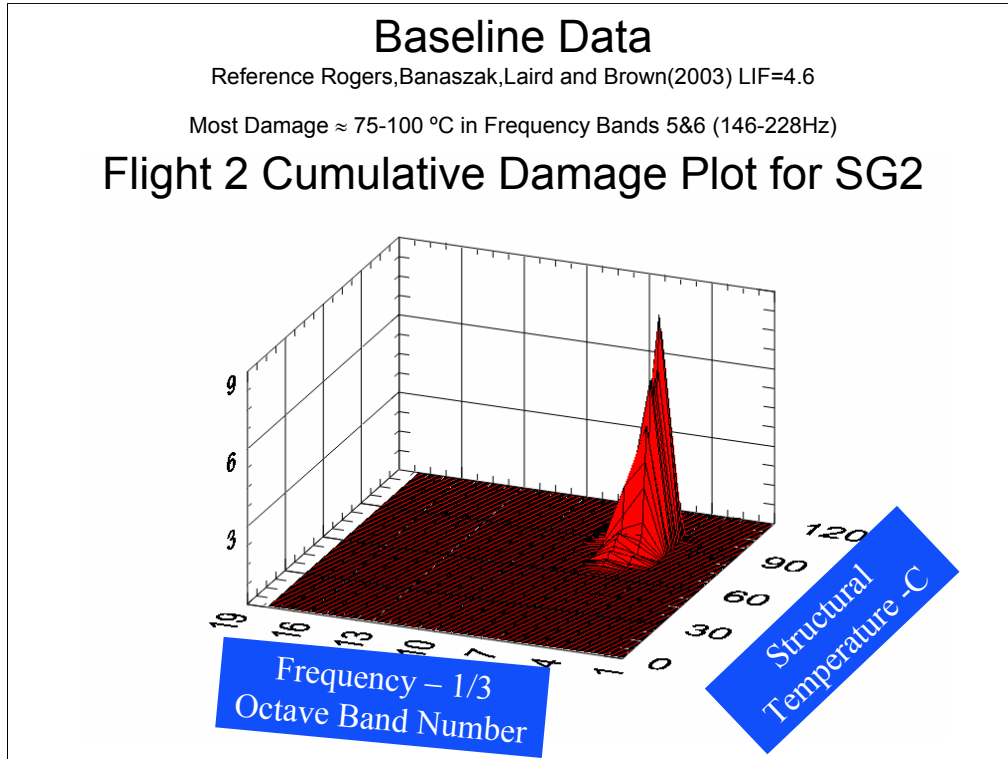
A cumulative damage plot can be prepared as done previously for a flight with no repair during June 2003. This analysis is being continued by an emeritus engineer at AFRL. Preliminary indications are that there is a life improvement factor (LIF) of about 5.

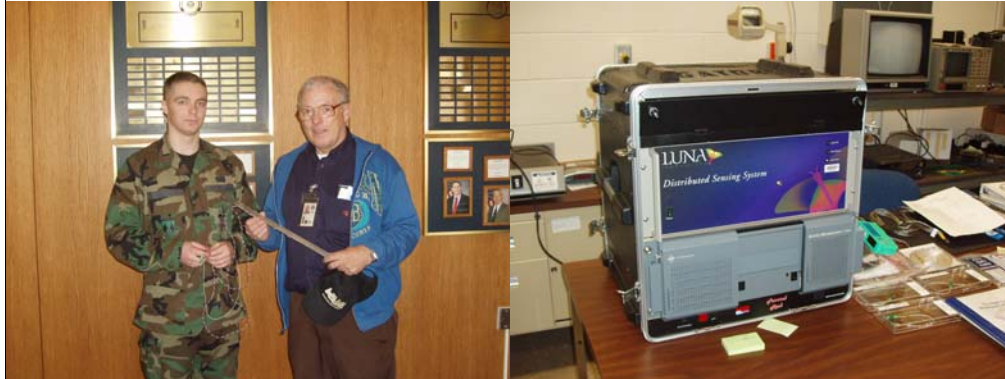
ML & VAS Start Evaluation of DSS System (26 Jan 06)

ML Presenting Test Beam to VASV

Luna DSS System

In a letter dated 17 August, 2005, MLL requested the support of VAS in testing the Luna Distributed Sensing System (DSS) deliverable under SBIR Topic AF# SD01-CBM04. AFRL/VAS agreed to provide this support in a memorandum dated 28 October 2005. The DSS hardware fits well into current VASV research plans. The payoff of this support included a new structural test measurement capability for efficient onboard sensing of multiple stain locations with a single fiber as well as enabling capability for Vehicle Health Monitoring in locations that are inaccessible to current NDE methods.

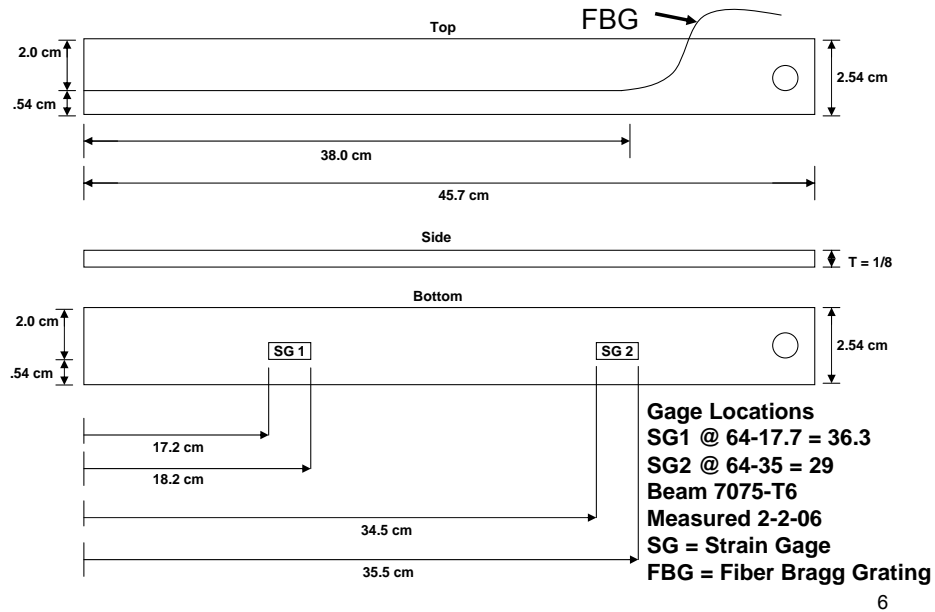
A sketch of the strain gages (SGs) and FBG sensor is shown above. The last FBG location is at about 65 cm on the left end of the beam. As show by the drawing, the strain gage 1(SG1) is at about fiber bragg grating location 37 and strain gage 2(SG2) is at about FBG location 29. Location 1-28 did not show strain during beam deflection since the FBG sensor was not attached for about the first 28 centimeters of the fiber.

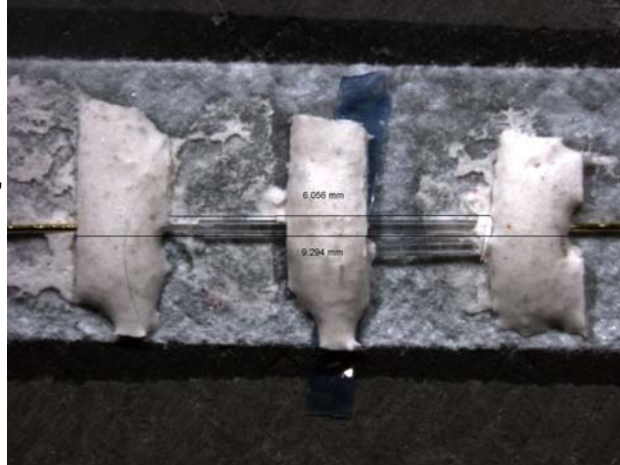
This figure is a close up view of a Sample Adhesive Mount of EFPI Sensor on Test Item 4 (CC). Fiber 3 is shown. This chart gives an overview of EFPI Strain Sensor Mounting and Installation Techniques. Engineers are exploring two methods of bonding EFPI sensors to test materials: flame spray techniques and high temperature adhesives. AFRL is still developing flame spray capabilities. AFRL engineers developed an in-house flame spray capability facility, which became operational during December 2005. Meanwhile, they are experimenting with using ceramic adhesives, like Sauereisen 13, to attach the EFPI sensors. For their initial attempts, AFRL engineers bonded EFPI sensors to Aluminum and CC using Sauereisen 13. The photograph shows initial attempts to mount the EFPI sensors.

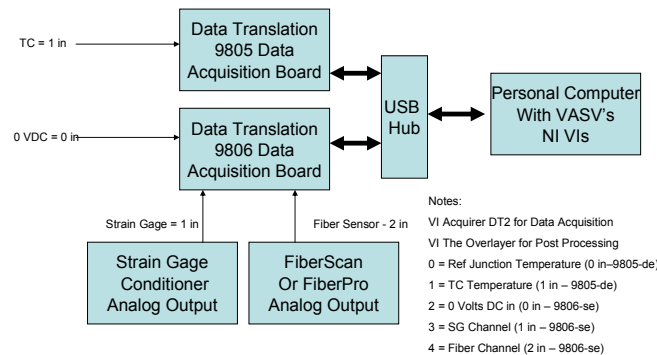
The quick response measurement system in these tests used a personal computer USB data acquisition board, designed by AFRL personnel, that measured outputs from the fiber optic signal conditioners, strain gage conditioners, and thermocouples in a timely manner. AFRL engineers acquired the test data using a read data virtual instrument (VI), which sampled each channel 10 times per second. They then used a VI titled “overlayer” to create an ASCII and Microsoft® Excel readable file. Finally, they imported all the data into an Excel workbook to generate time history and apparent strain plots. Engineers did not use anti-aliasing filters; however, these filters are highly recommended for a sampling based data acquisition system. For the oven portion of this test, engineers used a VAX based data acquisition system to record data from the thermocouples and strain sensor signal conditioners once per second.

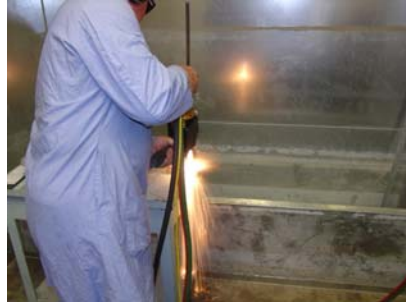
New Thermal Spray Chamber and Quartz Oven

- Flame Spray Capability activated December 2005
- Developed Quartz Lamp Oven for tests over 3000°
- Finish Item 4 Testing in New Oven Soon
- Plasma Spray Capability planned for September 2006
- Continue to Study Attachment Techniques

-AFRL engineers are determined to find a method to measure strain on aerospace structures at temperatures up to 2000°F (1093.3°C). They are confident that the EFPI fiber strain sensors will successfully take strain measurements in extreme thermal environments where many previous sensors failed. Preliminary experiments with mounting sensors using ceramic adhesives are not conclusive. The sensors appear to survive and give outputs at temperatures up to 1600°F (871.1°C) whereas conventional strain gages incinerate at temperatures exceeding 700°F (371.1°C). AFRL engineers hope that attaching the sensors by using flame spray or plasma spray techniques pioneered by NASA-LARC and NASA-DFRC will enable accurate apparent strain curves. This effort will require additional practice and experimental iteration. The photograph on the left shows AFRL personnel being trained to use the new flame spray capability.

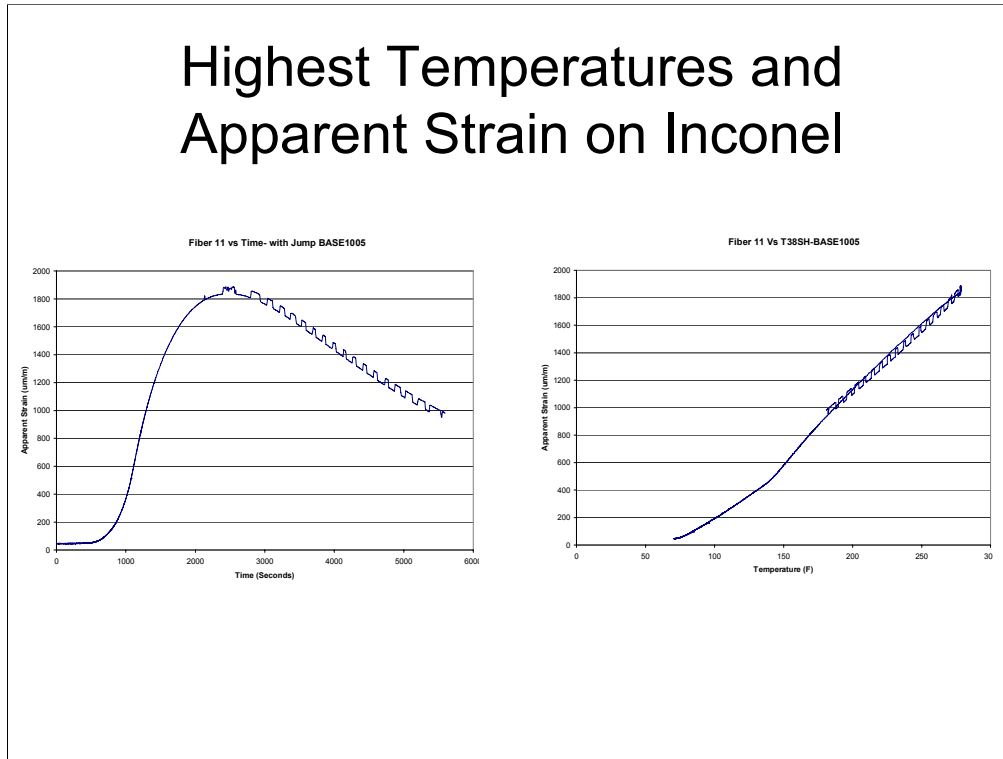
As noted earlier, one of the EFPI sensors was mounted on Inconel, which has a higher CTE. The data above show data for this sensor on the final run before failure. During the next run at higher temperature the fiber failed. Notice that sometimes there is a 50 microstrain jump in the fiber output. This is somehow related to $\frac{1}{2}$ of the 850 nm wavelength of light being used in the signal conditioning software algorithm. That is for a given gage length of 7.81 mm, we find a jump error of $425 \text{ nm} / 7.81 \text{ mm}$ or about 54.4 microstrain. This is one unresolved difficulties of using the EFPI sensors.

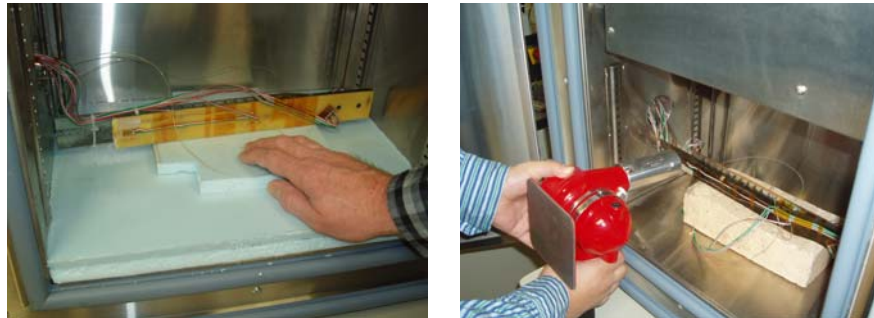
During January of 2006, AFRL started evaluation of commercial-off-the-shelf (COTS) EFPI strain sensors that are specified to work up to 350°C. A quick introduction to this work will now be given. AFRL engineers had two LUNA Commercial Off the Shelf EFPI Sensors mounted adjacent to foil strain gages as shown in the above figure. The fibers were LUNA stain sensors and the strain gages were CEA-03-250UW-350 on the graphite and CEA-06-250UW-350 on the astro quartz. A strain gage, strain sensor and T-Type TC were mounted on each material. The EFOU sensors are rated to operated at temperatures up to 350 °C. These COSTS EFPI sensors are mounted differently than the high temperature sensors discussed earlier. They were mounted with AE10 adhesive in accordance with the manufacture's instructions. The AE 10 adhesive rather than a higher temperature adhesive was used due to other testing constraints. Most of the 18 runs were accomplished from -60 to + 160 °F but some later runs were used to try to destroy the sensors using a heat gun as shown in the right hand photograph.

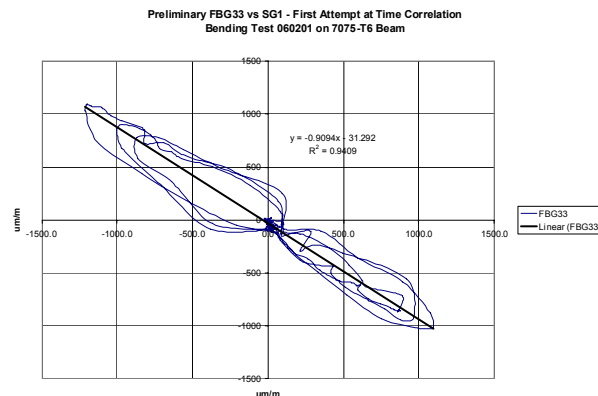
Since the data system used to record and process the optical strain data from the fiber is usually separate from the strain gage signal conditioning and recording system, it is hard to correlate the data between the strain gage and FBG fiber as the test beam is bended. In addition the strain gage system sample rate (set for 10sps exactly) is not an even multiple of the FBG system sample rate of about 1.56 samples per second. The graph shows an initial attempt to plot the strain output of the a FBG sensor versus the strain gage output. The above figure shows a slope of close to -1 between the FBG sensor opposite of the strain gage but the apparent hysteresis may be the result on time synchronizations difficulties. This is a difficulty that is currently being worked.
