**EFFECTS OF PRIOR AGING ON THE CREEP RESPONSE OF CARBON  
FIBER REINFORCED PMR-15 NEAT RESIN AT 288°C IN AN AIR  
ENVIRONMENT**

THESIS

Christopher A. Back, Ensign, USN

**DEPARTMENT OF THE AIR FORCE  
AIR UNIVERSITY**

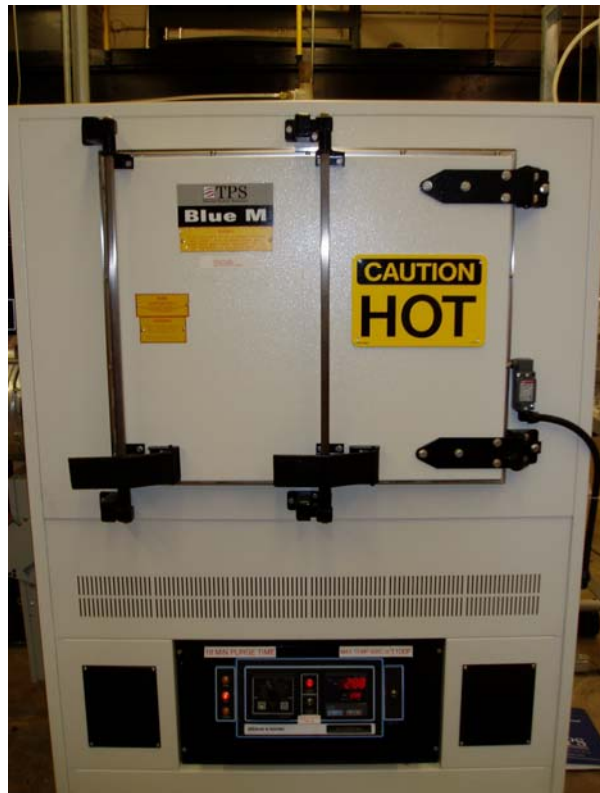
**Figure 21: Aging chamber**

The test specimens were aged in an air environment for different periods of time. The temperature of the aging environment was held constant at 288°C. For the aging process, air was supplied to the Blue M oven through a compressed air line with an inline filter and desiccator. The trays which held the specimens in the oven were covered with quartz cloth to prevent contamination. Throughout the entire aging period, the measured relative humidity (RH) of the air fed to the chamber was less than 10%. The steady air flow rate was approximately 30 standard cubic feet per hour (SCFH) at steady state and 150 SCFH during the purge cycle. It is assumed that any moisture released into the aging environment was removed by the flowing air and that any moisture present in the chamber was caused by the air supply. When the oven was opened to take out specimens,

the chamber automatically went into a purge cycle when the door was shut. The purge cycle lasts for eighteen minutes and ensures that any ambient atmosphere that entered the chamber is depleted. When the oven was opened to take out the aging specimens, it was opened without cooling and closed immediately. It is assumed that the short exposure of the aging specimens to the outside atmosphere did not cause any additional effects that were not already present from the production process (mainly oxidation and humidity). When the samples were removed from the oven, they were placed in a dry air-purged desiccator prior to testing. To ensure the absence of moisture effects, the desiccator was kept at a constant relative humidity of less than 10%.

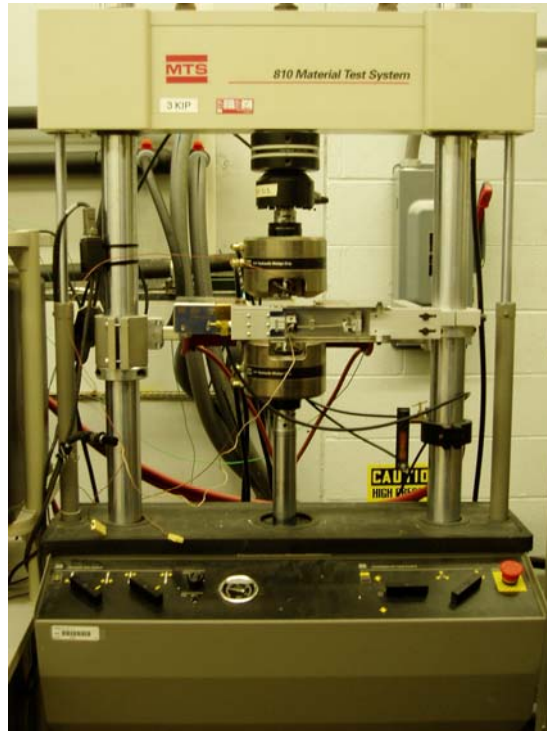
**Figure 22: 3 KIP MTS hydraulic machine**

Mechanical testing was completed using a vertically configured 810 Material Test System (MTS) servo hydraulic machine with a 3 KIP (13.3 KN) load cell. The servo hydraulic machine had MTS 647.02B hydraulic wedge grips capable of applying a pressure of up to 21 MPa (3000 psi) to each end of the test specimen. The grip pressure throughout the mechanical testing was 4.80 MPa. Each of the grips had a pair of flat wedges coated with surf alloy in order to allow for better gripping of the test specimen. Additionally, each wedge was equipped with an inlet and outlet to allow the flow of cool water through the grips to prevent overheating in the grip sections during high temperature testing.

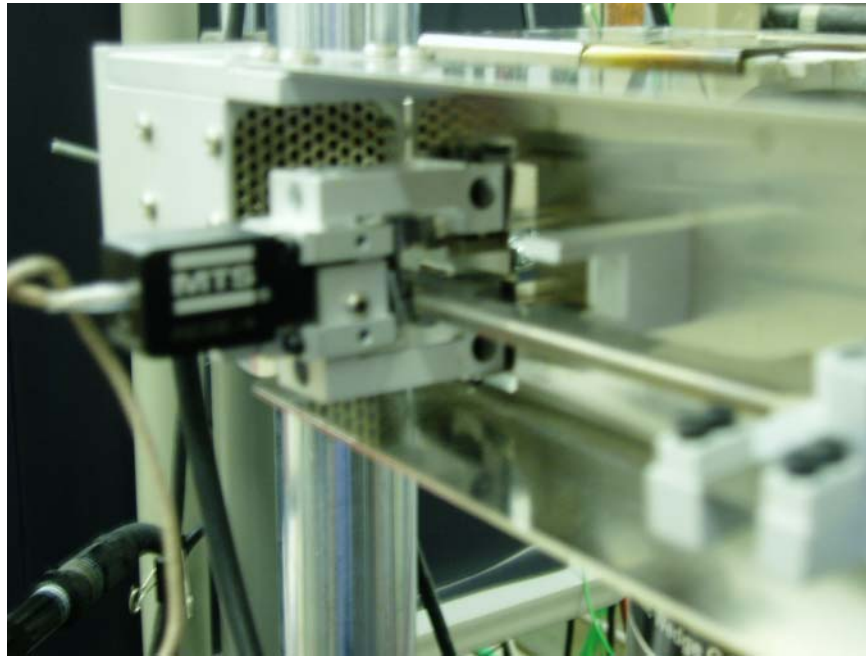
**Figure 23: MTS High temperature axial extensometer assembly with heat shield**

Strain measurements were taken with an MTS model 632.53E-14 axial extensometer during high temperature testing. It is capable of measuring strains between -10% and +20%. The extensometer has two 3.5 mm diameter alumina extension rods with conical tips that allow it to be placed in the dimples of the test specimen to maintain continuous contact between the specimen and the rods to prevent slipping during testing. Dimples were made in the gauge section of the test specimen 12.7 mm (0.5 in) apart using an MTS dimpling tool. Dimple size was kept minimal in order to avoid possible induction of crack propagation. Each alumina rod extended 150 mm to ensure that the extensometer was far removed from the heat source. The extensometer was held in place using a spring-loaded assembly which places a 3 N contact force per rod onto the test specimen. This low contact force ensures that there is no more damage added to the specimen that may have been caused by dimpling. The extensometer can operate in temperatures up to 650°C without air cooling and up to 1200°C with air cooling. The strain measurements are very accurate; however, electrical noise in the strain measurement cannot be avoided.

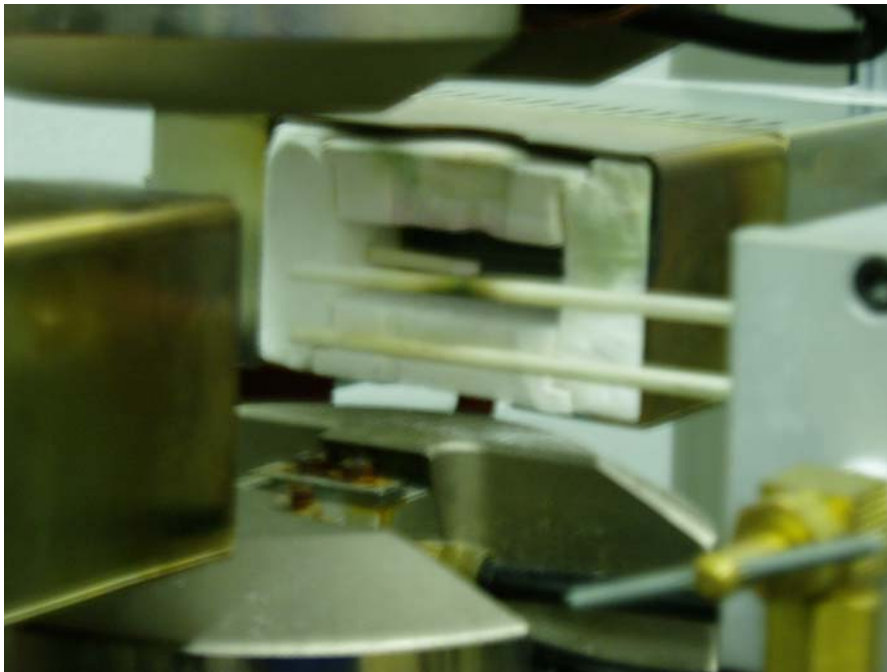
**Figure 27: Furnace**

An MTS 653 furnace was used to achieve the elevated temperature for mechanical testing. The operating temperature of the furnace ranges from 100°C to 1400°C. It has a center split design which closes around the test specimen and can be opened and shifted away from the testing area during specimen loading and extensometer setup. Each half of the furnace was equipped with a silicon carbide heating element surrounded by silica foam. The fibrous alumina inserts were filed down to make slots for both the specimen and extensometer rods to pass through. The temperature of the furnace was controlled with an MTS 409.83 Temperature Controller. During mechanical testing, a 19 mm section of the specimen was subjected to the elevated temperature. The MTS 409.83 Temperature Controller displayed the temperature of the furnace and the current input temperature. A feedback loop between the S-type thermocouple in the right side of the oven and the controller maintained the appropriate procedure temperature throughout the testing. The variation between both sides of the furnace did not exceed more than 5°C.

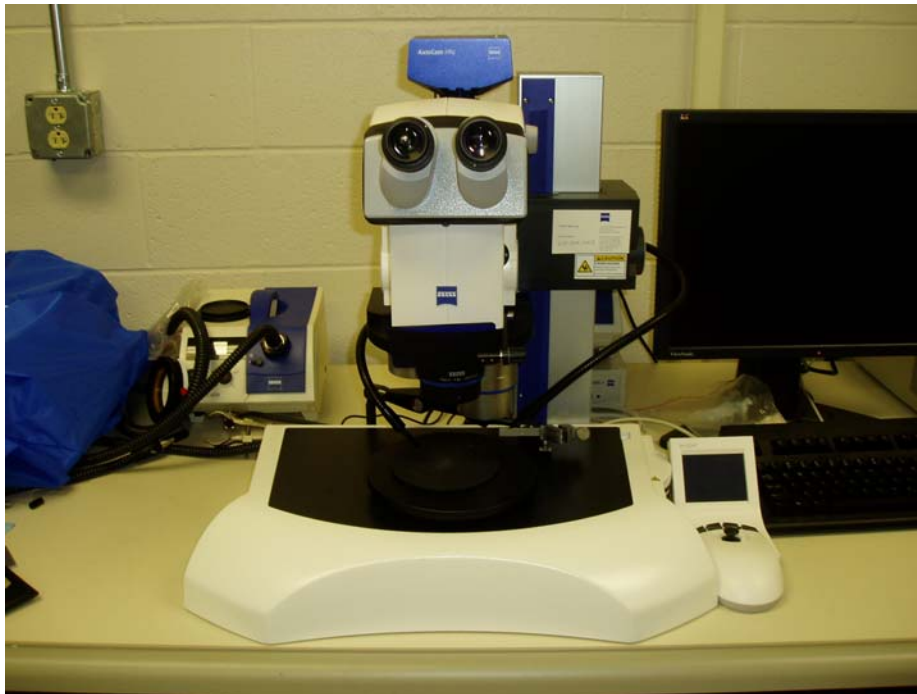
**Figure 29: ZEISS Discovery.V12 Model Stereo Microscope**

size of the data files. If a failure occurred during creep testing the fracture surfaces were observed using an optical microscope to view the morphology of the fracture surface. However, there were no failures during creep testing, but the microscope was used to examine fracture surfaces of the specimens that fractured during tensile testing.

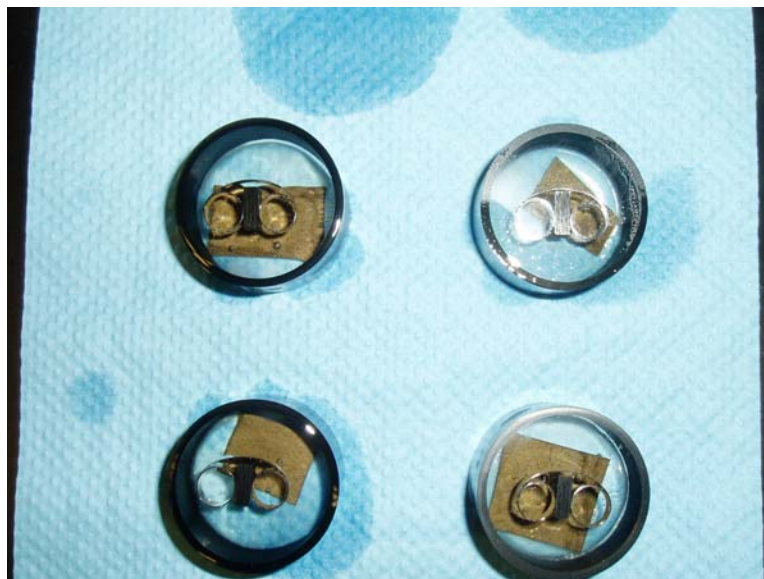
**Figure 32: Sections of test specimens ready to be analyzed for oxidation growth after being mounted, sanded, and polished.**
