## Report of Sampling and Analysis Results

Clementon Army Housing Units  
Clementon, New Jersey

April 1991

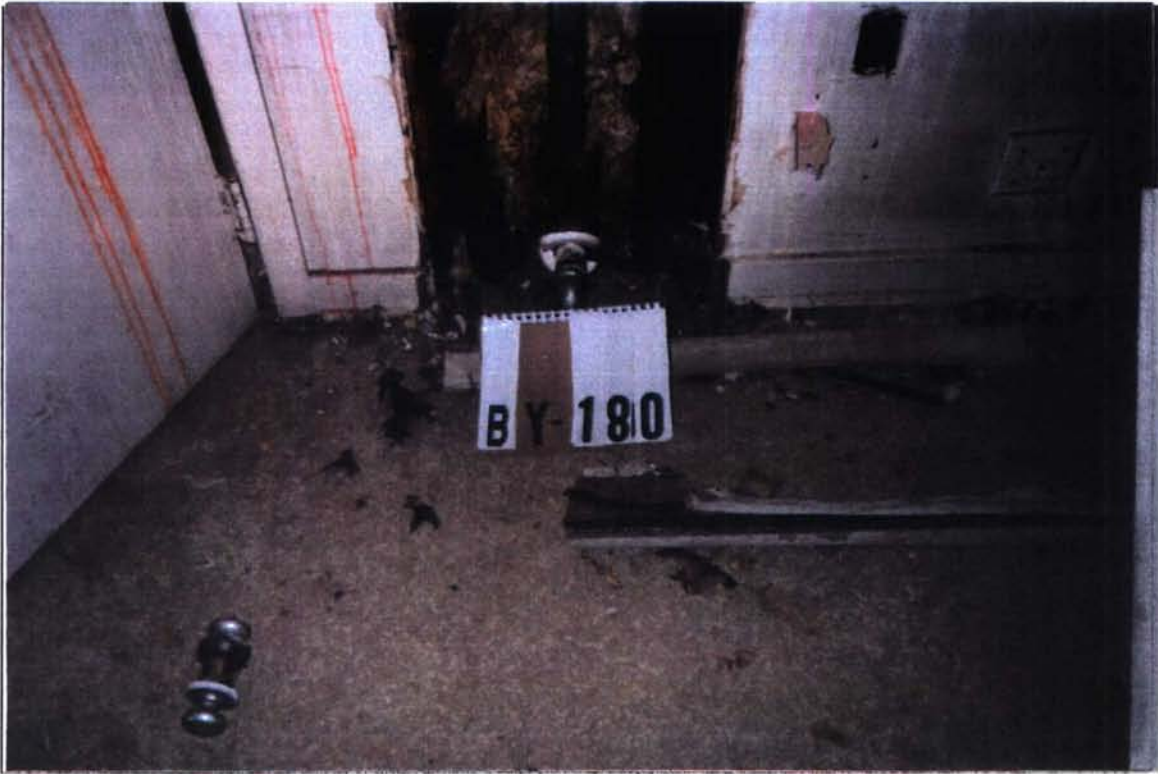
Each of the units was inspected to determine if suspect materials were present. The pipe runs for the domestic water supply system in the units were once insulated with a corrugated paper, air-cell type insulation. Due to extensive vandalism and theft of copper water pipes from all of the units, the pipe run insulation is in very poor condition (See Figures 2.1 and 2.2). Six samples of pipe run insulation were collected for analysis. The pipe run insulation is friable, as defined in the United States Environmental Protection Agency (EPA) regulations, meaning that it can be crushed, crumbled, pulverized, or otherwise reduced to a powder using hand pressure. Friable asbestos-containing materials (ACM) are considered to be more hazardous than non-friable ACM since they are much more likely to release asbestos fibers. Because of its friability and instances of damage, the pipe run insulation is considered to be the most hazardous type of ACM in the Clementon FHU.

FIGURE 2.1 PIPE RUN INSULATION IN THE KITCHEN OF UNIT 320

Analytical results of the pipe run insulation confirmed that asbestos is present in all of the samples taken. All of the asbestos-containing pipe run insulation should be removed prior to renovation or demolition of the units, to comply with the NESHAP provisions. This work must be done by workers trained in asbestos abatement procedures. The material appears to be damaged to a degree that repair and management under an Operations and Maintenance (O&M) program is not a viable option.

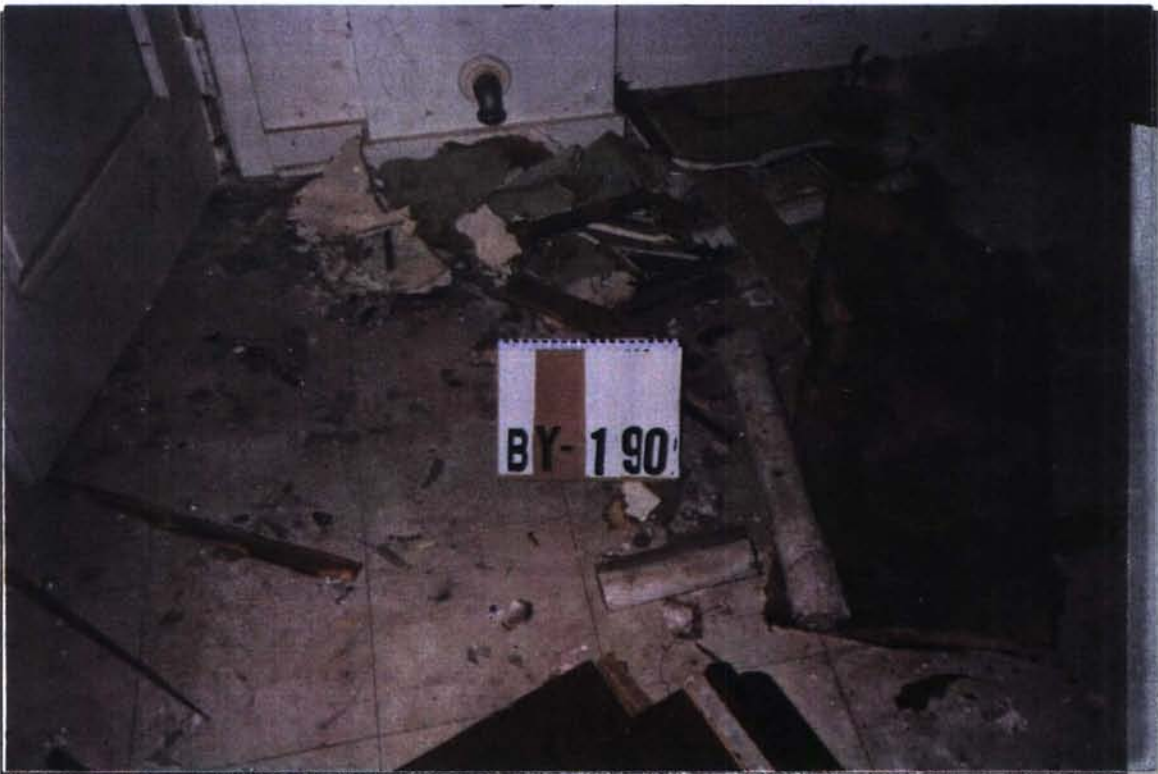
FIGURE 2.2 PIPE RUN INSULATION IN THE KITCHEN OF UNIT 311
