CSDL-R-1635  
REPORT ON LABORATORY TEST OF THE  
AERIAL PROFILING OF TERRAIN SYSTEM  
by  
James A. Hand  
February 1983

**The Charles Stark Draper Laboratory, Inc.**  
Cambridge, Massachusetts 02139

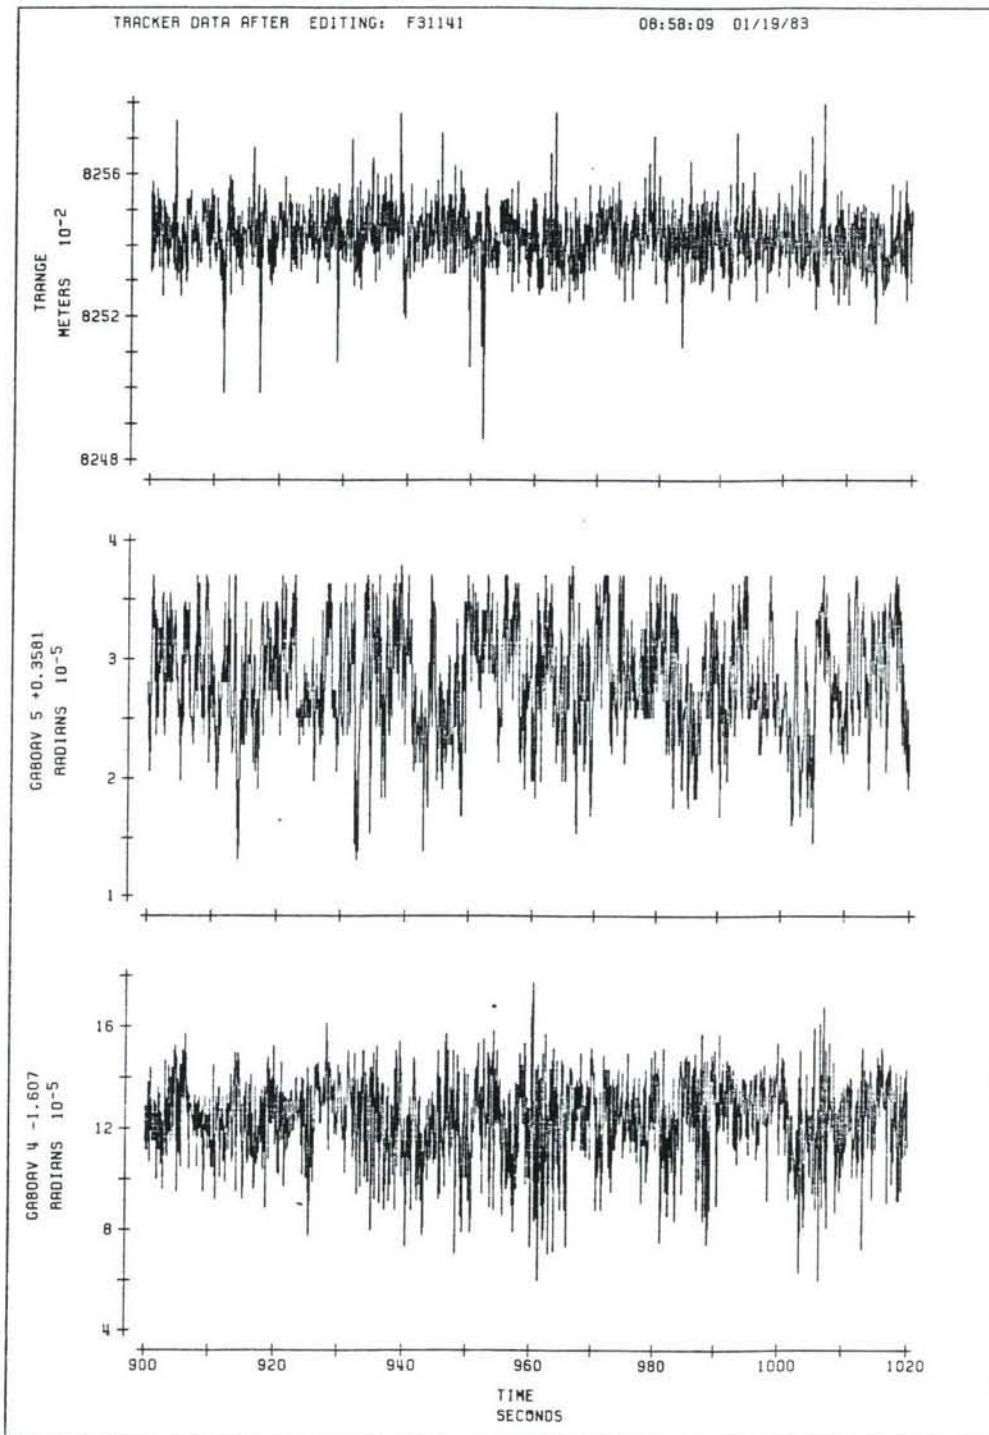
Figure 5-8. Typical tracker range data after editing; Test No. F31141.

The general results of the Tracker tests have been given and are exemplified by the previously-referenced Figs. 5-7 and 5-8. The detailed findings, using these figures are listed here and are from Test No. F31141.

2. After editing outer was 16.2 and the inner gimbal was 4.75 microrad; acceptable.
3. Before and after range standard deviations were .0159 and .0081 meters, respectively, both corresponding to single-shot values; acceptable.
4. The range data shows 10-15 cm spikes which can be filtered out by data editing for the near term and may be eventually filtered out with hardware changes, if deemed appropriate.

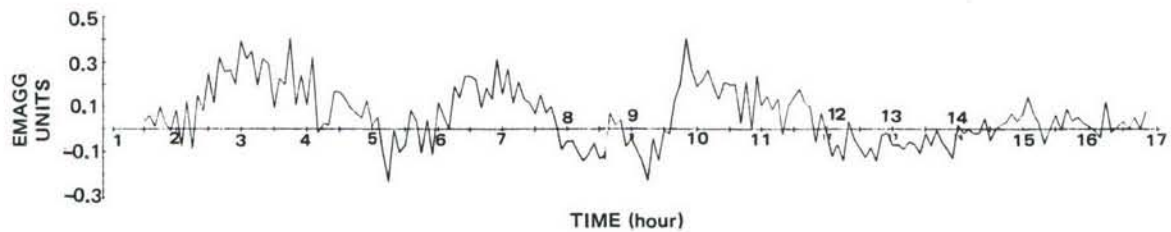
Figure 6-2. Residual error in magnitude of gravity;  
Test No. H31131 (Carousel).

Correlation between the gyro torque application and gravity residual was also observed. This problem is of second order importance in the flight trajectories where torque changes are relatively small. However, it is primarily being addressed by implementation of a constant-torque regime for flight where there will be no changes throughout flight.
