## **LBP Concerns in Producing Recycled Concrete Aggregate from Former Fort Ord Family Housing**

Stephen D. Cosper

January 2007

Final report

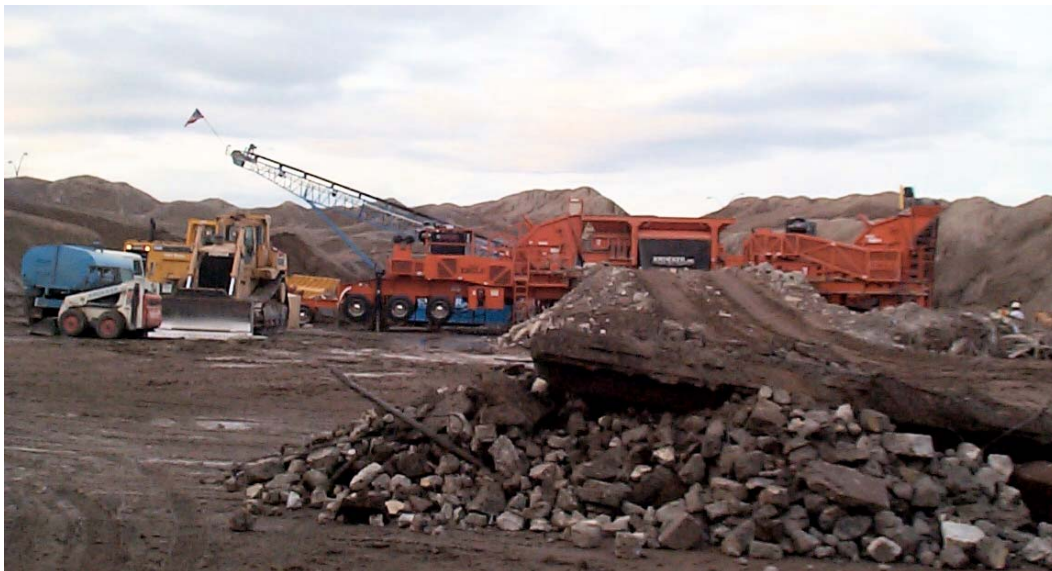
Figure 1. Overview of crusher plant.

Kroeker used an Eagle Crusher, Model CV 1400; an Eagle triple deck screen, Model 65D006; and associated conveyors. Go to the Eagle website <http://www.eaglecruser.com/?articleid=73> for an article with more specifics. Figure 1 shows the crusher plant in operation.

(Cover photograph: Discharge conveyor from Kroeker concrete crushing plant, with Confidential Compliance Consultants sampling technician in foreground.)

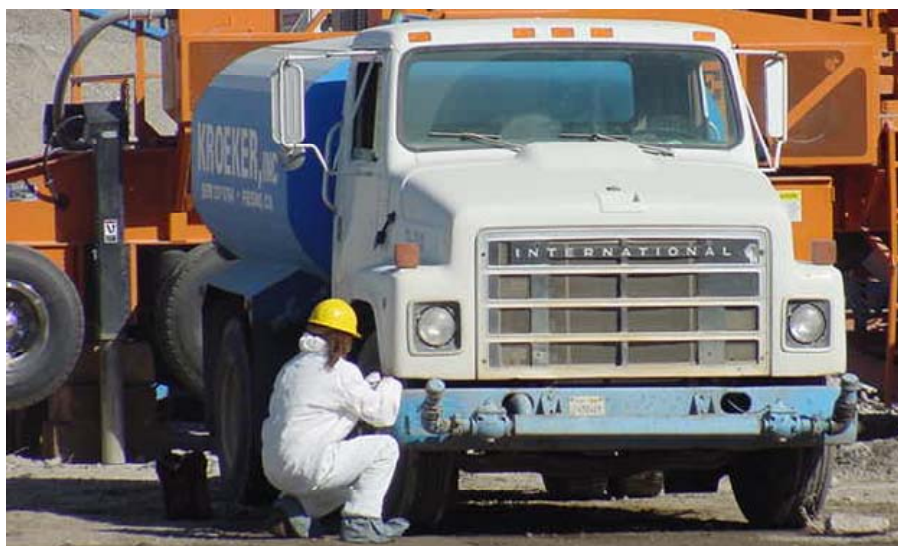
Figure 4. Dust wipe sampling.

sults of Pb wipe samples at the crusher site. Figure 4 shows a CCC staff member taking a wipe sample from a truck at the crusher site.

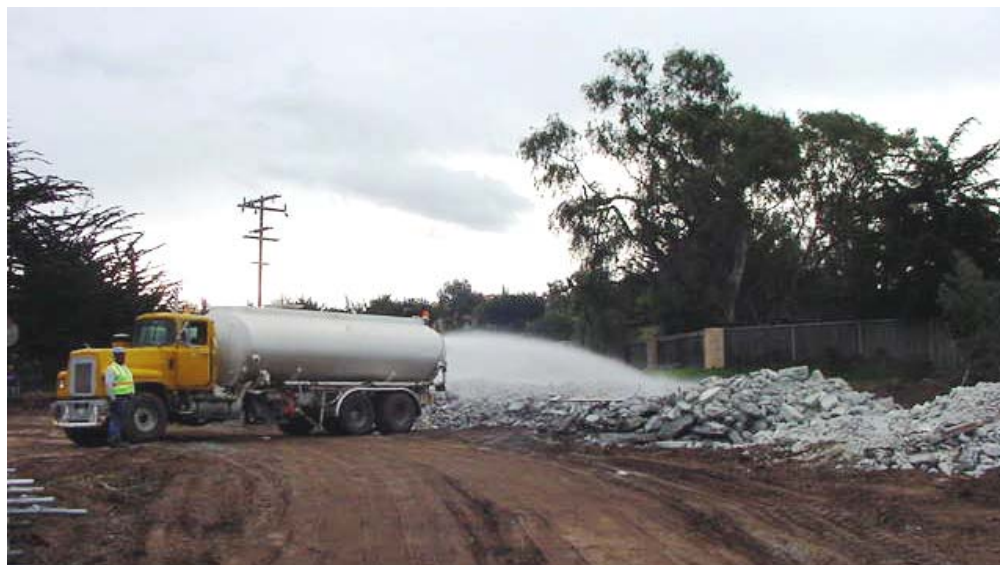
Figure 6. Dust control truck.

As evident from the results in Table 5, between the Contractor's use of water spray from tanker trucks for dust control (Figure 6), and the heavy, humid air of the rainy season conditions, the levels of air-borne, lead-laden dust were below normally detectable levels. These combined factors produce a very low risk of worker exposure to lead-laden dust at the demolition site.

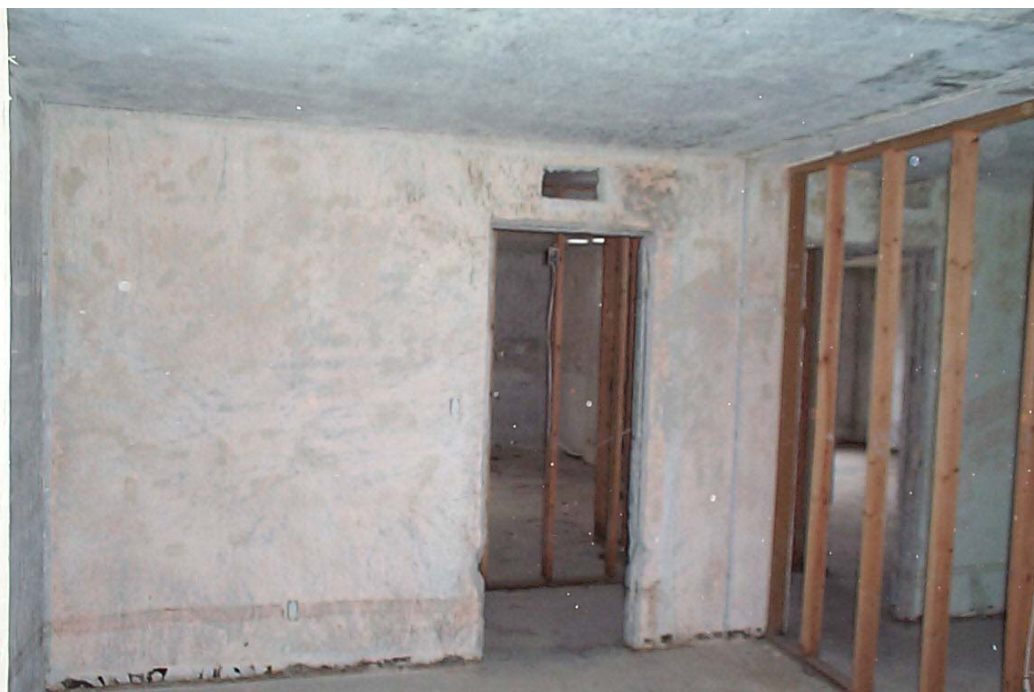
Figure 7. Remaining coating on interior walls.

As mentioned previously, interior paints had an asbestos component, as well as Pb content. Because of the asbestos, all interior wall surfaces were scraped, and most walls were covered in a sealant material, which is a sign of abatement completion. Some paint still remained on interior walls (Figure 7), and exterior paint remained intact. CCC sampled all wall surfaces for Pb content. The purpose was to help calculate the overall Pb content of the structures. CERL also took concrete samples, as described in the next section. The results of the Pb content of the paint samples are included in Table 7.

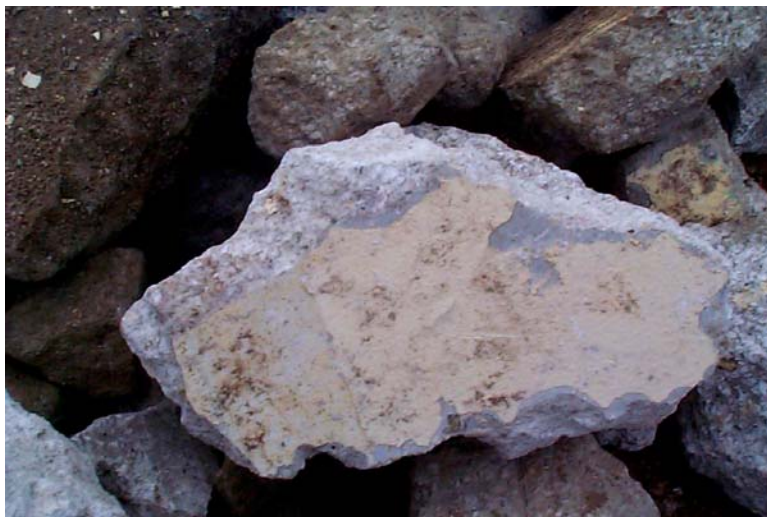
Figure 8. Painted concrete piece.

In addition to the CCC paint samples described in the previous section, CERL also took several samples for Pb analysis from the housing site and the crusher site. These samples represented the range of materials (Figure 9 for example) that would be combined at the crusher site to produce the recycled concrete aggregate (Figure 9) for use as road base and other products. CERL took 34 samples, and subjected them to various combinations of Pb analysis. Table 9 summarizes analytical results from these samples.

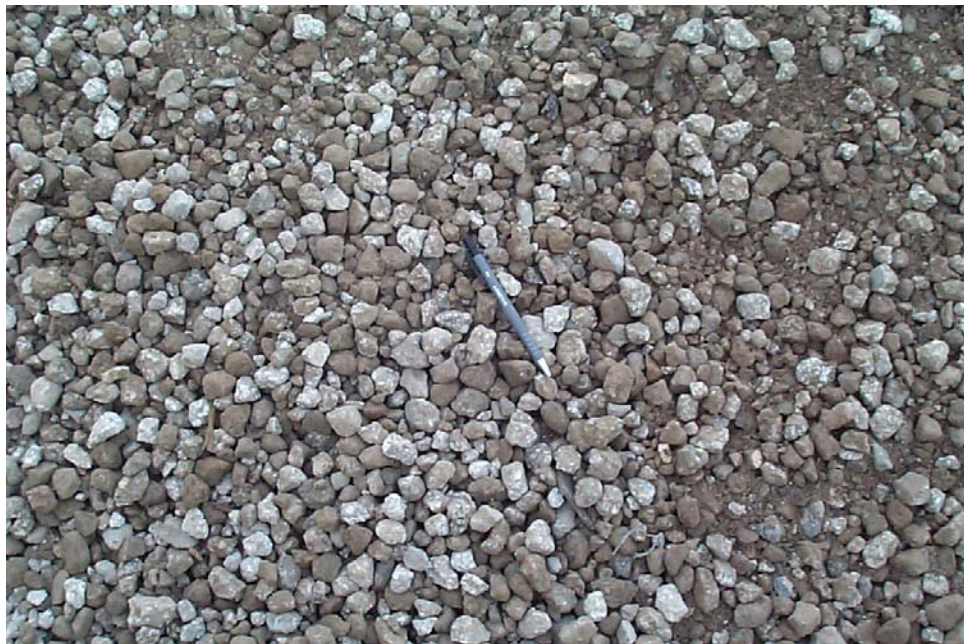
Figure 9. Finished recycled concrete aggregate.

Eleven samples of crushed concrete product were taken from various locations around the finished RCA pile at the crusher site. The average total Pb concentration was 17 ppm. Seventeen is a little above the expected background number. Given the source and intended application as a road base, however, the concentration is quite low and should not be an impediment to using RCA. TCLP Pb extractions were performed for two of the RCA samples with the highest total Pb concentration. In both cases, the result was less than 0.01 ppm — far below the RCRA limit of 5.

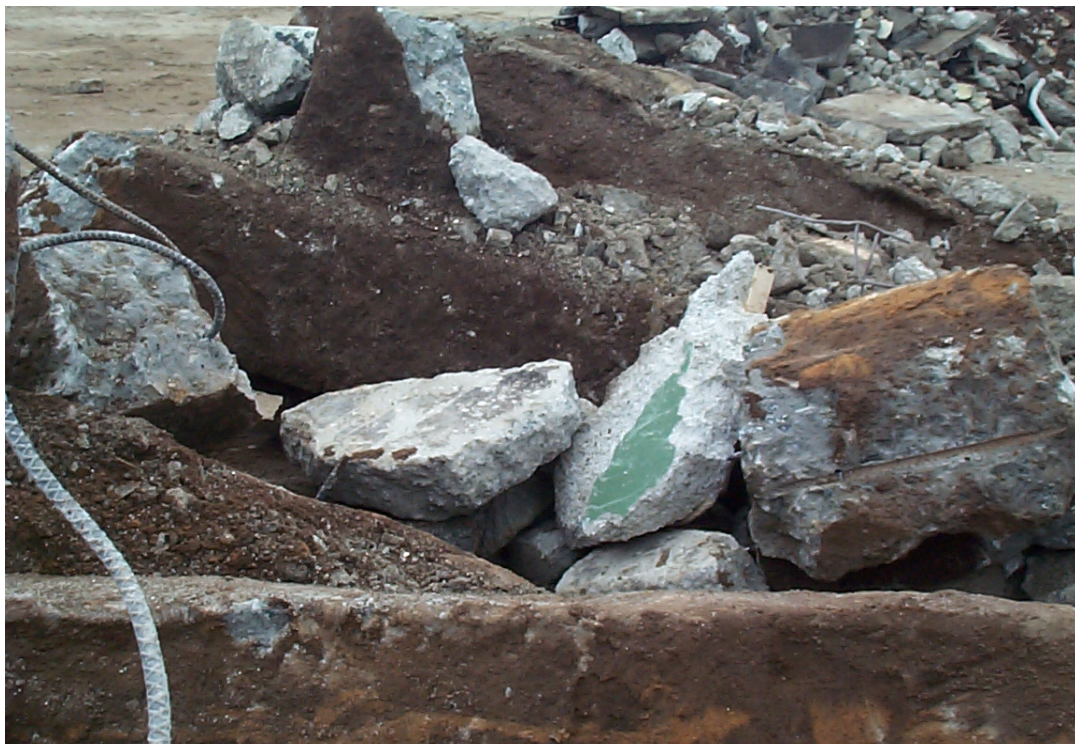
Figure 13. LBP covered concrete in mixed debris pile.

To perform total Pb analysis, an environmental chemistry laboratory requires only a few grams of material. A representative sample from a concrete demolition project might be several kilograms. The problem arises when trying to prepare a representative subsample. This is a long recognized problem with determining overall Pb concentration for building debris when trying to take representative samples for TCLP for RCRA hazardous waste determination (Figure 13).

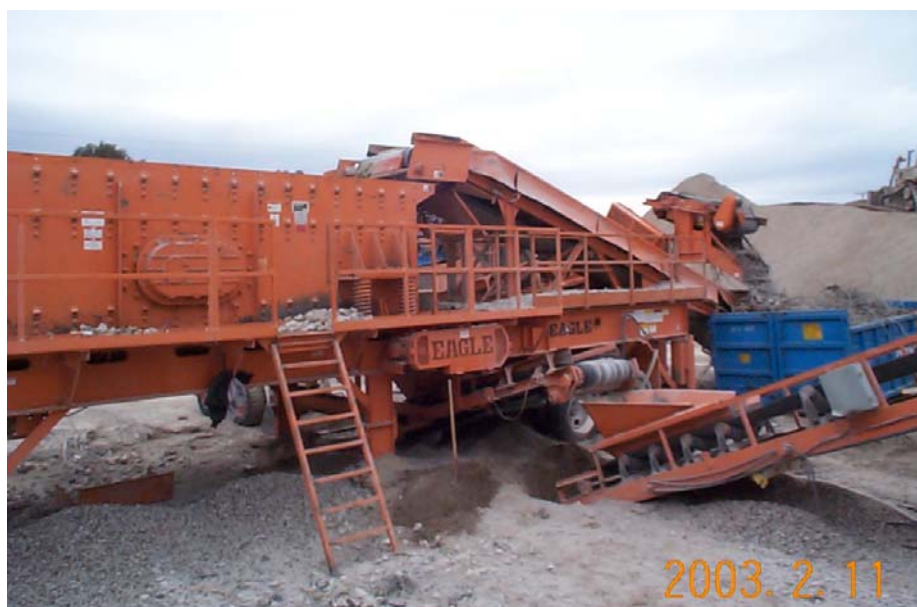
Figure 14. Fines sample location.

Three samples of fines from under the crusher were taken one evening as the crew was cleaning up. The average total Pb concentration was 111 ppm. It appears that this type of location is a major sink for LBP particles (Figure 14). Through the crushing process, loose paint flakes off and enters the fines waste stream. The Pb concentration in the fines is below the USEPA limit for Pb-in-soil for residential application. Because the fines are respirable as workers move around and clean up, appropriate personal protective equipment is recommended. CERL performed TCLP for Pb on the two samples with the highest total Pb (160 and 130 ppm). As with the crushed RCA product, the result was less than 0.01 ppm. The Pb in the fines would

be expected to be more “leachable” because more surface area is exposed to interaction with the acid test solution. However, much more concrete surface area is also exposed, which will neutralize the extracting solution.
