28 APR 1967

UNCLASSIFIED
~~CONFIDENTIAL~~

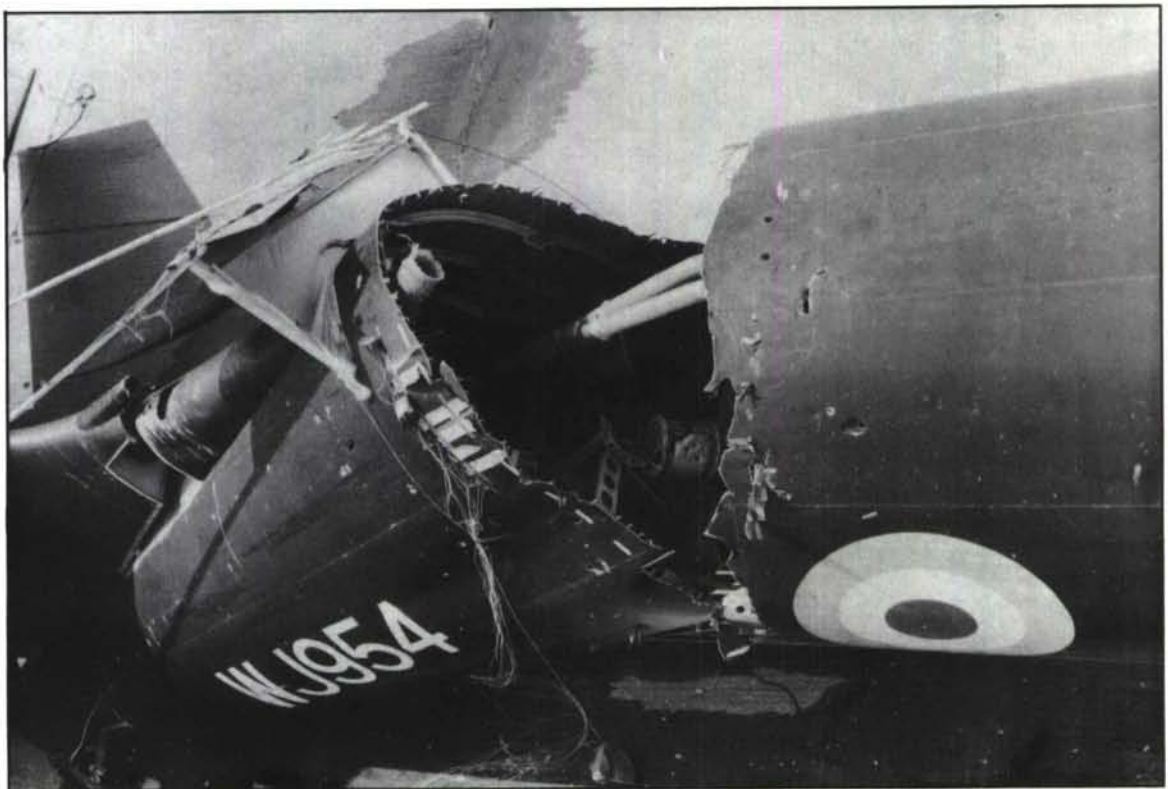
FIG.16b. TARGET 1a. DAMAGE TO ROD "ENTRY"
SIDE OF FUSELAGE SHOWING FAILURE

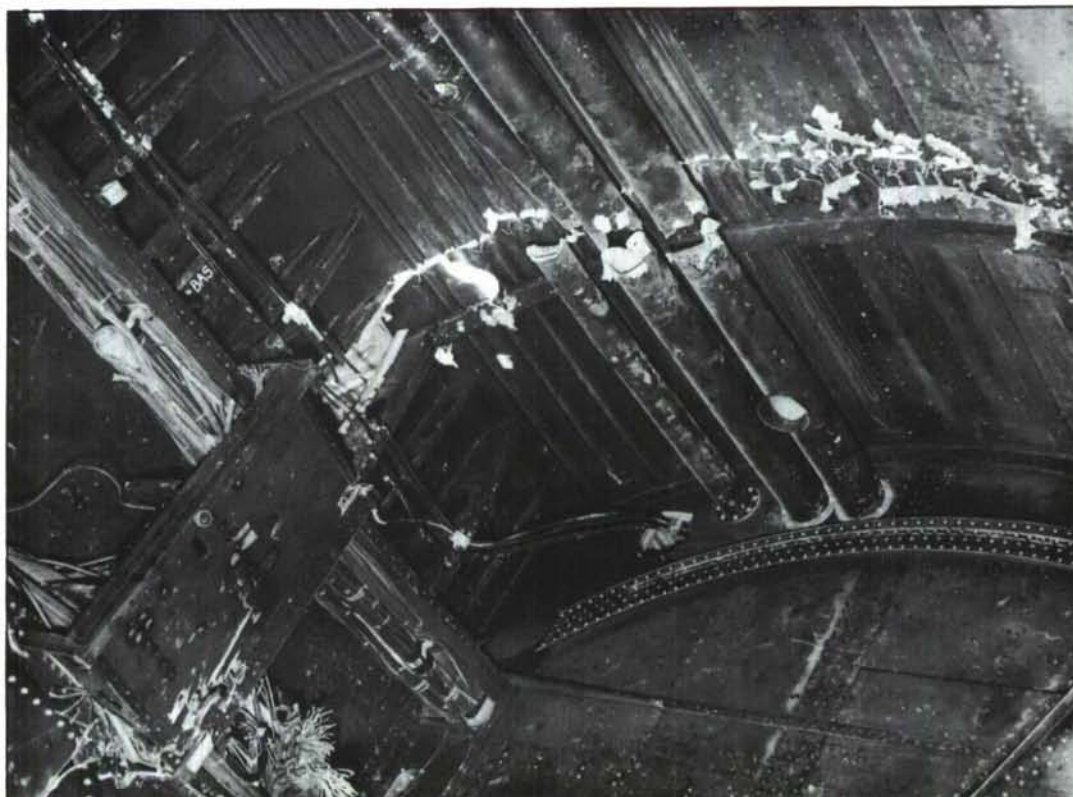
FIG.17e. ROD "ENTRY" SIDE

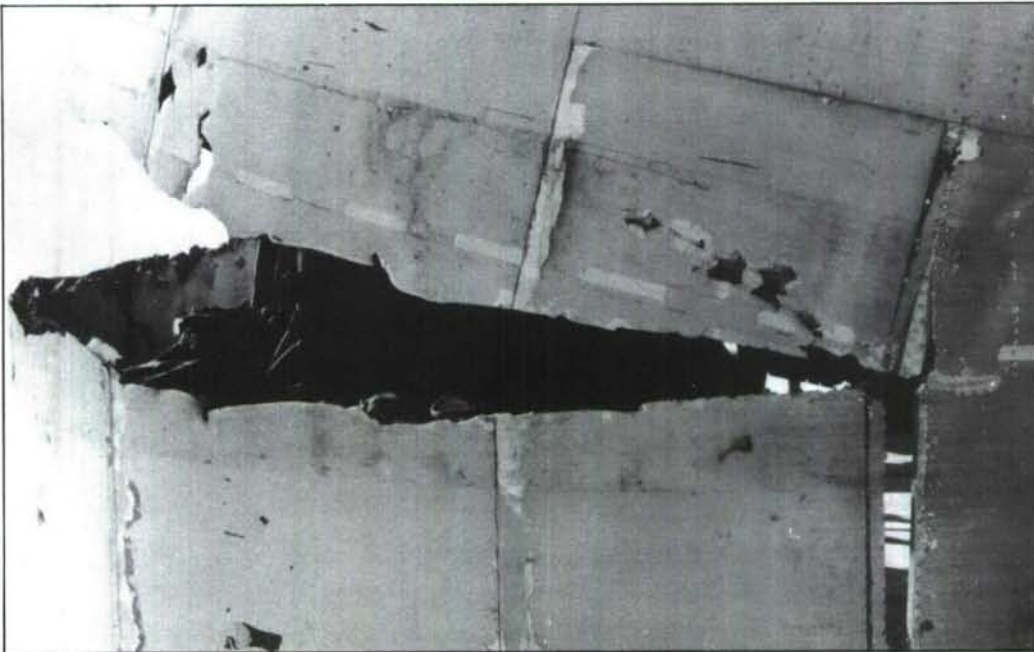
FIG.17j. ROD "ENTRY" SIDE

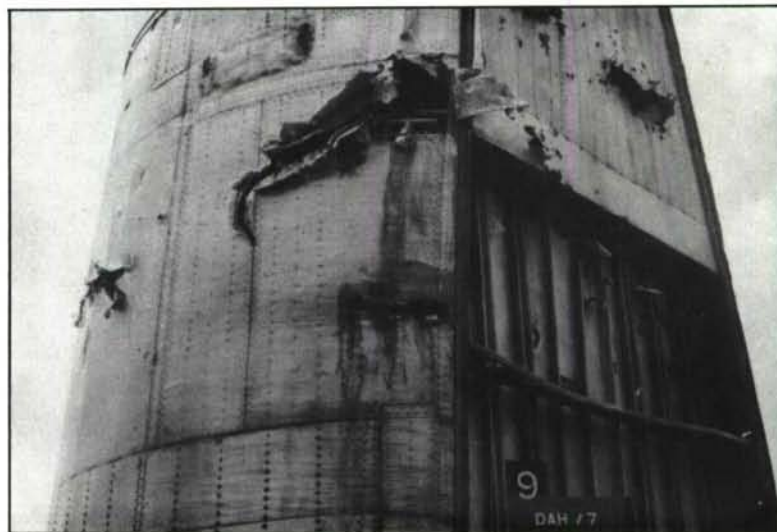
FIG.18c. ROD "EXIT" DAMAGE

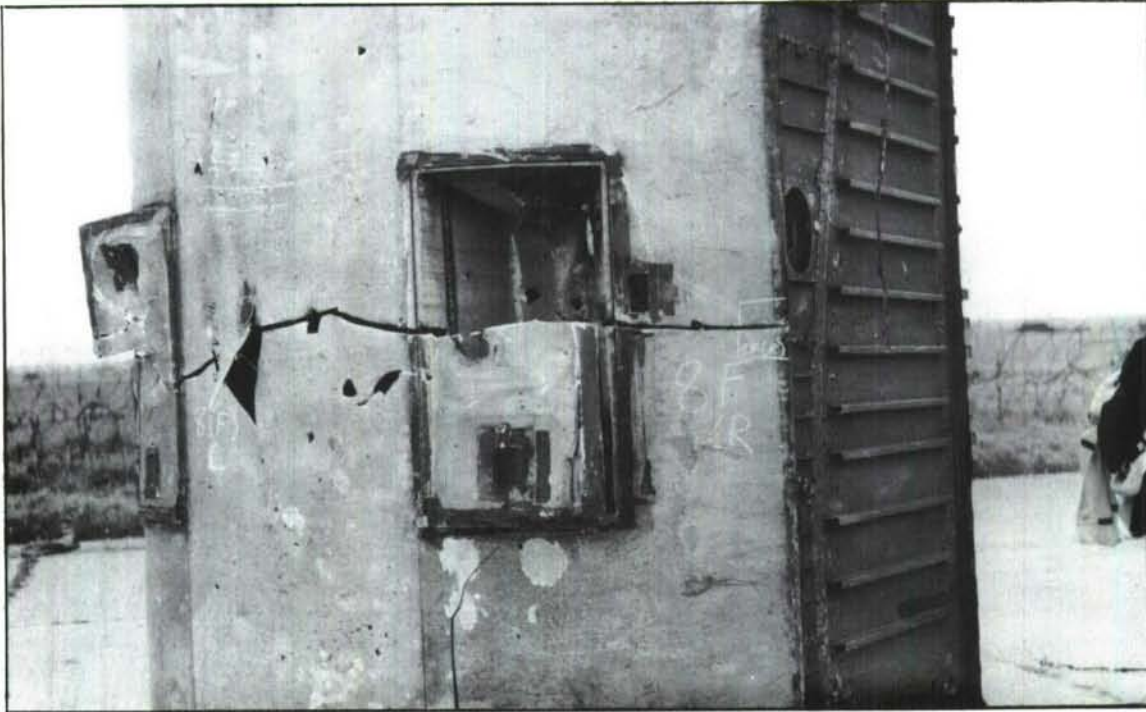
FIG.19a. TARGET 7a. ROD DAMAGE TO TOP OF B 29 WING/FUSELAGE JUNCTION
(LOW VEL. 1/4 in. ROD. STN. 434)

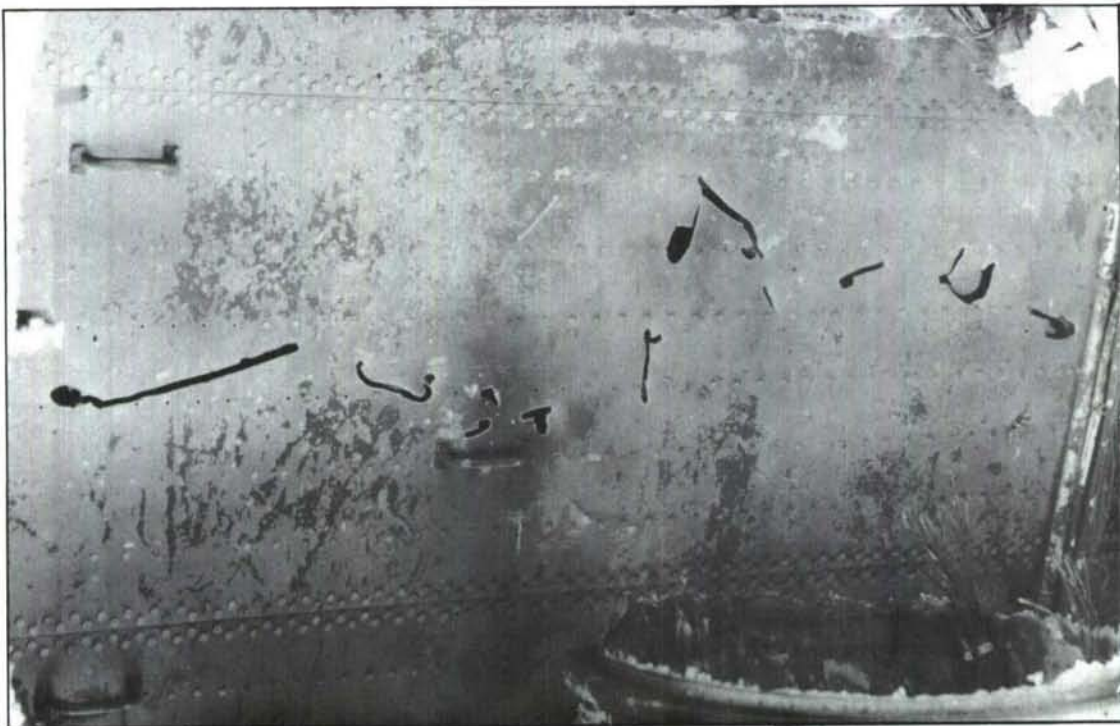
FIG.19b. TARGET 7a. ROD "ENTRY" DAMAGE TO WING BOX TOP SURFACE INSIDE "B 29" FUSELAGE
(LOW VEL. 1/4 in. ROD. STN. 434)

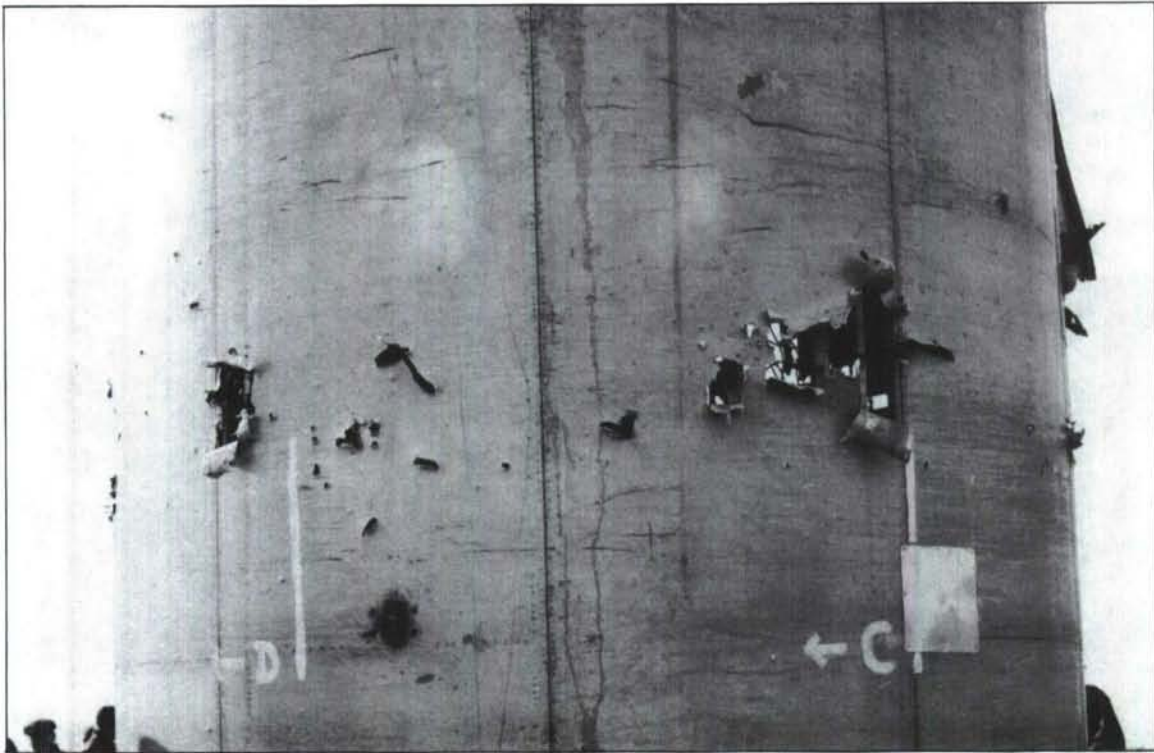
FIG.21c. TARGET 2. DAMAGE TO ROD "EXIT" SIDE OF "B29" FUSELAGE
(LOW VEL. $\frac{1}{4}$ in. ROD. STN. 566)

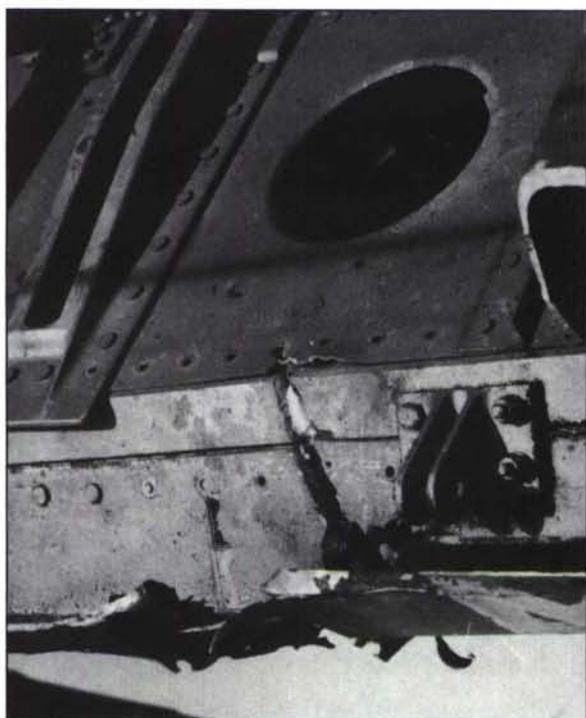
FIG.21e. STARBOARD LONGERON

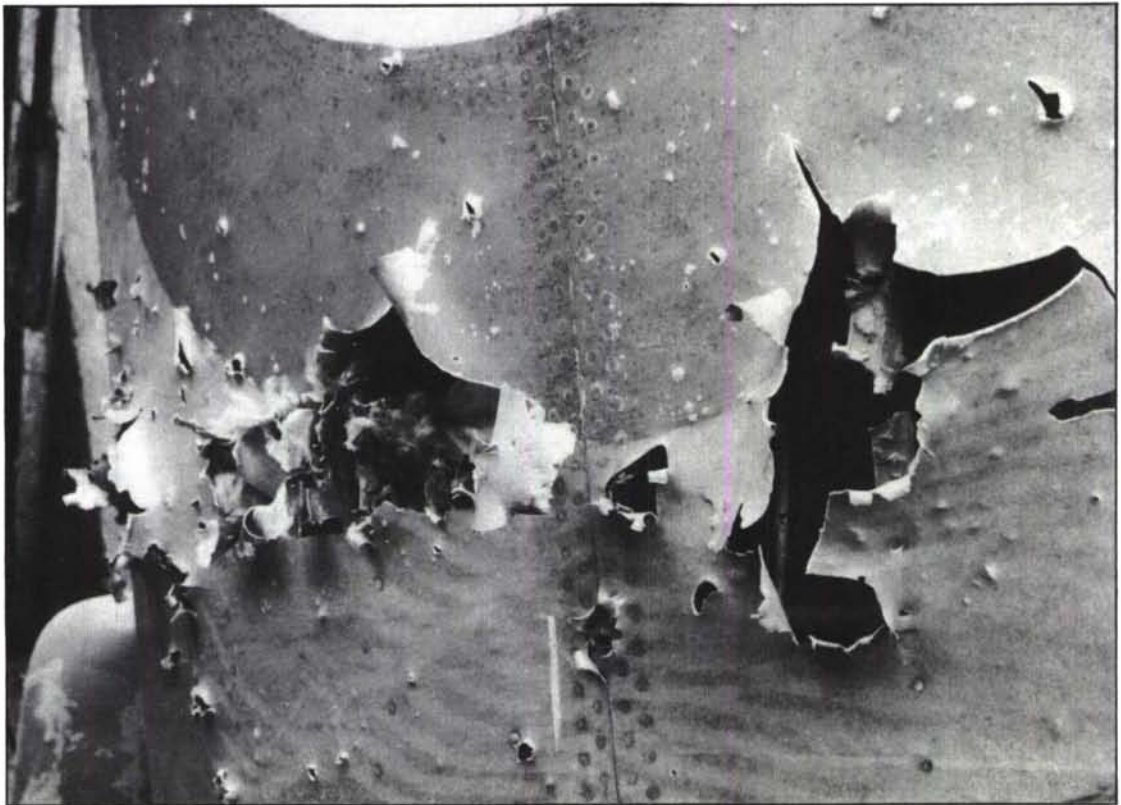
FIG.24d. TARGET 4a. DAMAGE TO ROD "EXIT" SIDE OF FUSELAGE
(HIGH VEL. $\frac{3}{16}$ in. ROD. STN. 768)

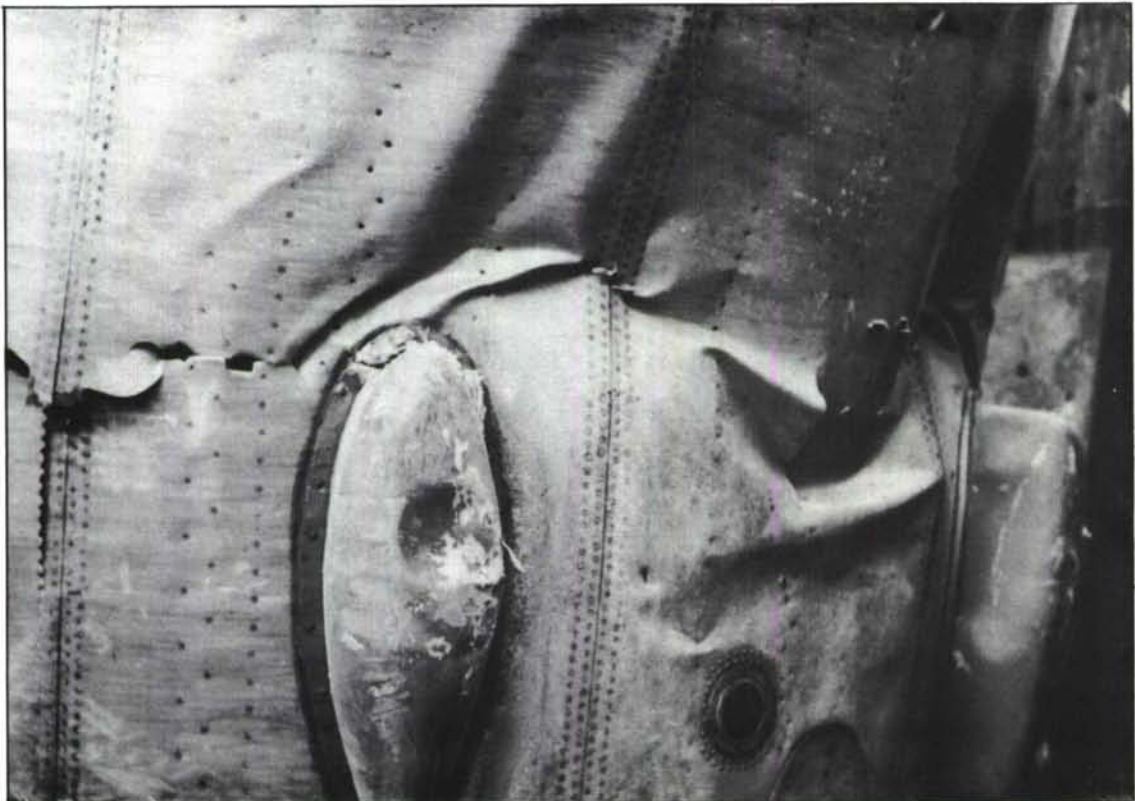
FIG.25d. TARGET 5a. DETAIL OF COMPRESSION LOADED SIDE OF FUSELAGE AFTER SUBSEQUENT FAILURE
(HIGH VEL. $\frac{3}{16}$ in. ROD. STN. 768)

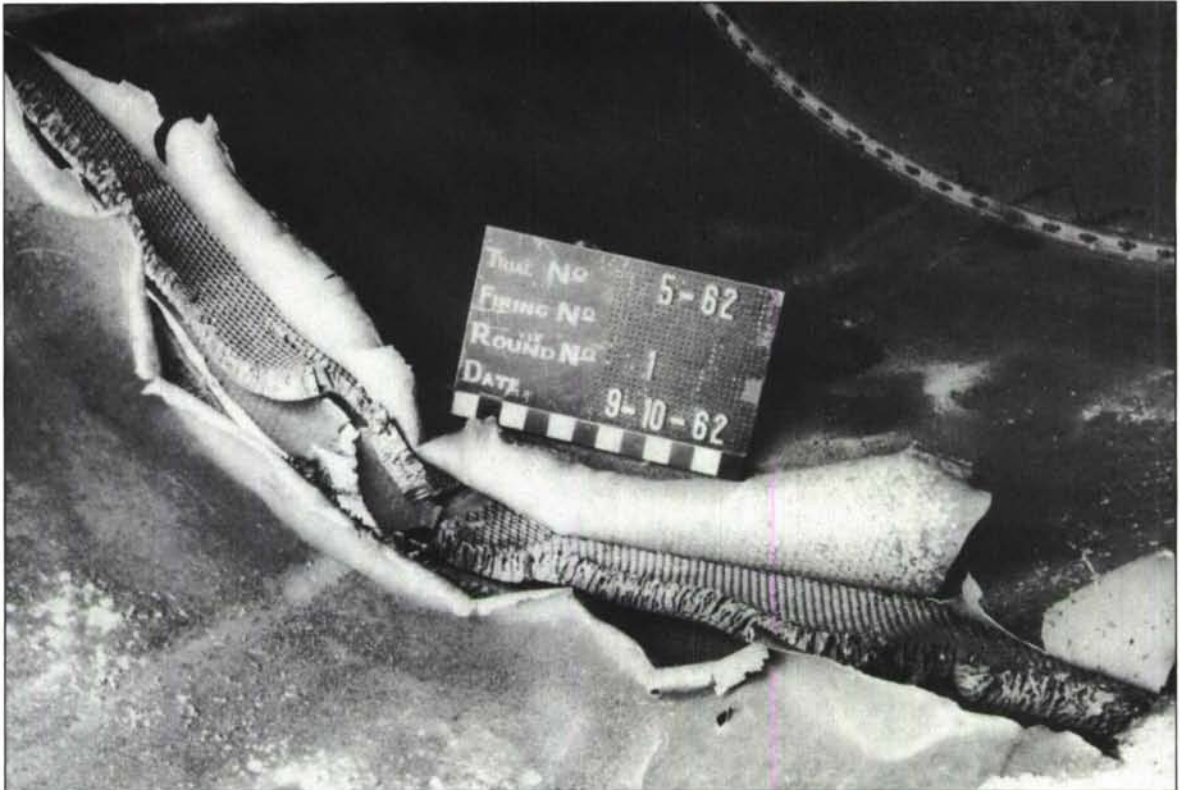
FIG.28c. TARGET 8. ROD DAMAGE TO HONEYCOMB CORE AND INNER SKIN
(LOW VEL. $\frac{3}{8}$ in. ROD)

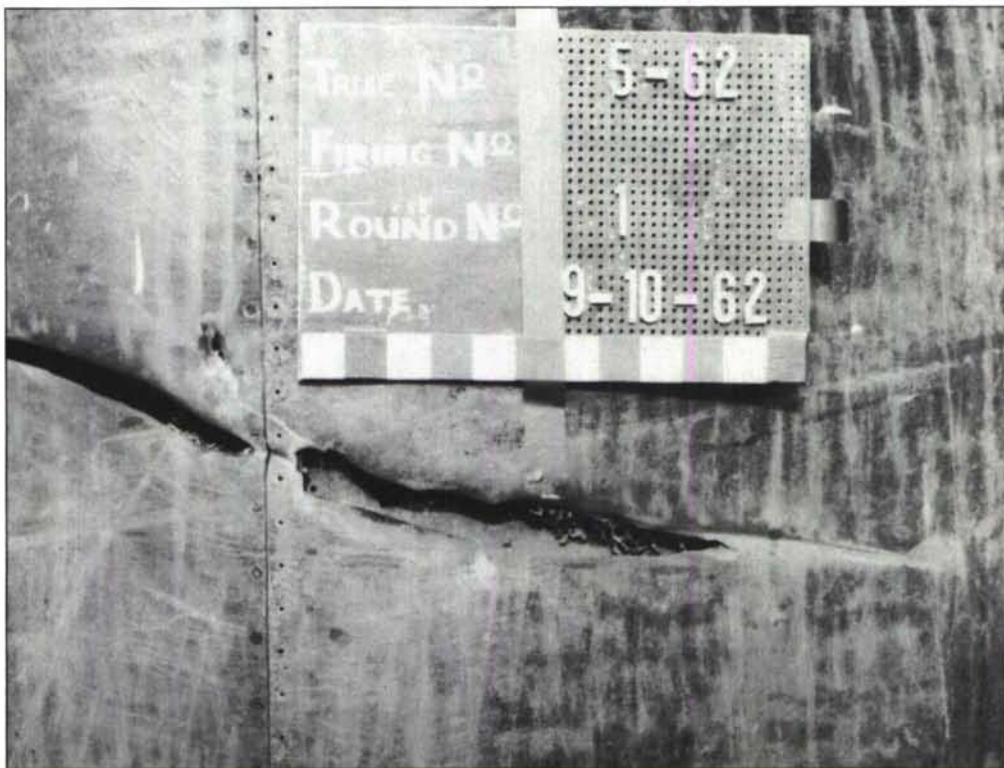
FIG.28d. TARGET 8. DETAIL OF TYPICAL ROD CUT END ON STEEL HONEYCOMB TARGET
(LOW VEL. $\frac{3}{8}$ in. ROD)

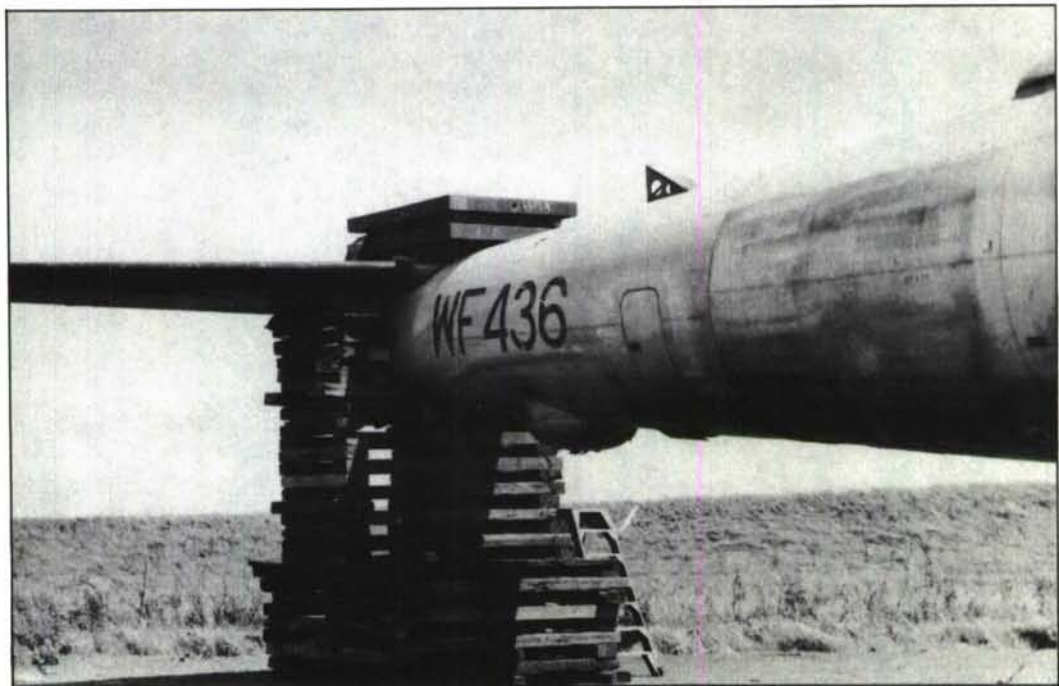
FIG.8b. OF APPENDIX I. DETAIL OF TAIL SUPPORT AND
COUNTERBALANCE LOADING
(TARGET 3b.)
