**CYCLIC CREEP AND RECOVERY BEHAVIOR OF NEXTEL™ 720/ALUMINA  
CERAMIC MATRIX COMPOSITE AT 1200°C IN AIR AND IN STEAM  
ENVIRONMENTS**

THESIS

Bridgett A. Whiting, 2<sup>nd</sup> Lieutenant, USAF  
AFIT/GAE/ENY/07-S05

***AIR FORCE INSTITUTE OF TECHNOLOGY***

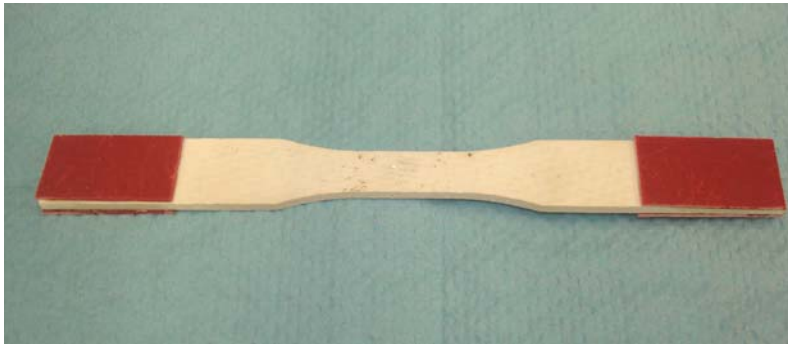
**Figure 10. Example of a tabbed Nextel 720/A specimen.**

The grips holding the specimens during the tensile and compressive tests apply a fairly high pressure to the specimen. To prevent grip failures, tabs were attached on the gripped portions of the specimens. The fiberglass/epoxy tabs were bonded to specimens with M-Bond 200 adhesive. A tabbed specimen is shown in Figure 10.

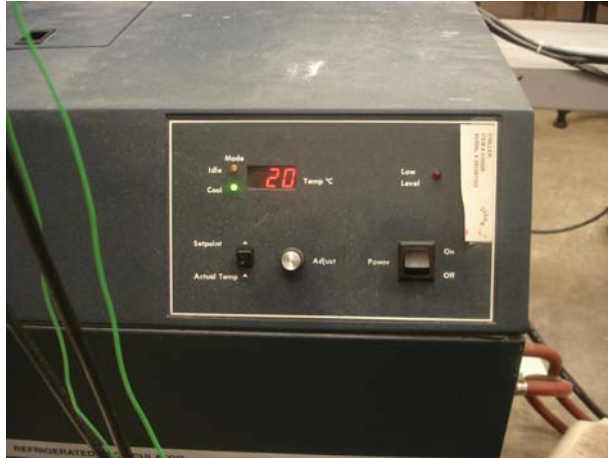
**Figure 12. NESLAB model HX-75 cooler.**

The chilled water is pumped through 6.35 mm outer diameter tubes passing through the grip wedges. The average water temperature was 16-20° C. To prevent corrosion deionized water was used.

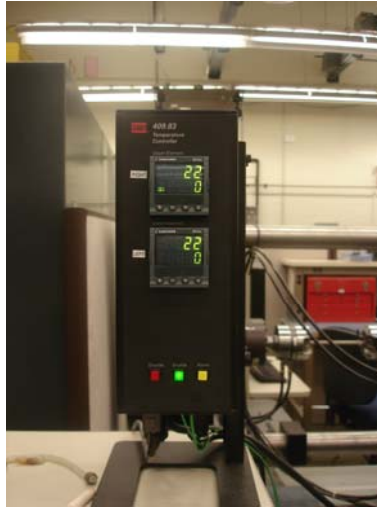
**Figure 13. Temperature controller.**

An AMTECO Hot-Rail Furnace System with two resistance elements ovens. The ovens were controlled by MTS Model 409.83B Temperature Controller. The thermocouples connected the controller to the ovens were R-type in order to withstand the high temperatures.

The temperature was set according to TestStar II and sent to the temperature controller. The controller can be seen in Figure 13. The temperature recorded by the thermocouples is not the temperature of the specimen but only the oven temperature. Therefore, temperature controller was calibrated to ensure specimen was at the desired temperature level.

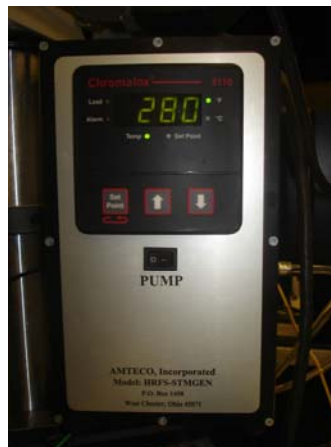
**Figure 16. AMTECO, Inc steam pump.**

For those tests requiring steam, a continuous steam environment was provided by an AMTECO HRFS-STMGEN Steam Generation System seen in Figure 16. Steam was guided to the alumina susceptor through a ceramic feeding tube at a temperature of approximately 300° C. The steam was comprised of deionized water.

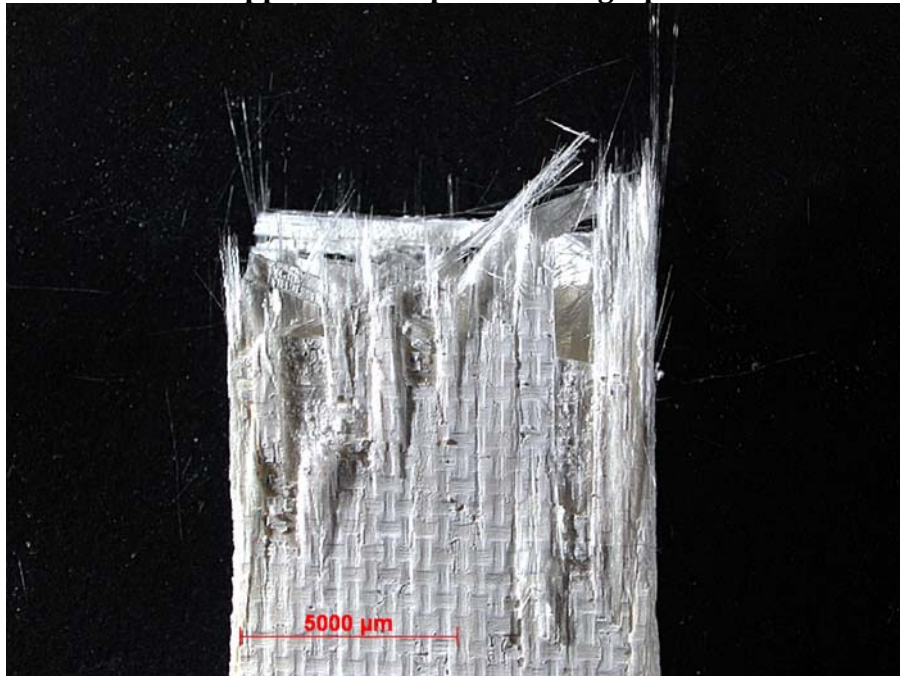
**Figure 53. Fracture surface of N720/A specimen tested with cyclic creep-recovery with 30 hour hold times at 100 MPa in air at 1200 °C.**

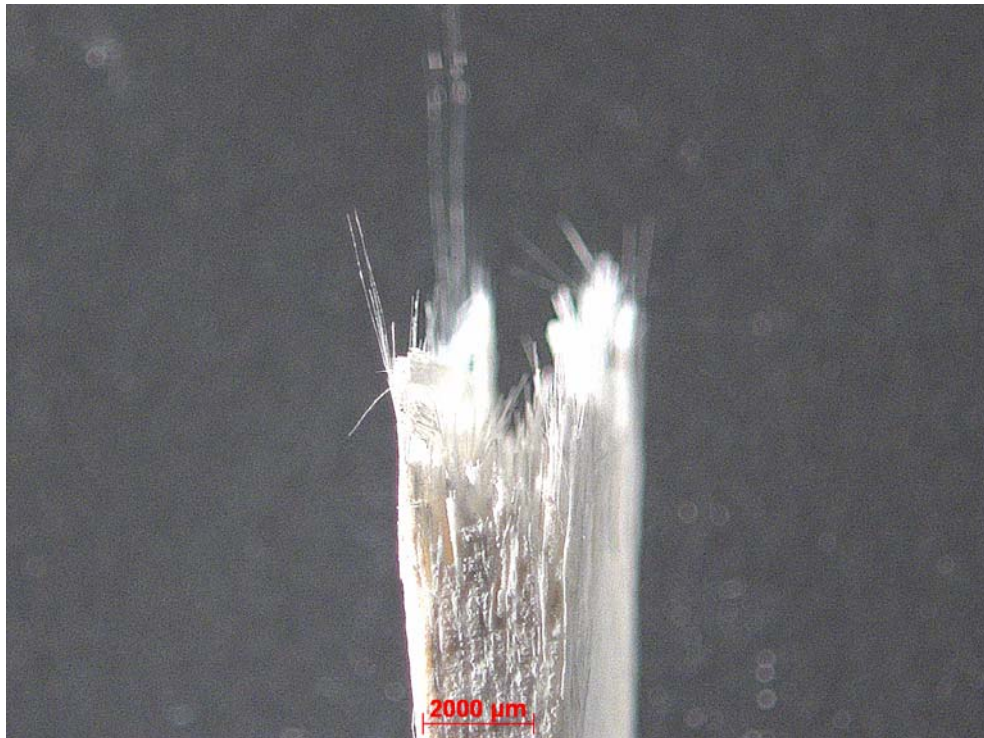
**Figure 54. Fracture surface of N720/A specimen tested with cyclic creep-recovery with 30 hour hold times at 100 MPa in air at 1200 °C.**

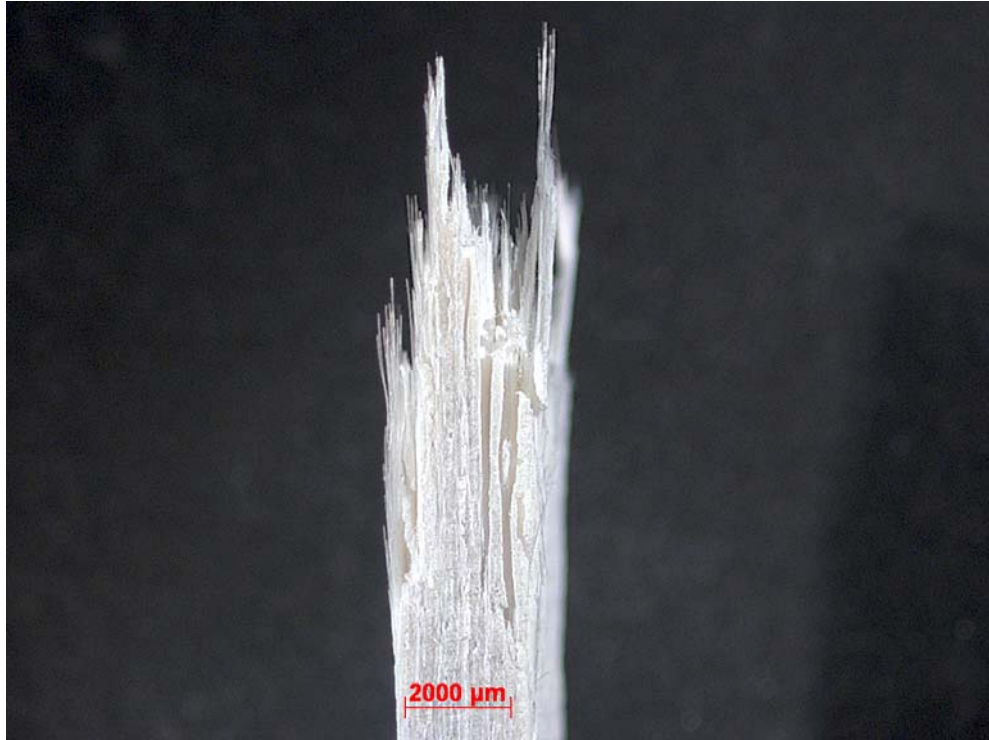
**Figure 57. Fracture surface of N720/A specimen tested with cyclic creep-recovery with 30 hour hold times at 100 MPa in air at 1200 °C.**

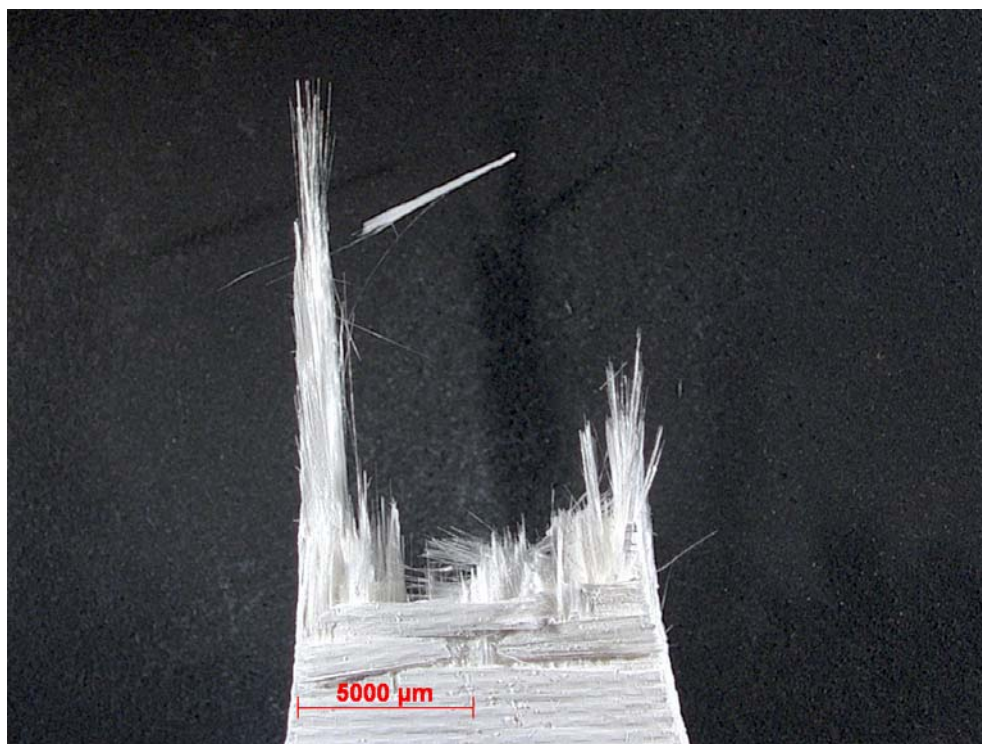
**Figure 59. Fracture surface of N720/A specimen tested with cyclic creep-recovery with 1 hour hold times at 100 MPa in air at 1200 °C.**

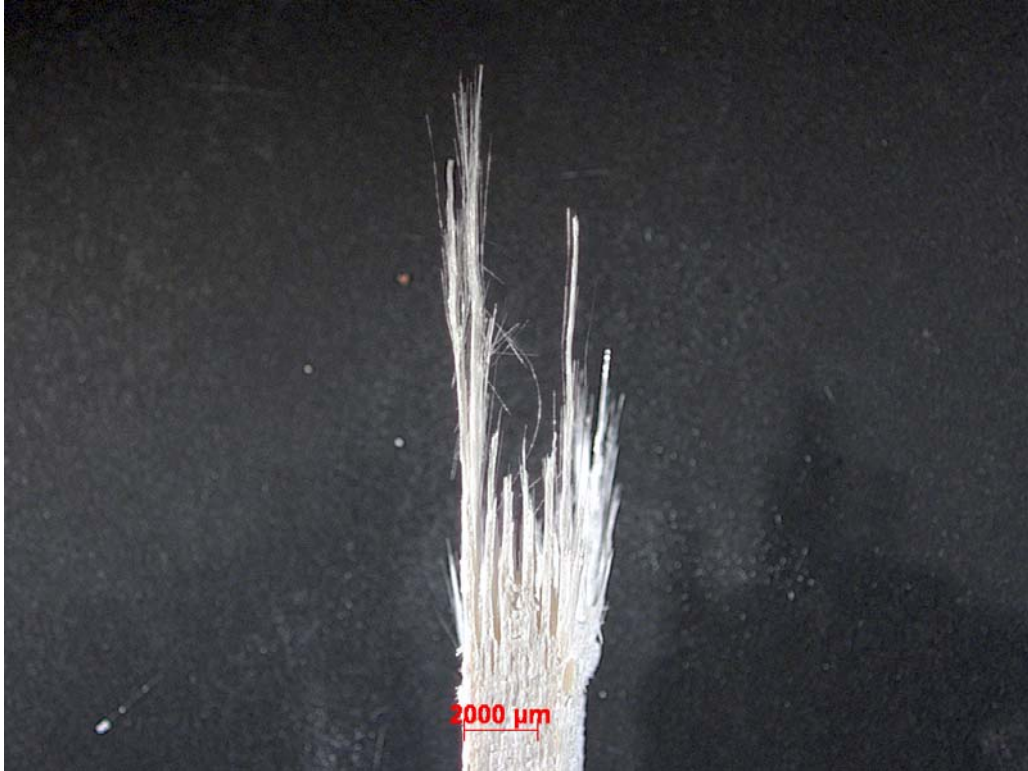
**Figure 61. Fracture surface of N720/A specimen tested with cyclic creep-recovery with 1 hour hold times at 100 MPa in air at 1200 °C.**

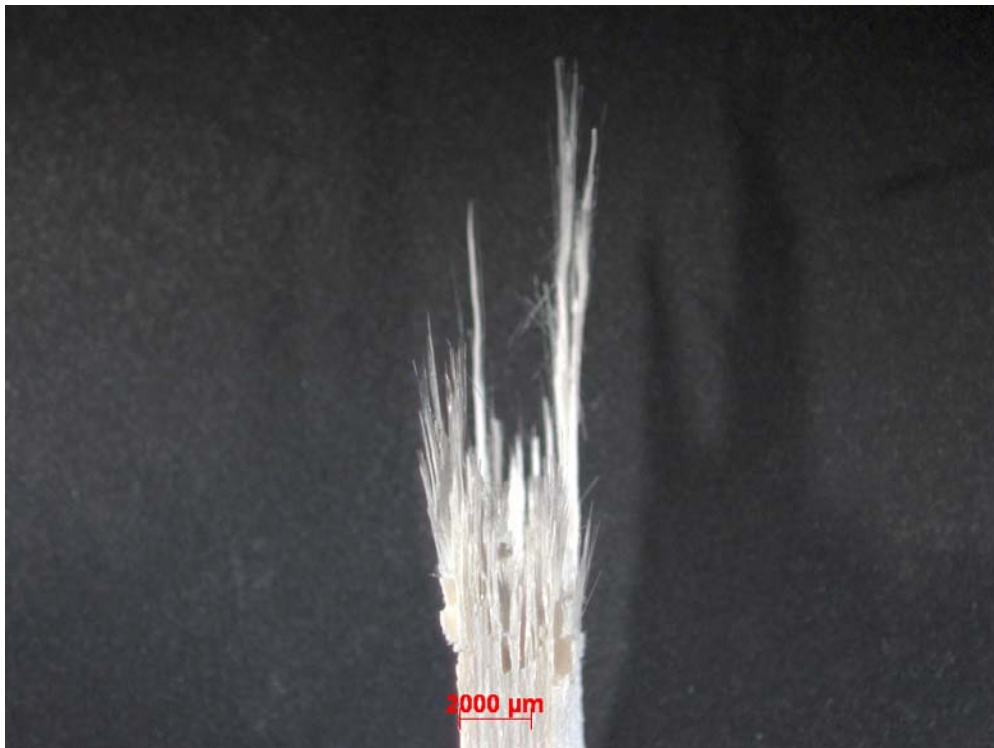
**Figure 62. Fracture surface of N720/A specimen tested with cyclic creep-recovery with 1 hour hold times at 100 MPa in air at 1200 °C.**

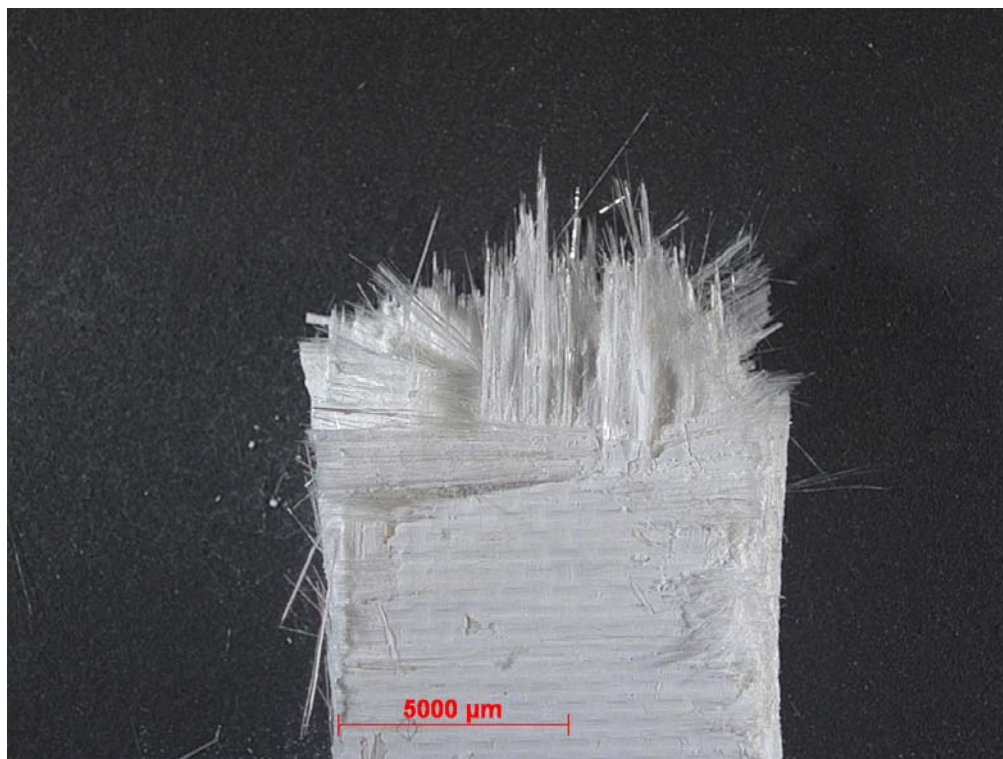
**Figure 63. Fracture surface of N720/A specimen tested with cyclic creep-recovery with 1 hour hold times at 100 MPa in air at 1200 °C.**

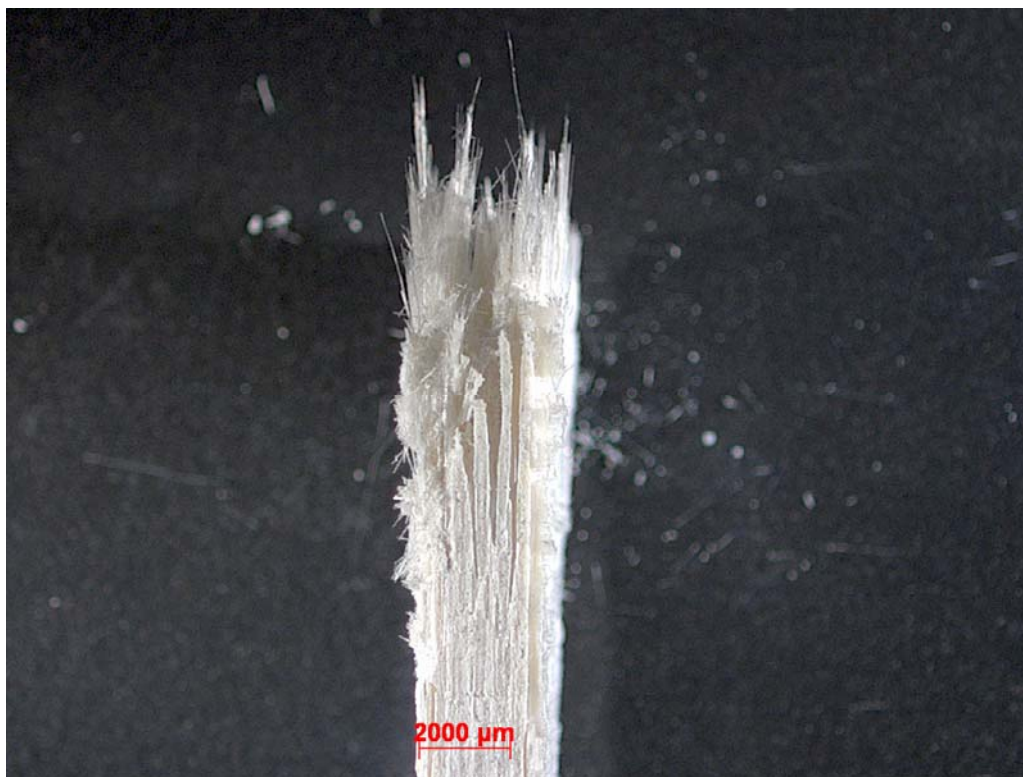
**Figure 64. Fracture surface of N720/A specimen tested with cyclic creep-recovery with 1 hour hold times at 100 MPa in air at 1200 °C.**

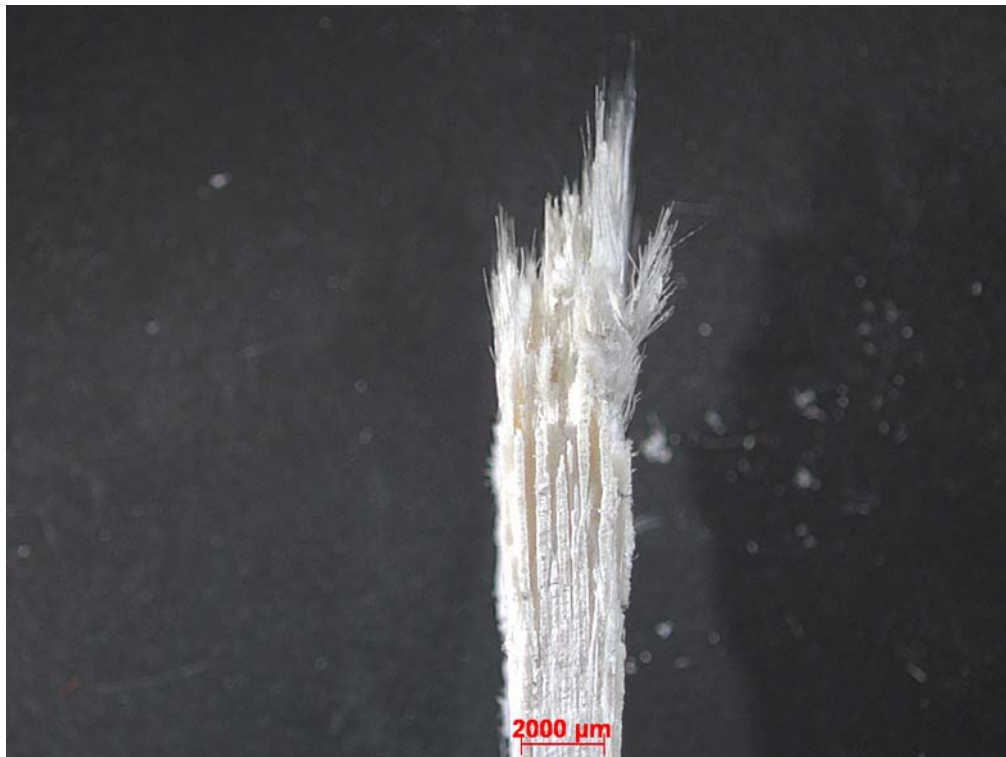
**Figure 66. Fracture surface of N720/A specimen tested with cyclic creep-recovery with 1 hour hold times at 125 MPa in air at 1200 °C.**

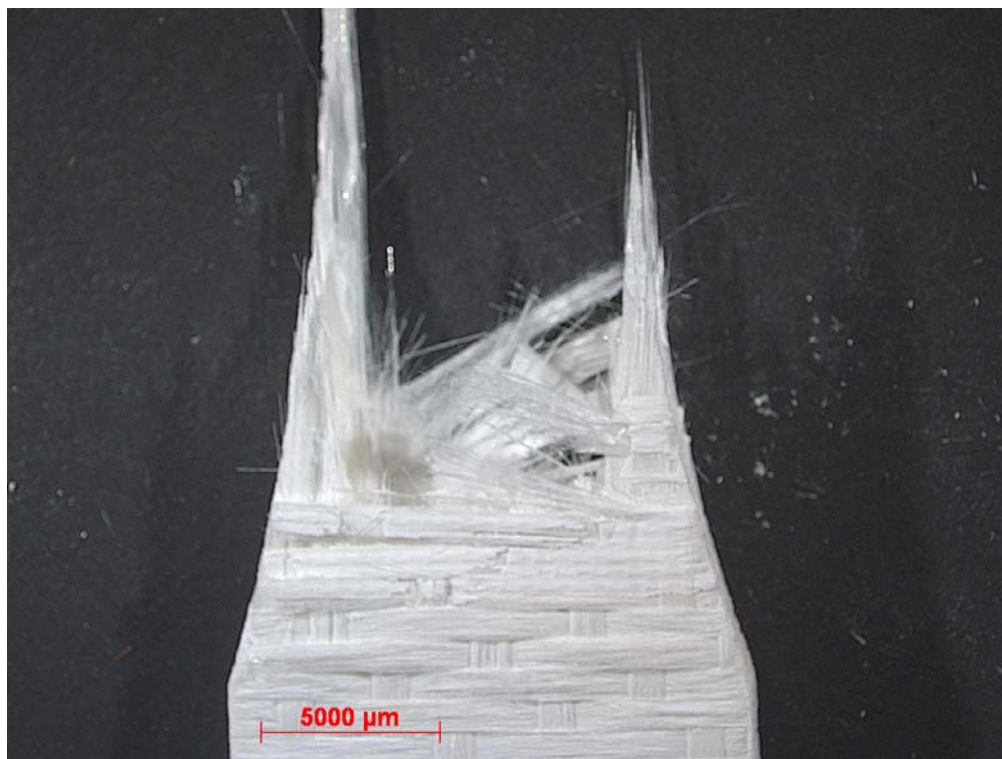
**Figure 67. Fracture surface of N720/A specimen tested with cyclic creep-recovery with 1 hour hold times at 125 MPa in air at 1200 °C.**

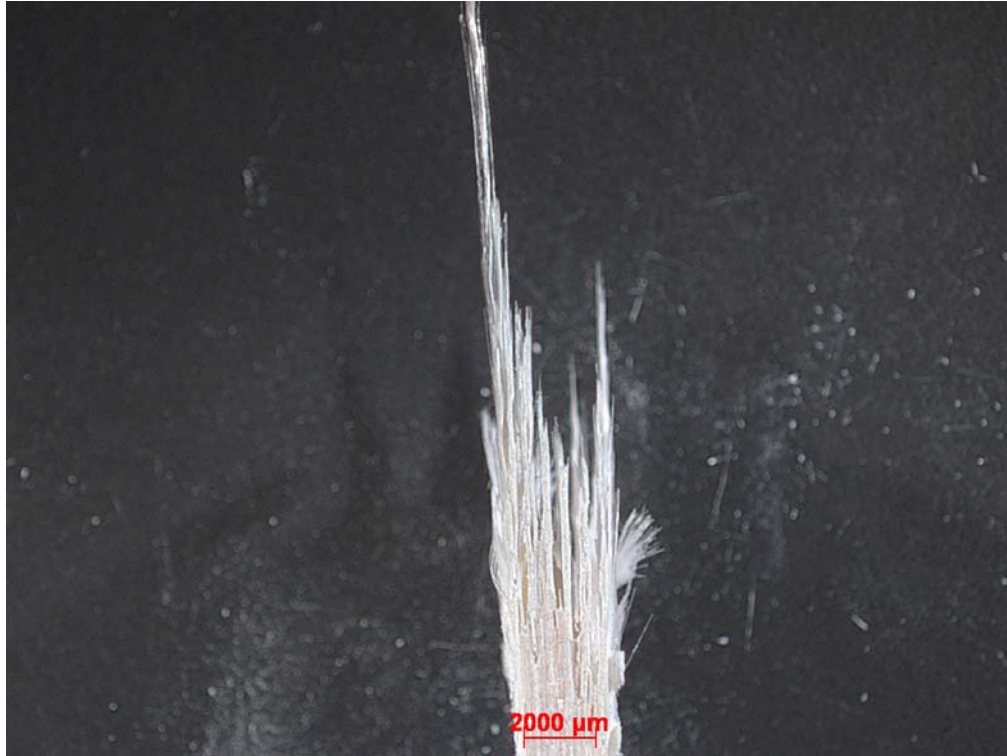
**Figure 69. Fracture surface of N720/A specimen tested with cyclic creep-recovery with 1 hour hold times at 125 MPa in air at 1200 °C.**

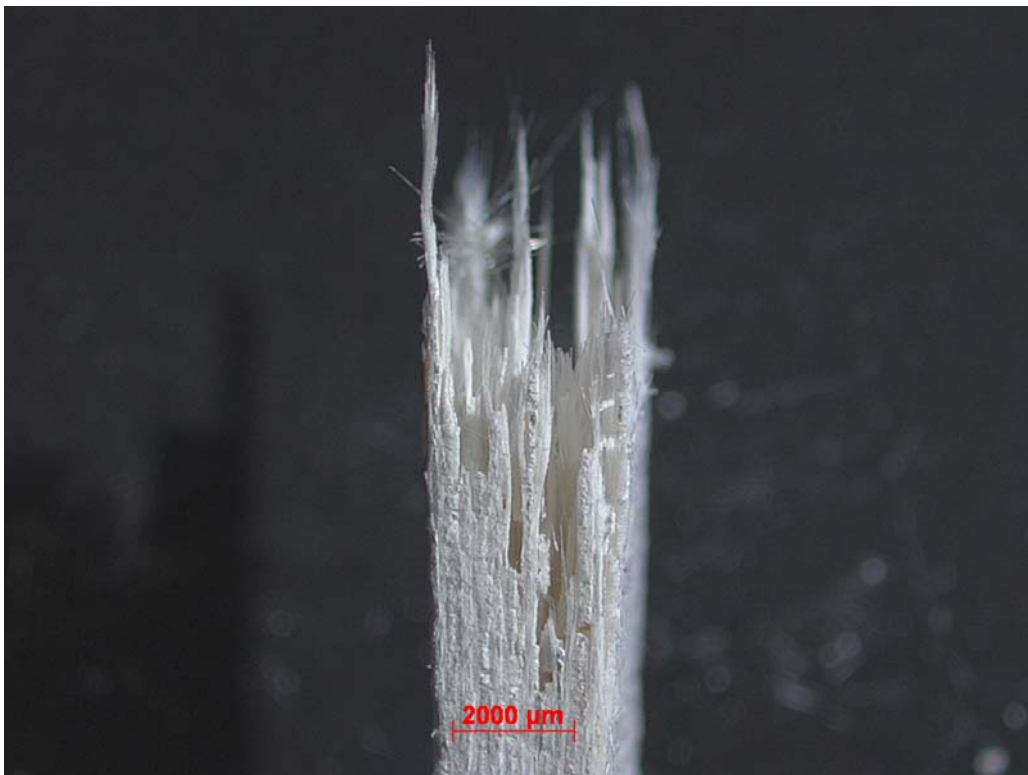
**Figure 72. Fracture surface of N720/A specimen tested with cyclic creep-recovery with 1 hour hold times at 100 MPa in steam at 1200 °C.**

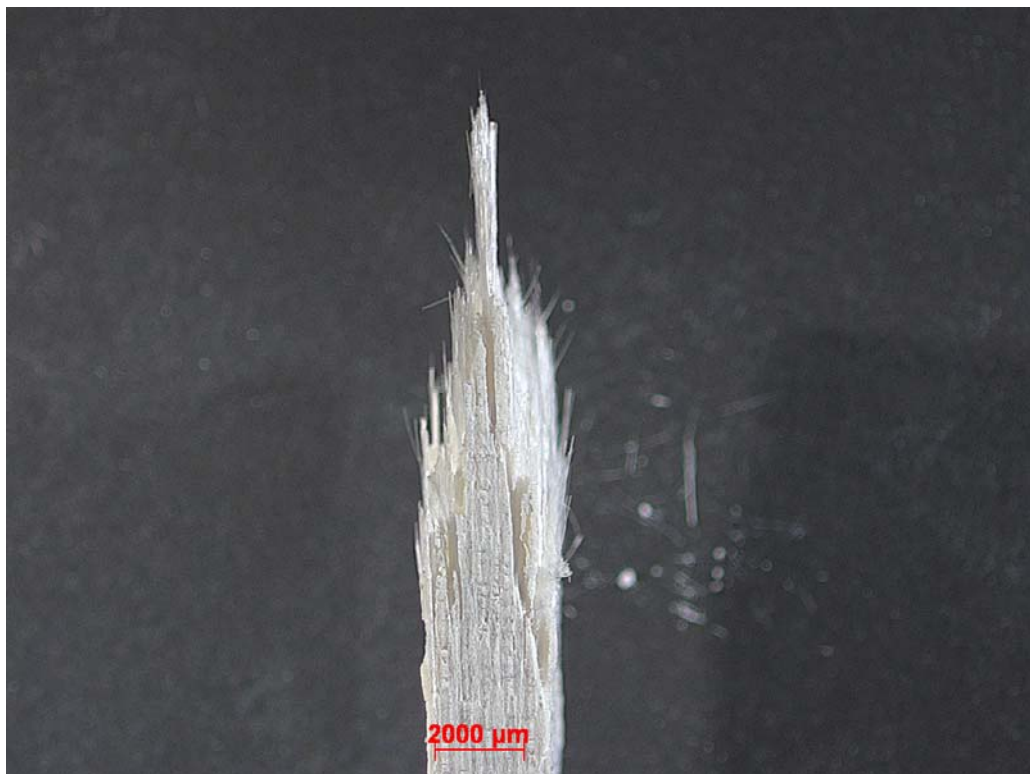
**Figure 75. Fracture surface of N720/A specimen tested with cyclic creep-recovery with 1 hour hold times at 100 MPa in steam at 1200 °C.**

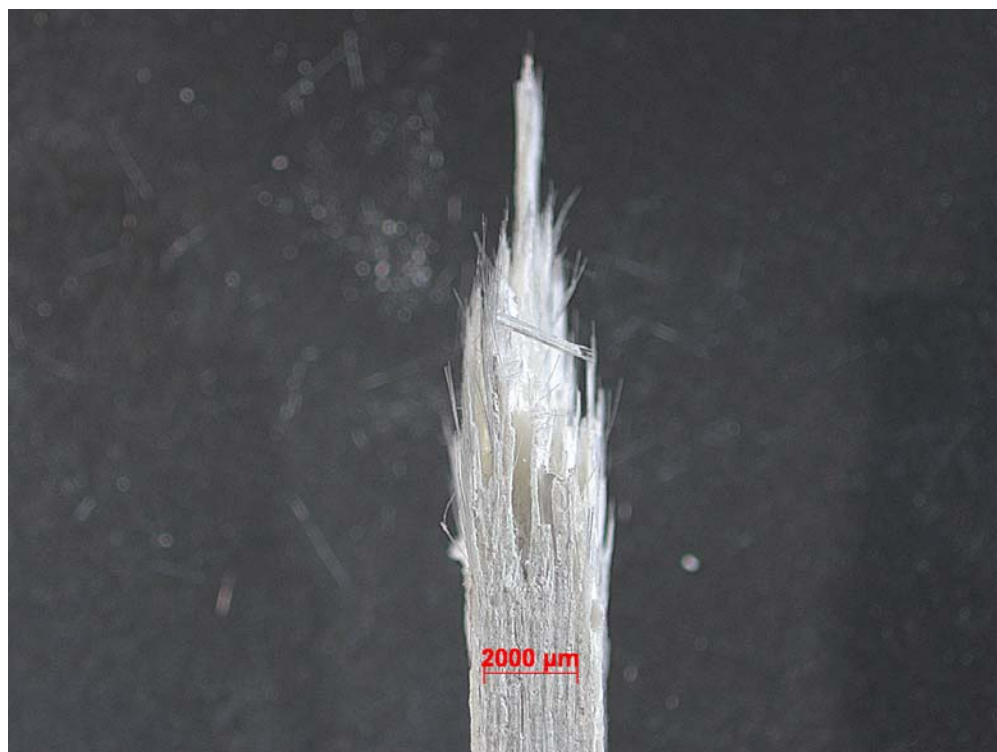
**Figure 76. Fracture surface of N720/A specimen tested with cyclic creep-recovery with 1 hour hold times at 100 MPa in steam at 1200 °C.**

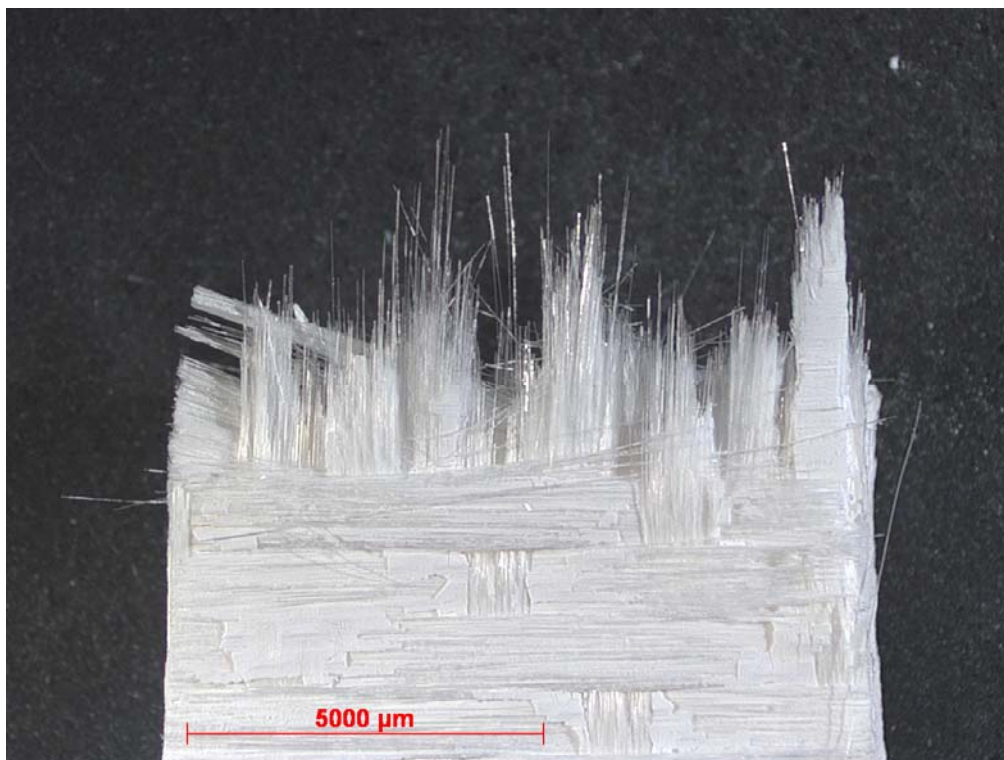
**Figure 78. Fracture surface of N720/A specimen tested with cyclic creep-recovery with 1 hour hold times at 100 MPa in steam at 1200 °C, possible kinking.**

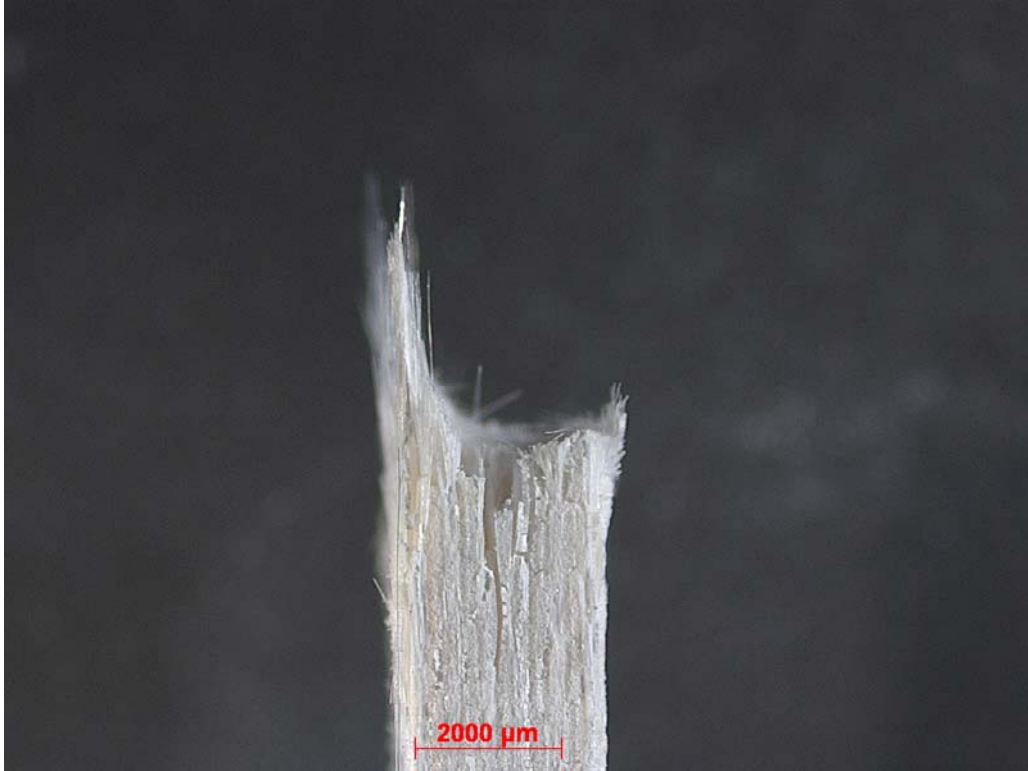
**Figure 79. Fracture surface of N720/A specimen tested with cyclic creep-recovery with 1 hour hold times at 100 MPa in steam at 1200 °C, possible kinking.**

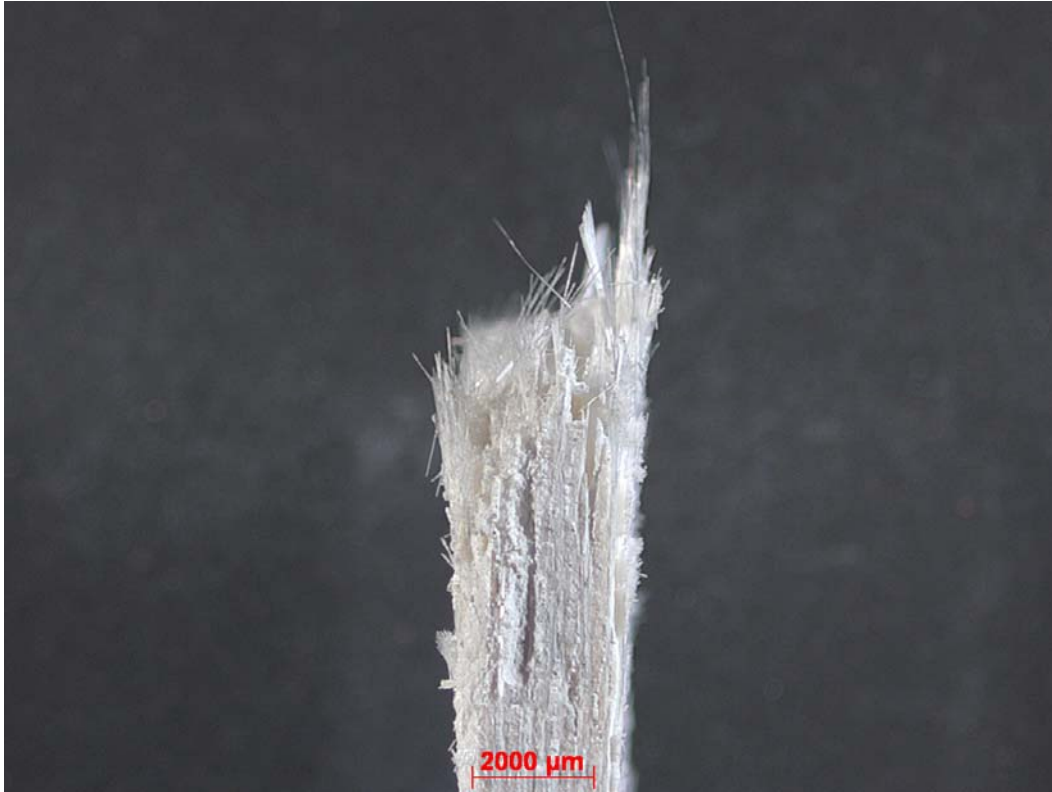
**Figure 83. Fracture surface of N720/A specimen tested with cyclic creep-recovery with 1 hour hold times at 100 MPa in steam at 1200 °C, possible kinking.**

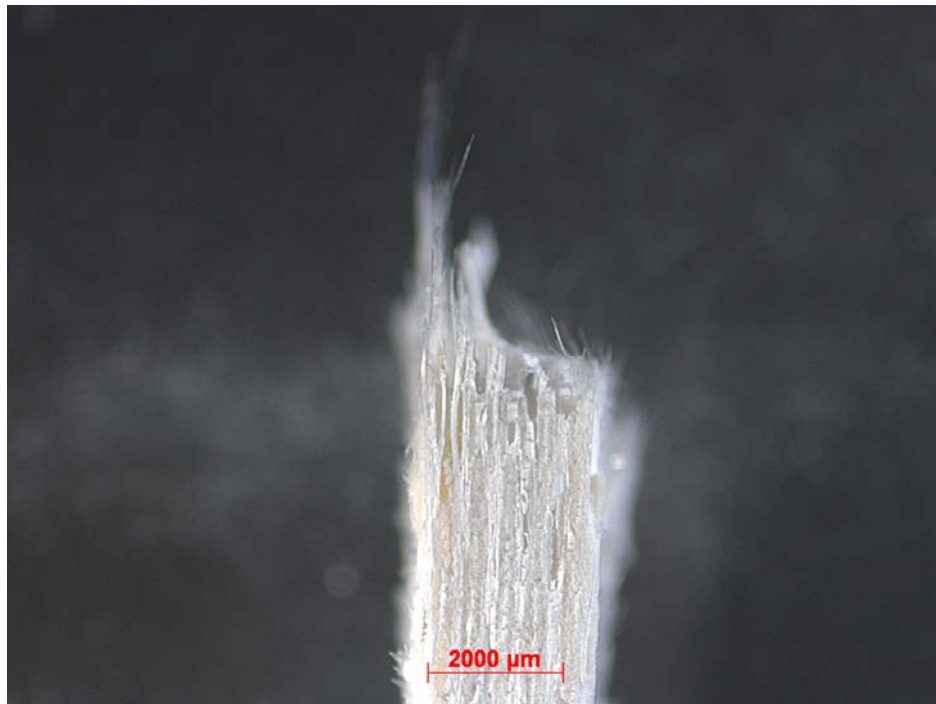
**Figure 84. Fracture surface of N720/A specimen tested with cyclic creep-recovery with 1 hour hold times at 100 MPa in steam at 1200 °C, possible kinking.**

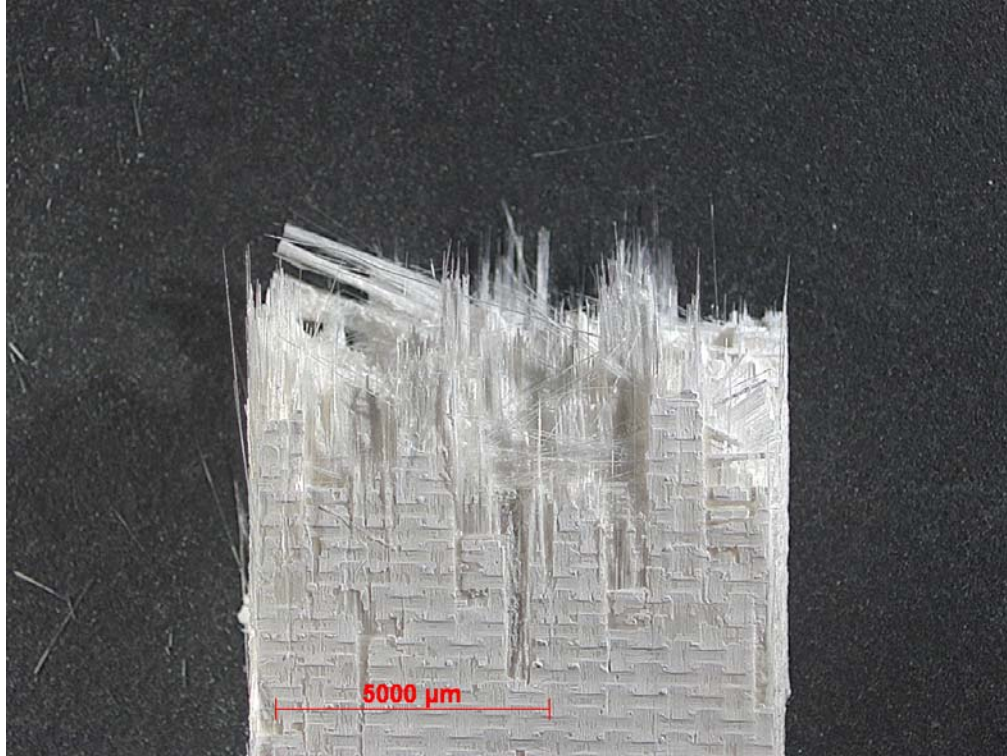
**Figure 87. Fracture surface of N720/A specimen tested with cyclic creep-recovery with 0.05 hour hold times at 125 MPa in steam at 1200 °C.**

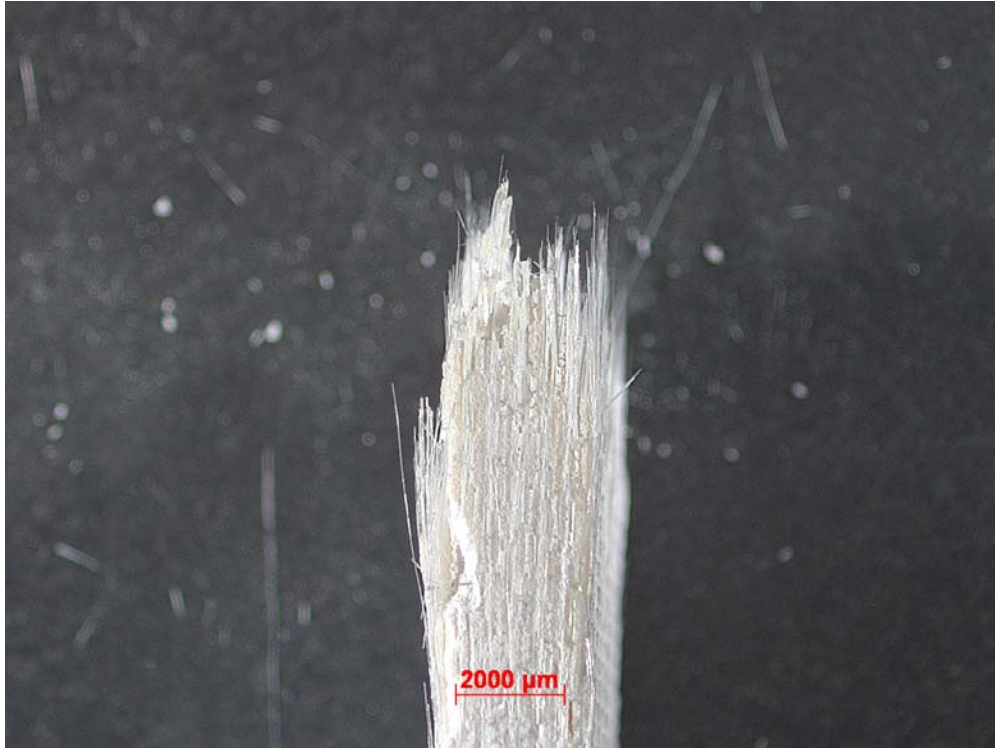
**Figure 89. Fracture surface of N720/A specimen tested with cyclic creep-recovery with 0.05 hour hold times at 125 MPa in steam at 1200 °C.**

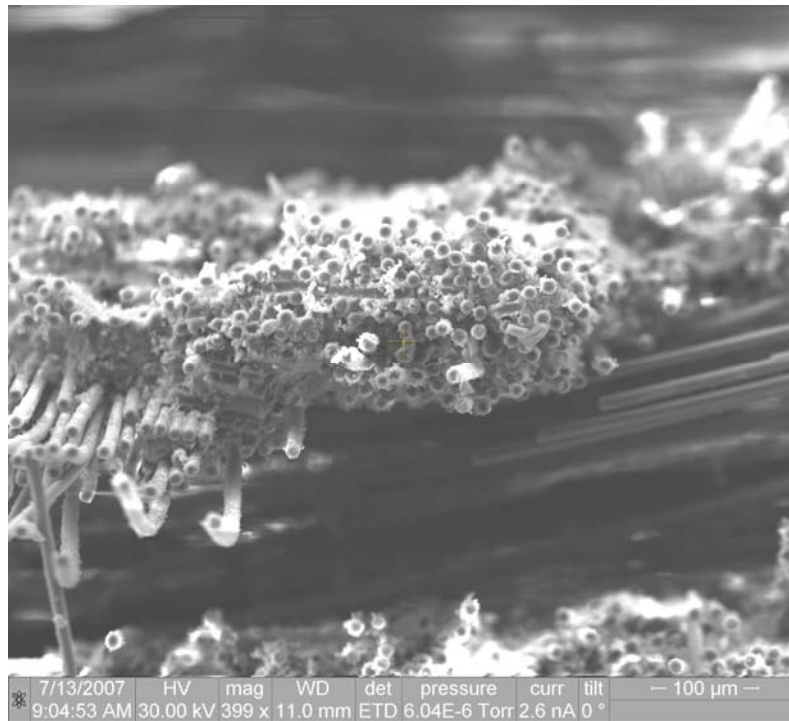
**Figure 92. Fracture surface of N720/A specimen tested with cyclic creep-recovery with 30 hour hold times at 100 MPa in air at 1200 °C.**

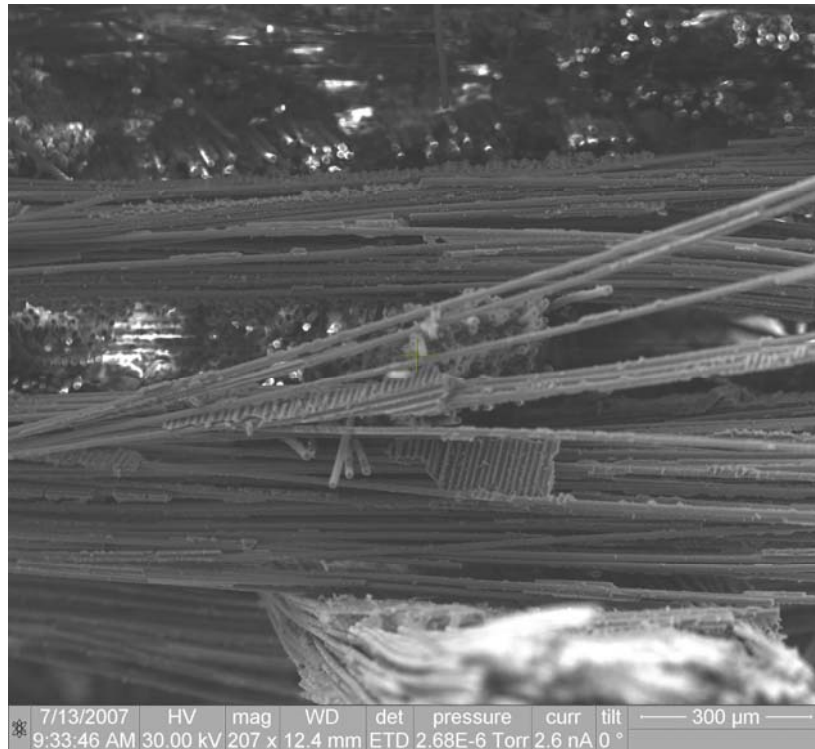
**Figure 95. Fracture surface of N720/A specimen tested with cyclic creep-recovery with 30 hour hold times at 100 MPa in air at 1200 °C.**

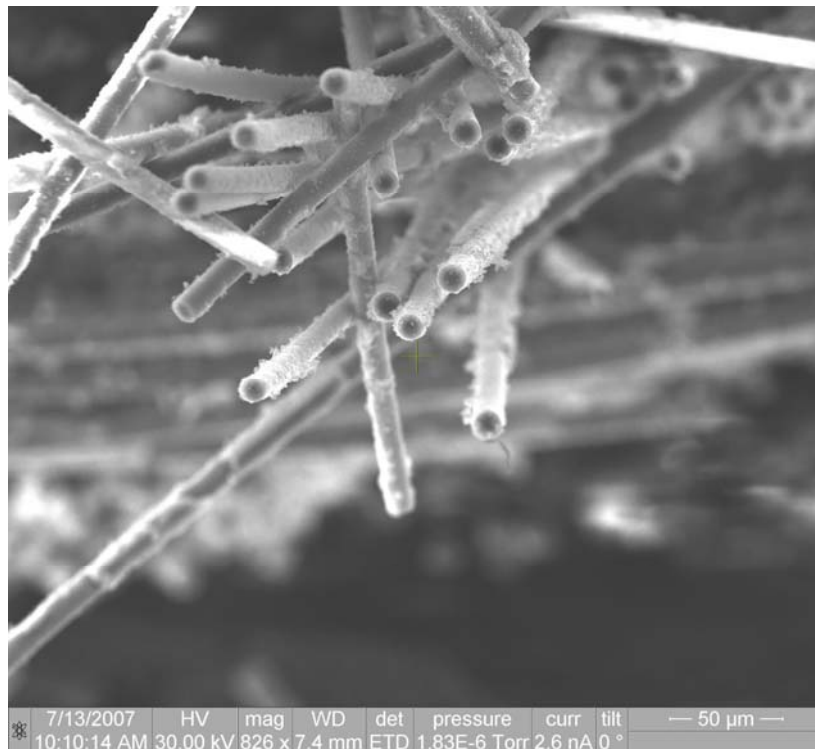
**Figure 100. Fracture surface of N720/A specimen tested with cyclic creep-recovery with 30 hour hold times at 100 MPa in air at 1200 °C.**

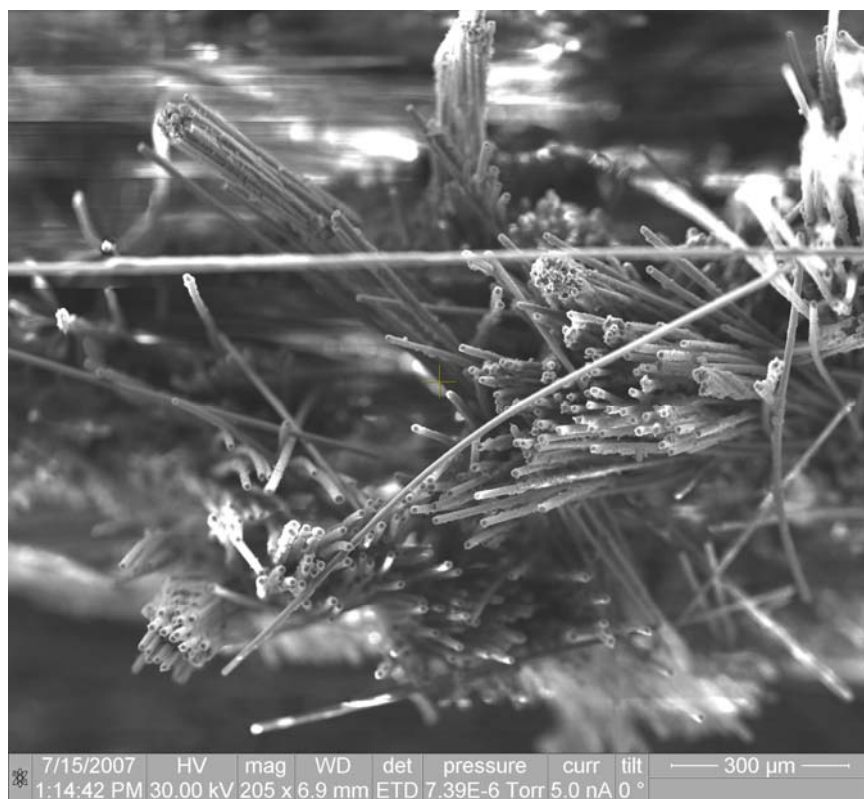
**Figure 105. Fracture surface of N720/A specimen tested with cyclic creep-recovery with 1 hour hold times at 100 MPa in air at 1200 °C.**

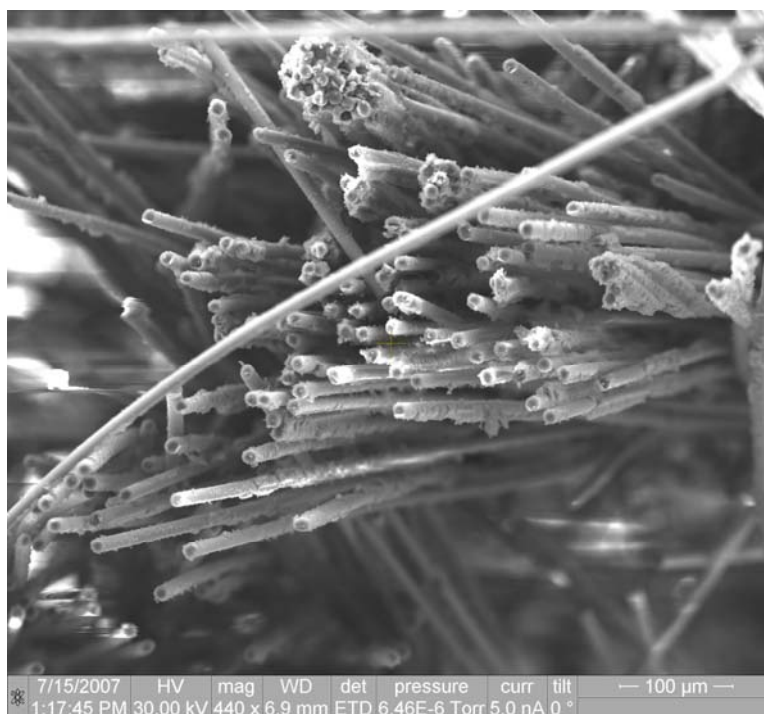
**Figure 106. Fracture surface of N720/A specimen tested with cyclic creep-recovery with 1 hour hold times at 100 MPa in air at 1200 °C.**

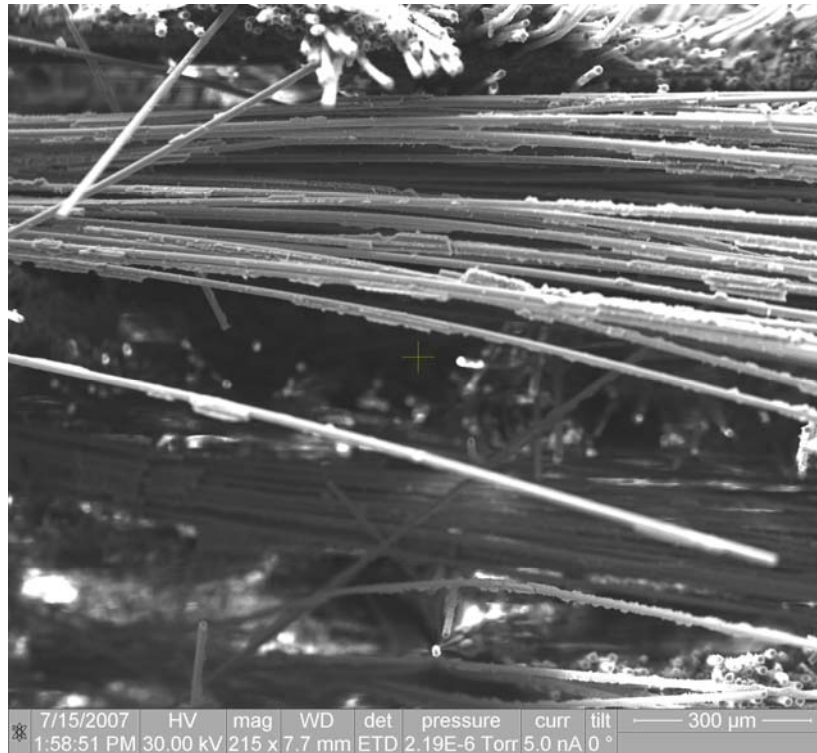
**Figure 115. Fracture surface of N720/A specimen tested with cyclic creep-recovery with 1 hour hold times at 100 MPa in air at 1200 °C.**

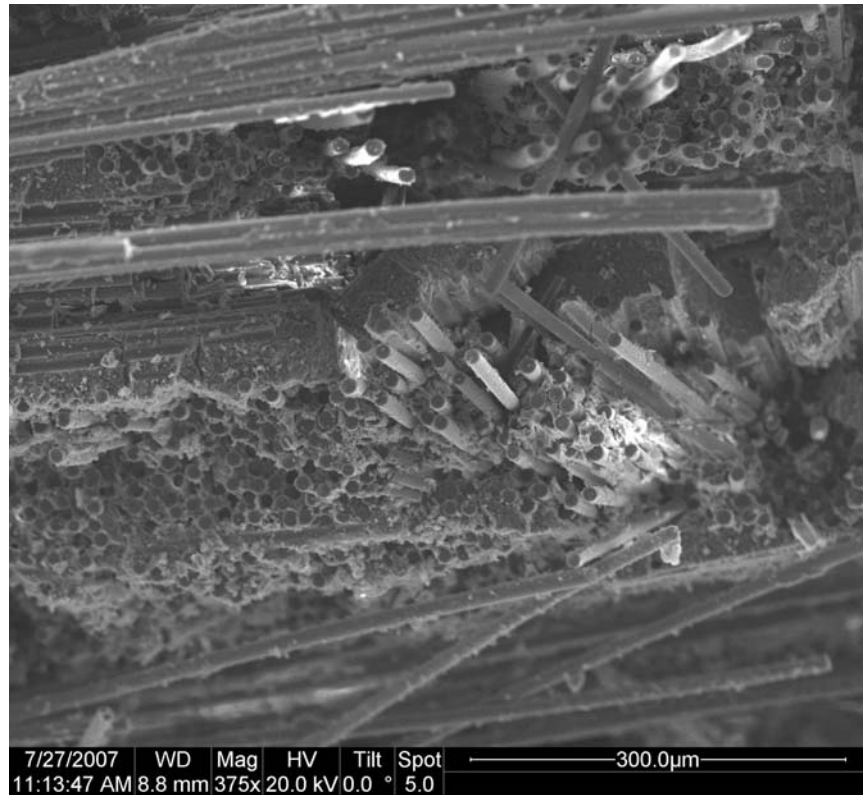
**Figure 145. Fracture surface of N720/A specimen tested with cyclic creep-recovery with 1 hour hold times at 100 MPa in steam at 1200 °C, possible kinking.**

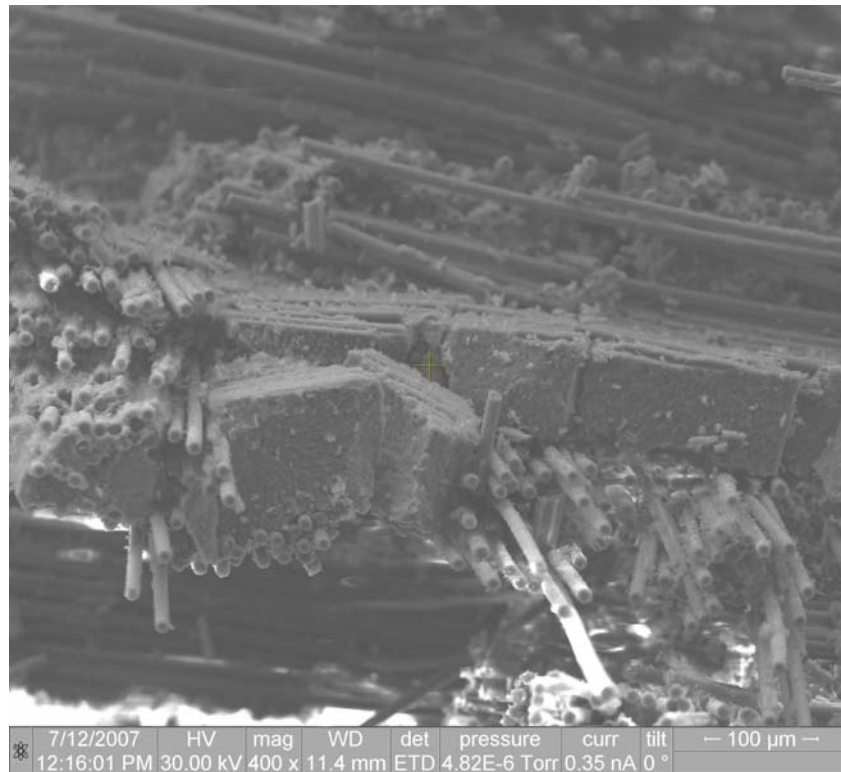
**Figure 151. Fracture surface of N720/A specimen tested with cyclic creep-recovery with 1 hour hold times at 100 MPa in steam at 1200 °C, possible kinking.**

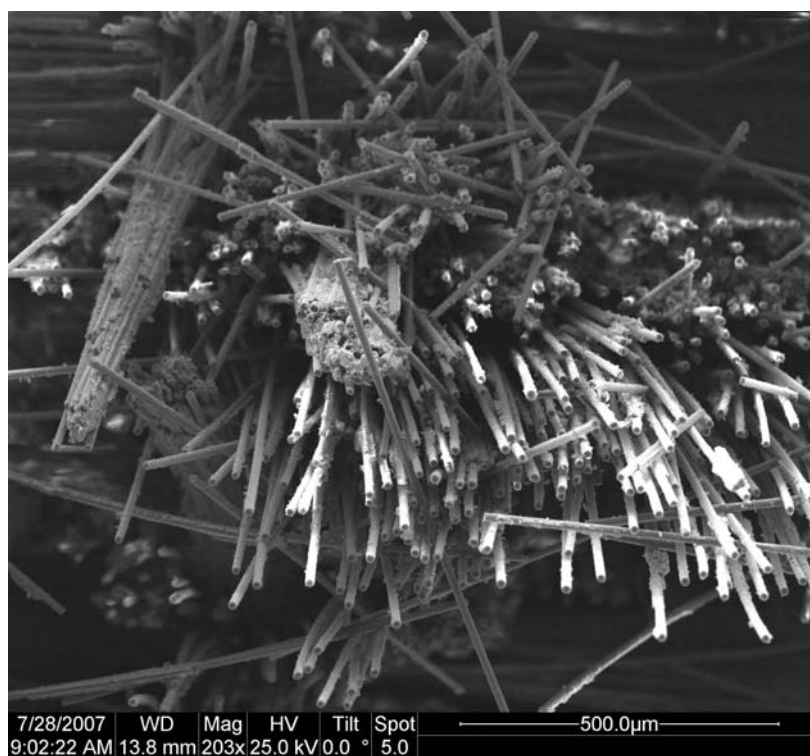
**Figure 156. Fracture surface of N720/A specimen tested with cyclic creep-recovery with 0.05 hour hold times at 125 MPa in steam at 1200 °C.**
