**FINAL REPORT
JULY 2007**

REPORT NO. 06-04D

**EVALUATION TRANSPORTABILITY TESTING OF THE JOINT
MODULAR INTERMODAL PLATFORM (JMIP) UNIT #4
TP-94-01,
“TRANSPORTABILITY TESTING PROCEDURES”**

**Evaluation Transportability Testing of the Joint Modular Intermodal
Platform (JMIP) Unit #4
TP-94-01, Revision 2, June 2004 "Transportability Testing Procedures"**

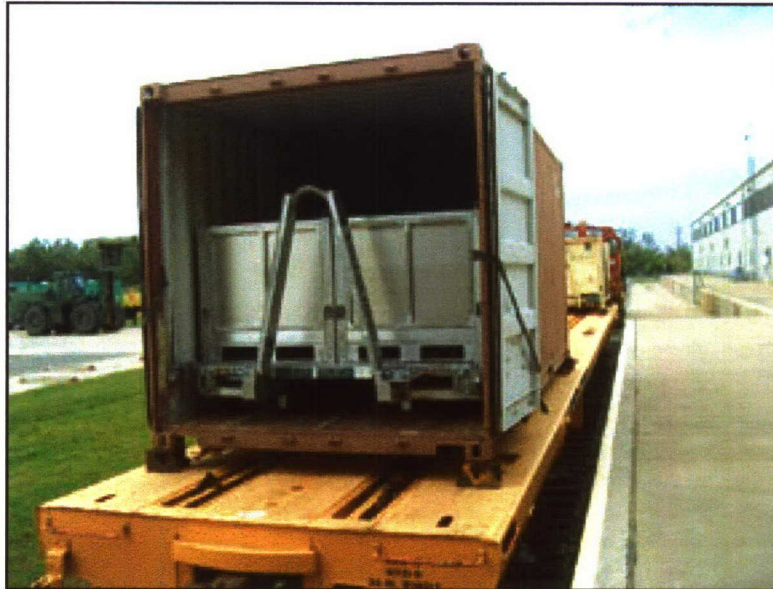
Photo 2. Rail Impact Testing of the JMIP (Prior to Testing)

Description	Weight
Flatcar Number: DODX 42353	85,000 lbs.
Intermodal Container with JMIP	31,230 lbs.
M1 Flatrack with MLRS Pods	28,265 lbs.
Total Specimen Wt.	144,495 lbs.
Buffer Car (four cars)	257,900 lbs.

Remarks: Figure 4 lists the test components and weights of the items used during the Rail Impact Tests.

1. Figure 5 lists the average speeds of the specimen car immediately prior to impact with the anvil. Impact #5 is the reverse impact.
2. Impact #3 was determined to be a “no test” due to the insufficient velocity at impact. The test was repeated.
3. Following Impact #5 the JMIP moved 0.5 inches in the direction of impact and the JMICs moved 0.25 inches in the direction of impact.

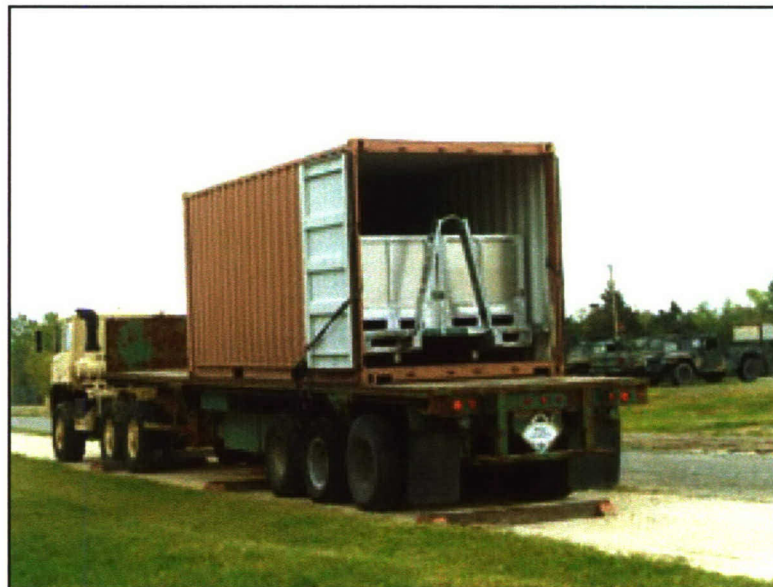
Photo 3. Hazard Course Testing of the JMIP

Pass No.	Elapsed Time	Avg. Velocity (mph)
1	25 Seconds	6
2	24 Seconds	6

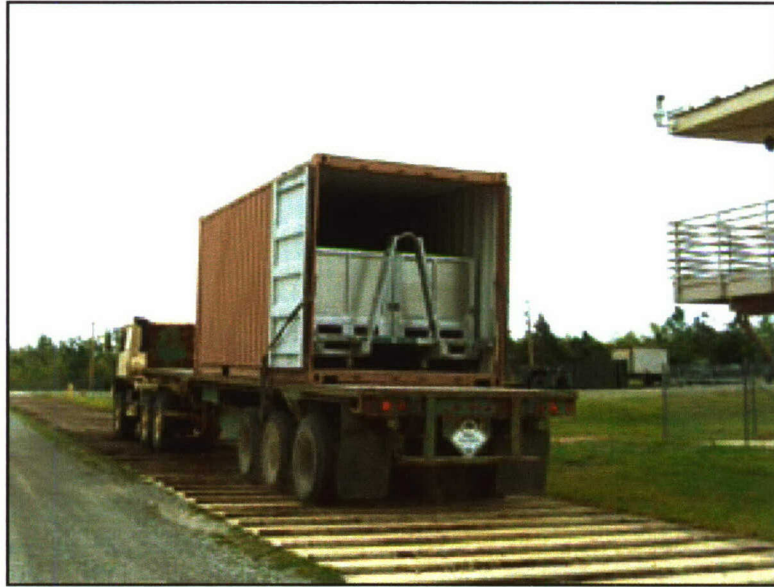
Photo 4. Washboard Course Testing of the JMIP

Inspection following the Washboard Course revealed no damage to the JMIP.

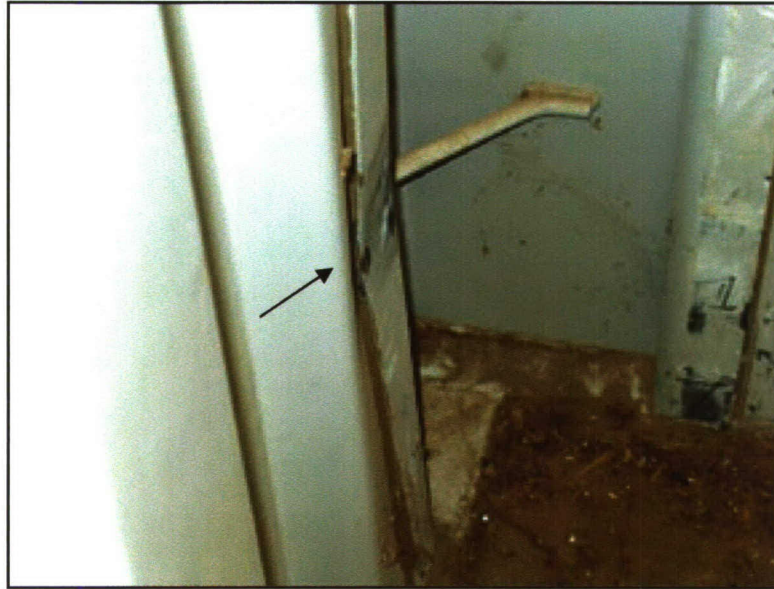
Photo 7. Damaged Container Corner Post

4. The container corner posts at the closed end were damaged due to contact with the hard blocks on the JMIP.

1. The JMIP, as currently designed, is **not adequate** to transport the Navy JMICs , in an intermodal container due to the damage the JMIP end blocks caused to the intermodal container.

Note: The hard plastic end blocks were replaced with a softer rubber end bumpers for follow on testing (06-04F, 06-04G, 06-04H, 06-04J). The intermodal container corner posts were not damaged during testing when the softer rubber end bumpers were used. Therefore, the JMIP with the soft rubber end bumpers, is adequate to be used in container transport.

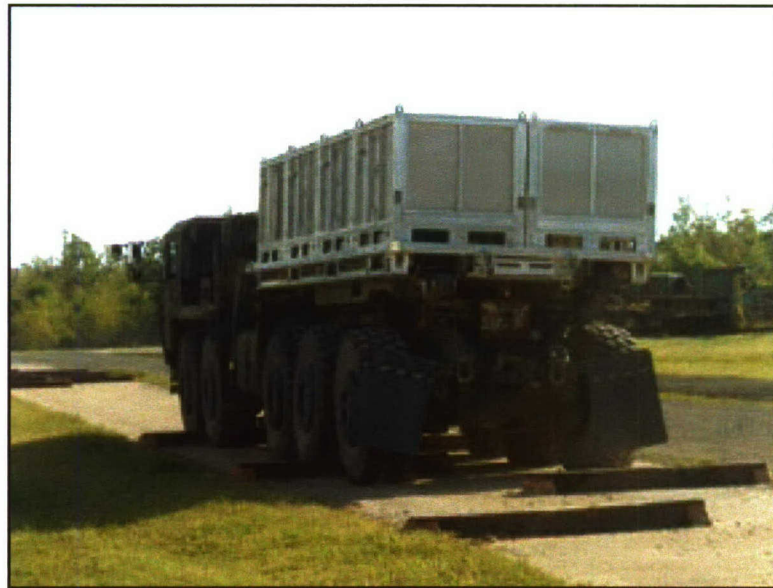
Photo 9. Hazard Course Testing of the JMIP

Pass No.	Elapsed Time	Avg. Velocity (mph)
1	24 Seconds	6
2	24 Seconds	6

1. Figure 9 lists the average speeds of the test load through the Hazard Course.
2. Inspection did not reveal any damage to the JMIP.

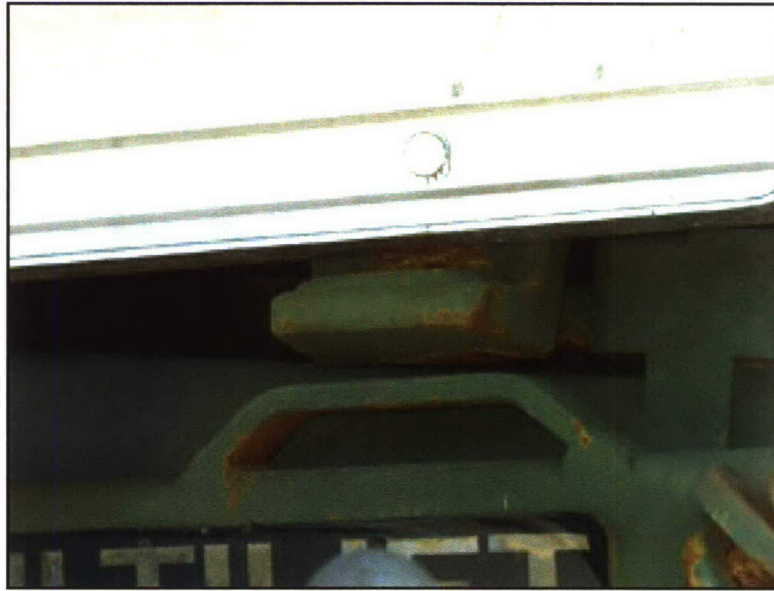
Photo 10. JMIP Rails not on PLS Truck Supports

B. OBSERVATION: The rails at the front of JMIP #4 did not rest on the PLS truck supports (frog feet) and the holes in the JMIP rail did not align with the rail transport pin hole on the PLS truck.

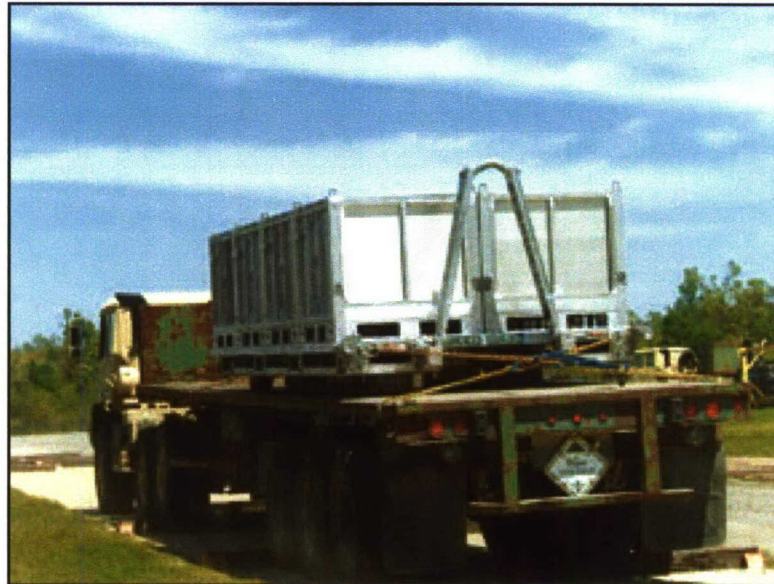
Photo 13. Hazard Course Testing of the JMIP

Pass No.	Elapsed Time	Avg. Velocity (mph)
1	25 Seconds	6
2	24 Seconds	6

1. Figure 11 lists the average speeds of the test load through the Hazard Course.
2. Inspection did not reveal any damage to the JMIP.

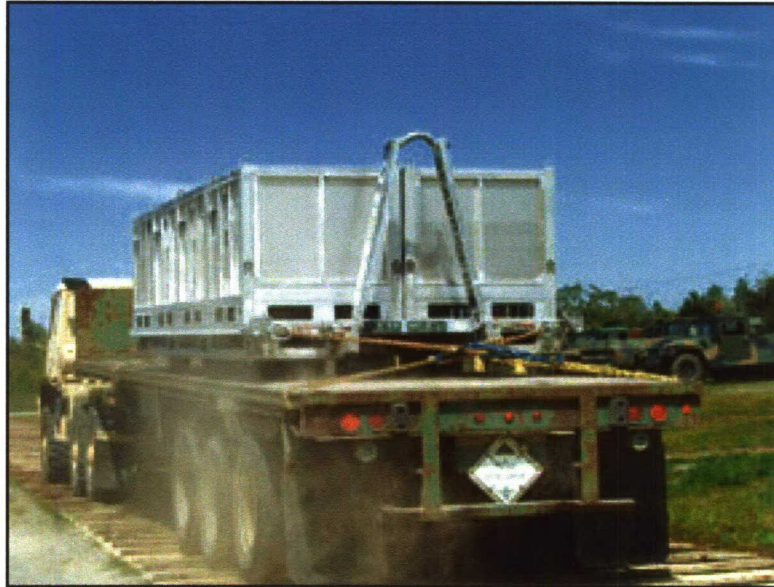
Photo 14. Washboard Course Testing of the JMIP

Remarks: Inspection following the Washboard Course revealed no damage to the JMIP.

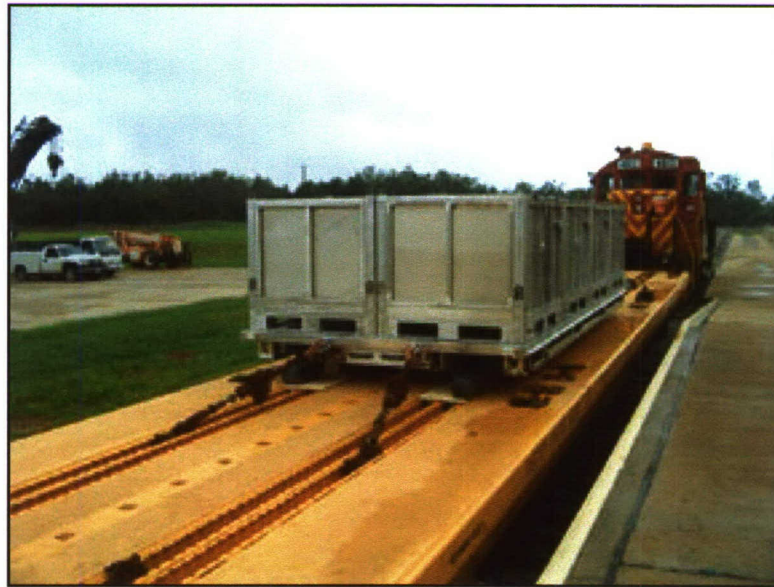
Photo 15. Rail Impact Testing of the JMIP (Prior to Testing)

Description	Weight
Flatcar Number: DODX 42353	85,000 lbs.
JMIP with JMICs	26,360 lbs.
M1 Flatrack with MLRS Pods	28,265 lbs.
Total Specimen Wt.	139,625 lbs.
Buffer Car (four cars)	257,900 lbs.

1. Figure 13 lists the average speeds of the specimen car immediately prior to impact with the anvil. Impact #5 is the reverse impact.
2. Impact #4 was determined to be a “no test” due to the insufficient velocity at impact. The test was repeated.
3. Following Impact # 4 one JMIC door lock was partially disengaged.
