NAVSWC TR 90-176

# USS PRINCETON (CG 59): MICROBIOLOGICALLY INFLUENCED CORROSION (MIC) AND MACROFOULING STATUS OF SEAWATER PIPING SYSTEMS

1 JUNE 1990

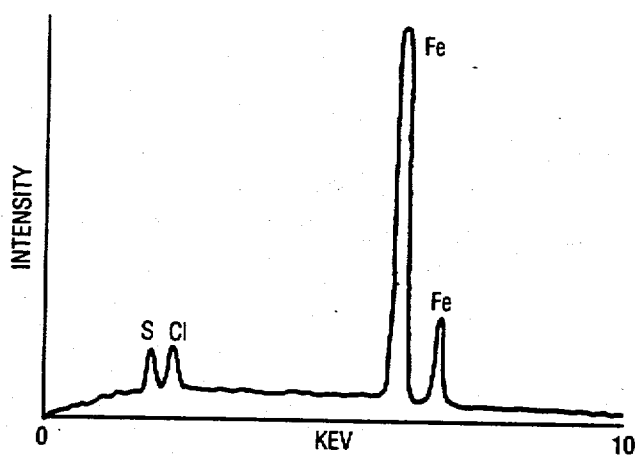
FIGURE 1. EDAX SPECTRUM OF THE BLACK DEPOSIT REMOVED FROM THE WASTER PIECE OF THE #6 MAIN SEA CHEST (SRB WERE ISOLATED FROM THIS DEPOSIT)

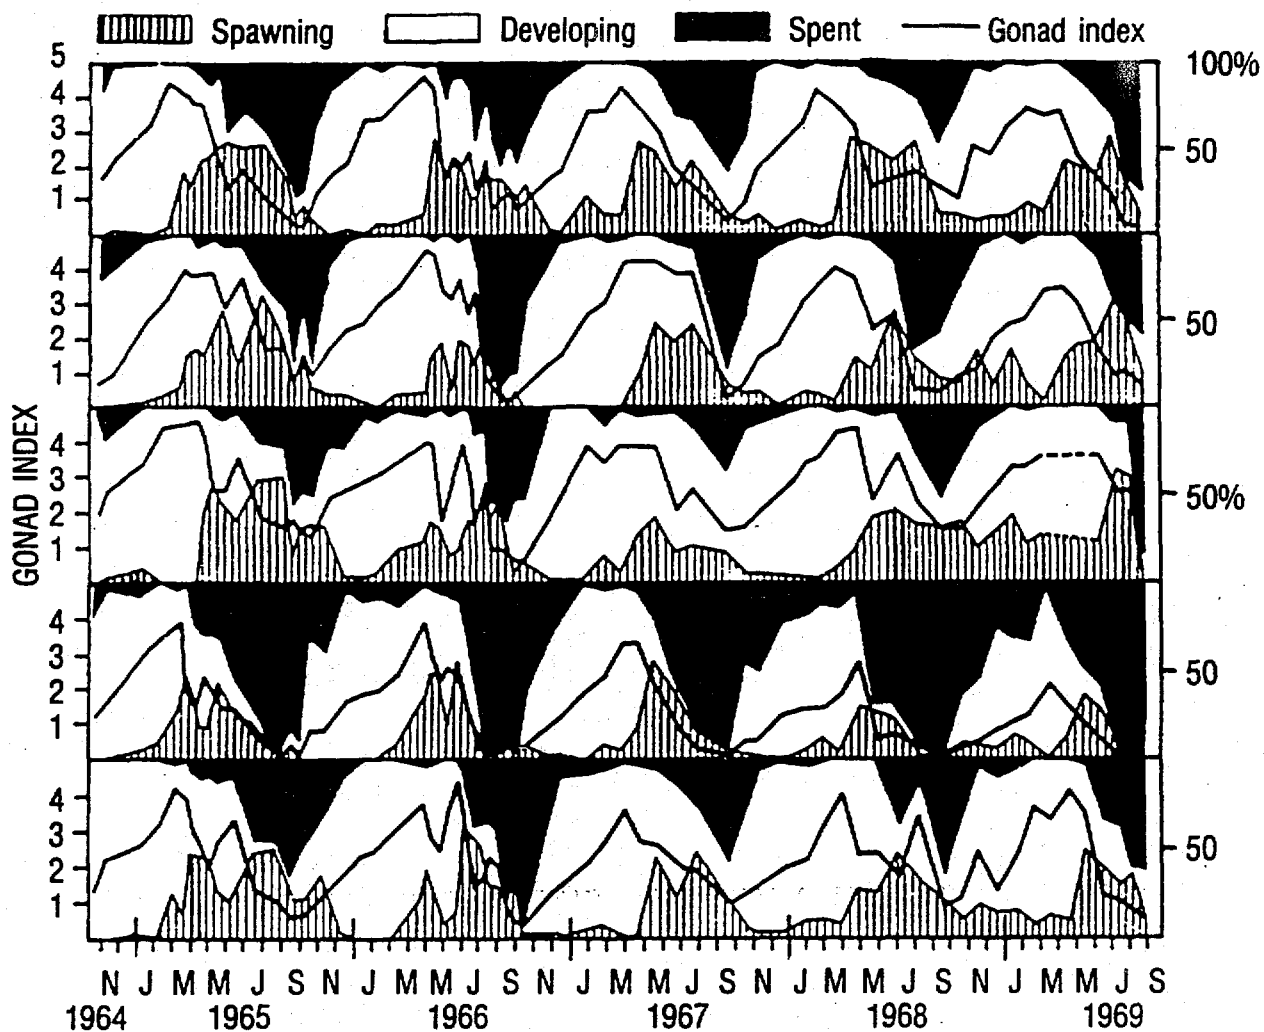
FIGURE 2. GONAD INDEX AND PERCENTAGE DISTRIBUTION OF SPAWNING, DEVELOPING AND SPENT MARINE MUSSELS (*MYTILUS EDULIS*) IN FIVE POPULATIONS OVER A FIVE YEAR TIME PERIOD (FROM SEED, 1975)<sup>91</sup>

Mussel larvae could not be identified in the water that was removed from the sea chest. This result was expected since the end of January is not a month in which one would predict a large number of mussel larvae to be in seawater (see the background section on mussels in this report; see Figure 2).

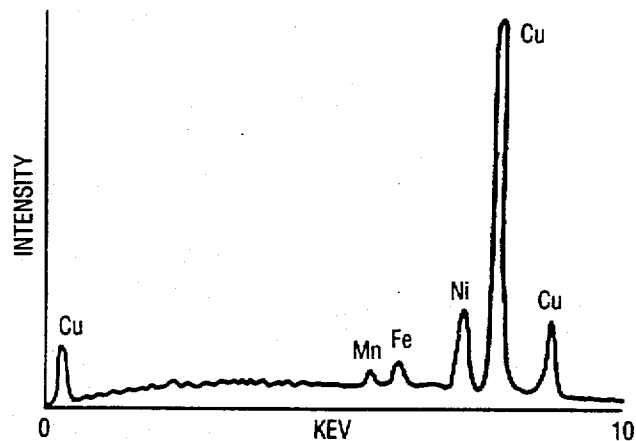
FIGURE 7. EDAX SPECTRUM FOR THE BASE METAL (90:10 COPPER-NICKEL) OF THE AFT MASKER COOLING DISCHARGE PIPING REMOVED FROM CG 59

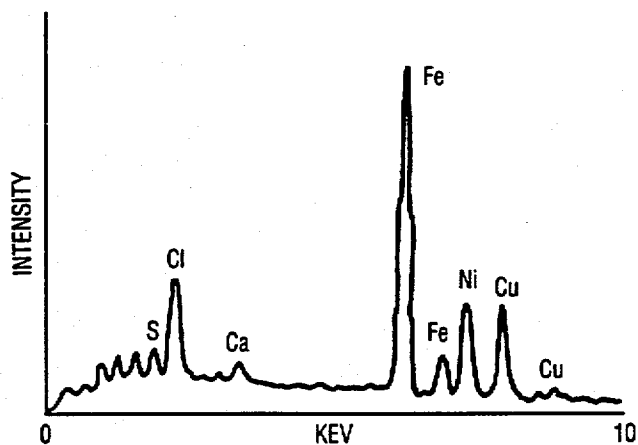
FIGURE 8. EDAX SPECTRUM WITHIN A PIT IN THE AFT MASKER COOLING DISCHARGE PIPING (90:10 COPPER-NICKEL) REMOVED FROM CG 59 SHOWED AN ENRICHMENT FOR IRON AND CHLORINE COMPARED TO THE BASE METAL

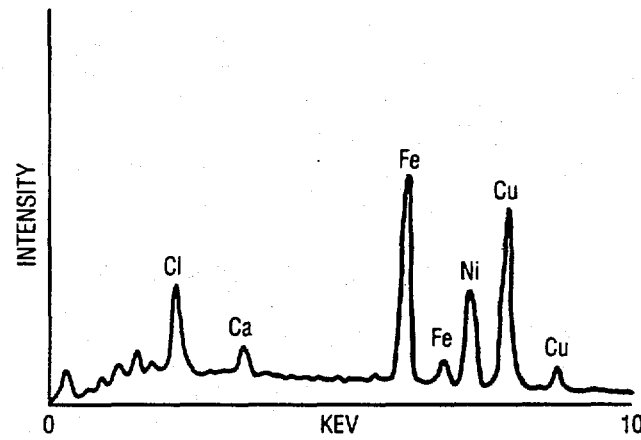
FIGURE 9. EDAX SPECTRUM FOR A BLACKENED AREA ON THE AFT MASKER COOLING DISCHARGE PIPING SHOWED HIGHER LEVELS OF IRON, NICKEL, CHLORINE AND CALCIUM COMPARED TO THE EDAX SPECTRUM FOR THE BASE ALLOY

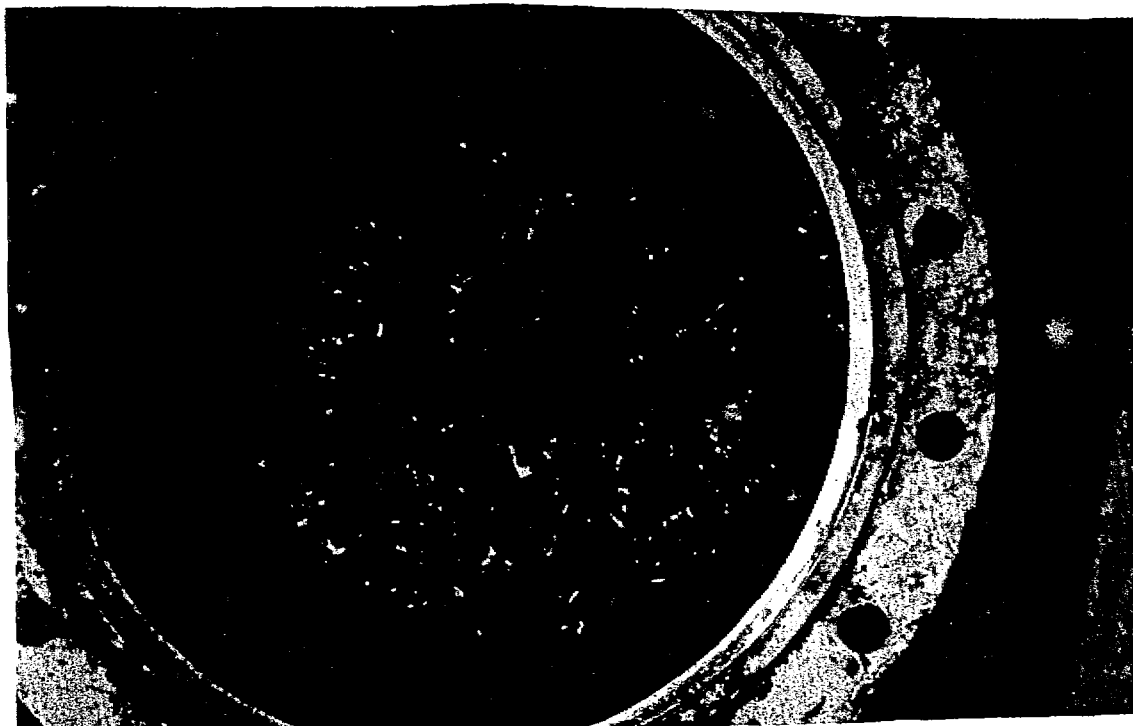
Mussel shell fouling (macrofouling) of the forward condensate drain cooler in MER-1 was observed (see Figures 10 and 11) during a NAVSSES shipboard investigation and pitting of tubes and tubesheet was visible after the macrofouling debris was removed (see Figure 12). Table 1 shows the sites from which macrofouling organisms and their fragments were removed. These macrofouling organisms were not directly attached to those substrata. Most of the biofouling was not alive at the time of removal. Instead the dead mussels, shell halves, shell fragments, hydroids and serpulids had been trapped in these locations. The mussels shown in Figure 13 were identified as Mytilus edulis by John DePalma (2408 Shadyside Lane, Picayune, MS 39466) and Dr. Marianne Walch (COMB). The mussel shells could be divided into four size classes indicating four age groups ranging from approximately two weeks old to two months old. Intact mussels were typically 8mm X 11mm, 11mm X 18mm, 15mm X 22mm and 17mm X 30mm. It is impossible to accurately determine the precise age of the mussels without specific information about the growth medium and habitat conditions. Some of the intact mussels were attached to other mussel shells to form long strings. The white spots on the shells indicate the former positions of byssus threads used to attach mussels to surfaces.

FIGURE 10. MACROFOULING DEBRIS OBSERVED IN THE INLET END BELL OF THE FORWARD CONDENSATE DRAIN COOLER IN MER-1 (FROM NAVSSES PUBLICATION 10310-1, MARCH 1990)<sup>1</sup>

The heavy macrofouling (from marine mussel shells/shell fragments and hydroids) and associated failures/corrosion problems in some of CG 59's seawater piping systems clearly show the importance of frequent cleaning of strainers and baskets, as well as, the need for a procedure that could reduce (control) the macrofouling in the sea chests/inlet piping. Biological systems respond very strongly to temperature. Marine organisms, possibly as a result of the relative stability of their natural environment, are extremely sensitive to temperature fluctuations. Relatively small increases in temperature cause significant mortality in Mytilus.<sup>64-68</sup> Efforts to use thermal control to inhibit Mytilus have been successful.<sup>34,64,65</sup> The following temperature-time requirements have been established for total kill of Mytilus: 106°F for 1 hour; 95°F for 7 hours; 82°F for 4 days and 77°F was completely ineffective for all durations evaluated. These early tests also demonstrated the synergistic effect of chlorine in this process.<sup>65</sup>

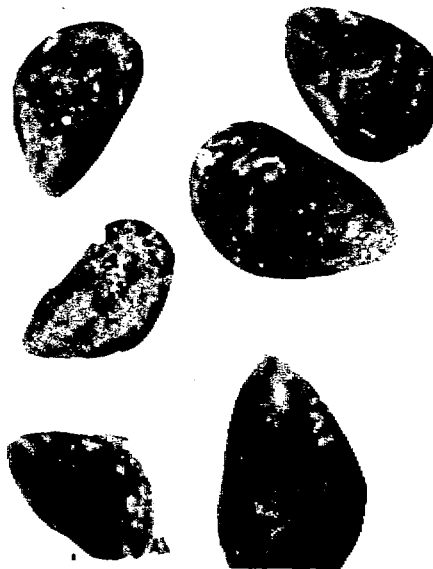
FIGURE 13. INTACT MARINE MUSSEL SHELLS, MYTILUS EDULIS, REMOVED FROM CG 59 SEAWATER PIPING SYSTEMS RANGED IN SIZE FROM APPROXIMATELY 8MM X 11MM (TWO WEEKS OLD) UP TO 17MM X 30MM (TWO MONTHS OLD)

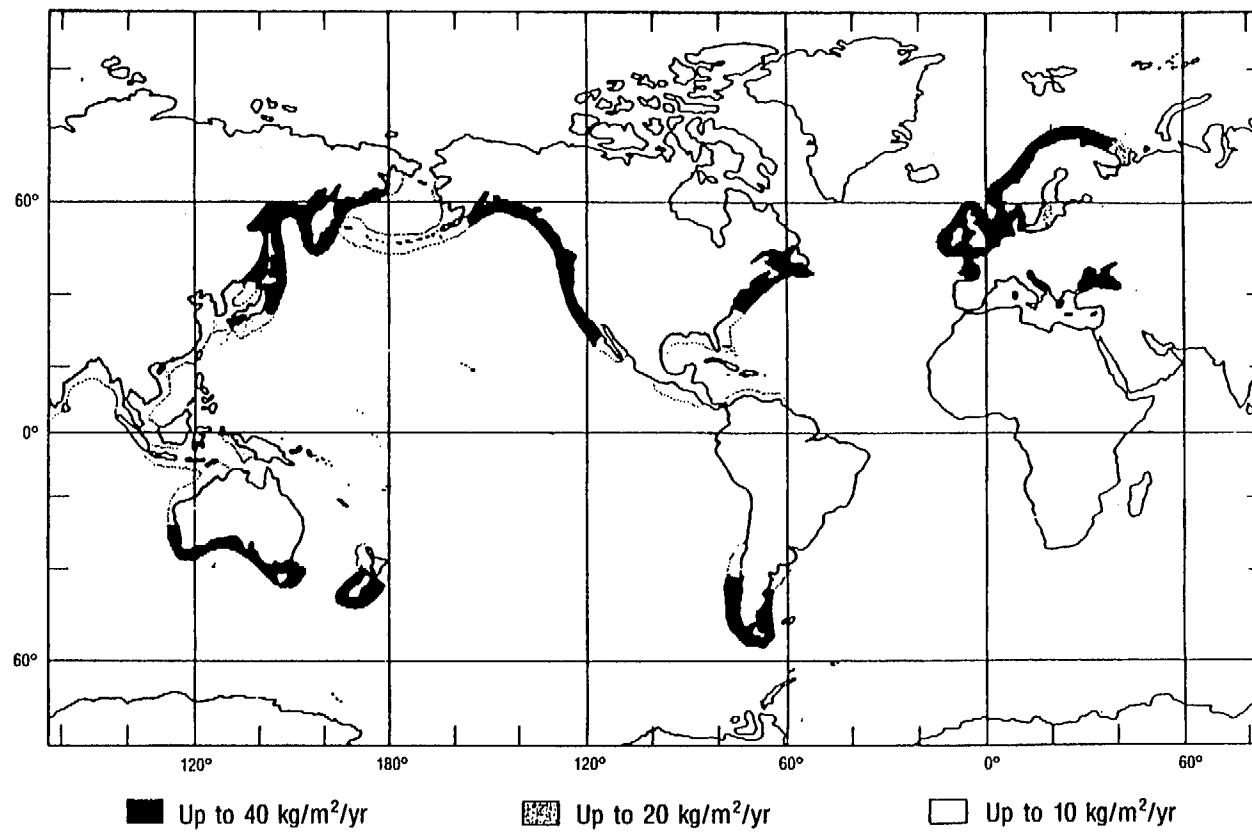
FIGURE 14. DISTRIBUTION OF MYTILUS MUSSEL BEDS SHOWN HERE INDICATES THAT MUSSEL FOULING CONDITIONS ARE MORE SEVERE IN HIGH AND MIDDLE LATITUDES WHERE THESE MUSSELS ARE THE DOMINANT FOULING SPECIES (FROM LITTLE AND DEPALMA, 1998)<sup>18</sup>

We would predict that without a control procedure for the biofouling described in this report, other failures/corrosion problems are likely in ships: (1) with seawater piping systems like CG 59 that are moored in regions (high and middle latitudes) where Mytilus mussels are the dominant fouling species, (2) that are anchored at times of the year for Mytilus spawning and (3) that are at mooring depths below the recommended navigational draft.

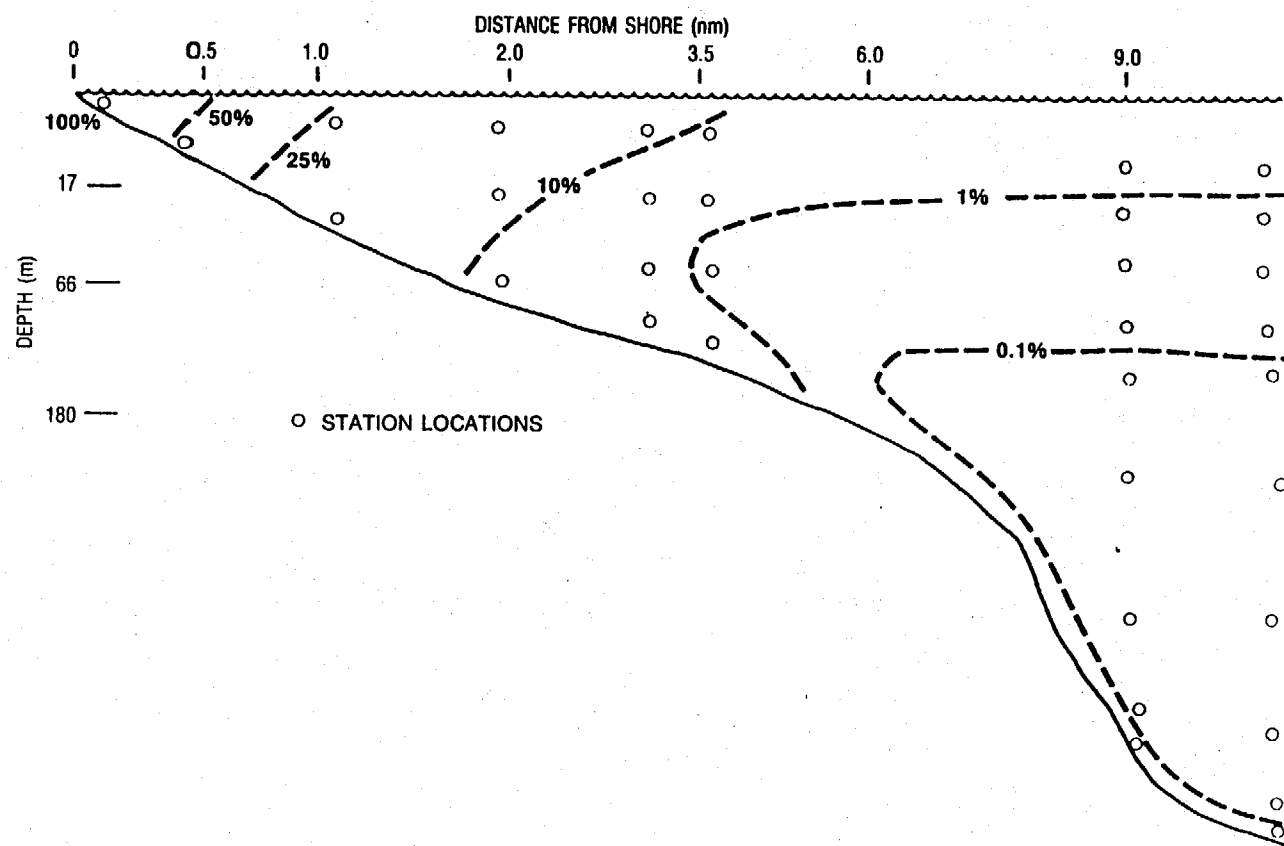
FIGURE 15. NUMBER OF MYTILUS MUSSELS THAT COULD CAUSE FOULING PROBLEMS DECREASES WITH THE DISTANCE FROM THE SHORE (FROM LITTLE AND DEPALMA, 1988)<sup>18</sup>

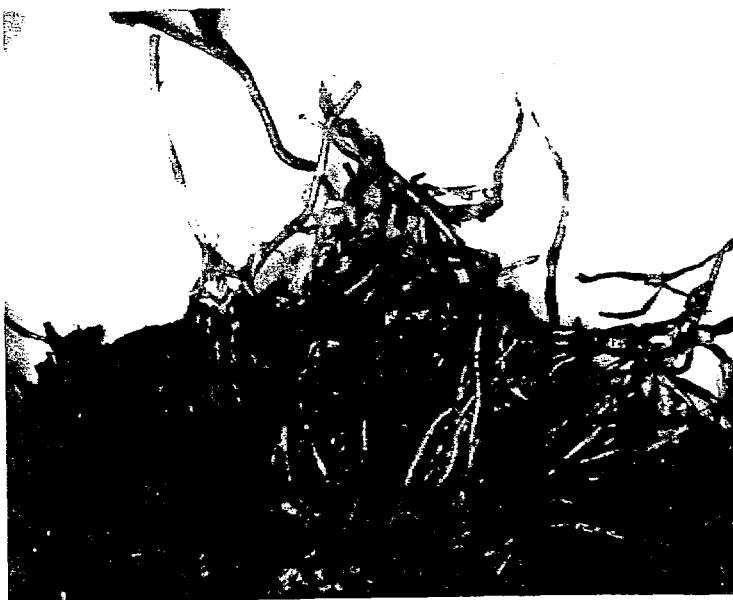
FIGURE 16. DENSE COLONIES OF HYDROIDS (ANIMALS) REMOVED FROM CG 59 SEAWATER PIPING SYSTEMS HAD THE APPEARANCE OF SEAWEED; COPPER (FROM THE COPPER-NICKEL SEAWATER PIPING) GIVES THE HYDROIDS A GREEN COLOR

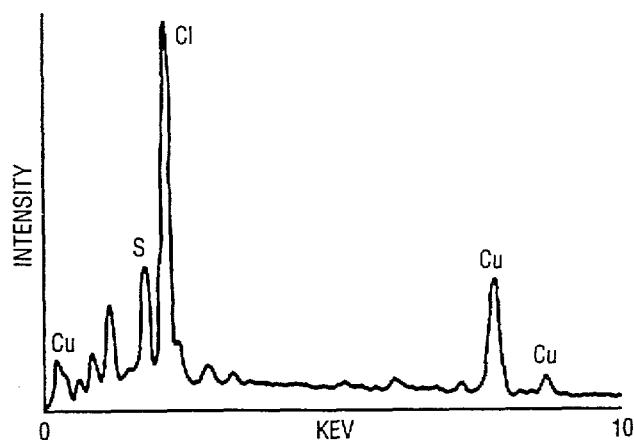
FIGURE 17. EDAX SPECTRUM OF THE HYDROIDS REMOVED FROM CG 59 SEAWATER PIPING SYSTEMS SHOWED LARGE AMOUNTS OF CHLORINE, COPPER AND SULFUR
