AFRL-RX-WP-TP-2008-4043

**DETECTION OF INCIPIENT THERMAL DAMAGE IN
POLYMER MATRIX COMPOSITES (PREPRINT)**

13. SUPPLEMENTARY NOTES Conference paper submitted to the Proceedings of the 2007 Society for Advanced Materials and Processing Engineering (SAMPE) Conference. The U.S. Government is joint author of this work and has the right to use, modify, reproduce, release, perform, display, or disclose the work. PAO Case Number: AFRL/WS 07-0418, 25 Jan 2007.

DETECTION OF INCIPIENT THERMAL DAMAGE IN POLYMER MATRIX COMPOSITES

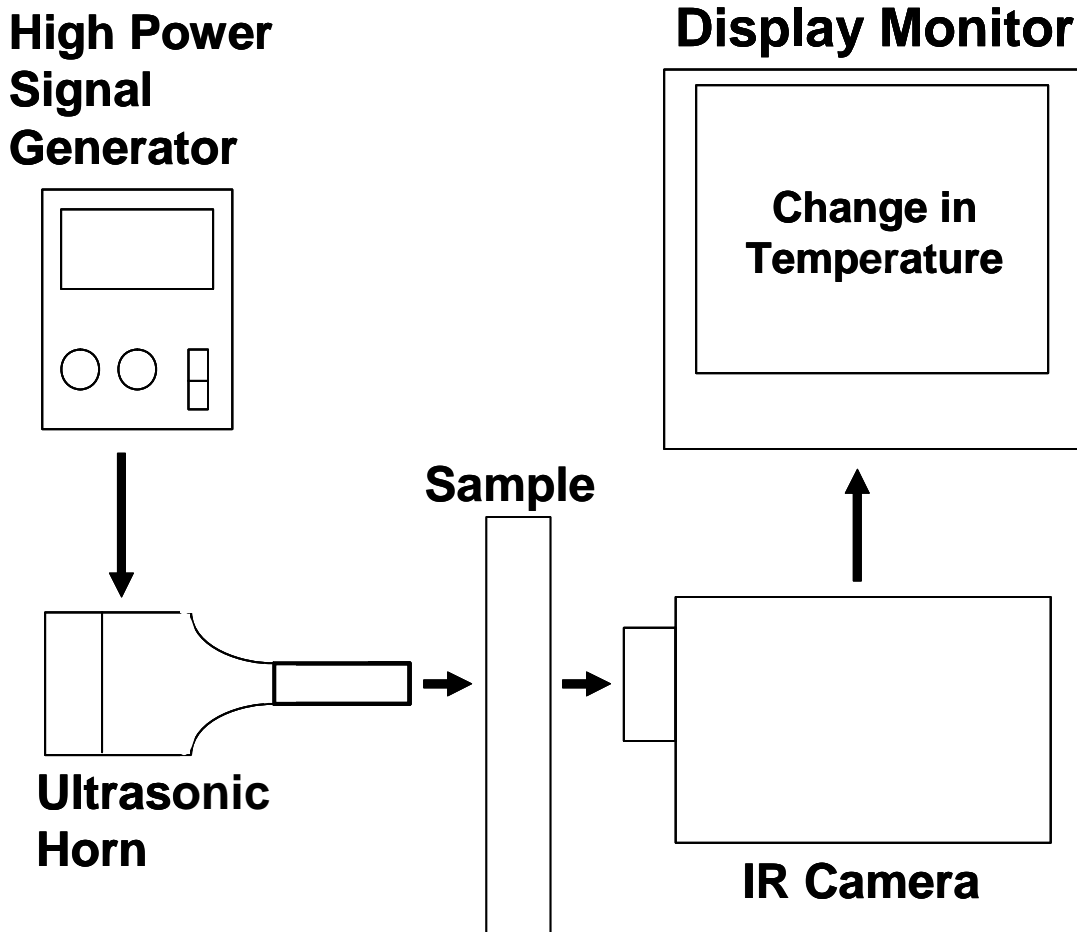
Figure 1. Schematic of experimental instrumentation used to measure the temperature changes in the samples as a function of excitation power before and after thermal damage.

A schematic of the instrumentation used for the thermo-elastic measurements is shown in Figure 1. The ultrasonic signal is transmitted into the sample using a 20 kHz ultrasonic horn. Note that the horn does not directly touch the sample, but is placed in close proximity to the sample surface. Thus, this signal is air-coupled to the sample, which eliminates any risk that the horn vibrations could generate damage in the composite sample. The ultrasonic signal locally heats the composite through thermo-elastic absorption. The temperature change in the sample is measured using a Merlin Mid infrared camera that has a sensitivity of 0.025°C. The camera is located on the opposite surface from the ultrasonic horn to measure the volumetric heating of the sample due to the thermo-elastic dampening. The temperature measurements for this study are relative and therefore the emissivity effects are cancelled. To perform out-of-plane displacement measurements, a fiber optic displacement sensor was used. The sensor replaced the infrared camera in the schematic shown in Figure 1. Environmental noise in the displacement sensor output was filtered using a high pass filter, which consisted of a low-noise pre-amplifier set with a gain of one. The amplitude of the displacement is measured using a digital oscilloscope.

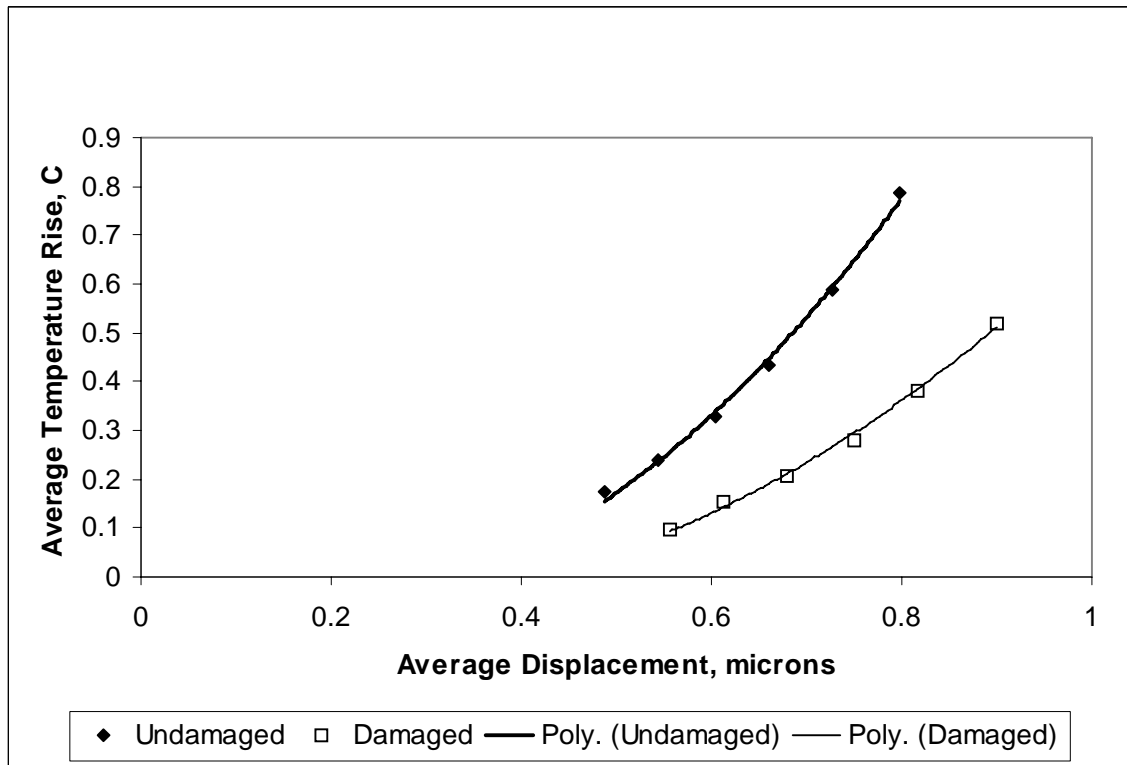
Figure 3. Plot of the average temperature rise as a function of sample displacement for six power levels of the ultrasonic horn for the sample exposed to 274°C for 20 minutes.

For the thermo-elastic measurements, the fifteen data points for each power level of the ultrasonic horn were averaged for the measured displacement of the sample surface and the temperature rise relative to the temperature before the application of the ultrasonic energy. The average temperature rise is plotted as a function of displacement for the six power levels. The results of plotting these data for the undamaged state and for the sample exposed to 20 minutes of elevated temperature are shown in Figure 3. Note that the temperature rise is less for the damaged sample when compared to the undamaged sample, whereas the magnitude of the displacement is greater for the damaged sample. This implies that the incipient thermal damage has generated a change in the matrix and/or matrix/fiber interface that allows more energy from the ultrasonic horn to be transmitted through the sample as less energy is being absorbed and converted to thermal energy by the damaged composite. Additional analysis is required to determine the degradation mechanism that correlates the decrease in interlaminar shear strength with the observed changes in the thermo-elastic behavior of the PMC.

The curves shown in Figure 3, which are fitted to the experimental data, are quadratic. The change in the coefficients between the undamaged and damaged state for this graph is 43 percent. For the sample exposed to the same temperature for 10 minutes, the change in the coefficient was 29 percent. These results confirm the feasibility of using the change in the coefficients as a method to determine the severity of the incipient thermal damage present in PMC's. Additional
