# **Operational Evaluation Test of Mine Clearing Cultivator and Mine Clearing Sifter**

**January 2005**

Institute for Defense Analyses  
4850 Mark Center Drive  
Alexandria, VA 22311-1882

**Humanitarian Demining Research  
and Development Program**  
Night Vision and Electronic Sensors Directorate  
10221 Burbeck Road, Suite 430  
Fort Belvoir, VA 22060

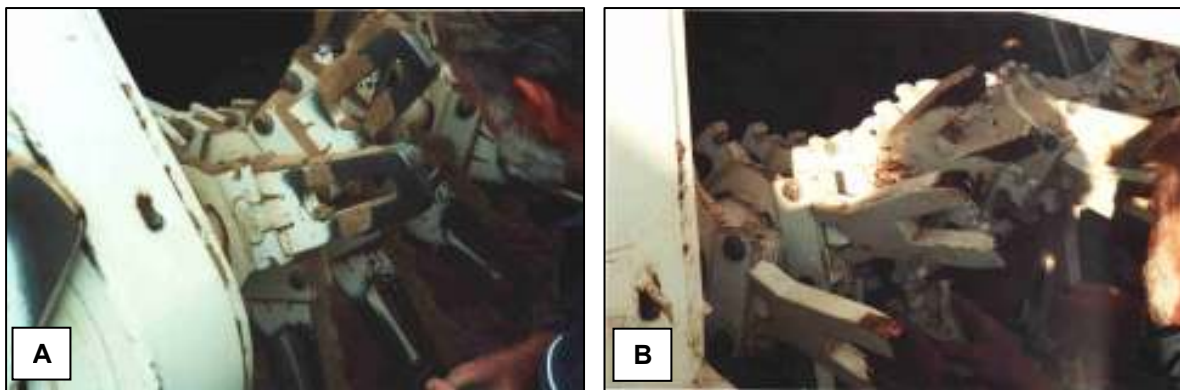
**Figure 6: MCC Auger Fingers: Straight (A) and Twisted (B)**

Two auger finger designs, straight and twisted, were tested to determine which design most efficiently moved surfaced mines out of the cultivator for different types of soil. During minefield tests in sandy loam and sandy clay soils, straight fingers were used very effectively. However, this was not the case in cultivating the minefield in sand. The twisted auger fingers proved to be more effective in sand. The reasons for this are discussed later in the report.

Two MCC auger configurations were used during the standardized tests. At Test Sites 1 and 2, in heavier soils with some moisture retention, the auger was used with straight fingers. At Test Site 3, the auger was used with twisted fingers. The reason for this configuration change is as follows. In heavier soils (other than predominately sand soils), sufficient amounts of soil are pushed forward of the auger thereby causing the soil to flow toward the discharge end of the auger. The movement of the soil influences the

direction in which mines reaching the auger tend to move. In sand, however, the straight fingers tend to cut through the sand as a knife would through water, thereby not causing the sand to flow in an outward direction. As a result, it was found that mines, which were normally moved by one finger at a time, would bounce along in a straight line in front of the auger, and without the added influence of outward flowing soil, would stay in the auger's working area. This situation was corrected by replacing the straight fingers with twisted fingers, which started the sand in front of the auger to flow in an outward direction. This, in turn, influenced the outward movement of the mines (see Figure 6 on page 5).

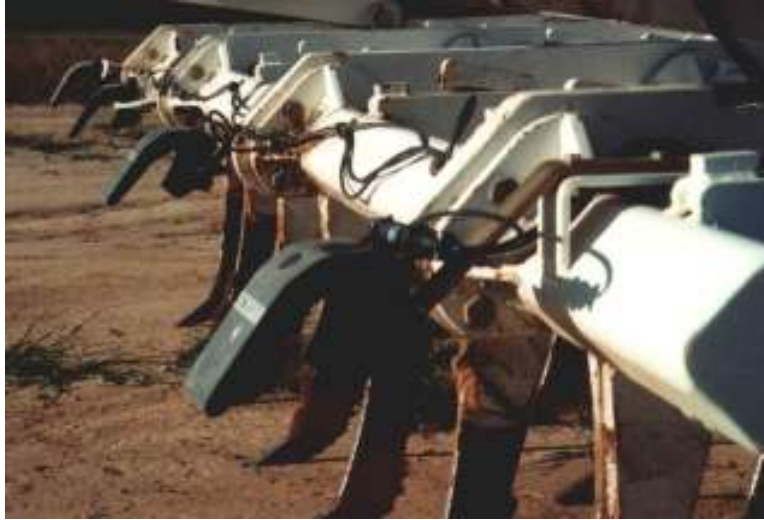
**Figure 7: Depth Sensors**

Figure 7 shows the depth sensors mounted on the front edge of the cultivator. Their purpose is to automatically control the operating depth of the cultivator tines by maintaining a constant distance above the ground.

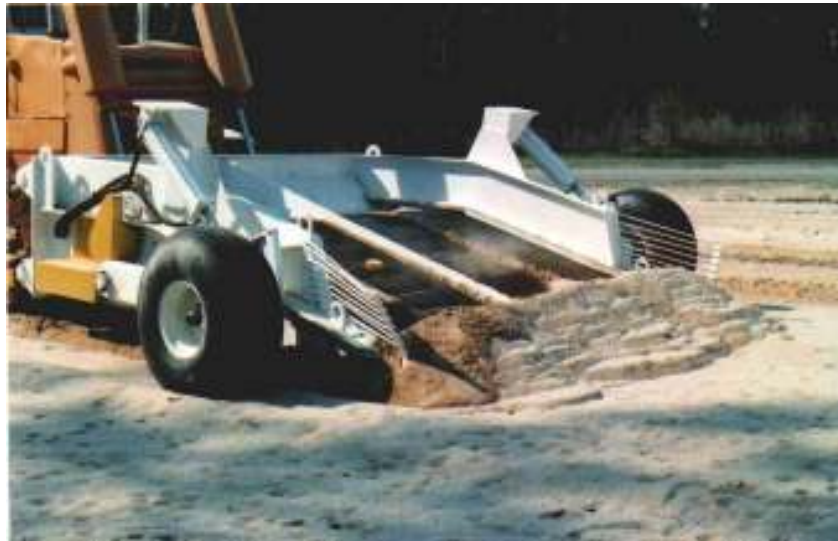
**Figure 8: Mine Clearing Sifter**

The Mine Clearing Sifter (MCS), manufactured by the Reliance Corporation, is identical to the Heartlands Sifter tested by NVESD in 2002. (The report on the 2002 test of the Sifter is presented in Appendix A). The sifter, an off-the-shelf agricultural machine, is used to remove land mines from the soil by the sifting action of two steel-bar conveyor belts and a discharge conveyor belt that deposits the mines in windrows off to the side of the sifter and prime mover. The discharge belt drive mechanism allows selecting the side of discharge.

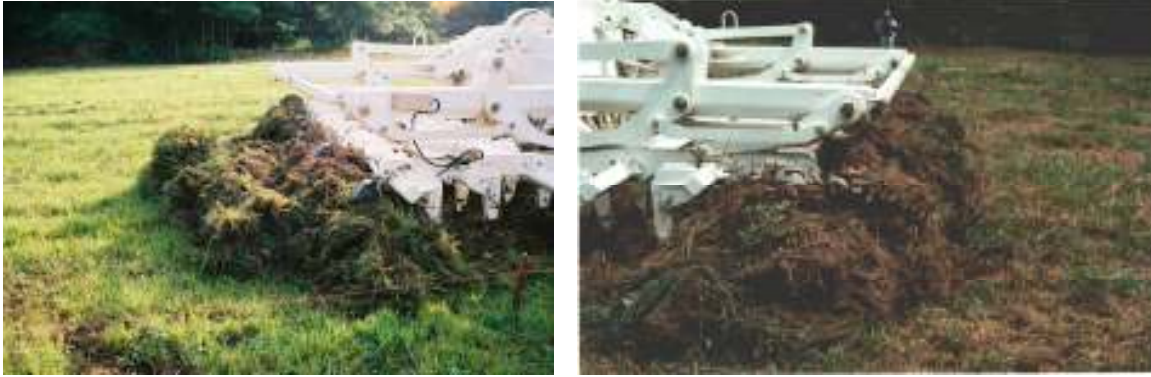
**Figure 22: Sod Build-up In Front and Within the Cultivator's Tines**

It was during this test that the problem with sod build-up in the cultivator was encountered. As the tines of the cultivator went through the soil, they picked up the grass including the topsoil and the root system underneath. In addition, the moist soil tended to clump and bind with the sod. This sod and soil build-up within the tines prevented the mines from passing between the tines and reaching the auger. At a couple of points during the test, the build-up became so great that the prime mover lost traction and could no longer make forward progress with the cultivator. The cultivator then had to be lifted out of the ground, sod and dirt removed from the tines, the tractor backed up at least 5 meters, and the cultivator reinserted into the soil to continue the operation. It was during the reinsertion of the cultivator into a lane that some mines were stabbed or activated. The sod build-up also resulted in a very large end-berm that had to be cleared of mines by hand after scanning with a metal detector.

The expectations for this test were reduced after the results of the standardized testing of the cultivator in sod-covered soil. The test was started but it was found that the soil and sod build-up in the cultivator was so extensive that it adversely affected the operational usefulness of the equipment. The problem was the combination of long grass, its soil-holding root system, and soil moisture content which caused a heavy build-up of soil and sod both in front of and within the tines of the cultivator (see Figure 22). The build-up in front of the cultivator negated the functioning of the depth sensors to maintain the cultivator's operating depth. The weight and volume of the sod and soil build-up in front and within the cultivator became so great that, at times, the tractor was not able to move. The test was stopped after one and a half passes into the minefield. While some performance data was recorded, it was not statistically significant and no valid quantitative conclusions could be drawn. This portion of the test was halted and the mines removed from the minefield.

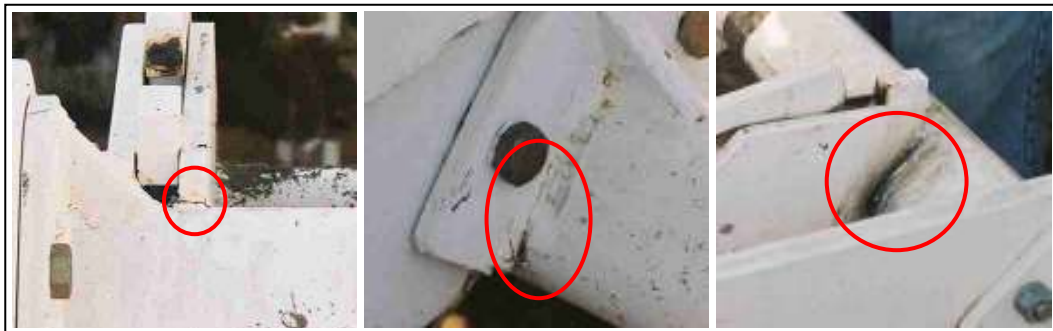
**Figure 23: Cracks Found on the MCC**

1. During a routine inspection of the tines of the MCC after the trials at Test Site 1, cracks were found along the welds between the connecting bar and the tines (see Figure 23). A welding unit was brought in and the cracks were fixed within an hour. The remainder of the test was completed with no new cracks developing.

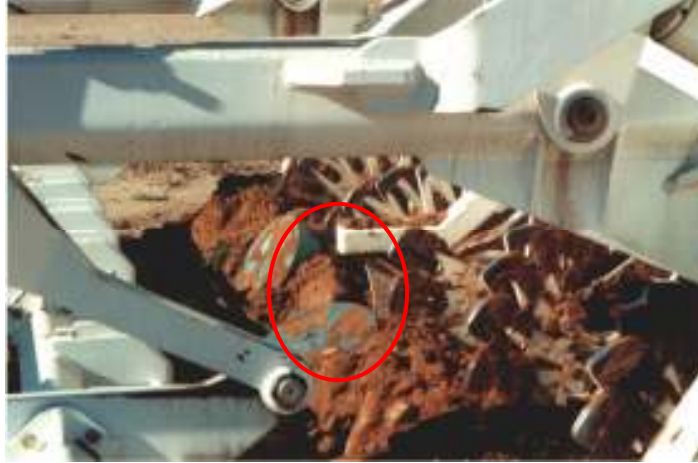
**Figure 25: Mine Caught Under Center Bar**

- Center fingers in the middle of the auger combined with the presence of the center structural bar (see Figure 25 below) tend to roll mines forward instead of to the side and out the auger. Redesign of the center left and right auger fingers and the structural center bar should induce a mine coming into the very center of the auger to move to one of the sides.

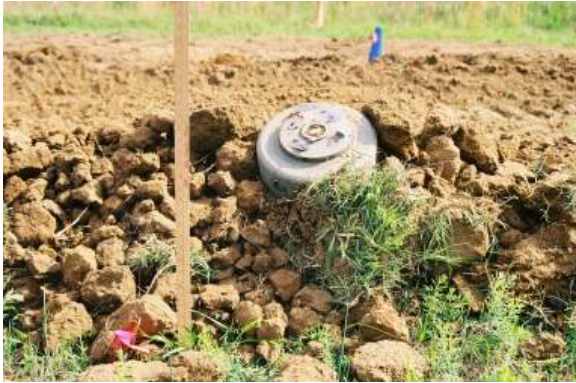
**Figure A-19:**  
**Mine Deposited in Berm**

In both heavy and light clay soils, the HLS left large windrows, where the targets were either partially or totally reburied under the clumps of soil. For actual demining operations, another mechanical system or deminers with metal detectors will have to follow the HLS to find and remove these reburied targets from the berms. In all soil conditions, a soil bow wave formed on the front scoop during operations through which mines entering the sifter had to pass. When the dirt bow wave was removed from the sifter at the end of each lane, an end-berm was formed. Since the end berm could also contain mines, it also must be treated mechanically or by deminers with metal detectors to removes any remaining mines.

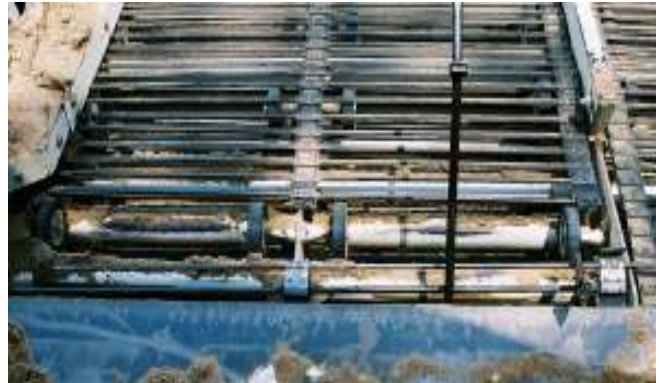
The only damage to the HLS that required major repair occurred at the beginning of the test period, during the start of the second run. The left sprocket chain and the right main sifting web broke. The repair took about half a day once the parts arrived. The HLS performed well for the rest of the testing period.

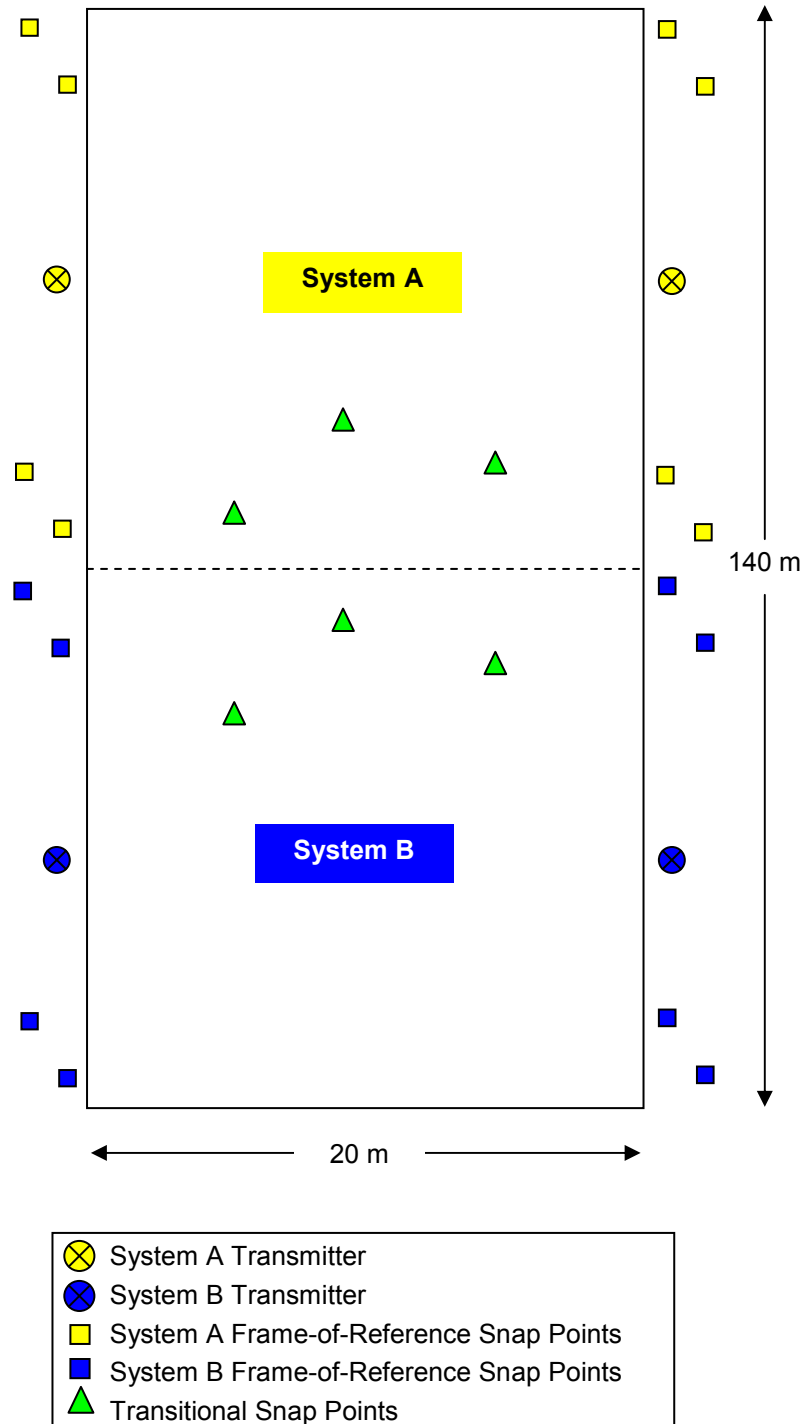
**Figure B-1: VLPS Field Coverage and Snap Point Setup**

Though the test area was covered by two VLPSs, it was imperative that location measurements of all mines in the minefield be made relative to a single starting point. To establish this chosen origin, the field was set up using transitional snap points located in the middle of the field in an area covered by both sets of transmitters. Once the VLPSs were coordinated, frame-of-reference snap points were established with each half of the field having two frame-of-reference snap points near each corner (see Figure B-1). These frame-of-reference snap points were used to relocate both systems to their original positions on subsequent testing days.
