**CREEP-RUPTURE AND FATIGUE BEHAVIOR OF A NOTCHED  
OXIDE/OXIDE CERAMIC MATRIX COMPOSITE AT ELEVATED  
TEMPERATURE**

THESIS

Barth H. Boyer, Lieutenant Commander, USN  
AFIT/GAE/ENY/08-J01

**AIR FORCE INSTITUTE OF TECHNOLOGY**

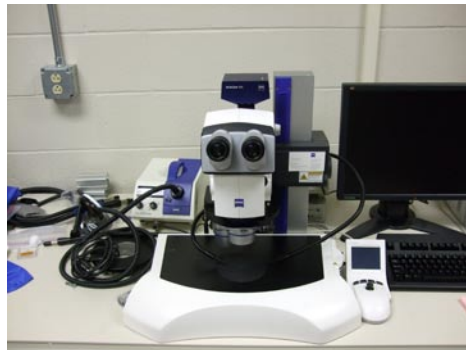
**Figure 15. Zeiss Discovery V12 optical microscope**

Specimen fracture regions were imaged using a Scanning Electron Microscope (SEM) as well as an optical microscope. The SEM employed in this research was the FEI Quanta 200 and the optical microscope was the Zeiss Discovery V12 with an attached Zeiss Axiocam HRC.

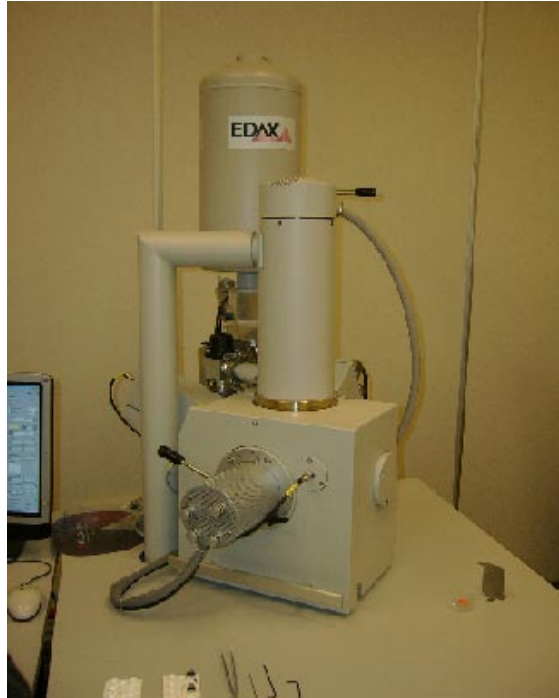
**Figure 16. Quanta 200 SEM**

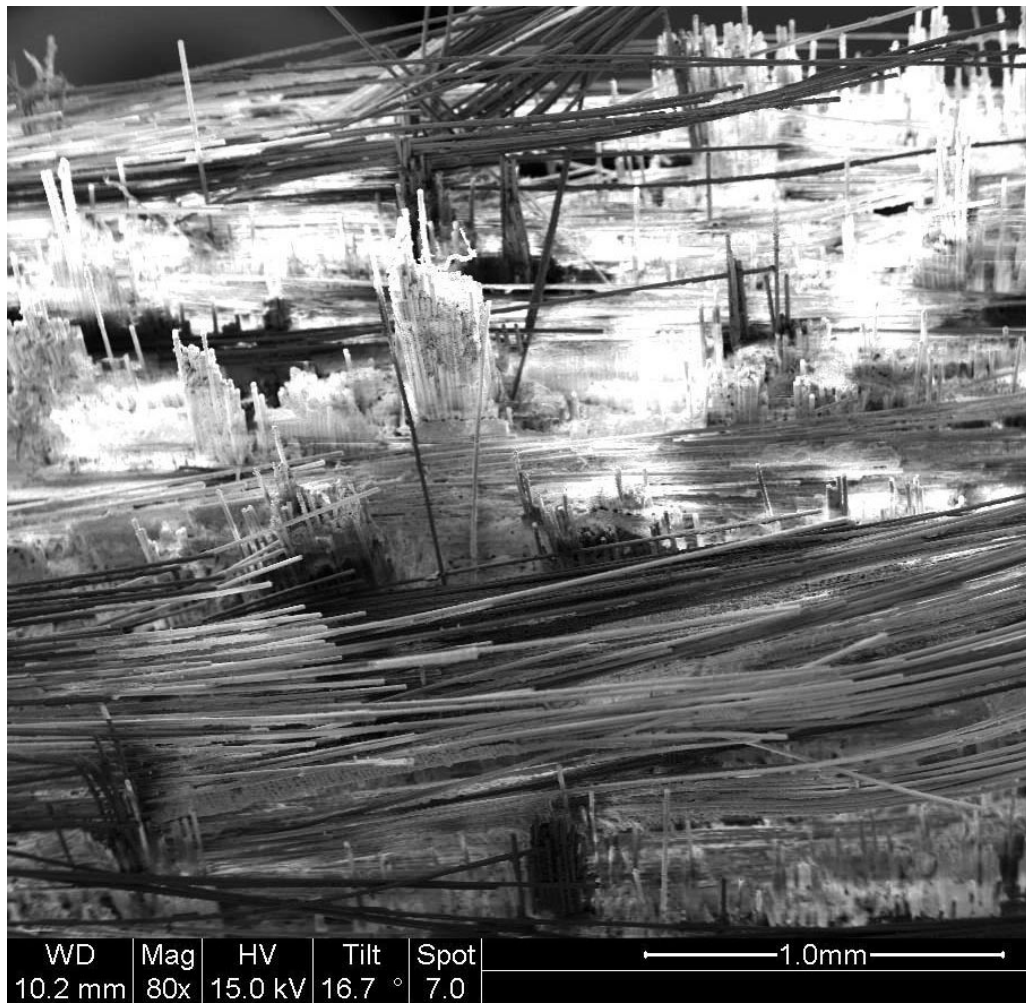
**Figure 59. Individual and Bundle Fiber Pullout, 175 MPa Creep (middle)**

Stress dissipation was caused by the 0° fibers deflecting stress into the 90° fibers. This was facilitated by the matrix porosity and allowed for some crack bridging to occur. In areas where greater matrix cracking was observed, more individual fiber pullout was also observed. However, when the matrix remained tightly bonded, this prevented individual 0° fibers from pulling out singly but instead pulling out as bundles (see Figures 59 and 60). This pulled-out bundle then would fracture across the transverse plane. Level areas of planar fracture could also be seen in regions where the 0° fibers did not develop any microcracking (see Figure 61).

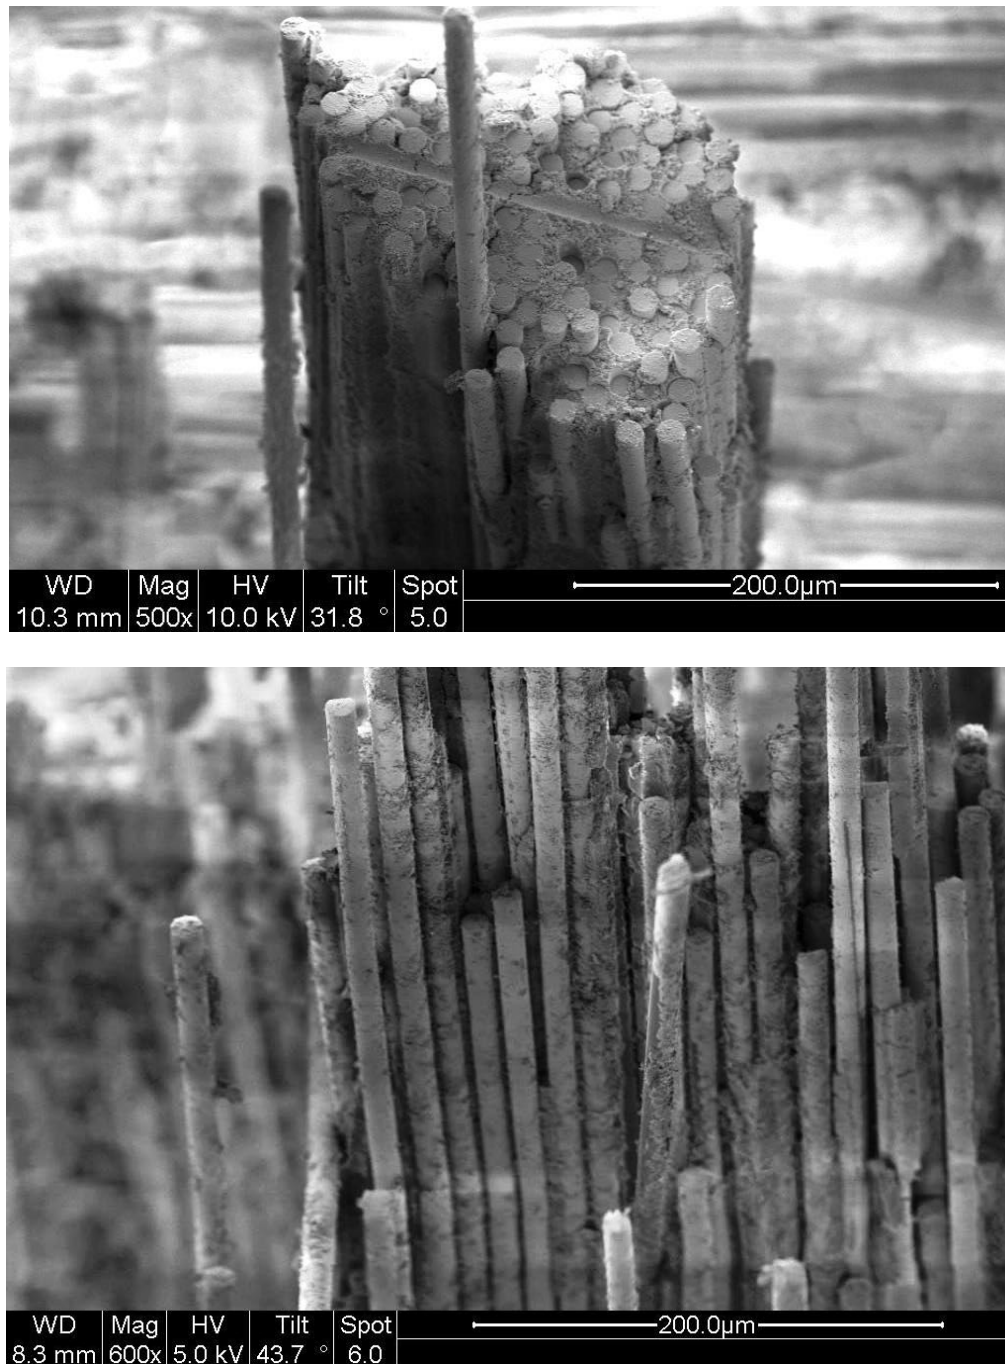
**Figure 63. 0° Bundles**  
Top: 100 MPa Creep (center)  
Bottom: 152.5 MPa Fatigue, (center)
