# **SPALL REPAIR TEST AND EVALUATION (BRIEFING SLIDES)**

**Michael I. Hammons, PhD, PE**

This briefing was presented to the Airfield Damage Repair Working Group on 27 August 2008 at Tyndall Air Force Base, Florida.

**AIRBASE TECHNOLOGIES DIVISION  
MATERIALS AND MANUFACTURING DIRECTORATE  
AIR FORCE RESEARCH LABORATORY  
AIR FORCE MATERIEL COMMAND  
139 BARNES DRIVE, SUITE 2  
TYNDALL AIR FORCE BASE, FL 32403-5323**

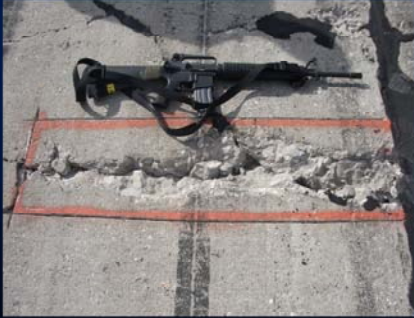
- Cracked, fractured, chipped-out pavement
- Contributes to FOD and roughness
- Repairs usually partial depth (<1/3 pavement depth)
- Need materials, equipment, and procedures to rapidly repair spalls with minimum impact on ops tempo

Spalling describes cracking, breaking, chipping, or fraying of a concrete slab near a joint or crack. Spalls may be partial or full depth. In the case of both full- and partial-depth spalls, foreign object debris (FOD) may be generated, and the rough surfaces at the spall may damage aircraft tires. Full-depth spalls reduce the structural capacity of the slab and exacerbate fatigue failure under repeated loading.

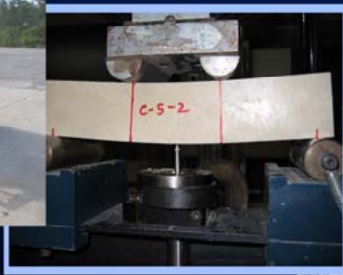
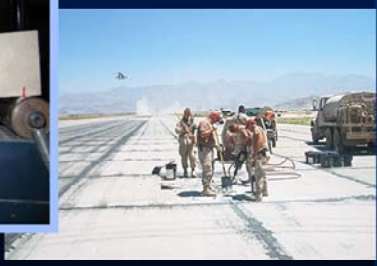
- Adopt optimal spall preparation techniques and equipment
- Select optimal spall repair materials
- Predict spall repair performance

The objectives of this research are to adopt optimal spall preparation techniques and equipment, select optimal spall repair materials, and to predict spall repair performance. Because airfield operations are negatively impacted during the process of performing spall repairs, the time required to perform spall repairs is critical to maintaining the flying mission. The impact of the spall repair process on aircraft operations can vary by degree, ranging from an inconvenience to the complete suspension of flight operations.

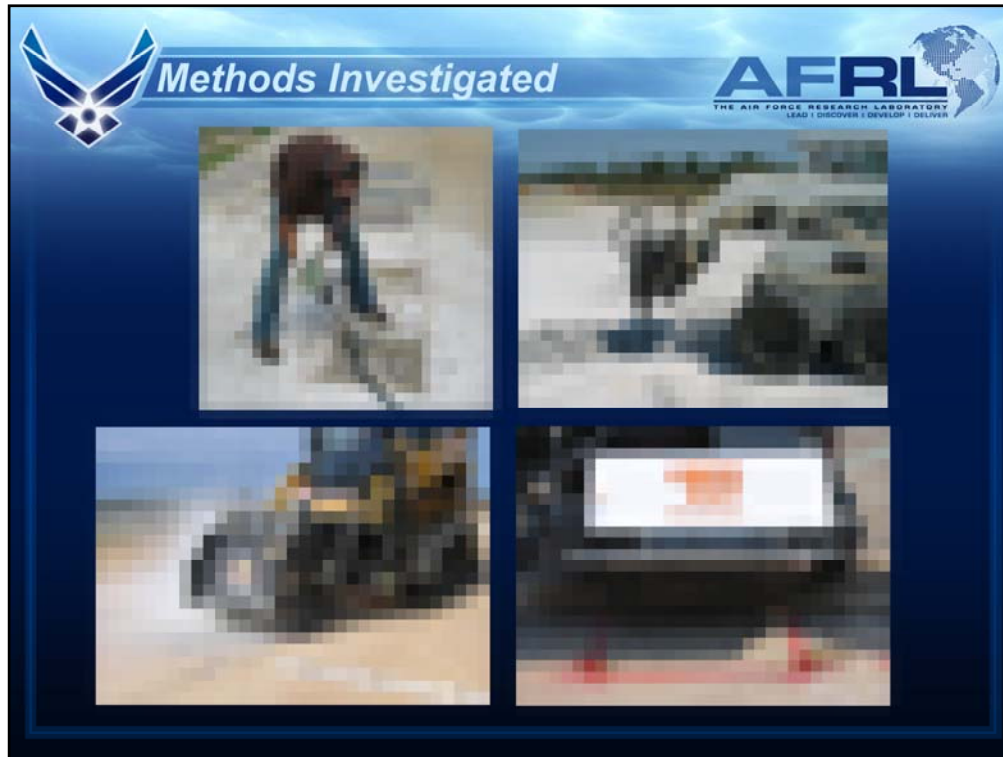
The common method to remove material from a spall repair is to use a portable pneumatic jackhammer as shown in Figure 6. ACI RAP Bulletin 7 recommends that jackhammers larger than 30 lbs not be used, because they may cause damage to the surrounding concrete. For this experiment a 2 ft by 2 ft area was cut using a walk-behind saw to a depth of approximately 4 inches. The concrete inside the cut was removed with a 30-lb pneumatic jackhammer. A nail-point breaker tip was used to break up the concrete, and a spade tip was used to dress the repair area. Final clean up was performed by shoveling the rubble in to a loader bucket, sweeping around the hole, and vacuuming the fines from the hole.

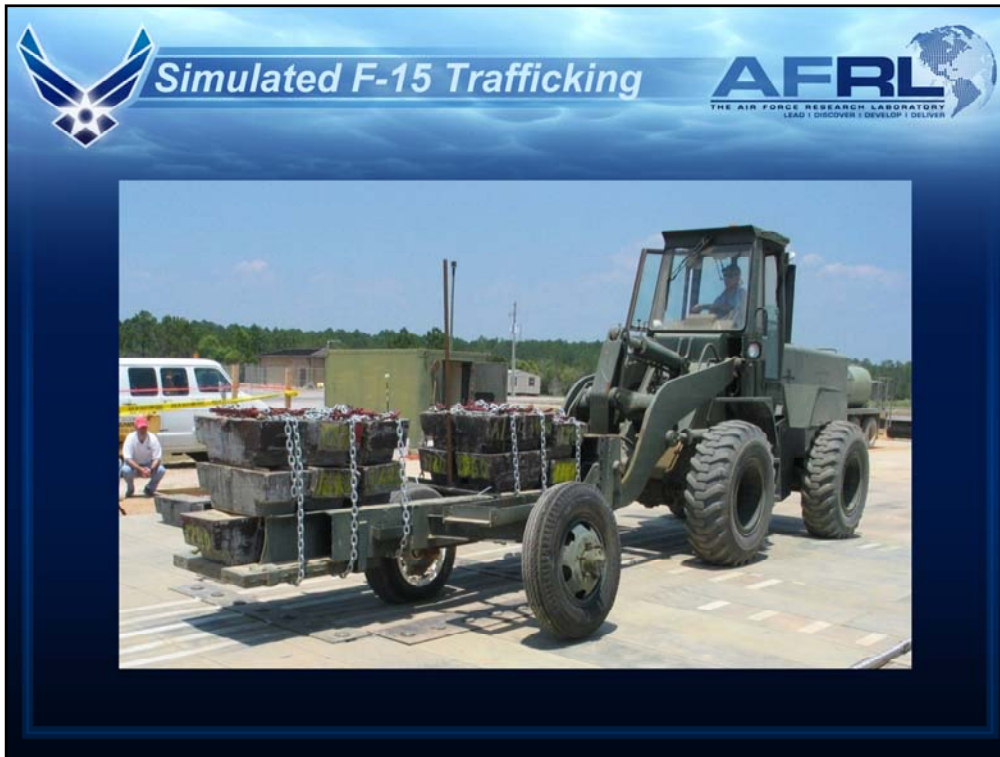
Each of the replicates and treatments were subjected 1500 passes of simulated F-15E tire traffic using AFRL's F-15 load cart. During the conduct of the testing, no cracking, spalling, or any other type FOD-creating distresses were observed. During the testing, the spall repairs were sounded with a small hammer in an attempt to detect delamination or debonding of the repair from the substrate. As the testing progressed, the technicians observed a hollow-sounding thud from the hammer blows, which interpreted as delamination. However, post-trafficking evaluations revealed this not to be the case, as the spall repair material remained bonded to the substrate.
