CREEP BEHAVIOR OF OXIDE/OXIDE COMPOSITES  
WITH MONAZITE FIBER COATING  
AT 1100 °C IN AIR AND IN STEAM ENVIRONMENTS

THESIS

AFIT/GA/ENY/08-S01

***AIR FORCE INSTITUTE OF TECHNOLOGY***

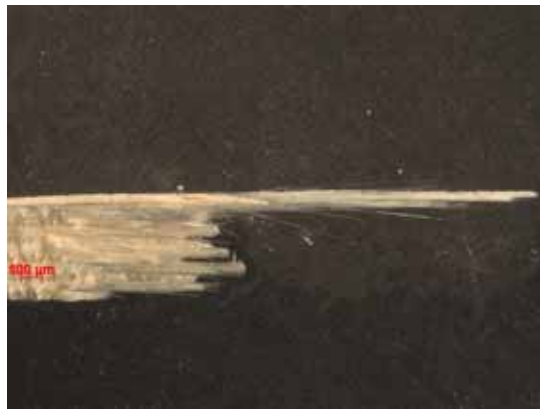
Figure B.61: Fracture surface of the N610/LaPO<sub>4</sub>/Al<sub>2</sub>O<sub>3</sub> specimen with 10ply 0°/90° uni-tape lay-up subjected to creep test at 85 MPa in air at 1100 °C ( $t_f = 16.2$  h).

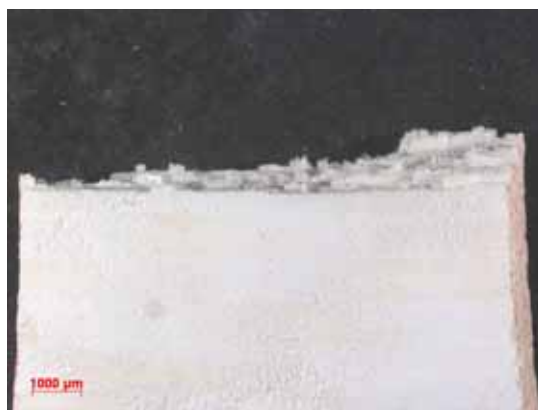
Figure B.215: Fracture surface of the N610/LaPO<sub>4</sub>/Al<sub>2</sub>O<sub>3</sub>-AlOCl specimen with 8ply HSW subjected subjected to creep test at 32 MPa in air at 1100 °C ( $t_f > 100$  h).
