REPORT NO: NAWCADPAX/TR-2008/9

### **ANALYSIS AND TESTING OF FLEET CORRODED F/A-18C/D ARRESTMENT SHANKS**

**20 June 2008**

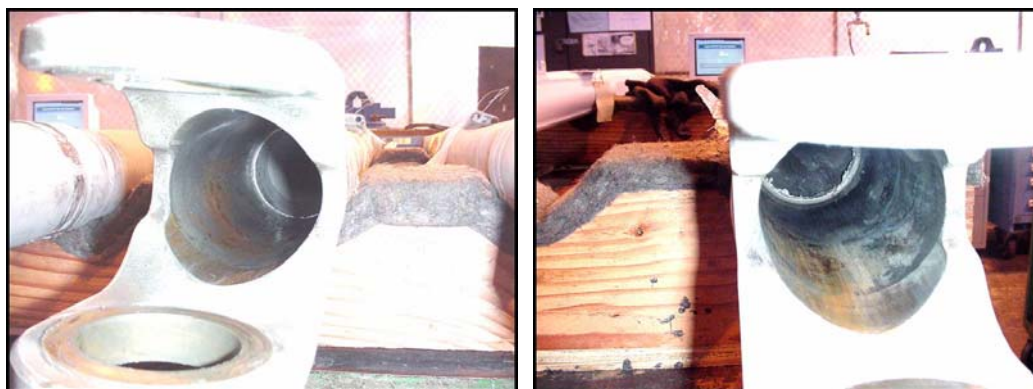
Figure 1: Examples of Corrosion Found in the Damper Sleeve Region

Prior to cleaning the shanks, acetate replicas were made in small spots within corroded regions of the interior lateral damper sleeve regions to extract corrosion by-products from the surfaces. The corroded regions looked discolored with small amounts of thin red rust. Examples of what the regions of interest looked like upon receipt are shown in figure 1. Miniscule samples of oxide solids were removed on several acetate replicas. The solids were examined using x-ray spectroscopy techniques and found to contain oxides of several of the base metal constituents. Details of the oxide analysis can be found in appendix A.

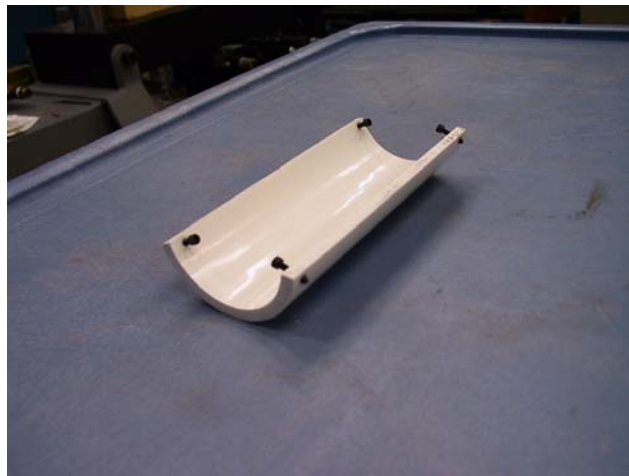
Cut PVC pipe into 6 in. lengths, then cut lengthwise to produce pieces of about 145 deg arc. This will create enough overlap to allow the entire ID of the shank to be replicated with three molds. Near the ends of the PVC pieces, and as close to the edges as possible, drill and tap four holes for #4-40 screws. (Since these tapped holes will only get used once a larger drill bit than specified can be used. This makes it easier to thread the screws in by hand and to adjust their depth.) See figure C-1 for a photo of a PVC section ready to be used for replication of the shank. Roughen the outer surface of the PVC with sandpaper to help the replica material adhere to the PVC. File down sharp edges and wipe the pieces off thoroughly to prevent foreign material from getting onto the molded surface.

Figure C-1: Photo of a PVC section that has been prepared for replication of the shank

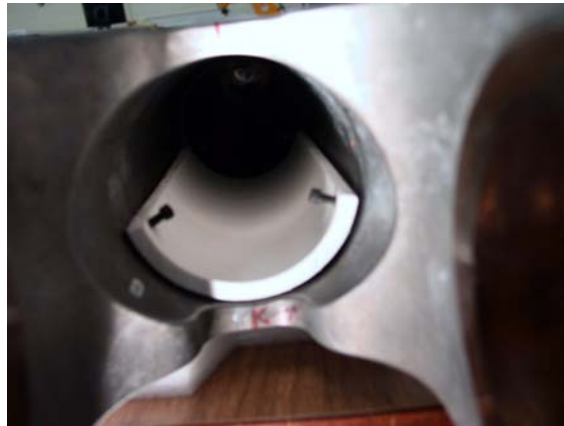
Insert screws into a piece of PVC pipe and adjust the depth of the screws to allow approximately 3/32 in. between the shank and the PVC when it is put in place. Be careful when inserting and removing the PVC from the shank not to scratch the surface of the shank. Figure C-2 illustrates how the PVC section should look when in place inside the shank.

Figure C-2: Photo of a PVC section inserted into place within the shank

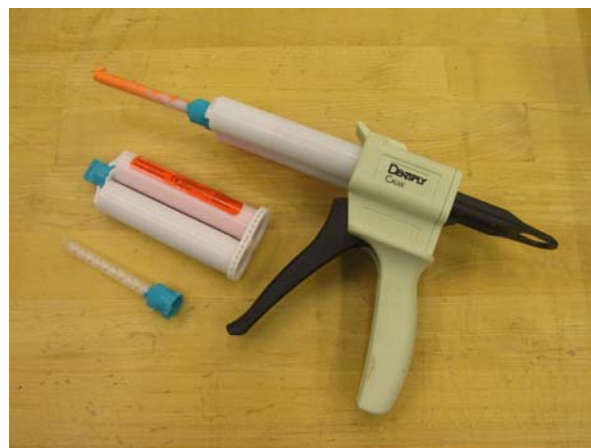
Install a cartridge of Aquasil Ultra XLV in the application gun, remove the cap, and install a mixing nozzle on the cartridge. A photograph of the loaded application gun is shown in figure C-3.

Figure C-3: Photo of an application gun with Aquasil Ultra cartridge and mixing tube

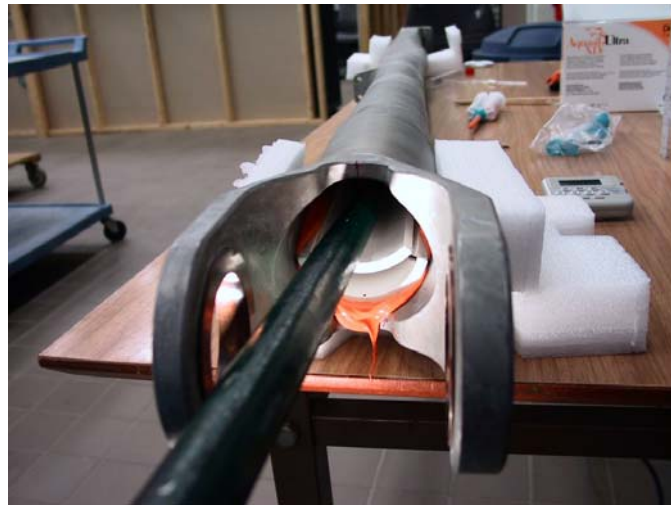
Once mixed, the working time of the Aquasil is only 2 min and 15 sec so the next steps must be performed as quickly as possible. Squeeze the Aquasil onto the surface to be replicated, trying to spread it fairly evenly. Use the entire cartridge to ensure adequate coverage. Place the PVC over the Aquasil with the PVC roughly centered on the alignment mark on the shank. Press the PVC into the Aquasil by hand. The PVC will tend to float on the Aquasil so care must be taken to prevent the PVC from sliding very far either front-to-back or side-to-side. Place the smaller piece of PVC so that it rests on the screw heads. (If the weight is placed directly on the PVC mold backing, it can flex enough to bottom out on the surface of the shank. The smaller piece of PVC transfers the weight directly through the screws.) Support the large end of the pry bar and insert the small end into the shank until the end is approximately halfway along the top piece of PVC. Rest the pry bar on the PVC and exert enough downward force to ensure that the screw tips are in contact with the shank. See figure C-4 for an illustration of the method used to apply pressure to the PVC backing using a large bar.

Figure C-4: Illustrates how pressure to the PVC backing is applied using a large bar

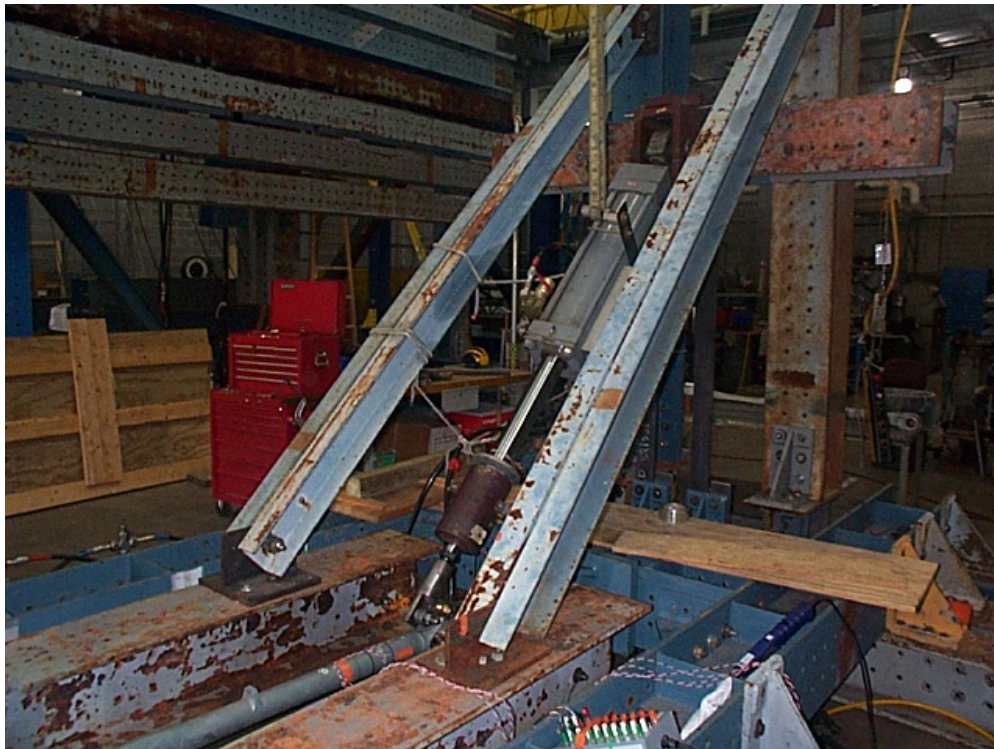
Figure E-2: Test Fixture Showing Damper Actuator

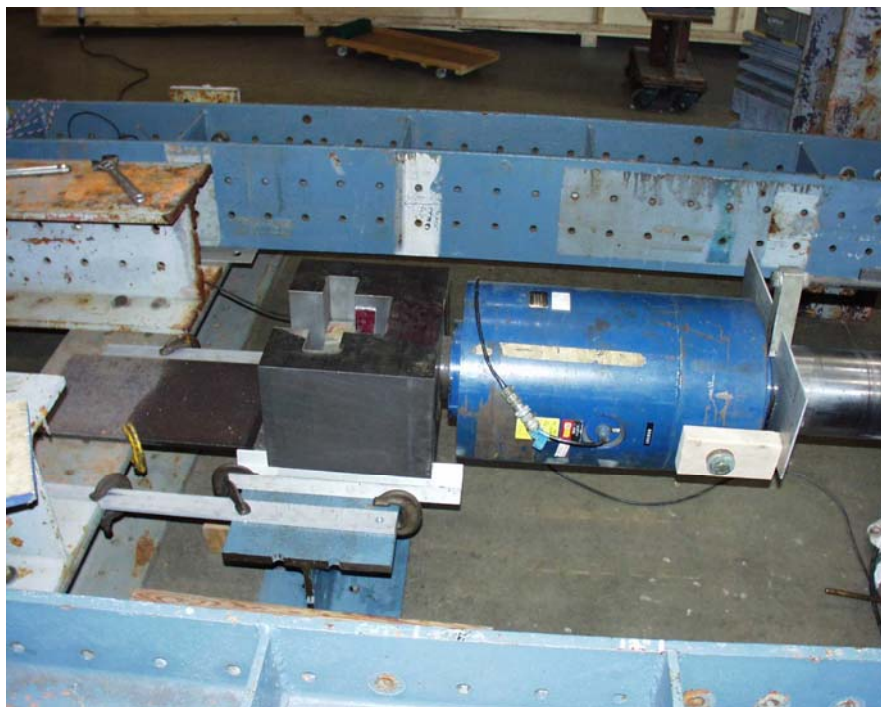
Figure E-4: Hook End Fixture and Axial Load Cell

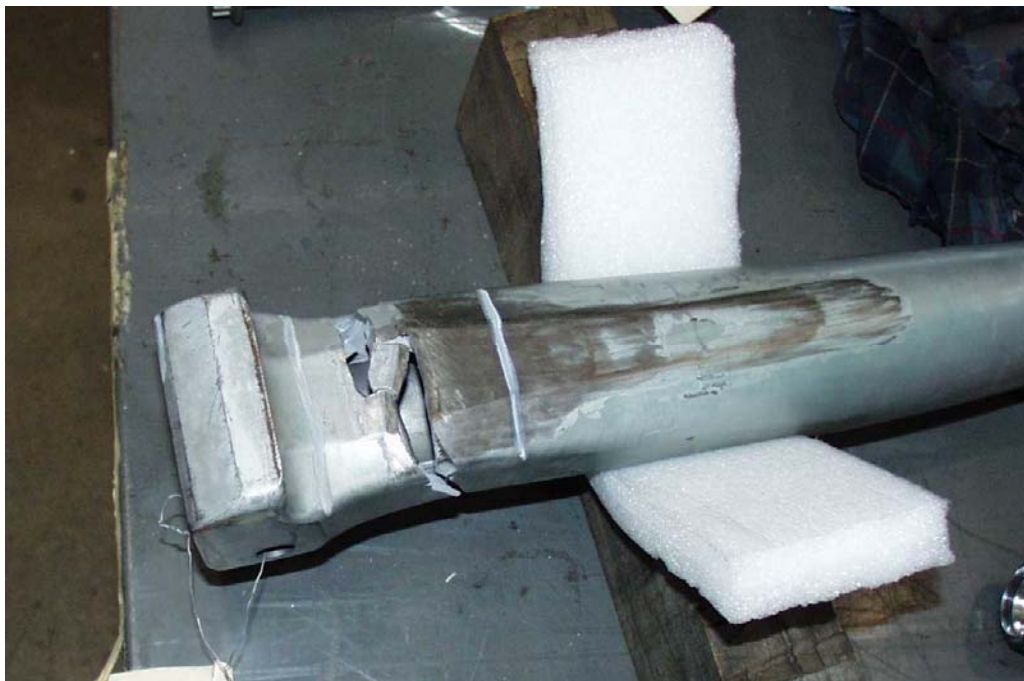
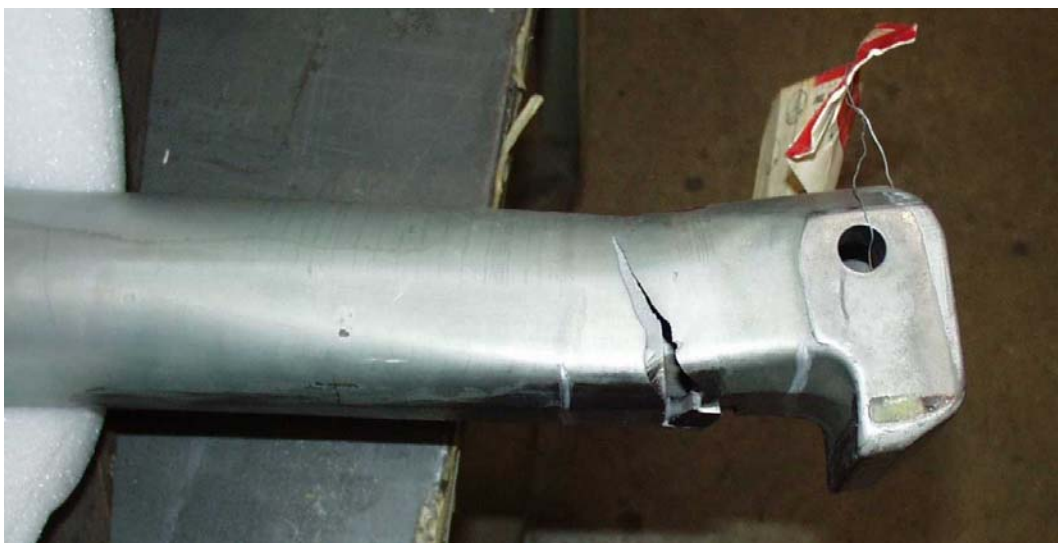
Shank PT0099 failed at 11,089 test spectrum arrestments. The failure location was 1.3 to 1.8 in. forward from the load bearing face of the hook point, at the bottom of the shank tube (figures F-1 and F-2). Two primary crack origins are present on the fracture surface. Crack 1 is 1.3 in. forward from the hook point, and originates from localized surface roughness, as shown in figure F-3. The final crack depth is 0.81 in. Crack 2 is 1.8 in. forward from the hook point, and originates from a scratch that is nearly perpendicular to the loading direction (figure F-5). The final crack depth is 1.27 in. Significant fretting damage is evident on the shank surface in the region of cracks 1 and 2. Multiple secondary crack initiation locations are also visible on the fracture surfaces of cracks 1 and 2 (figures F-4 and F-6).

Figure F-1: Fatigue Test Failure Location for Shank PT0099 (Bottom View)

Figure F-2: Fatigue Test Failure Location for Shank PT0099 (Side View)

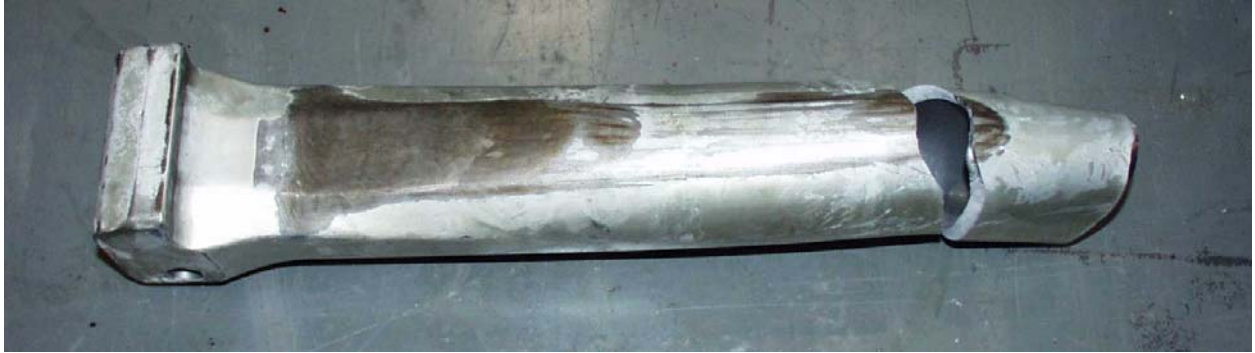
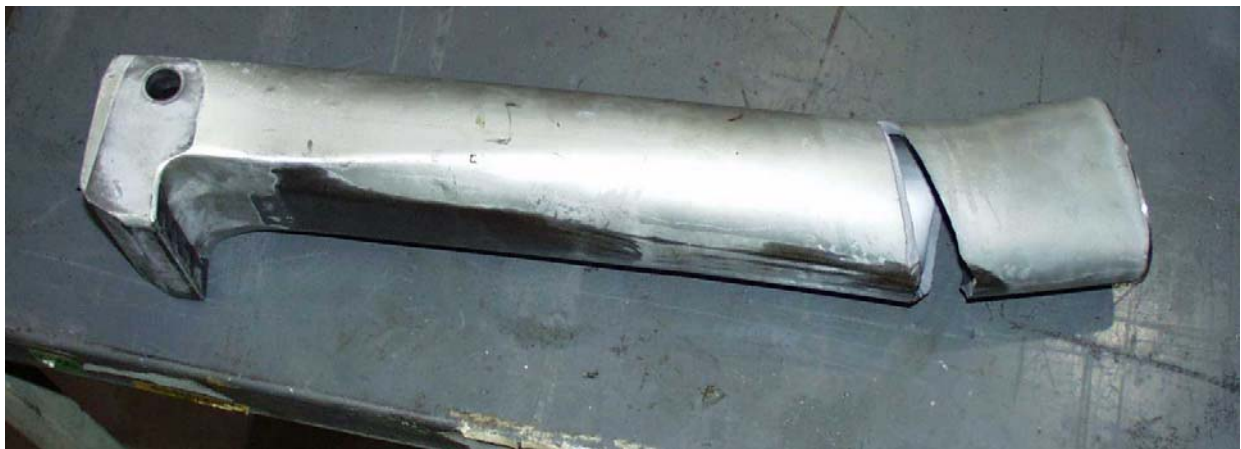
Shank 0491 failed at 9,811 test spectrum arrestments. The failure location was 12.68 in. forward from the load bearing face of the hook point, at the bottom of the shank tube (figures F-7 and F-8). The primary crack origin is a surface scratch approximately 30 deg off of an axis normal to the loading direction, as shown in figure F-9. The final crack depth is 0.92 in. Indications of mild fretting damage are visible on the shank surface in the region of the fatigue crack (figure F-10).

Figure F-7: Fatigue Test Failure Location for Shank 0491 (Bottom View)

Figure F-8: Fatigue Test Failure Location for Shank 0491 (Side View)

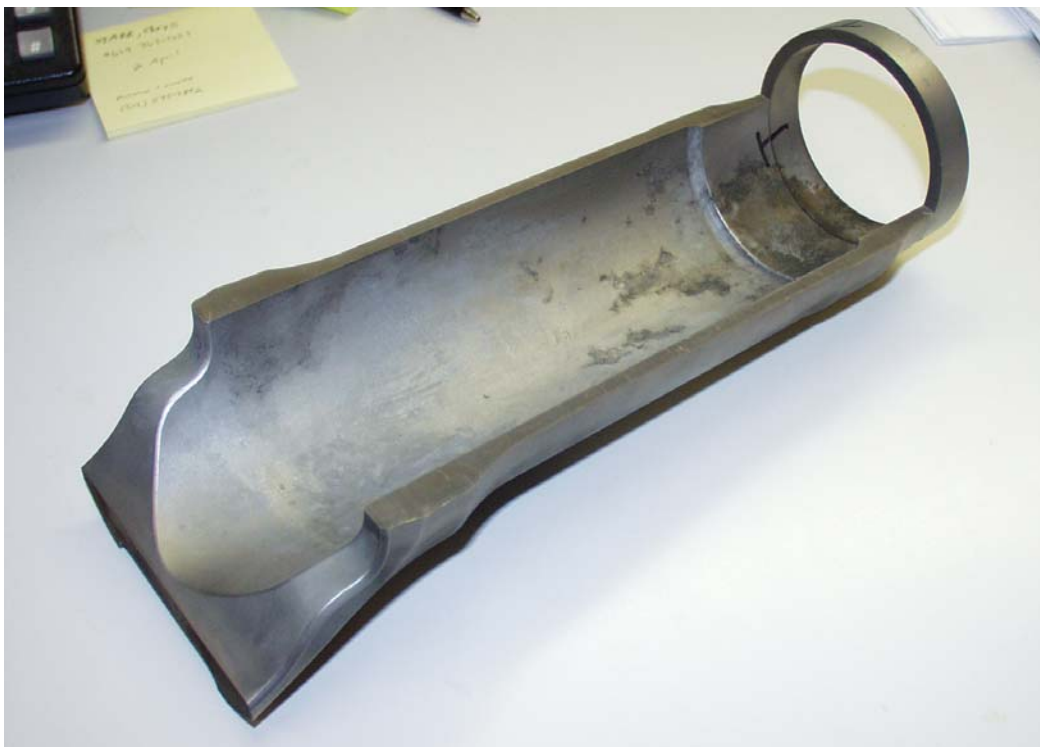
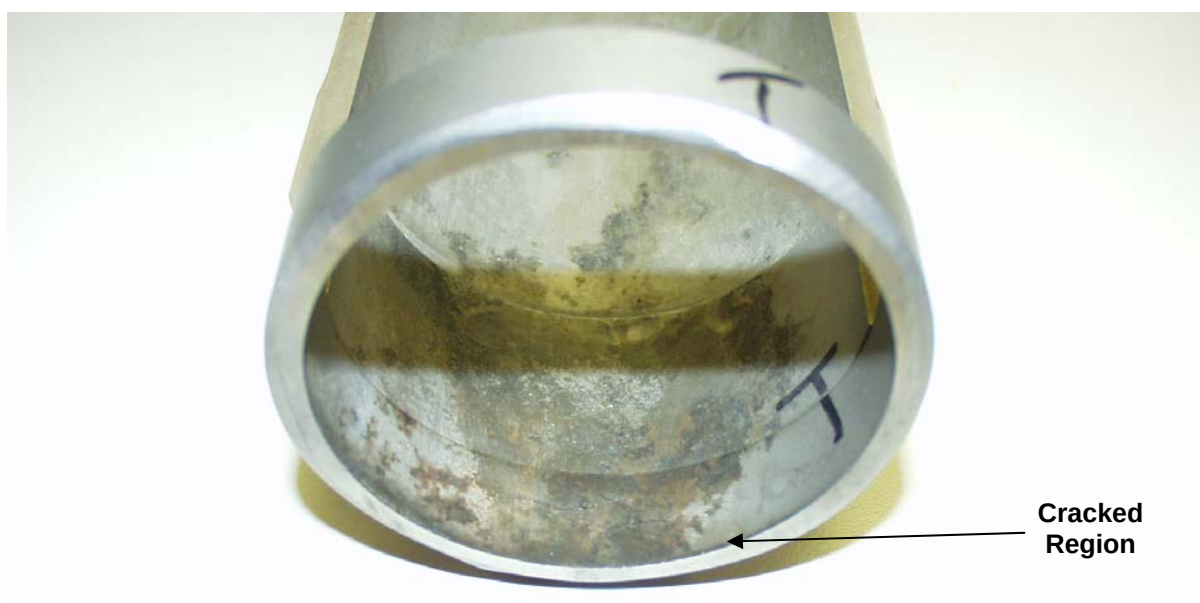
At the completion of fatigue testing, the shanks were destructively sectioned in the lateral damper region to expose the corrosion damage on the inside diameter. Each shank section was then subjected to a magnetic particle inspection in the damper region to look for cracks that may have initiated during testing, but did not grow to critical size. No evidence of cracking was found in any of the shank sections that were examined. However, two fatigue cracks were found on shank PT0099 at 1.55 in. and 1.65 in. forward of the lateral damper sleeve inside diameter fillet (figures F-15 and F-16). The cracks are at the bottom of the shank, and initiated from an area of significant corrosion damage on the inside bore (figures F-17 and F-18). The light colored material wedged in the open crack is replicating material left over from the replicating process.

Figure F-15: Section of Shank PT0099 with Noncritical Fatigue Cracks  
(Forward of Lateral Damper Region)

Figure F-16: Section of Shank PT0099 with Noncritical Fatigue Cracks  
(Forward of Lateral Damper Region)
