# Performance Evaluation Test of the Nemesis M3

**September 2008**

Prepared by  
Institute for Defense Analyses  
4850 Mark Center Drive  
Alexandria, VA 22311-1882

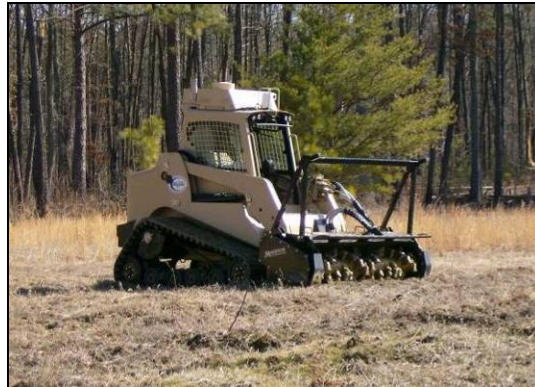
The Nemesis tracked vehicle (Figure 1) was assembled by Applied Research Associates, Inc., on an ASV SR-80 vehicle. It can operate a suite of area-preparation tools. The Nemesis hydraulic track-laying drive system gives the operator the ability to maneuver in all types of terrain, as well as perform 180-degree turns within its own length. Table 1 lists the Nemesis specifications.

Figure 1: Nemesis with Vegetation Cutter Attachment

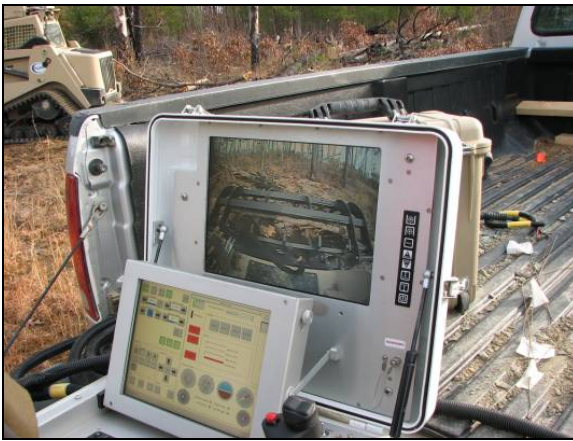
The Nemesis, which can also be controlled by an on-board operator, is fitted with the Modular Robotic Control System (MRCS), a remote-control system manufactured by Applied Research Associates, Inc. This system can provide up to 1.5 km line-of-sight control with video and up to 2.4 km without video. The remote system consists of a receiver antenna, a remote operator control unit, a battery, and the transmit antennas and cameras mounted on the Nemesis vehicle. The operator control unit gives remote operators the ability to fix vehicle speed, maneuver and perform operations with attachments, and view operations from a selection of four cameras (to include a pan/tilt camera that can be slewed by the operator to any desired forward-looking location) through the use of touch-screen and joystick controls (expandable up to eight cameras). In addition, the remote system is equipped with Global Positioning System (GPS) receiver to provide tracking, track mapping, and a record of the vehicle's current location. Figures 2–5 give images of the remote system components, and Table 2 lists specifications of the radio control system.

**Figure 2: Remote Operator Control Unit with Battery Box**

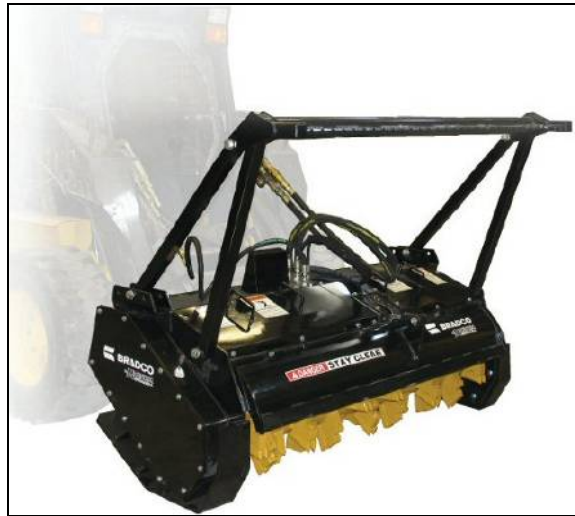
The set of attachments for Nemesis currently contains four skid-steer tools: a mulcher, grapple bucket, 4-in-1 bucket, and a cold asphalt planer. The primary tool is the heavy-duty Bradco Mini-Mag Mulcher brush cutter, capable of cutting heavy undergrowth and trees up to 20 cm (8 inches) in diameter. Figure 6 shows the mulcher, with specifications given in Table 3.

**Figure 6: Bradco Mini-Mag Mulcher XL 165-6**

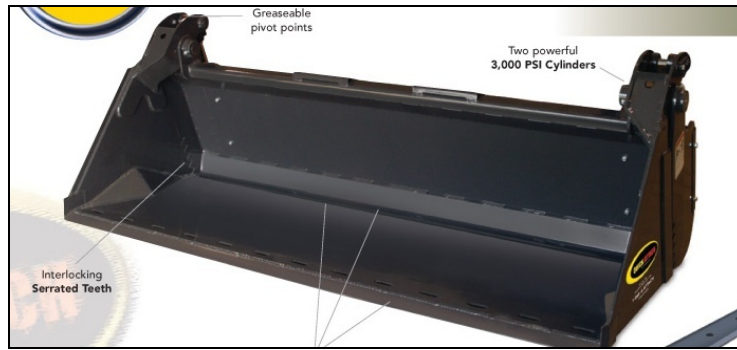
The 4-in-1 bucket (the Quick Combo Bucket; see Figure 7) and the Eagle Talon grapple (see Figure 8), both built by Quick Attach Attachments, Inc., are used to clear areas where vegetation has been cut or stockpiled. The 4-in-1 bucket can be used as a shovel or scoop to pick up and move debris or as a plow/light grapple to push debris into berms for later disposal. The grapple is ideal for lifting large, heavy items (rocks, logs, etc.) and moving them to nearby locations. Specifications for both attachments can be found in Tables 4 and 5.

**Figure 7: Quick Combo, 4-in-1 Bucket**

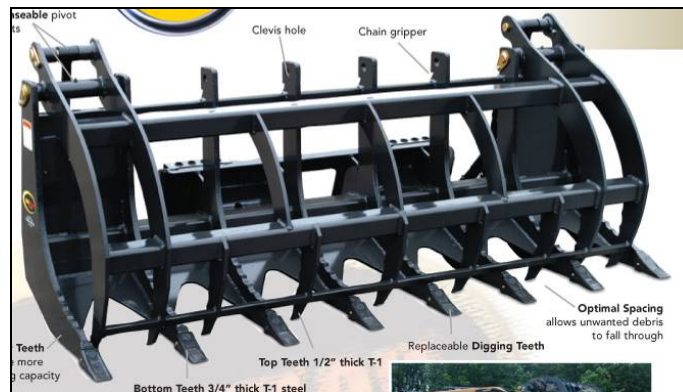
**Figure 8: Eagle Talon Grapple**

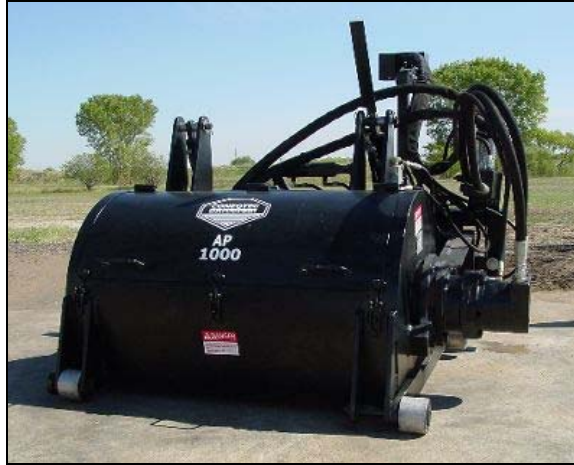
Adding the Coneqtec Corp. pavement planer to the Nemesis attachments tool box gave another dimension to the test program; namely, the ability to remotely control the tool versus the performance of the tool. In normal pavement planer operations, the cold planer is able to remove pavement to a depth of 15 cm (6 in.). Given this and the design of the planer, which is not unlike that of a very robust tiller, it was considered an ideal off-the-shelf tool for removal (including neutralization) of antipersonnel land mines and possibly for quality-assurance operations. Figure 9 shows the pavement planer, and specifications are given in Table 6.

**Figure 9: Cold Planer**

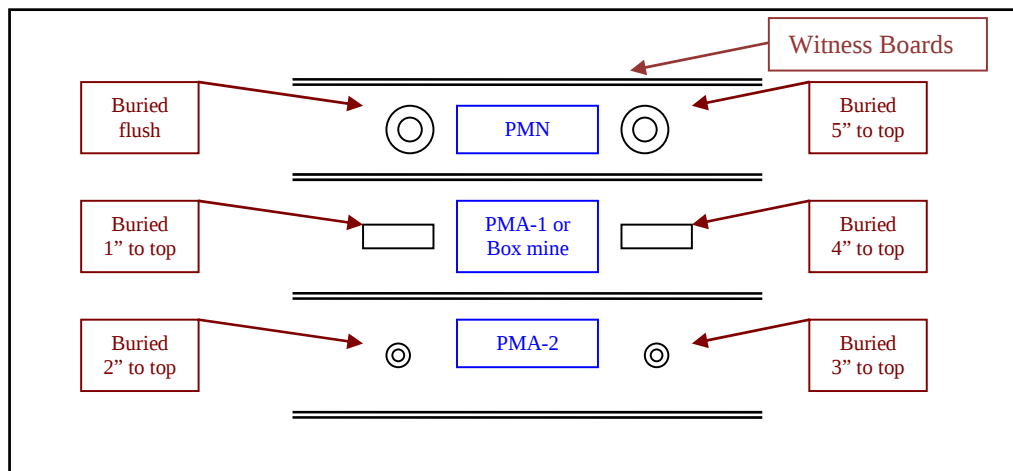
Figure 16 shows Test Site C, an area of little to no vegetation consisting of a clay and loam mix soil. Due to rain in the weeks prior to testing, the ground was relatively soft. Because this area was designated for planer testing, six antipersonnel mine simulants were buried at various depths, together with four 8 ft (length) × 1 ft (width) fiber witness boards. Figure 17 is a plan view of the layout. Use of the mines and boards during testing will be described in Section 5.6.

**Figure 17: Test Site C, Mine Simulant and Witness Board Layout, Plan View**

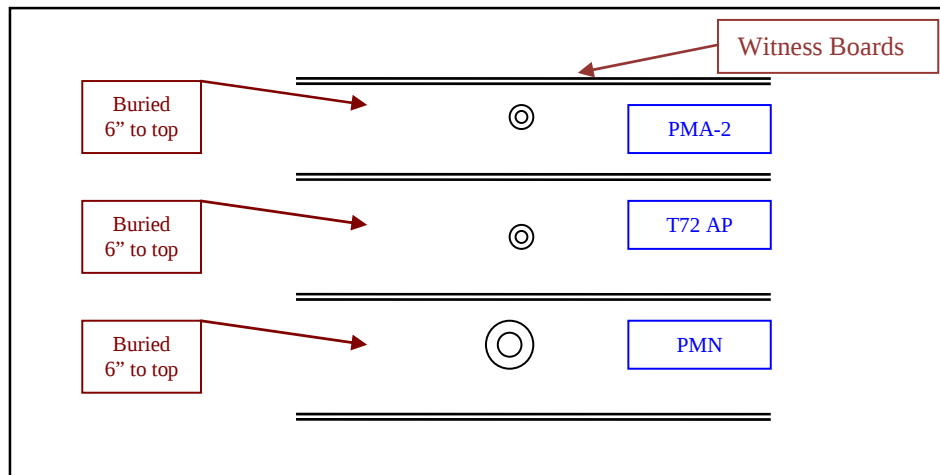
Test Site D was used for additional testing of the cold planer. The soil in Test Site D is a sandy loam consisting of a low, thick, grass-like vegetation with a heavy root system (see Figure 18). Like Test Site C, mine simulants and fiber boards were buried within the test area for the cold planer testing. Figure 19 is a plan view of the mine and board layout.

**Figure 19: Test Site D, Mine Simulant and Witness Board Layout, Plan View**

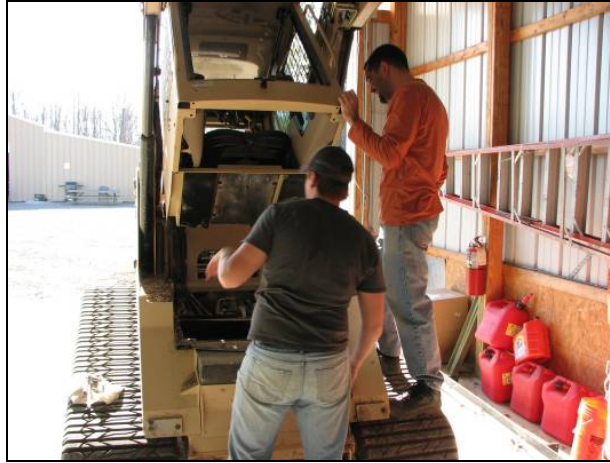
All maintenance and inspections, except those items requiring under-the-cab investigation, can be performed by a single trained person in less than 2 hours. For under-the-cab inspections, three persons are recommended to lift and lock the cab in its raised position (see Figure 21). Tools needed to perform maintenance inspections will be provided with the Nemesis.

**Figure 21: Cab Raised for Maintenance Inspection**

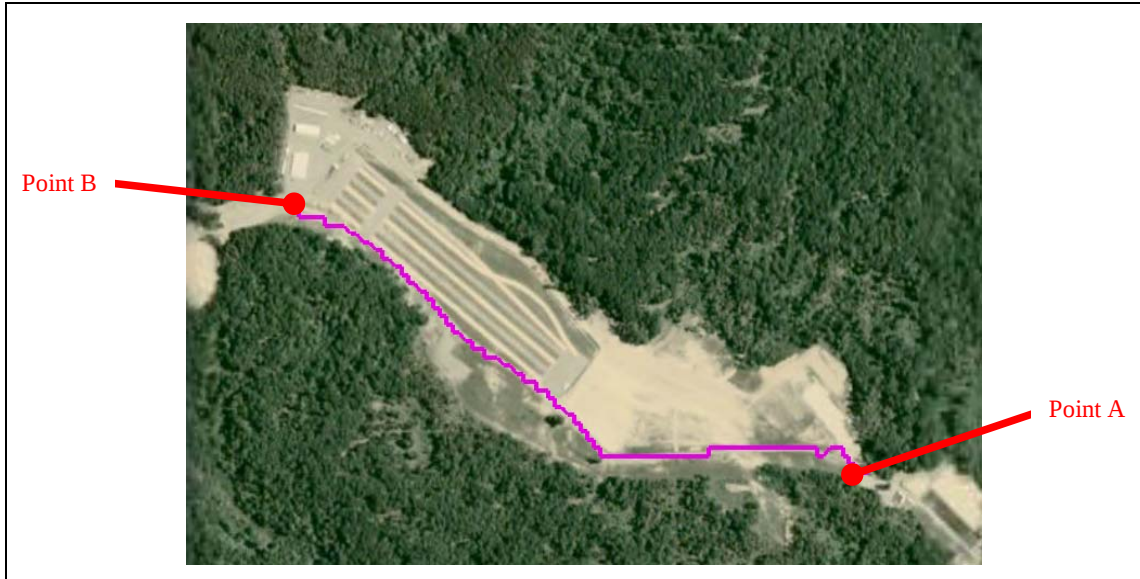
During the line-of-site test, the Nemesis passed by three GPS monuments located within the test site compound. Since a mapping of the vehicle's path and its current GPS locations are viewable on the operator control unit, the GPS monuments located within the test site were used to verify the accuracy of the system's GPS (latitude-longitude in degrees, elevation in meters). For each monument within the test site, the operator stopped the vehicle next to the monument location and the corresponding GPS coordinates were compared. In each case, the GPS coordinates of the remote guidance unit were identical to those of the GPS monuments.

**Figure 22: Line-of-Site Test Route**

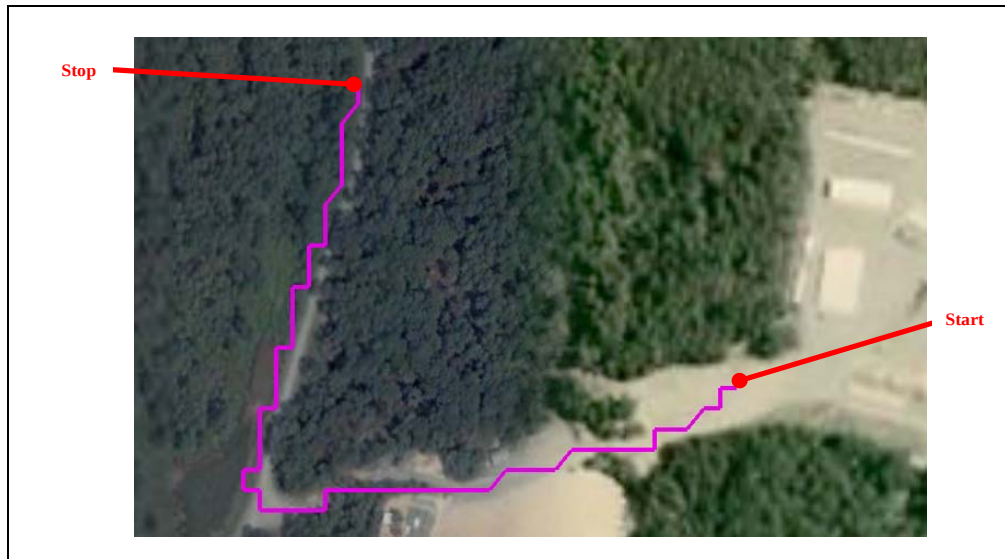
The test was conducted in an area with hills, trees, and other vegetation acting as line-of-sight obstructions. The remote operator maintained complete control of the Nemesis for a travel path of approximately 0.45 km, at which time the video feed began to skip and delay. The operator continued movement along the road until a total loss of video feed occurred. Although the video transmission ceased, the operator maintained control of the vehicle. (Nevertheless, in any situations in which the vehicle is beyond the operator's line of sight, it is recommended that operations stop once video feedback is lost.) The total path traversed was approximately 0.55 km, a straight-line distance of approximately 0.25 km. Figure 23 shows the non-line-of-site path.

Figure 23: Non-Line-of-Site Test Route

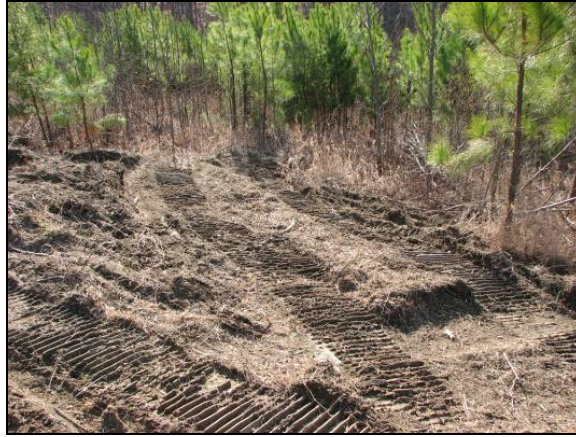
The second cutting performance evaluation included the remote cutting of Category 2 vegetation in Test Site B. Slopes within the Category 2 test area averaged 14 degrees, and cutting operations in this area were executed in with-slope passes to avoid the mobility issues caused by the vegetation and dirt mounds in Category 1 testing. This with-slope pattern appeared to alleviate some of the problems experienced earlier. In total, 240.8 m<sup>2</sup> of Category 2 vegetation were cut within 28 minutes, giving a cutting rate of 516 m<sup>2</sup>/hour. Figures 27 and 28 show the Category 2 test area before and after cutting operations.

**Figure 24: Vegetation/Dirt Mounds Created During Mulching Operations**

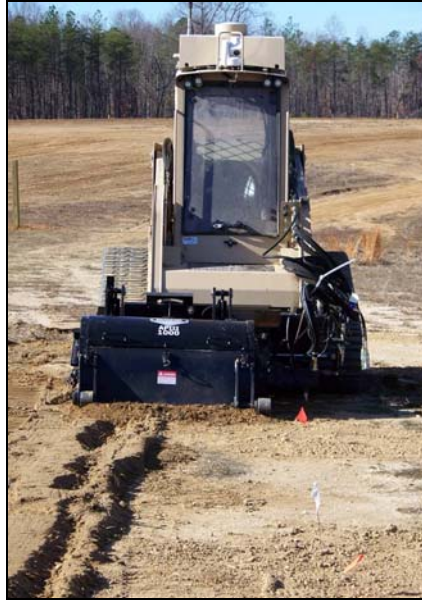
The cold planer is a 101.6 cm wide off-the-shelf asphalt planer that has potential for the removal or neutralization of small antipersonnel mines. Because the cutting width of the planer is less than the width of the Nemesis, the planer's attached position relative to the vehicle will be offset to the right to cover the path of the right track (see Figure 39). This will ensure that the planer will engage threats before that side's track overpasses them. The exposed left track will always operate in an area already cleared of mines to maintain its safety.

**Figure 39: Cold Planer Attached to Nemesis**

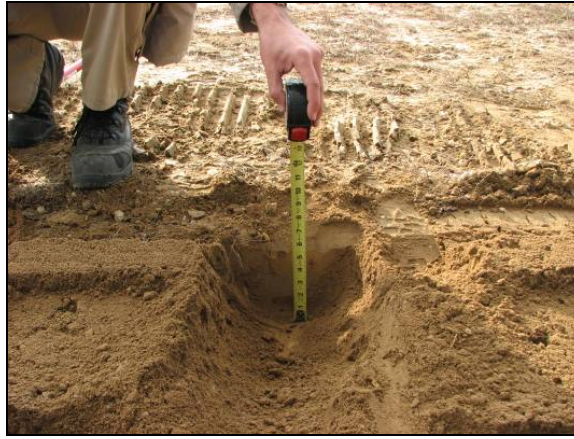
Before remote operations, the planer was manually operated within Test Site C. The purpose of this manual operation was to determine the ground-to-planer height that should be maintained for planing operations. During this test, it was observed that the weight of the planer caused the vehicle to rock while operating, stop abruptly when attempting to brake, and tilt forward when the planer was lifted off the ground. Also, due to the skewed location of the planer in relation to the Nemesis, the vehicle tended to drift to the right when forward operations straight ahead were attempted. The planer was able to penetrate 6 inches into the ground (see Figure 41), although buildup inside and in front

**Figure 41: Penetration Depth of Planer in Manual Operations**

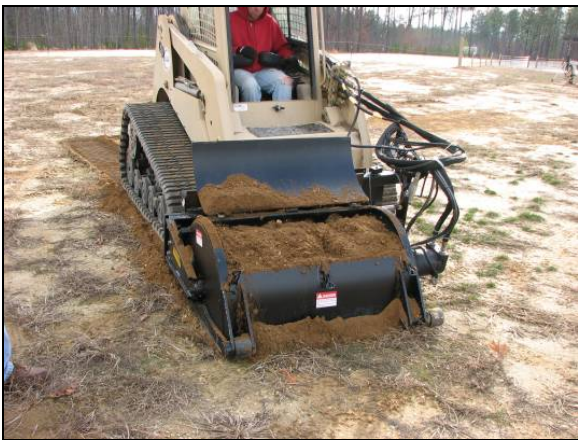
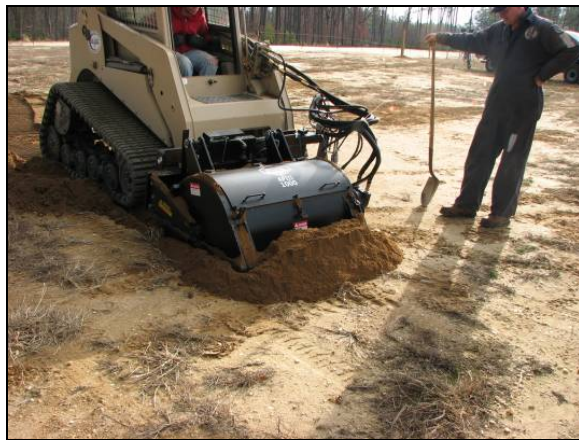
of the planer caused the vehicle's forward movement to slow or stop on many occasions. Figures 42 and 43 show dirt buildup inside and in front of the planer.

**Figure 42: Dirt Buildup Inside Planer**

**Figure 43: Dirt Buildup in front of Planer**

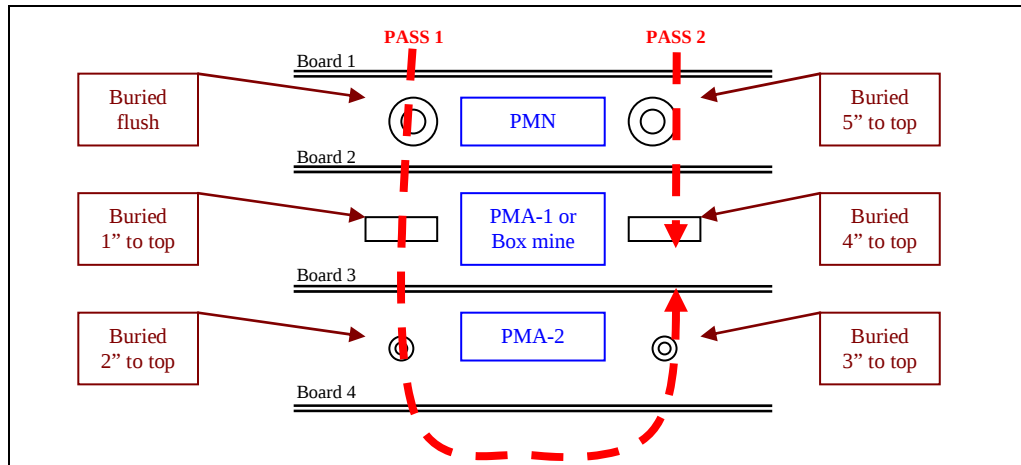
The first remote operation performance test of the Planer occurred at Test Site C. As described in Section 3.3, Test Site C consists of flat ground with clay and loam mixed soil and spotty amounts of low vegetation (e.g. ,grass, shallow roots). Simulated mines and 8 ft × 1 ft fiber witness boards were buried according to the layout in Figure 44. The dotted line represents the path forward by the Nemesis.

**Figure 44: Test Site C, Vehicle Path**

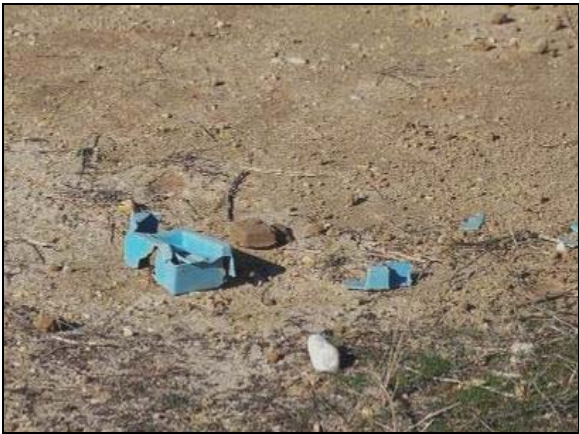
| <b>Simulated Mine Description</b> | <b>Outcome</b> |
|---|---|
| Box mine, buried 1 in. to the top of the mine | Mine broken into pieces by the planer |

**Figure 45: Box Mine Broken in Pieces by Planer, Test Site C (Pieces Recovered by Test Personnel)**

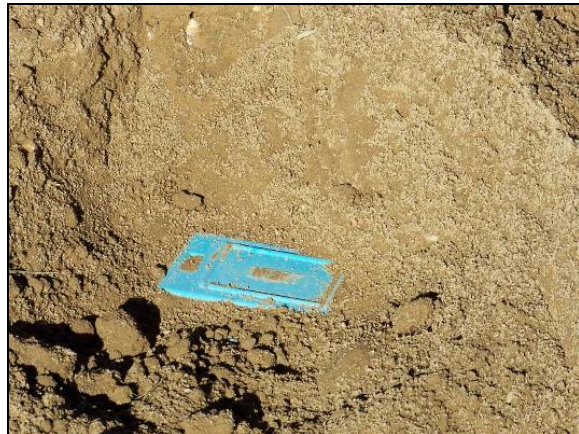
**Figure 46: Box Mine Untouched by Planer, Test Site C (Uncovered by Personnel for Photo)**

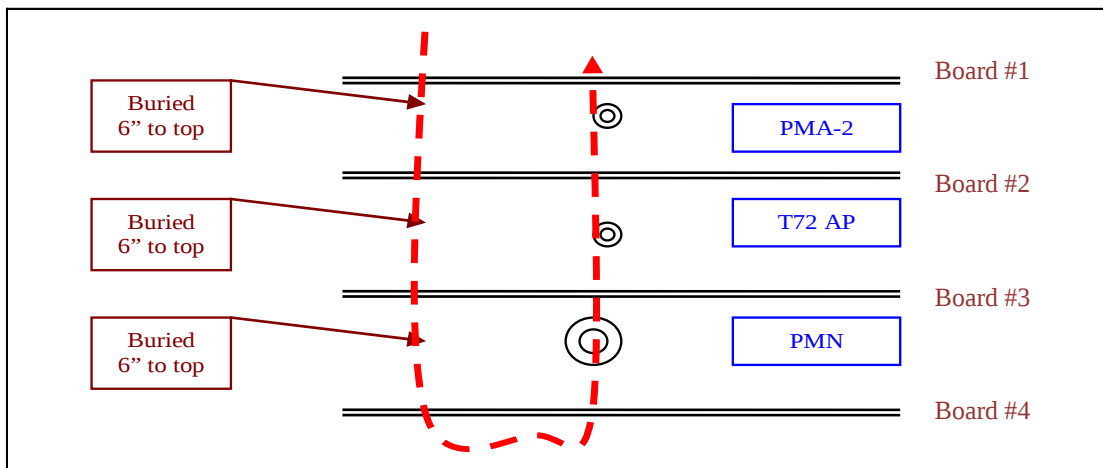
The second performance evaluation for the remotely operated planer occurred at Test Site D. As mentioned earlier, surrogate mines and fiber boards were buried there. Figure 51 shows the vehicle's path. The major difference between this planer test and the previous test is the abundance of low vegetation and the density of the root systems present in Test Site D (see Figure 52).

**Figure 51: Test Site D, Vehicle Path**

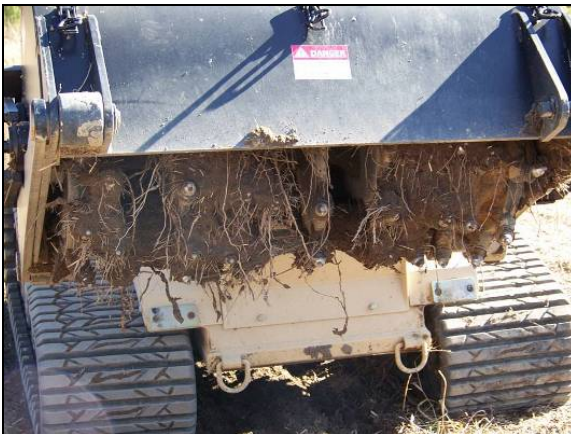
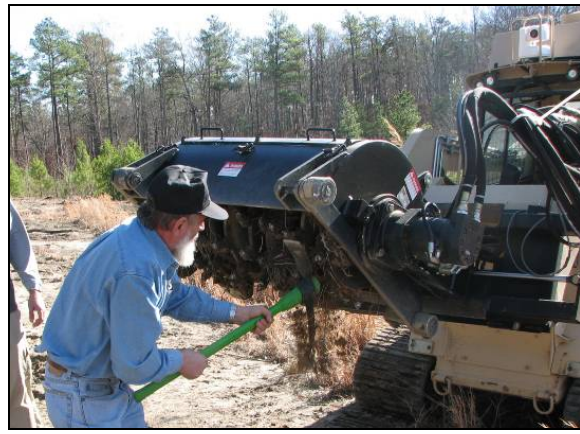
The vegetation present in Test Site D posed new challenges for the planer. Whereas in Test Site C the dirt accumulated within and in front of the planer, at Test Site D the density of the root systems and the moisture retained in the soil by the vegetation caused the dirt to pack in between the planer cutting tillers. Compounding this, the cutting tiller disks are canted to the mounting shaft to provide maximum coverage of the cutting teeth, but the variable separation between the tiller disks became traps for the roots and soil. This collection of dirt and roots was hard enough to require the use of picks and shovels for removal (see Figures 53 and 54).

**Figure 53: Dirt and Vegetation Accumulation Inside Planer**

**Figure 54: Removal of Dirt and Vegetation Accumulation**

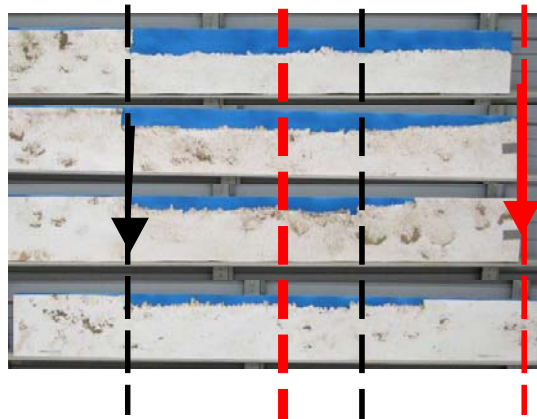
As dirt and vegetation accumulated within the planer as it traveled forward, the ground-penetration depth decreased dramatically. Furthermore, the inability of the planer to achieve deep penetration due to vegetation and dirt accumulation made contact with the buried surrogate mines impossible. As a result, all mines were left untouched by the planer. Tables 11 and 12 provide data on the buried mines and fiber boards for Test Site D. (Note that the top-most board in Figure 51 is labeled as Board #1 and the bottom-most board is Board #4.) A picture of the boards is shown in Figure 55. Black and red lines/arrows represent first and second pass, respectively.

**Figure 55: Witness Boards Test Site D**

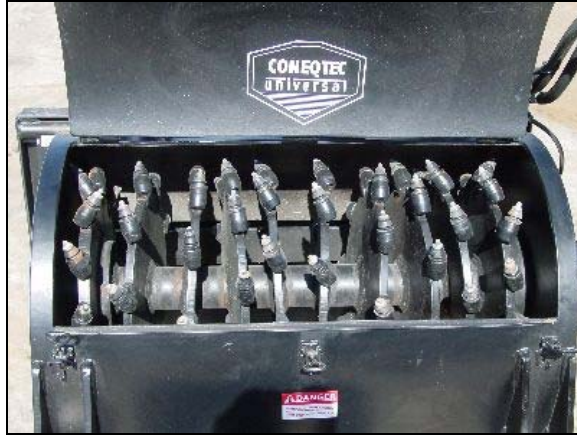
Although the planer was clogged with soil at both test sites, it was slowed less while remotely operated than while manually operated. The remote system allows the Nemesis to maintain a constant forward speed and a maximum speed limit. For example, in “slow-ops” mode, a forward speed down to 0.3 kph can be maintained. During this test, the optimum speed for the cold planer was 0.4 kph. In Test Site D, where more vegetation and root systems were present, the clogging problems limited the use of the planer. A manufacturer’s representative recommended that the cold planer be reengineered to incorporate straight-mounted tiller disks, as opposed to the canted disk installation (see Figure 56), to eliminate some of the dirt collection problems faced during operation. This dirt and vegetation accumulation not only slows operations, but could potentially present a danger to personnel clearing the dirt out of the tiller head if a mine became lodged inside the clogged dirt.

**Figure 56: Angled Digging Tooth Plates in Planer**

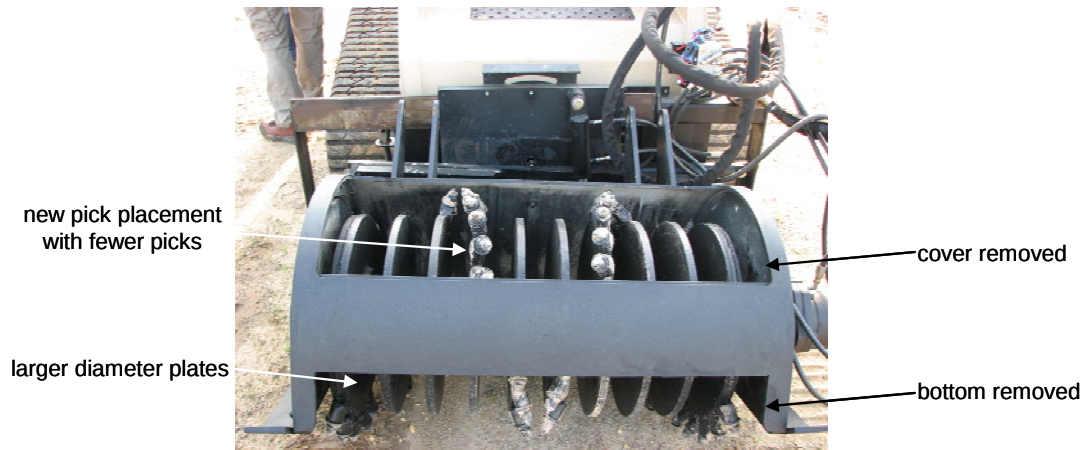
The modifications made to the cold planer helped reduce the amount of dirt buildup in the drum and behind the attach plate. However, the performance overall decreased as can be seen on the witness boards. The cuts made were not as clean as before and they are still not consistent across the boards. The change from an undercut to an overcut resulted in the planer stalling frequently and bouncing off of the ground. The undercut configuration helped keep the planer in contact with the ground, where the overcut caused the planer to jump off of the ground when the teeth first try to cut into the surface. The new motor spun the drum at a slower RPM causing the planer to push mines rather than destroy them. This can also be seen on the witness boards and explain why the cuts were not as clean. When the picks contacted the witness boards at the slower RPM, the tendency was to push on the board until it cracked rather than cleanly cut through them.

The new perpendicular plate orientation and the removal of the cover and front and rear shield help reduce the dirt buildup in the drum and the clogging of material between the plates. However, the drum will have to be returned to its original “undercut” direction in order to help maintain a consistent depth into the ground. The motor will have to be replaced again with one that can provide a higher RPM in order to create a consistent cut and facilitate destruction of mines, preventing them from potentially being

**Figure 57: Test 2 Configuration, Cover Removed, Planer Disks Perpendicular to Shaft**

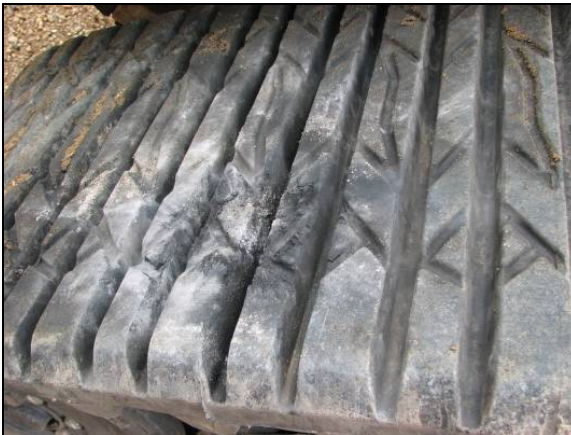
The first mine to be used for testing was Mine A, a small, round antipersonnel mine. Inspection of the vehicle after the blast showed damage to both the exterior and interior of the rubber track (see Figures 62–65). Exterior damage was limited to surface scarring, whereas interior damage resulted in a deep crack in one of the belt's drive cogs. In addition to the track damage, the drive system encoder, which is located at the rear inside the loop of the track, sustained some damage. As a result of the damage, the vehicle veered slightly left during straight drives.

**Figure 64: Damage to Track Exterior, Mine A**

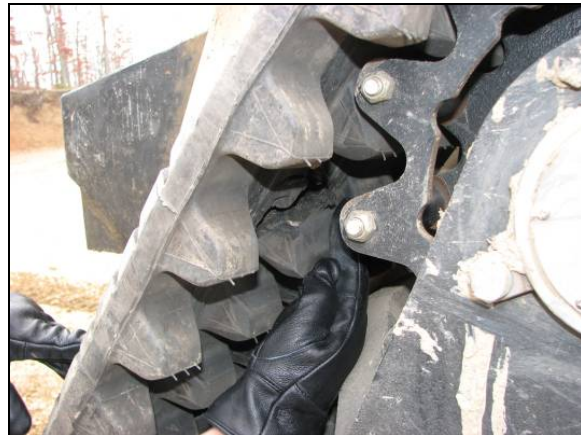
**Figure 65: Damage to Track Interior, Mine A**

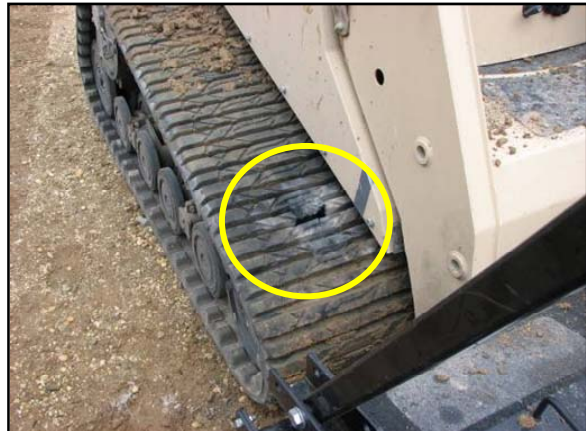
The last mine tested, Mine C, had the largest explosive (TNT) content of the three mines tested. The blast from this mine damaged both the exterior and interior of the rubber track, as well as two of the graphite composite wheels inside the track. Although the damage was more severe than the damage sustained from Mine A, the vehicle was still able to function and could safely move both forward and backward after the blast. In fact, the Nemesis traveled approximately 200 m from the blast test site to a maintenance garage. Figures 66–69 are images of the blast and damage incurred from Mine C.

**Figure 67: Damage to Track Exterior, Mine C**

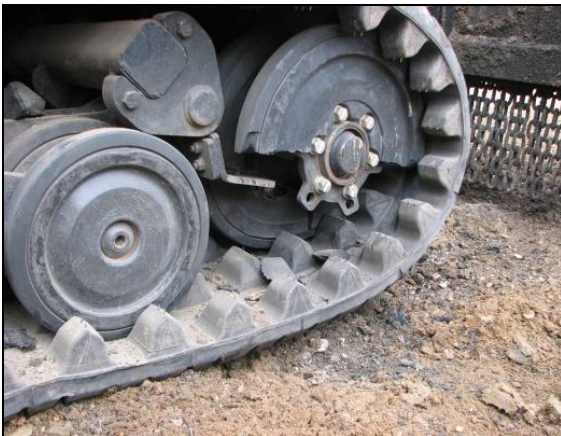
**Figure 68: Damage to Outer Wheel, Mine C**

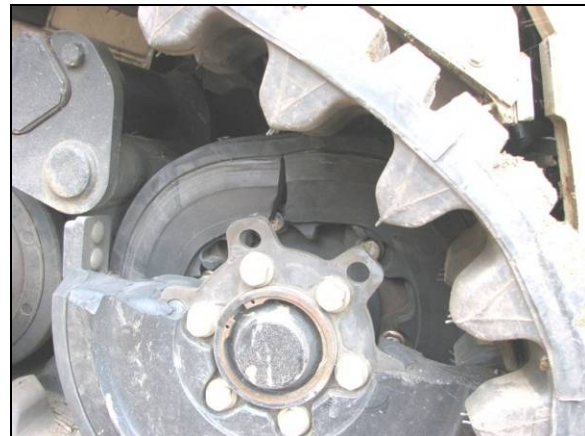
**Figure 69: Damage to Outer and Inner Wheel, Mine C**

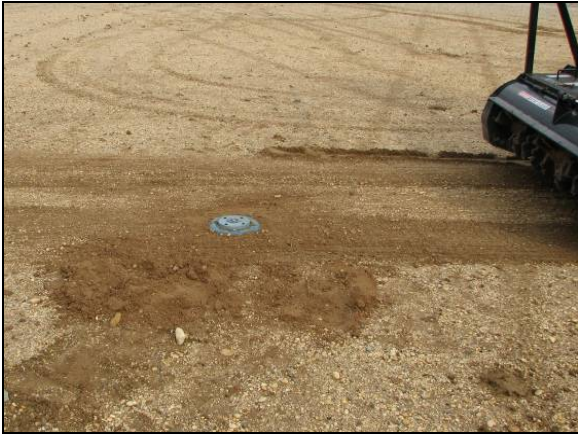
To perform the test, the smoke-fused antitank mine was buried flush to the ground's surface, as shown in Figure 69. The Nemesis was remotely driven over the mine without activating the fuse (Figure 70). The Nemesis then backed over the mine, again without setting the mine off. The mine was lifted and reburied with the fuse at one inch above the ground. The Nemesis again drove over the mine without detonating the fuse. To ensure the fuse was functioning properly and that the Nemesis had indeed demonstrated an overpass capability, test personnel drove a pickup truck over the mine. This set off the smoke fuse (see Figure 71), thus verifying that the Nemesis has a potential antitank mine overpass capability.

**Figure 70: Emplaced Smoke-Fused Antitank Mine**
